# Missing aircraft, VH-WRT, GA-8 Airvan, Buckingham Bay, NT. 16 Oct 2008

INFRA-08361

## Abstract

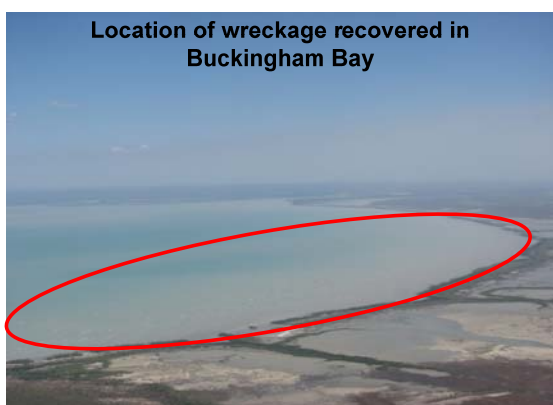
**Figure 3: South-western part of Buckingham Bay**

On 17 October 2008, items of wreckage were found in the south-western part of Buckingham Bay (Figure 3).

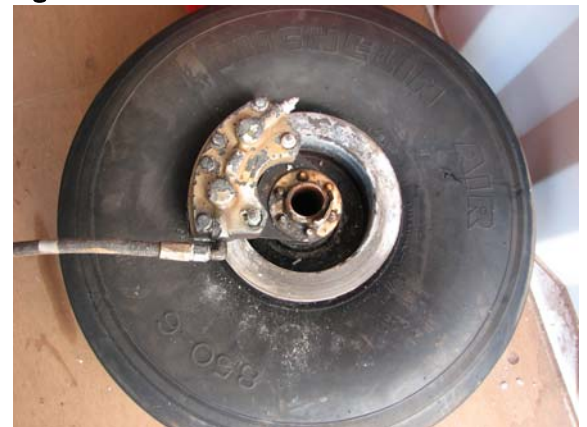
**Figure 4: Left main wheel**

Fracture of the left main landing gear wheel (Figure 4) had occurred transversely through the welded transition between the stub axle and landing gear leg. The fracture surfaces were typical of a ductile shear mechanism, and their form was consistent with failure occurring under bending overstress conditions. The nose wheel yoke had separated from the oleo at the bolted connection between the two components. Both the left main wheel and the nose wheel components showed significant levels of corrosion and associated metal-loss that attested to their period of immersion in salt water.

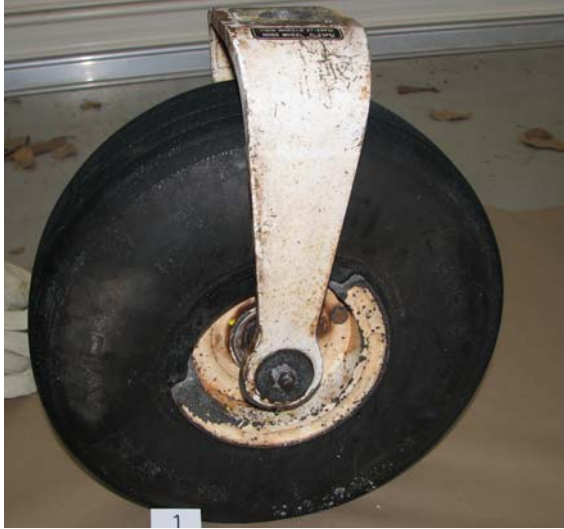
Figure 5: Nose wheel

Items of wreckage were recovered from the south-western part of Buckingham Bay by parties from Elcho Island and by the Australian Customs Vessel 'Roebuck Bay'. This included the left main wheel, the nose wheel, nineteen 20 L jerry cans, six seat bases, one seat back, and miscellaneous cargo, including school stationery (Figures 4 to 6).

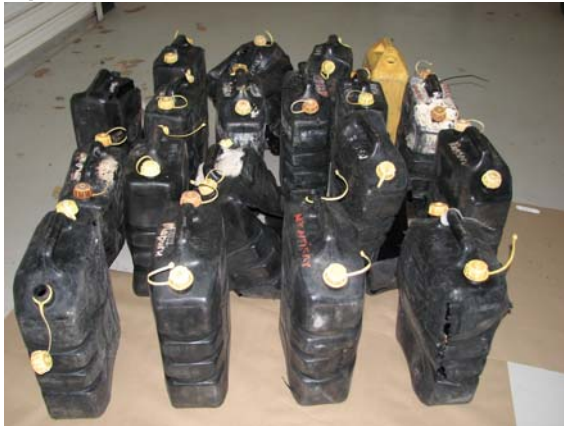
Figure 6: 20 L jerry cans

Around half of the 20 L jerry cans recovered had ruptured in a manner consistent with their exposure to the abrupt hydraulic pressure effects created within the internal liquid, as the aircraft impacted the water (Figure 6).

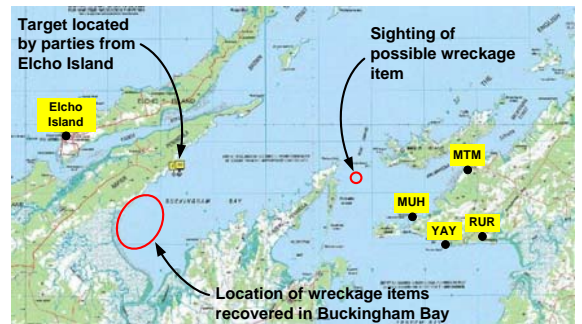
Figure 7: Location of wreckage recovered and sighted, and a possible wreck target

western side of Buckingham Bay, just south of the direct track between Elcho Island Airport and MataMata, was at first thought to be the aircraft. NT Police divers searched this area, but found nothing at that site.

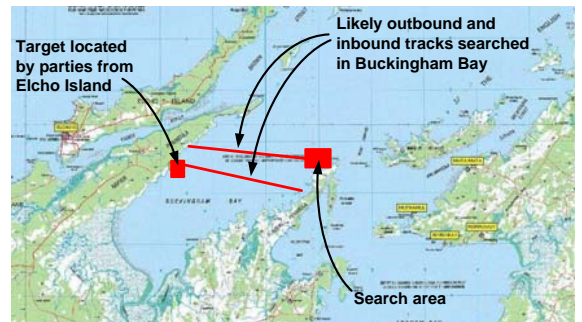
Figure 8: Location of NT Police and ATSB search effort

Subsequently, a systematic 6-day search was conducted by the NT Police and the Australian Transport Safety Bureau (ATSB) in the area around the suspected target mentioned above, as well as in the area west of the northern end of the Flinders Peninsula, and across Buckingham Bay along the possible outbound and return tracks it was believed the pilot would have been most likely to take (Figures 7 and 8).
