MARINE SAFETY INVESTIGATION
REPORT 162

Independent investigation into the grounding
of the Malaysian flag container ship

Bunga Teratai Satu

Sudbury Reef, Great Barrier Reef
2 November 2000

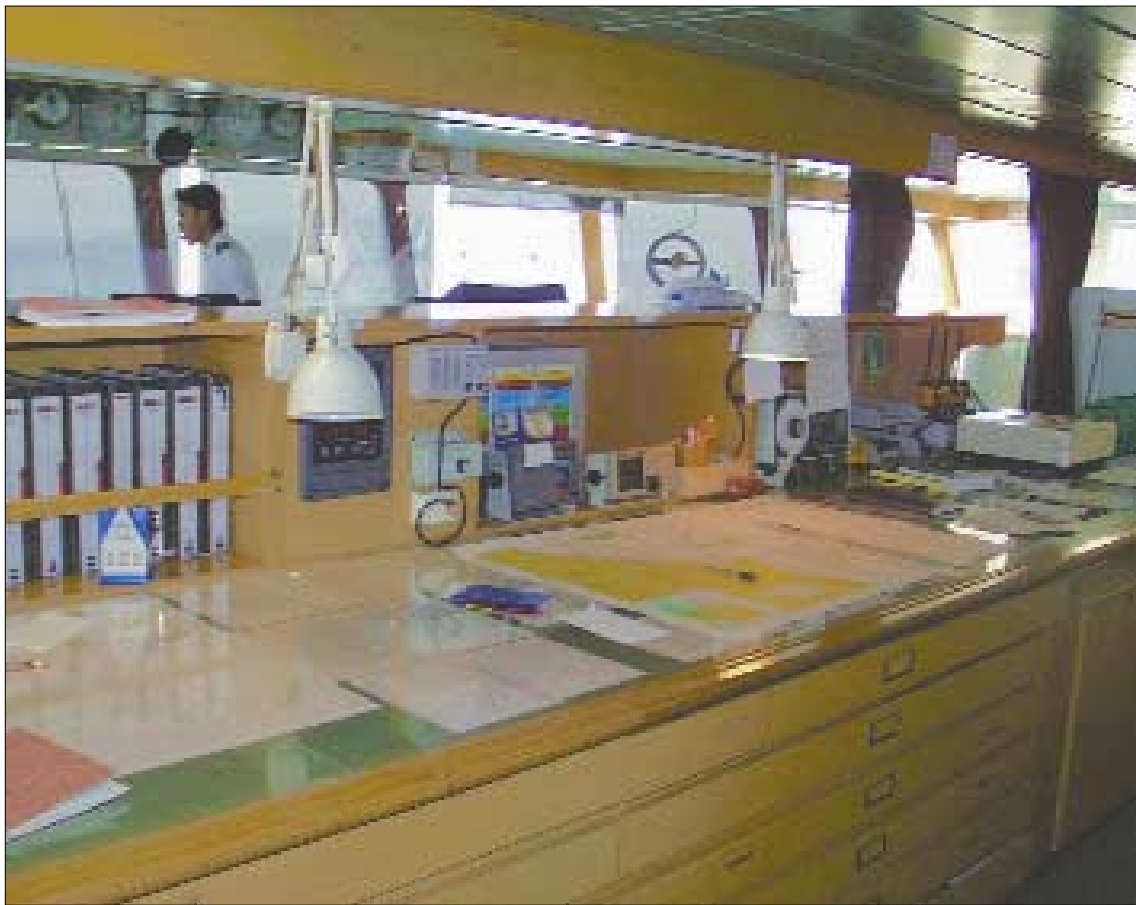
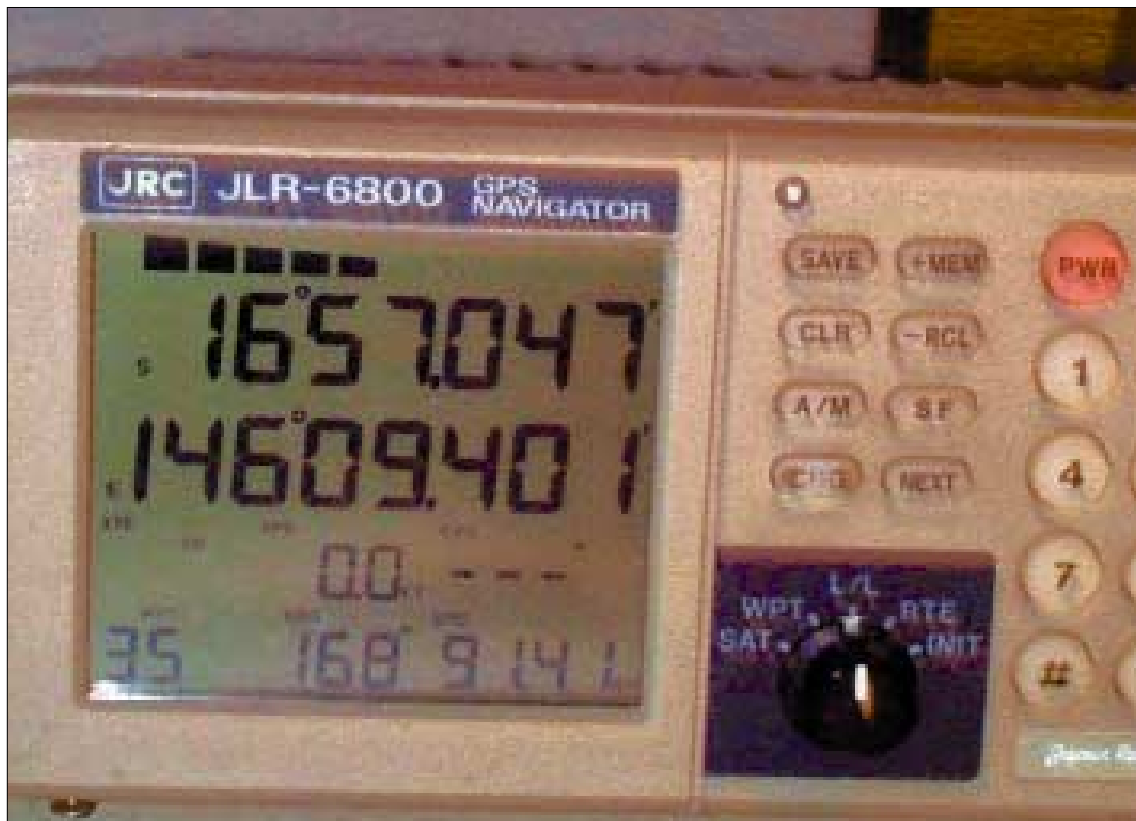
On 21 November, a specialist maintenance engineer examined the ship's GPS on behalf of the Inspector. (Figs. 4 and 5) No fault was found either in the aerial or in the receiver. The ship's staff stated that the GPS was functioning properly both before and after the grounding. It is therefore concluded that the GPS was working properly and there was no fault in the system at the time of the incident.

It should be pointed out that the GPS alarm is not loud and is identical for all alarm conditions. The alarm cannot be heard on the bridge wing, or over the noise of the vacuum cleaner when the bridge is being cleaned. Also it is similar to the Digital Selective Call alarm, part of the GMDSS system, which was located a few metres from the GPS.

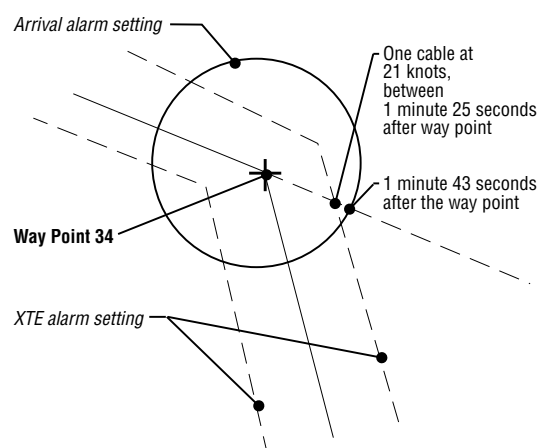
Figure 6:
Diagram showing GPS urgent alarm times

There is no clear evidence as to when any audible alarm was cancelled at, or near waypoint 34. The arrival alarm would have sounded just after 0658 and if it had not been cancelled, would have continued sounding until the XTE alarm was finally cancelled after the grounding. The AB could not recall either the alarm or the mate being inside the wheelhouse after the time his wife arrived on the bridge. The mate stated that he cancelled the alarm, although it is not

clear if this took place at 0700, or after 0715 when he checked the ship's position following the phone calls.

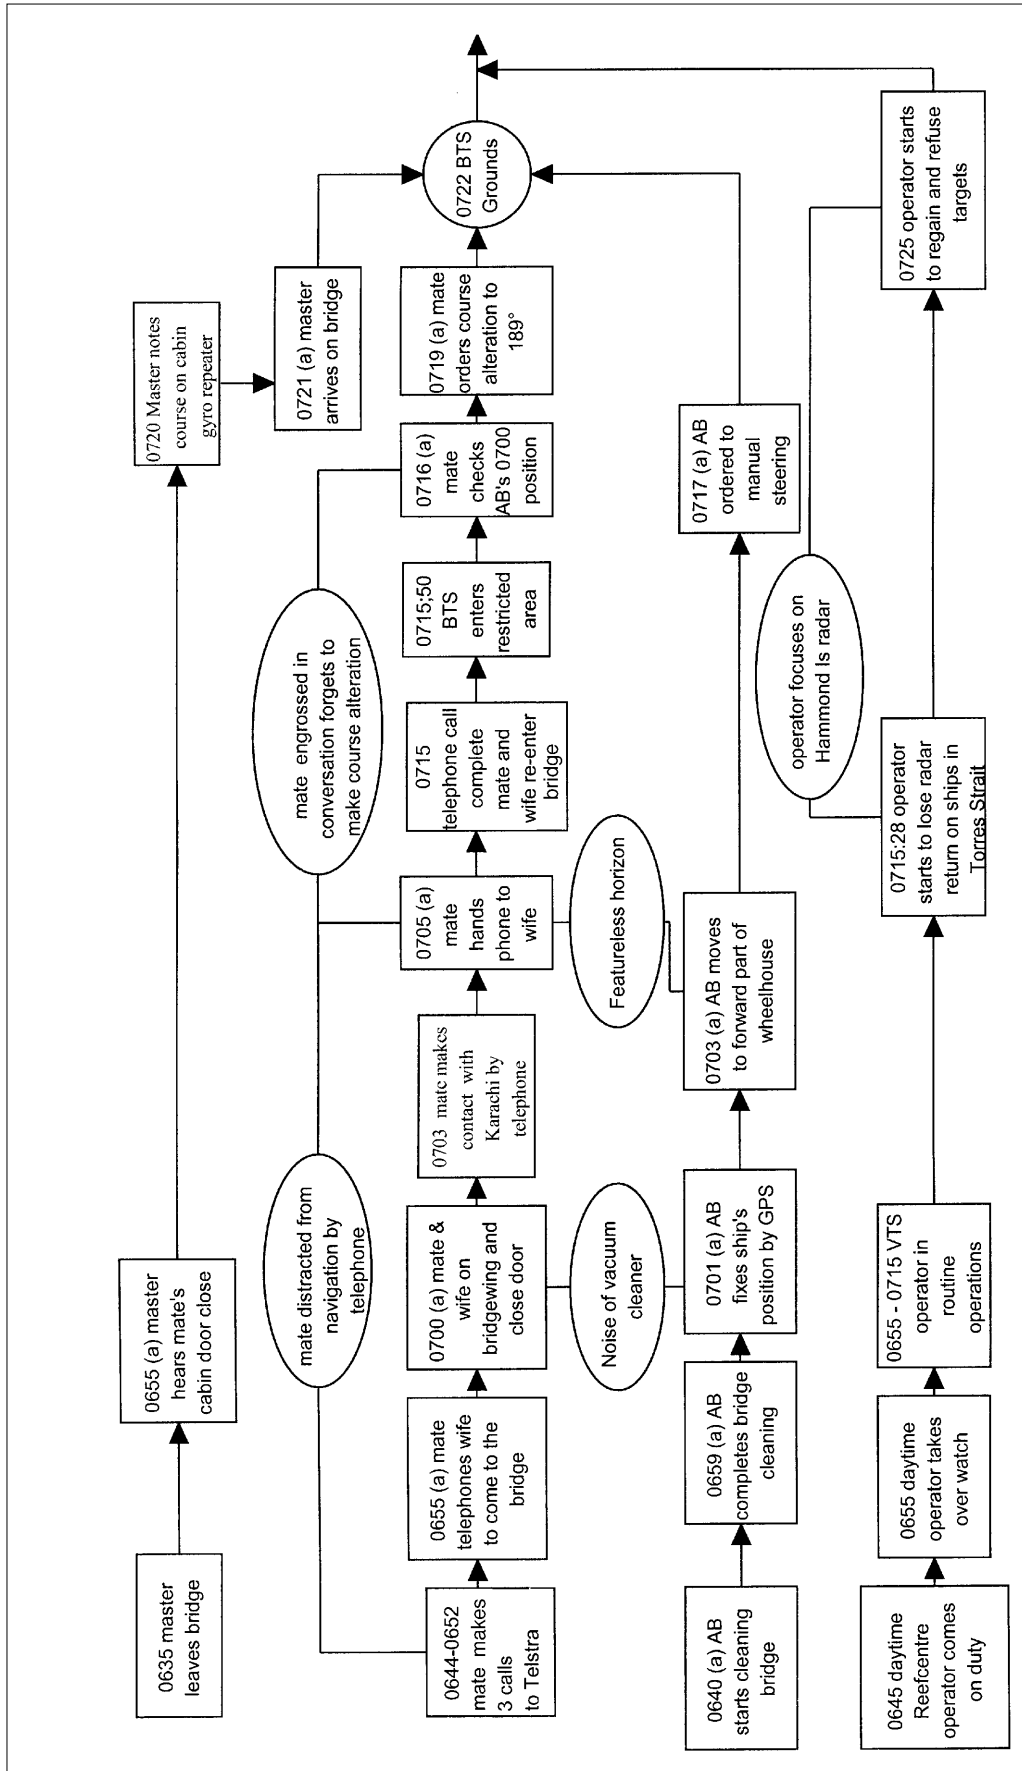
Figure 8:
Bunga Tertai Satu events and causal factor chart

1. The significant unsafe act that resulted in the grounding was that the mate allowed himself to become distracted, for a period of about 15 minutes, from the navigation of the ship by a telephone conversation between his wife, who was on the ship's bridge wing, and his family overseas.
2. From about 0645 to 0715 the mate had become preoccupied with arranging and making private telephone calls while the ship was in cellular phone range of the coast, rather than monitoring the ship's course, speed, position and his other watchkeeping duties.
3. The manner in which the mate maintained his watch on 2 November 2000 lacked appropriate motivation and fell well below proper professional standards.
