# **Collision with terrain involving Robinson R22 Beta, VH-8BW**

29 km north of Southport Aerodrome, Queensland, on 26 February 2025

**ATSB Transport Safety Report**

AO-2025-011

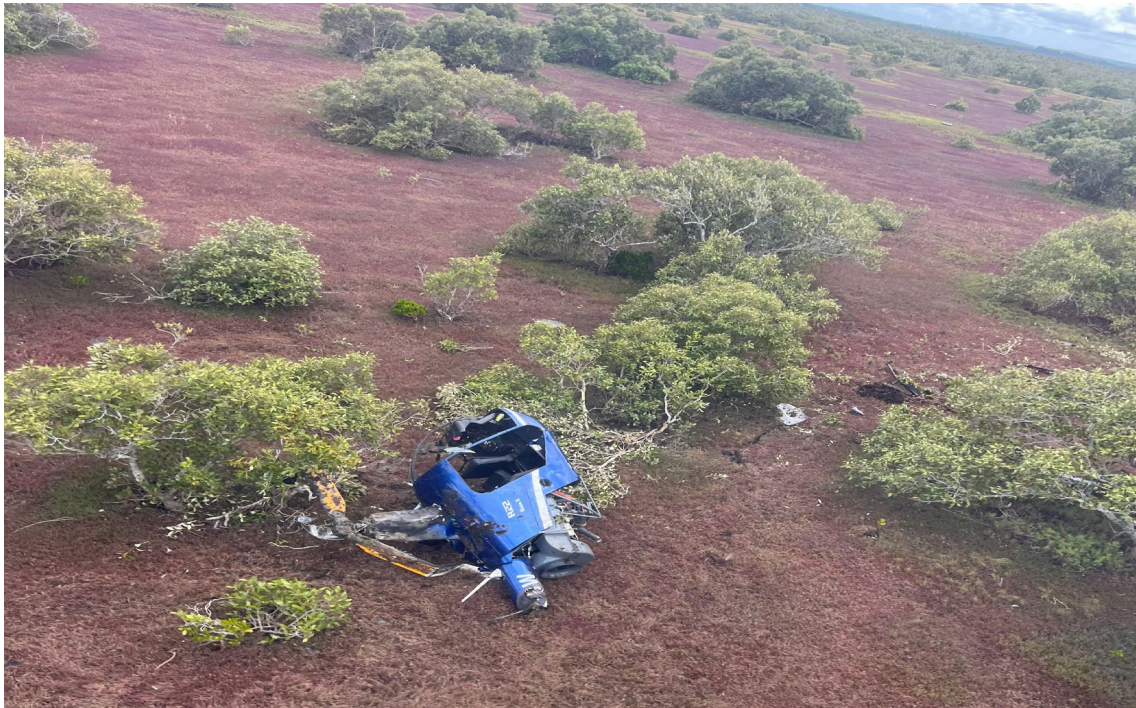
**Figure 1: Accident site**

Both occupants recalled that everything happened quickly prior to ground contact and that the estimated speed at impact was about 60–70 kt. The instructor recalled that the helicopter impacted hard in a flared nose high attitude and that the stinger<sup>4</sup> contacted the ground first. The helicopter slid along the ground on its skids for about 40–50 m between mangrove bushes before the left skid dug into the muddy ground and dynamically rolled over.<sup>5</sup> The helicopter came to a stop on its left side after numerous rotations and was destroyed (Figure 1). The instructor recalled that the student remained in the helicopter momentarily after impact and then managed to exit and appeared to have had less injuries than themselves so was able to follow instructions to shut down the machine.

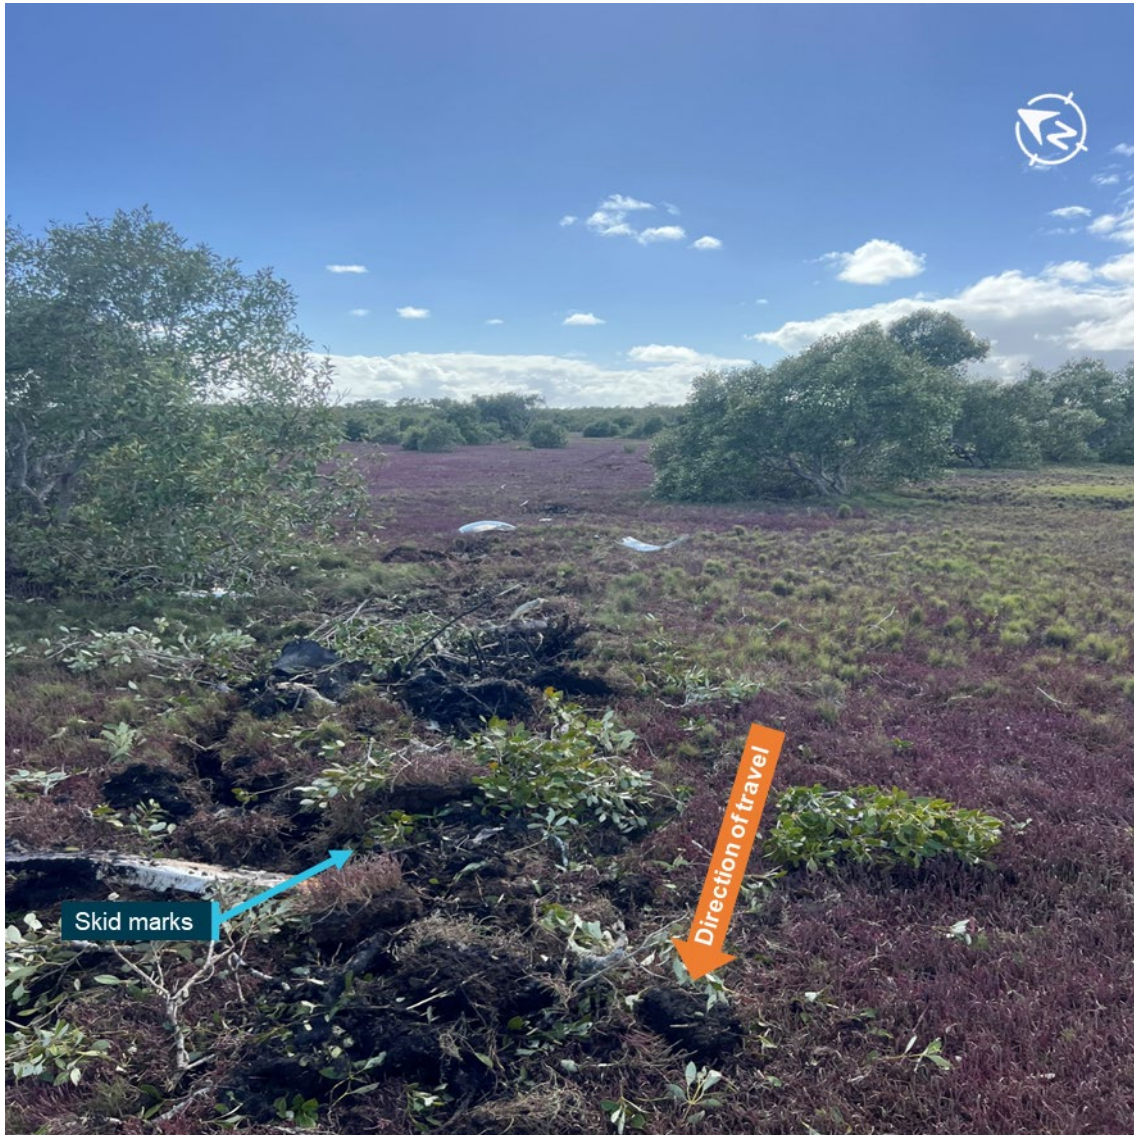
Figure 4: Photograph of impact site

The initial ground contact of the helicopter indicated a high-speed, upright skid contact before further loss of directional control and impact (Figure 4). The student and instructor reported that the speed on touchdown of the helicopter was about 70 kt and was consistent with the skid mark length.

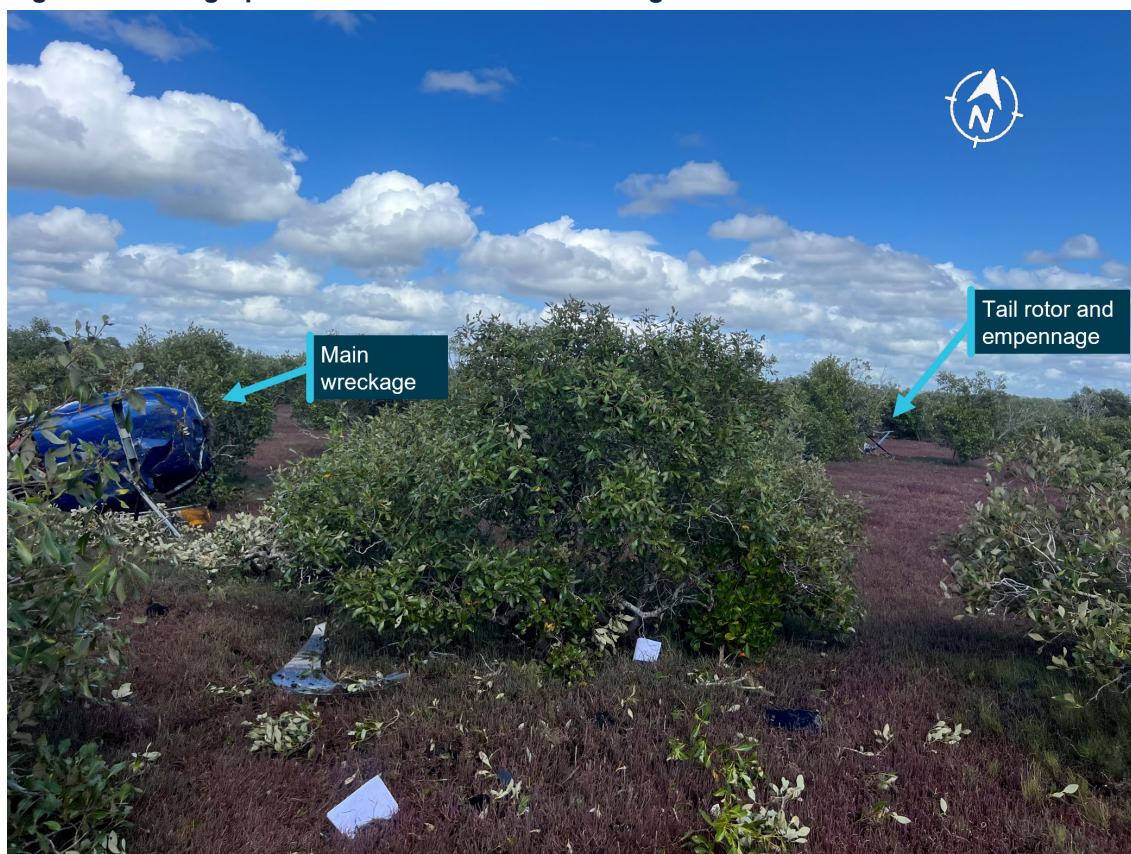
**Figure 5: Photograph of main and tail rotor wreckage at accident site**

After further impacting mangrove trees, the tail rotor assembly, including tail rotor, gearbox vertical and horizontal stabiliser, separated from the cabin and was reported as being located about 15 m north of the wreckage (Figure 5) and was largely intact.
