# Collision with terrain involving Kavanagh E-240 Balloon, VH-LUD

2.1 km east-south-east of RAAF Base Amberley, Queensland on 8 October 2021

**ATSB Transport Safety Report**

AO-2021-042

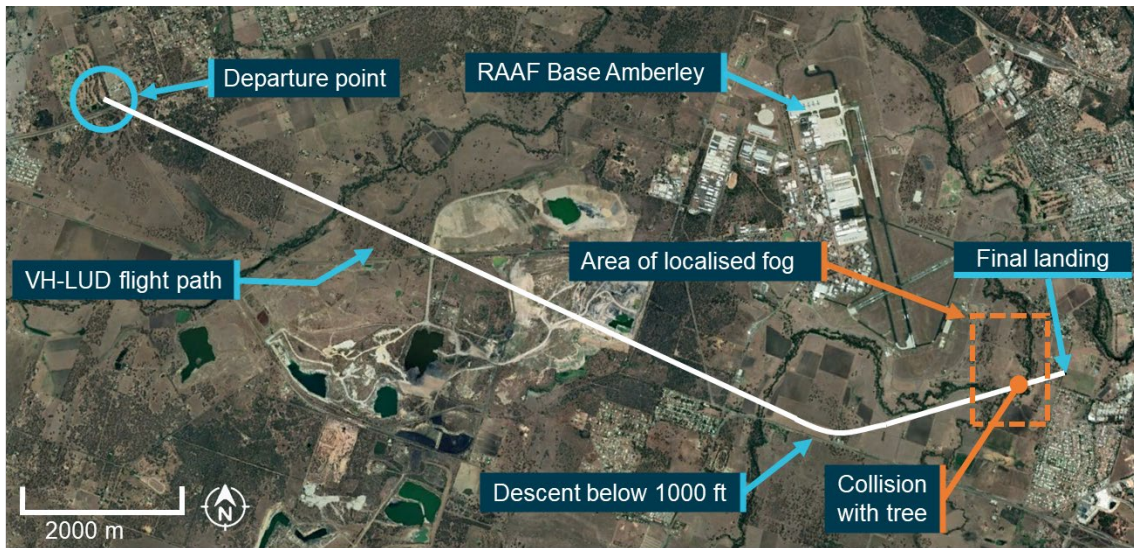
**Figure 1: Flight path of VH-LUD**

Following an assessment, via the observation balloon, that the wind was from the west-north-west, the pilot planned the flight to commence at Rosewood Golf Club with an intent to track south-east, to the south of RAAF Base Amberley, and continue towards Yamanto (Figure 1). The pilot commented that there was no fog present at the departure time.

The balloon took off at around 0520 and tracked towards the east-south-east as expected from the wind observations. The pilot reported clear skies with some localised fog present to the south-east of the RAAF base. The pilot estimated the fog to be from the surface to a height of 500 ft.

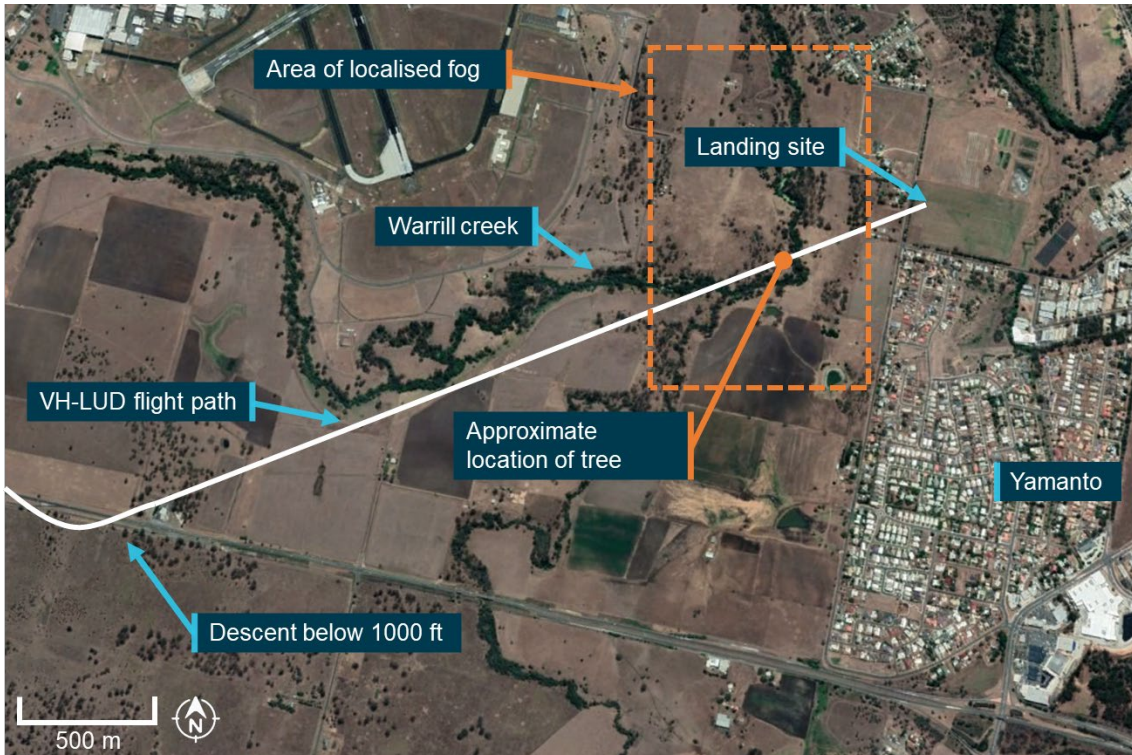
**Figure 2: Descent of VH-LUD to Yamanto**

After about 55 minutes of flight time the pilot commenced a descent to visually identify and select a suitable landing area. As the balloon descended below 1,000 ft the wind backed<sup>5</sup> to a south-westerly. As a consequence of that wind change, the balloon began tracking north-east towards the previously-identified fog bank (Figure 2).

The pilot approached the fog expecting to be able to maintain visual requirements for landing. However, upon entering the fog, the pilot recalled observing that it was significantly thicker than they expected or had flown in before with visibility of about 10 m. The pilot continued to descend at approximately 200 feet per minute into the fog until they sighted a tree directly ahead of them. In response, the pilot immediately commenced burning on all 3 burners to arrest the descent and transition to a climb, but the balloon collided with the tree at a speed of about 4 knots. The balloon came to rest on the side of the tree at a height of about 60 ft above the ground.

The pilot commenced a descent with the intention of locating a suitable landing area. During this descent, the wind backed, and the balloon began tracking towards the area of localised fog. Instead of remaining above the localised fog and descending in the clear air beyond, the pilot continued the descent and entered the fog believing that adequate visibility would exist for the landing. The visibility subsequently reduced to 10 m.

The pilot observed a tree, and in an attempt to prevent a collision, lit the burners to transition to a climb. However, due to the 20-30 seconds required before the descent could be arrested and a climb commence, there was insufficient time for the tree to be avoided due to the limited visibility. Given the climb performance of the balloon, even if the circumstances around the airspace allowed for the flight to be conducted in visibility conditions down to 100 m, the collision would still have occurred.

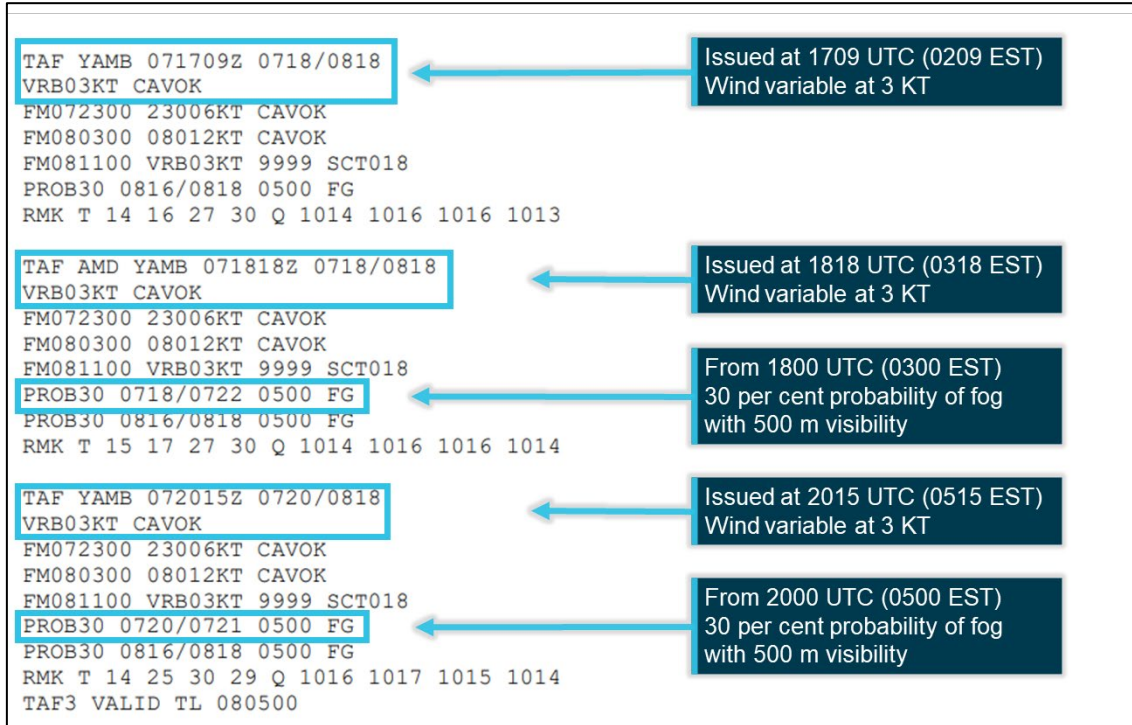
**Figure 3: RAAF Amberley terminal area forecast**

An Amberley terminal area forecast (TAF) was issued at 0209 EST for the 24 hours from 0300 with an amendment issued at 0318 (Figure 3). A further TAF was issued at 0515, about the same time the balloon took off. All 3 forecasts predicted variable winds at 3 knots and a 30% probability of fog, in which visibility would reduce to 500 m.

The RAAF Base Amberley TAF listed a 30% probability that fog would be present in the area, in which visibility would be 500 m. The pilot reported that during flight preparation there was no fog present. During the flight, fog was observed in a localised area to the south-east of RAAF Base Amberley.
