In-flight propeller loss involving Jabiru J170, 24-7496

Muchea/Greenside ALA, Western Australia, on 22 December 2021

ATSB Transport Safety Report

AO-2022-004

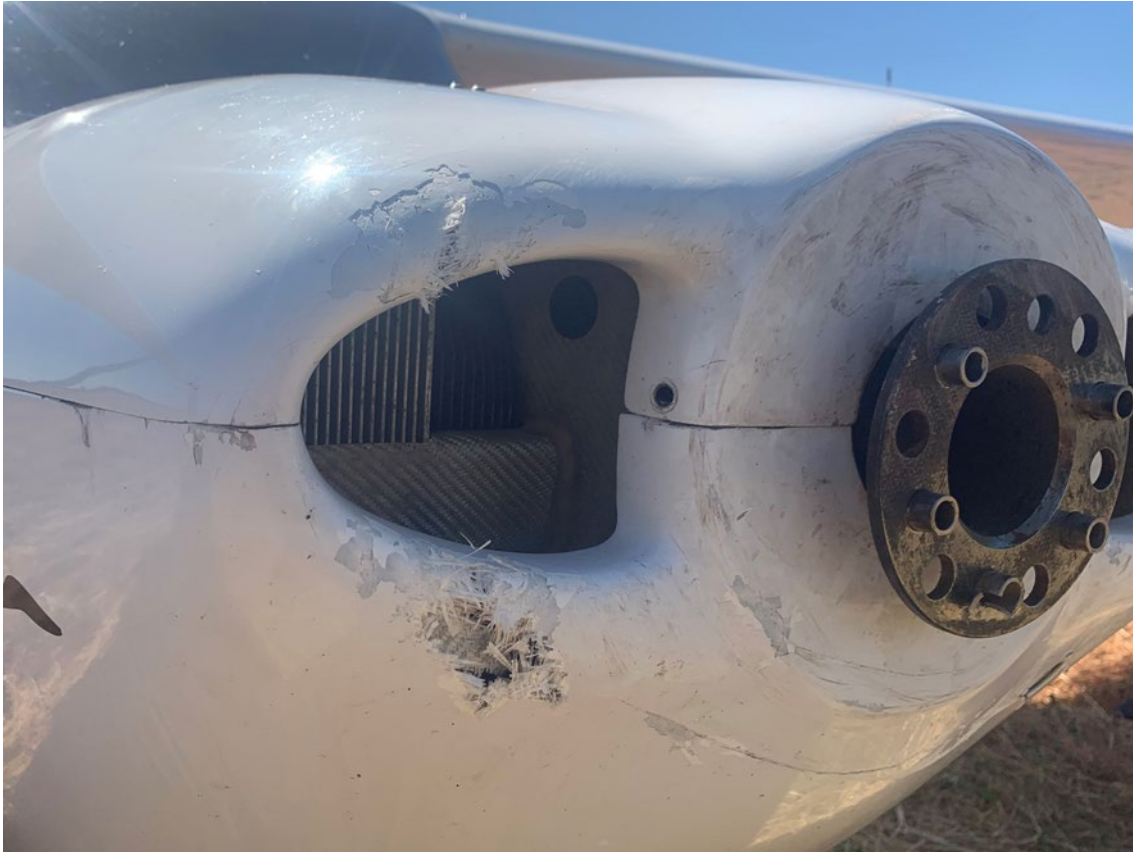
After securing the engine, the pilot elected to land ahead and configured the aircraft for a glide to reach some cleared paddocks. The pilot then made a MAYDAY¹ call that was received nearby at Pearce RAAF base, who contacted the chief flying instructor at Muchea. The pilot subsequently conducted an uneventful landing in a paddock, approximately 2.5 km from the end of the runway. The aircraft suffered minor damage to the nose cowl (Figure 1) and right, main landing gear. The pilot was uninjured.

Figure 1: Propeller flange and nose cowl damage

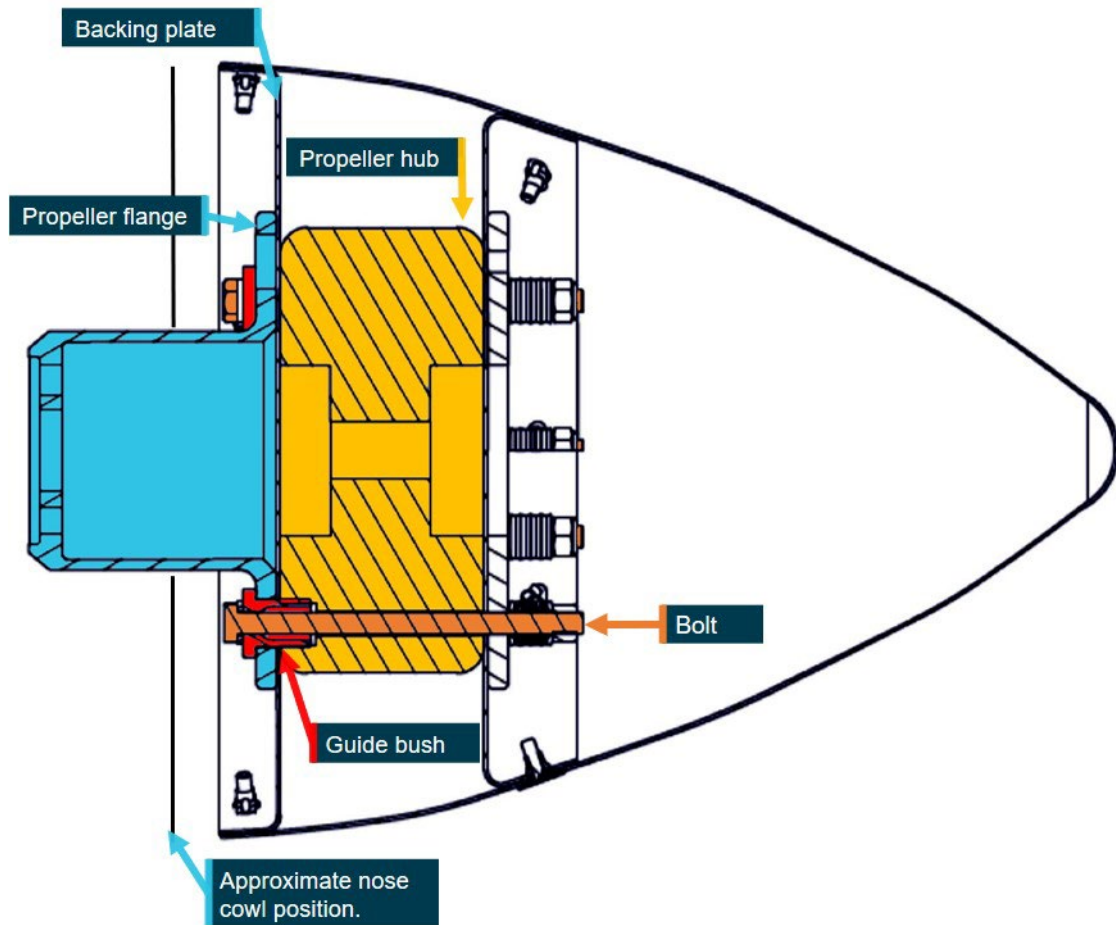
The Jabiru C000242-series wooden propeller was attached to the propeller flange by 6 propeller bolts (Figure 2). The propeller bolts were specified as either AN4-37 or AN4-40, meaning they were approximately 4 inches (10 cm) in length. They were installed with the bolt heads facing rearwards. The gap between the rear of the flange and the front of the engine cowl did not allow for the bolts to be installed or removed with the cowl in place.

In this installation, the bolts were assembled with Belleville washers,² which was a recommended alternate propeller mounting system, introduced by Jabiru in 2005. The purpose was to allow the assembly to better account for seasonal changes in the wooden hub dimensions and as such, reduce the frequency of inspections of propeller bolt tension. Jabiru maintenance manual JPM3L1-4 indicated that the propeller bolts must be checked after the first flight following installation and then recommended every 100 hours and/or annually thereafter. Jabiru Service Bulletin JSB014-1 indicated that a loss of bolt tension can cause the propeller to move and fret³ on the mounting flange.

Figure 2: Propeller assembly

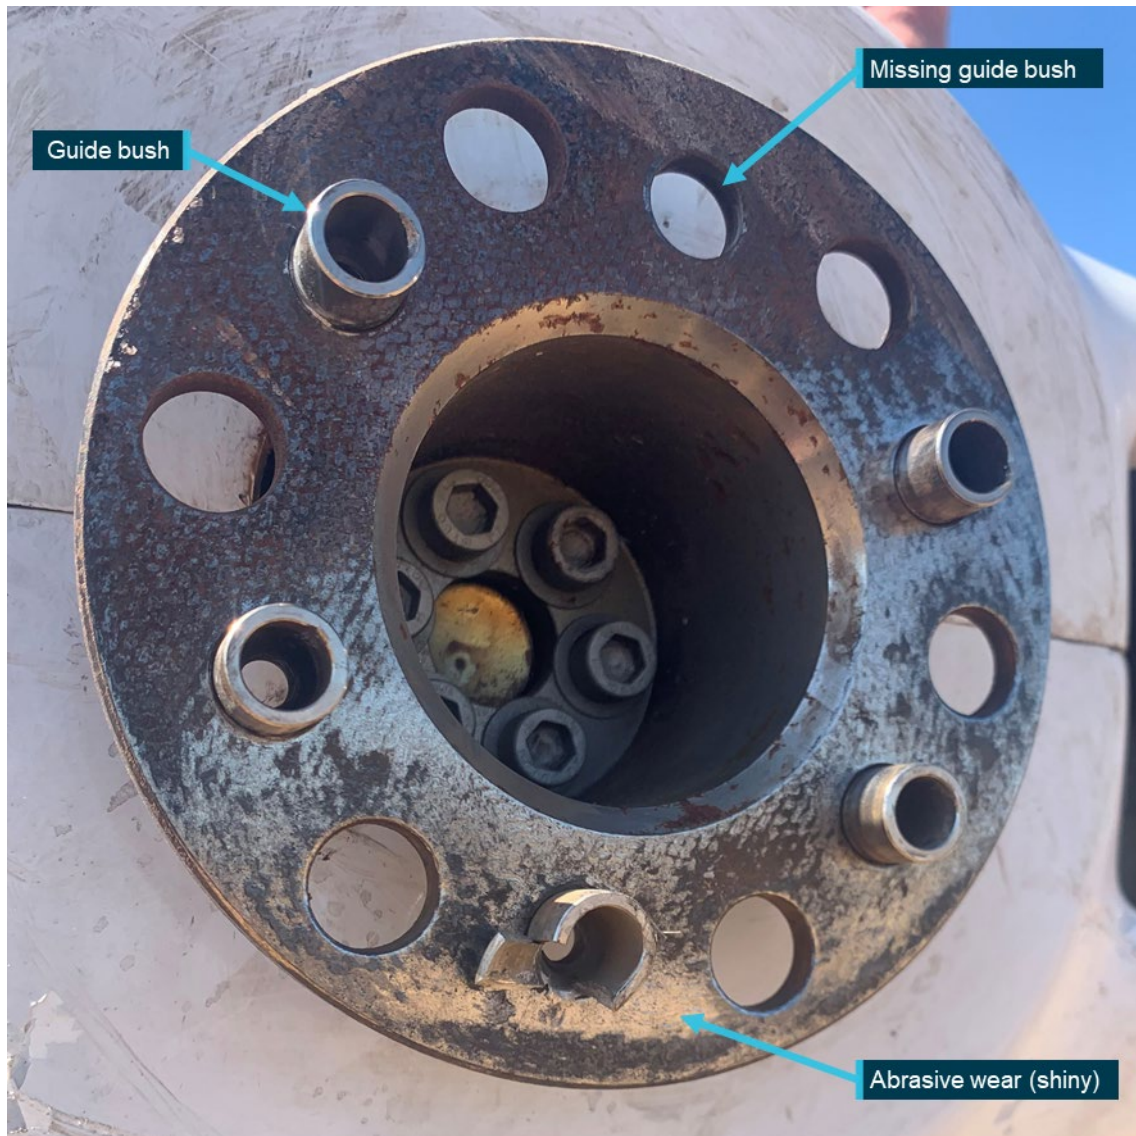
In an effort to locate the separated propeller, the operator conducted an extensive aerial photographic survey (approximately 89 hectares), covering the flightpath and surrounding area to the east of the airstrip. Despite this, the separated propeller assembly was not recovered. As a result, component examination by the ATSB was limited to the propeller flange and 5 (of 6) remaining guide bushes (Figure 3).

Figure 3: Propeller flange detail

- The flange forward face exhibited abrasive wear patterning consistent with the fibreglass weave of the backing plate, on one-half of the forward face of the flange. The wear had removed the surface contamination from the flange and microscopic grooves were worn into the surface in some areas. The presentation of the wear indicated that it likely predated the first indications of vibration observed by the pilot.

- One of the bushes had a section of the wall fractured laterally and the remaining bushes had small amount of deformation on the inside rim of the forward face. This was a result of contact with the bolt shank at the point of the propeller separation.

- There were no indications of how the missing bush separated from the flange, however wear around the associated hole indicated that it was in situ in the time leading up to the occurrence.

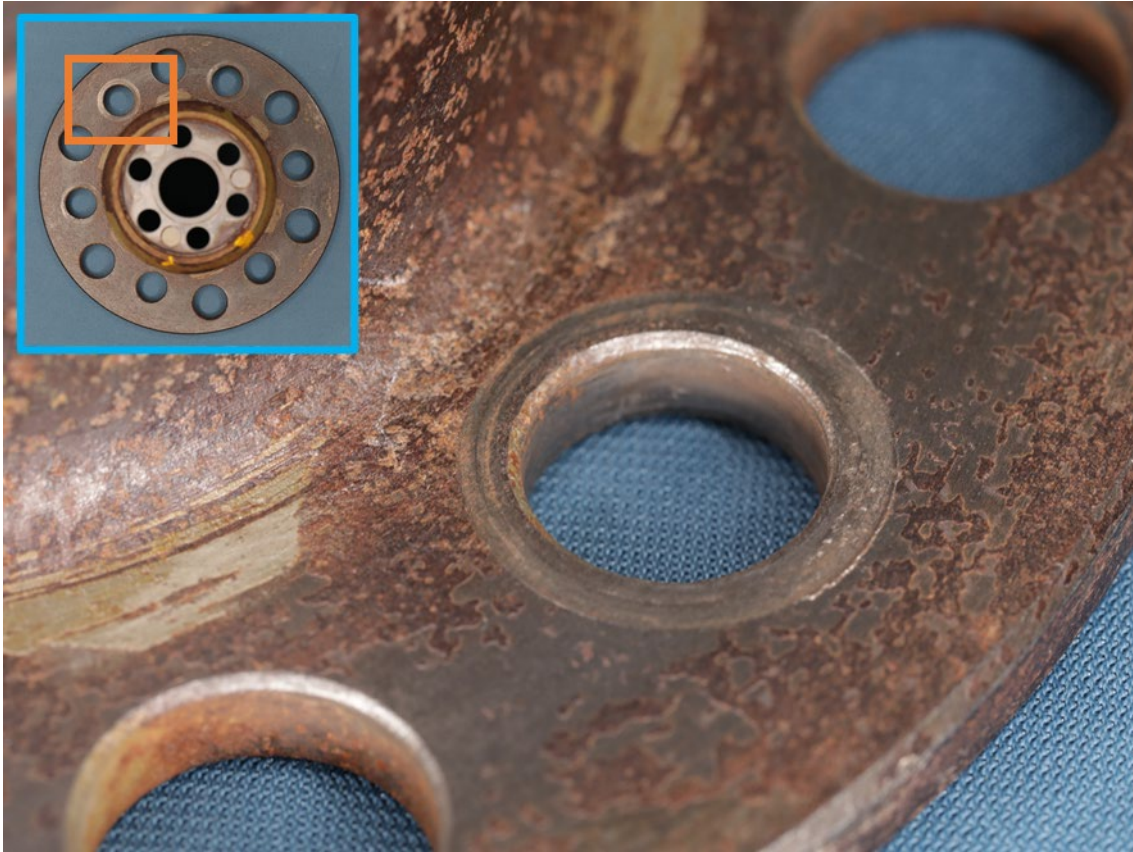
- Localised fretting wear was present between the guide bush and the rear face of the flange (Figure 4). The greatest amount of wear was associated with those bushes on the opposite half of the flange from the wear on the forward face. Surface contamination from the flange had also transferred to the bushes. This was most notable on those holes with the most wear indications.

Figure 4: Wear from drive bush on propeller flange

Without the bolts available for examination, the reason for the propeller bolt fractures was not conclusively determined. However, the evidence of movement and fretting on the flange was consistent with a loss of clamping force or low bolt tension. The pilot-observed vibration and smell of burnt pine in the minutes prior to the separation was also evidence of relative movement between the wooden propeller and the mounting hardware. Vibration in a normally rigid system will introduce abnormal loading conditions, subjecting components to stresses beyond design considerations. Additionally, fretting wear can significantly reduce the fatigue limit and hence, the working life of components in the assembly.
