# VFR into IMC and collision with terrain involving Bell Helicopter 206L-4, VH-PRW

33 km north-west of Adaminaby, New South Wales, on 3 April 2022

**ATSB Transport Safety Report**

AO-2022-017

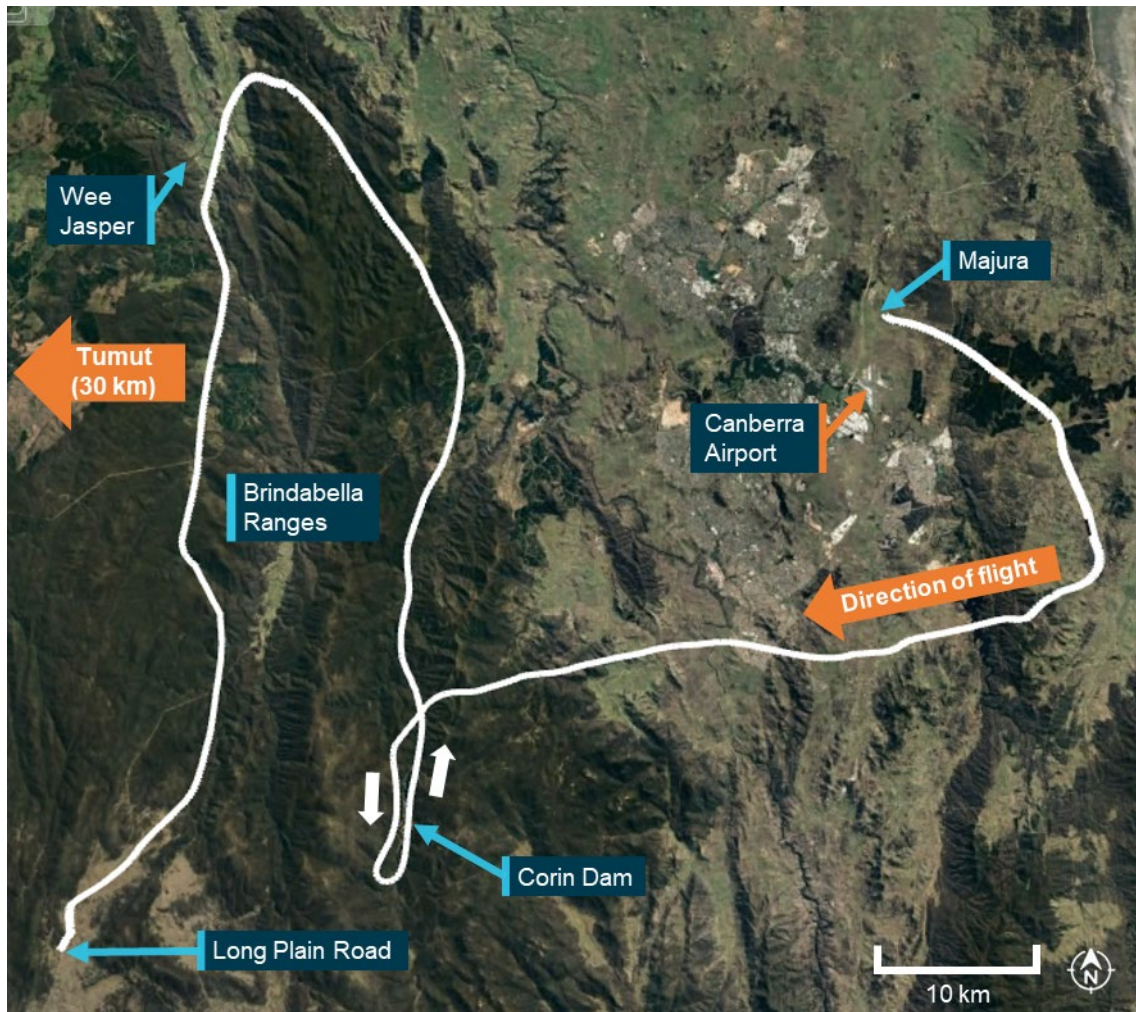
Figure 1: Flight from Majura to Long Plain

At 1021, VH-PRW, with the pilot and one passenger on board, departed the property at Majura along with the remaining 4 helicopters. Recorded tracking data showed that VH-PRW initially tracked south-east before turning west toward the Brindabella Ranges (Figure 1). The flight then proceeded south over Corin Dam before heading north to Wee Jasper. As the 5 helicopters approached Wee Jasper, they also encountered deteriorating cloud and visibility conditions. Four of the pilots elected to land on a property near Wee Jasper. The pilot of VH-PRW did not land but continued south to 'attempt to find a way through to Tumut'.

At 1129, the pilot of VH-PRW encountered poor weather conditions and landed the helicopter alongside Long Plain Road in the Brindabella region, outside of mobile phone coverage.

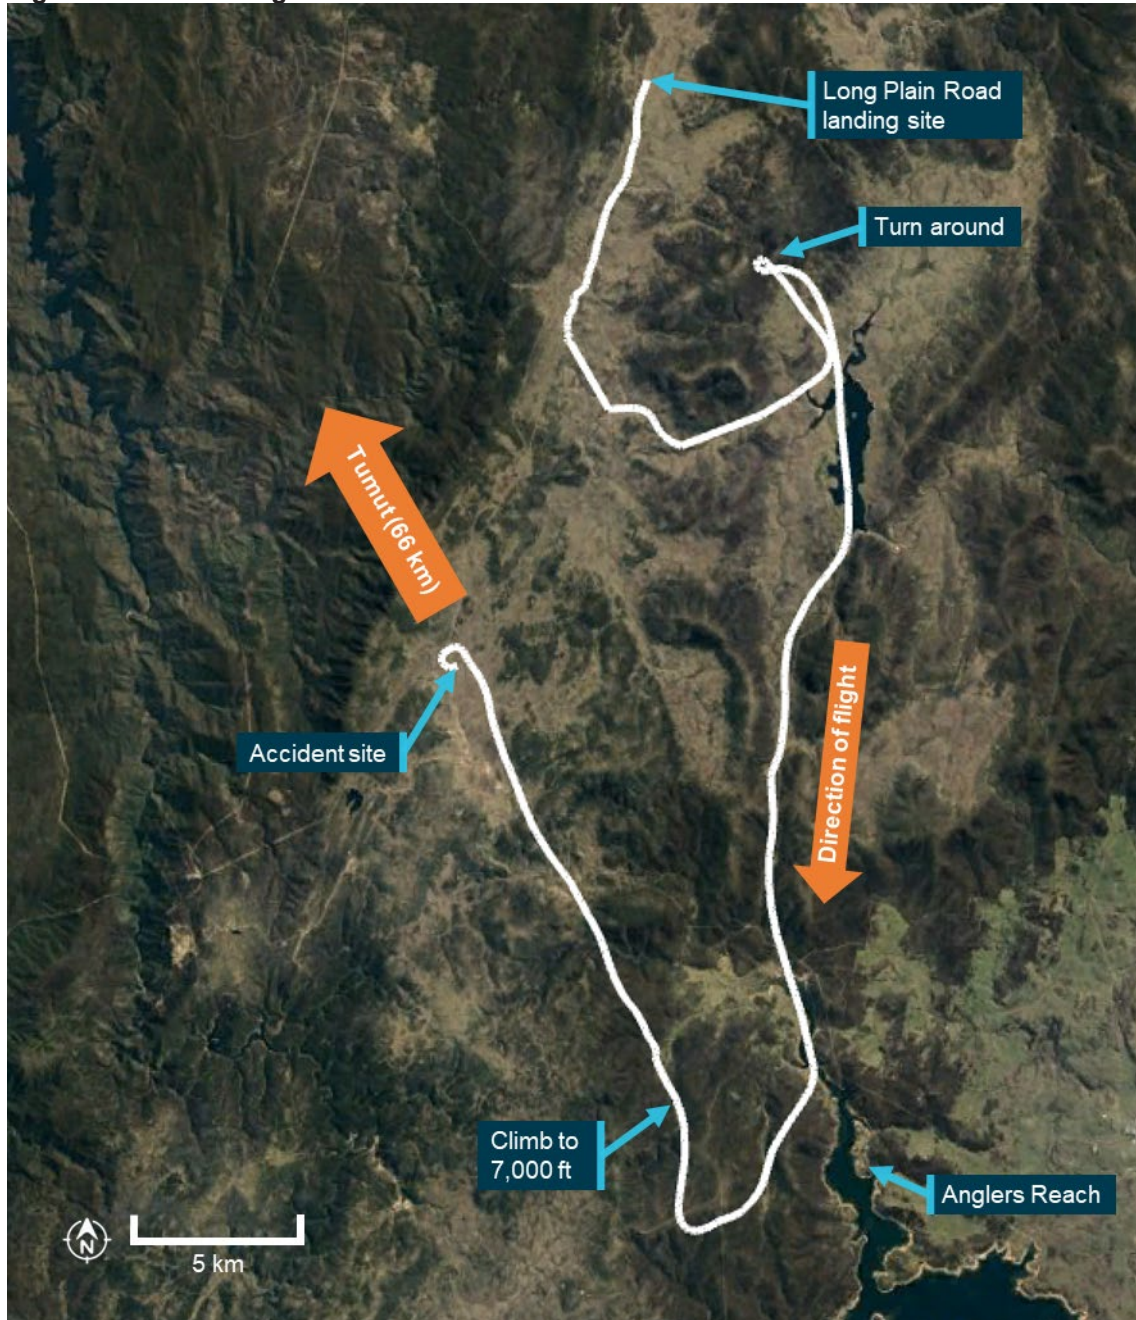
**Figure 2: Accident flight**

Recorded flight tracking data showed that at 1453, the helicopter departed Long Plain Road, with the pilot and passenger on board. Two minutes later, one of the other pilots in the tour noted the helicopter tracking south on a flight tracking application.

Police officers dispatched to locate the helicopter arrived at the landing site just after it became airborne. The motorist and police officers observed the helicopter depart to the south at low level,

in overcast conditions with low cloud and light rain. The police officers stated that the helicopter passed ‘at a similar height or slightly above the powerlines’ before being obscured by low cloud. The flight then progressed at heights below 500 ft AGL following geographical features along lower lying terrain (Figure 2). At 1504, the flight turned north-west and took up a track that corresponded with a direct track to Tumut. Two minutes later, the helicopter encountered higher terrain and turned around to head southward, again following lower lying terrain. At 1517, in the vicinity of Anglers Reach, the flight turned north. Two minutes later, the helicopter turned to the north-west, again along a flightpath that corresponded with a direct track to Tumut and commenced a climb to about 7,000 ft above mean sea level (AMSL).

The helicopter continued along that track at groundspeeds of 105-115 kt until 1525 when it descended to 6,800 ft. The helicopter then almost immediately commenced a rapid climb. As the

helicopter climbed, the recorded groundspeed reduced. After reaching 7,400 ft at a groundspeed of 60 kt, the helicopter entered a steep left descending turn.

The descending turn continued until the helicopter impacted terrain at an elevation of 4,501 ft at about 1526. The helicopter was destroyed, and both occupants were fatally injured.

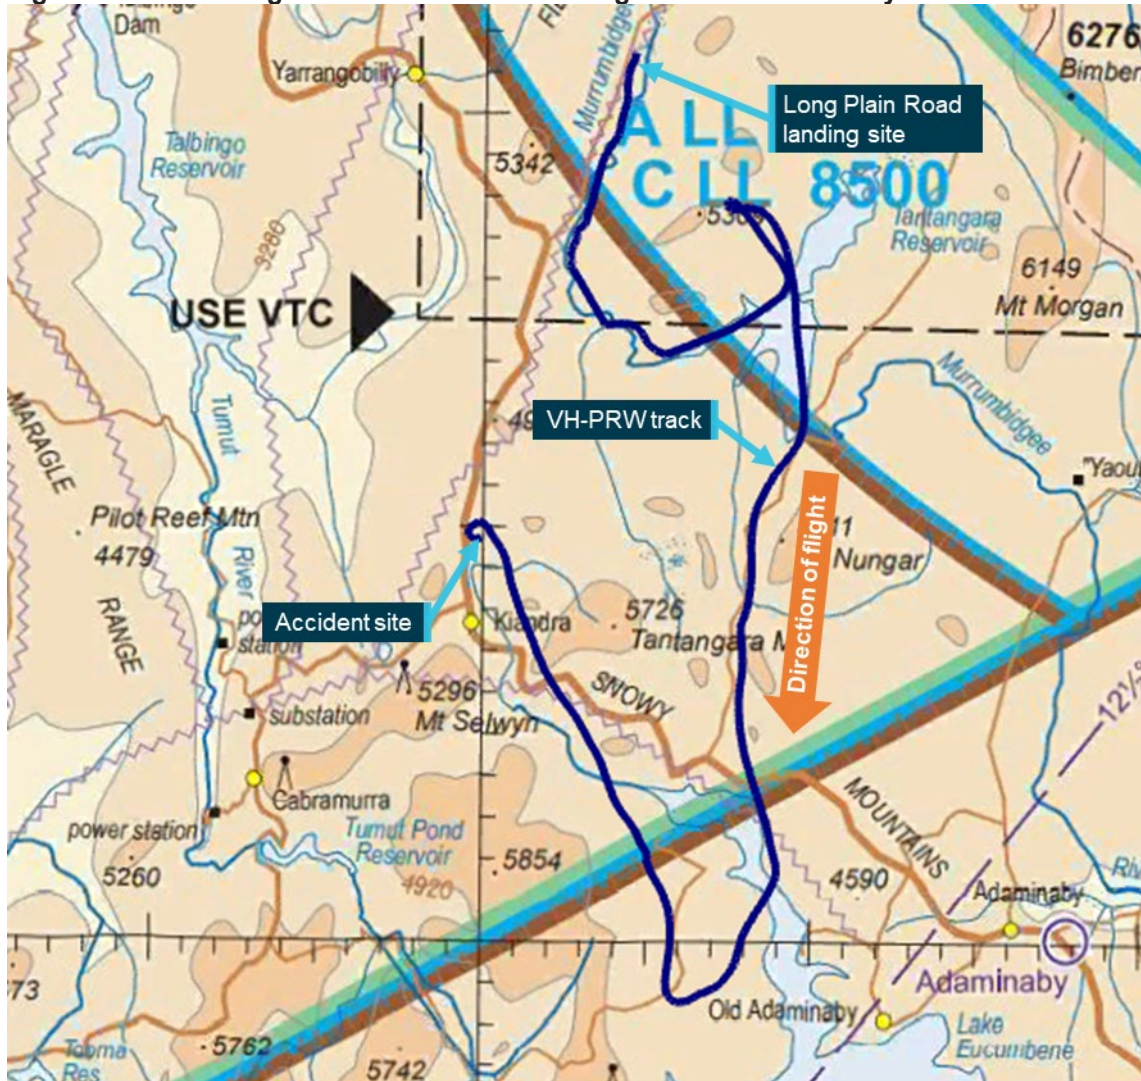
Figure 3: Visual navigation chart extract showing terrain in the vicinity of the accident

The helicopter departed an interim landing site along Long Plain Road in the Brindabella Ranges. The flight then proceeded over rugged alpine areas of the Snowy Mountains with terrain elevations generally higher than 4,000 ft AMSL. Peaks of 5,854 ft AMSL and 5,726 ft AMSL were located near the final flight track (Figure 3).

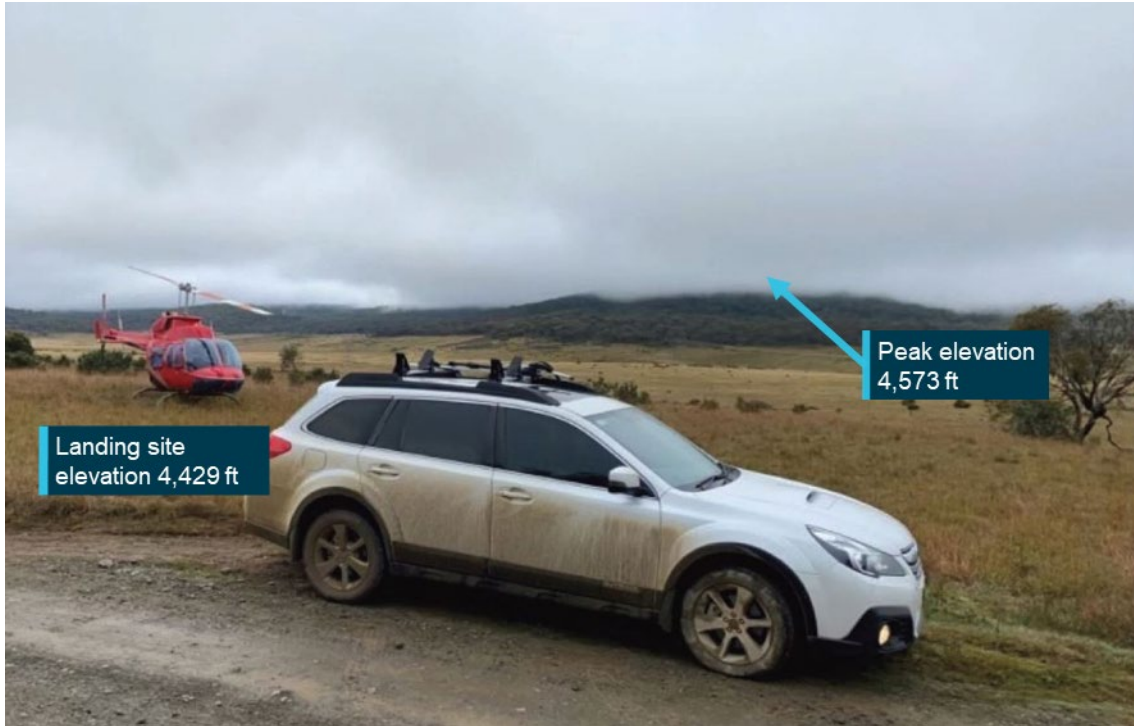
**Figure 4: Cloud conditions 2 minutes prior to departure from interim landing site**

A photograph taken 2 minutes prior to the helicopter departing Long Plain Road showed the cloud conditions at that time (Figure 4). The elevation of the landing site was about 4,429 ft AMSL. The peak of the terrain visible behind the helicopter is 4,573 ft AMSL. This peak was obscured by broken cloud indicating that the cloud base was less than 144 ft AGL.

Despite no such improvement eventuating, after about 3 hours and 24 minutes, the pilot elected to depart and continue to Tumut at about 50 ft above ground level. Photographs, along with police and witness reports, showed that at the time of the departure the cloud and visibility conditions were unsuitable for visual flight. The broken cloud base of less than 144 ft did not allow the pilot to maintain the helicopter both, clear of cloud as required by visual meteorological conditions (VMC) and at the minimum height above terrain of 500 ft.

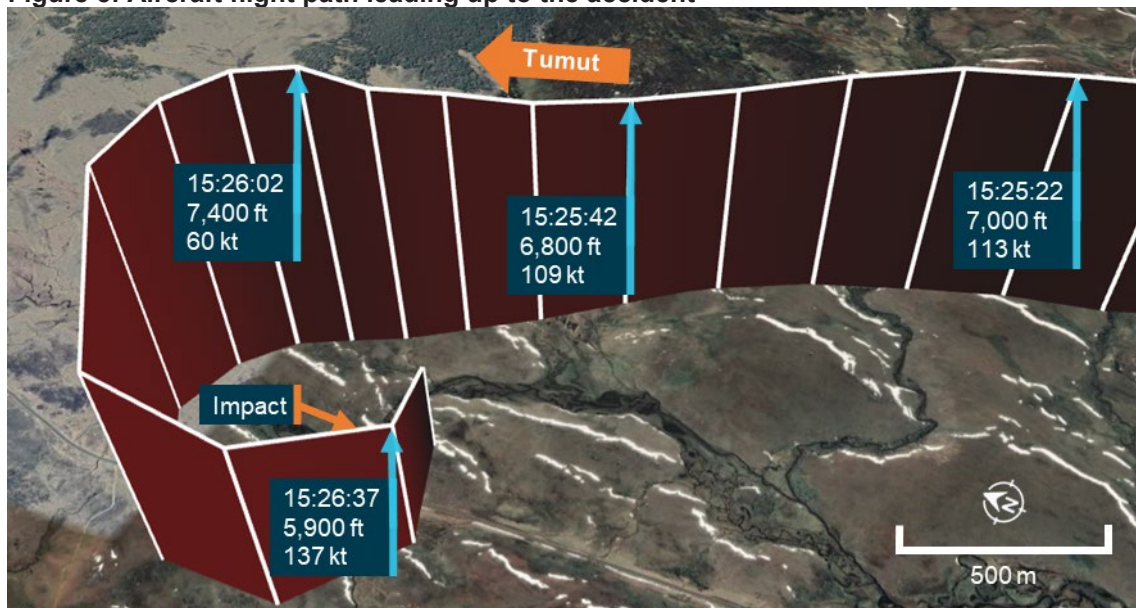
**Figure 5: Aircraft flight path leading up to the accident**

The data showed that at 1519:22 the helicopter turned to a track that corresponded with the direct track to Tumut and 15 seconds later commenced a climb from low level to about 6,600 ft. At 1522:02, a further climb commenced, reaching 7,000 ft at 1522:42. The helicopter continued to track generally toward Tumut at groundspeeds of 105-115 kt, corresponding to a normal cruise speed for the helicopter. During this segment of the flight, track variations of up to 21° and altitude variations of up to 300 ft were recorded.

At 1525:22, the helicopter descended from 7,000 ft, reaching 6,800 ft about 20 seconds later. From 6,800 ft, a climb was commenced and a further 20 seconds later, the helicopter reached 7,400 ft (at climb rate of 1,800 ft per minute) with a groundspeed of 60 kt. The helicopter then entered a steep left descending turn. During the turn, the groundspeed increased to 137 kt and the descent rate exceeded 3,800 feet per minute (Figure 5).

The flight at about 7,000 ft continued until 1525:42 when a rapid climb of about 1,800 ft per minute was commenced. This was immediately followed by a steep descending left turn. This manoeuvring was inconsistent with normal helicopter operation and was indicative of a loss of control.

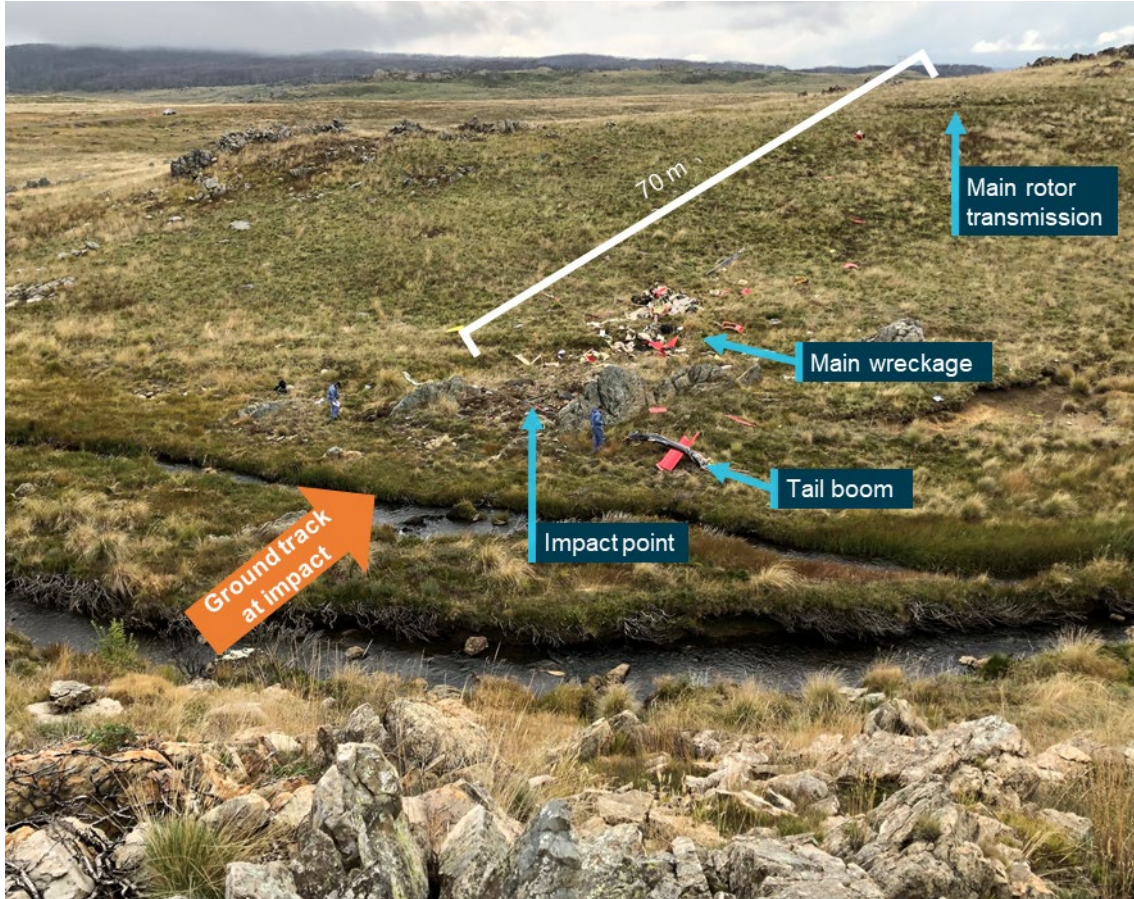
**Figure 6: Accident site**

The accident site was located within the Kosciuszko National Park in an area of tussock grass, interspersed by bare protruding rock (Figure 6).

The helicopter collided with terrain between two rock formations in a descending tight left turn and right side-slip in a northerly direction with a westerly heading. At initial impact, a main rotor blade struck the ground and the tail boom separated. The fuselage then turned left to about a southerly heading. Most of the wreckage was located within 8 m of the impact, but the main transmission, mounts and supporting airframe structure continued a further 70 m up an incline. On-site examination indicated that the engine was providing power at impact. There was no evidence of an in-flight break-up or a pre-existing defect with the drive train or flight controls.
