Runaway and derailment of TasRail freight train no. 604

Devonport, Tasmania, on 21 September 2018

Rail Occurrence Investigation (Systemic)

RO-2018-014

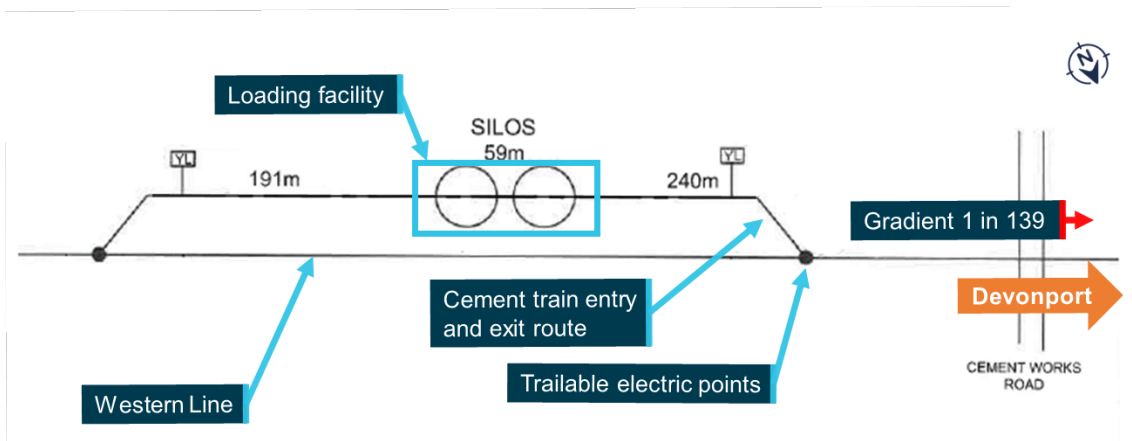
Figure 1: Railton cement siding and loading facility

As previously noted, from the loading facility, the track had a downhill grade of 1 in 139¹⁸ from the loading facility westward towards Devonport. There were no catch points or derailleurs fitted at the Railton cement siding (Figure 1). The purpose of catch points is to divert and derail an uncontrolled movement from a siding away from the main line. They are often installed on sidings with a downhill grade to the main line.

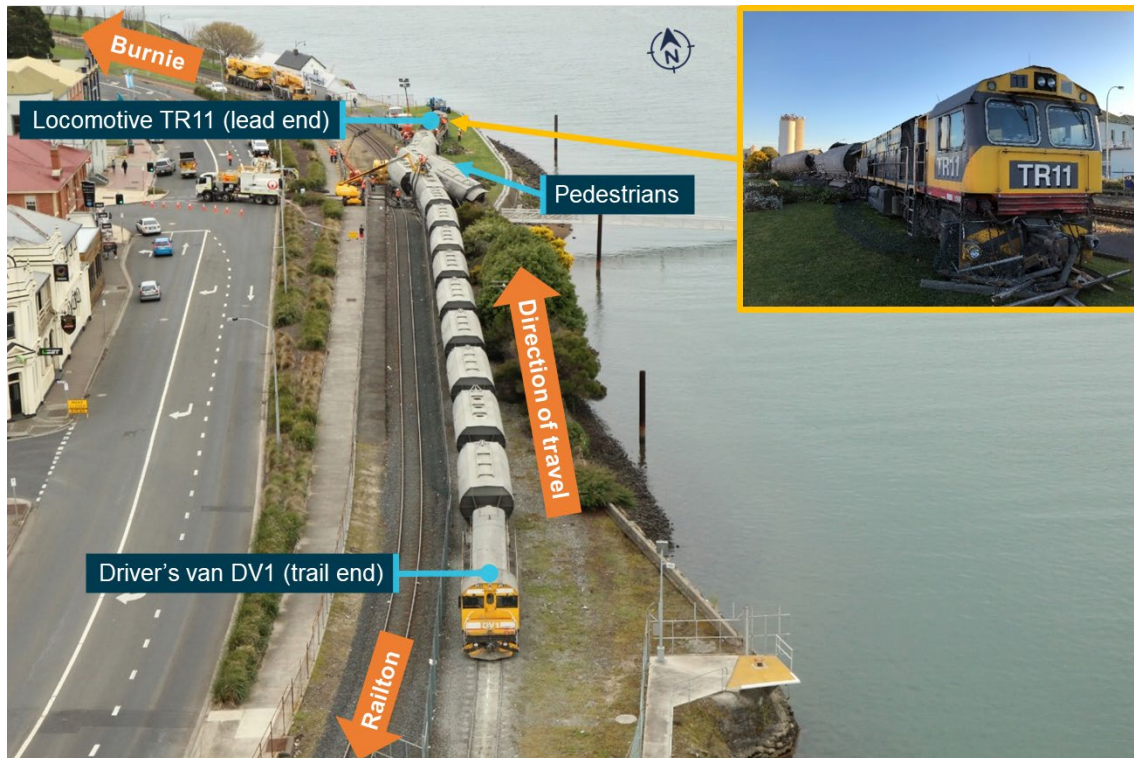
Figure 3: Derailment site in Devonport, Tasmania

In addition to the damage to the end of the silo siding, fences and park surrounds, 7 cement wagons and the locomotive were significantly damaged, with wagon wreckage blocking the main line between Devonport and Burnie (Figure 3).

Image shows the location of the injured pedestrians at the time of the derailment, as well as the cement train consist configuration.
Source: ATSB

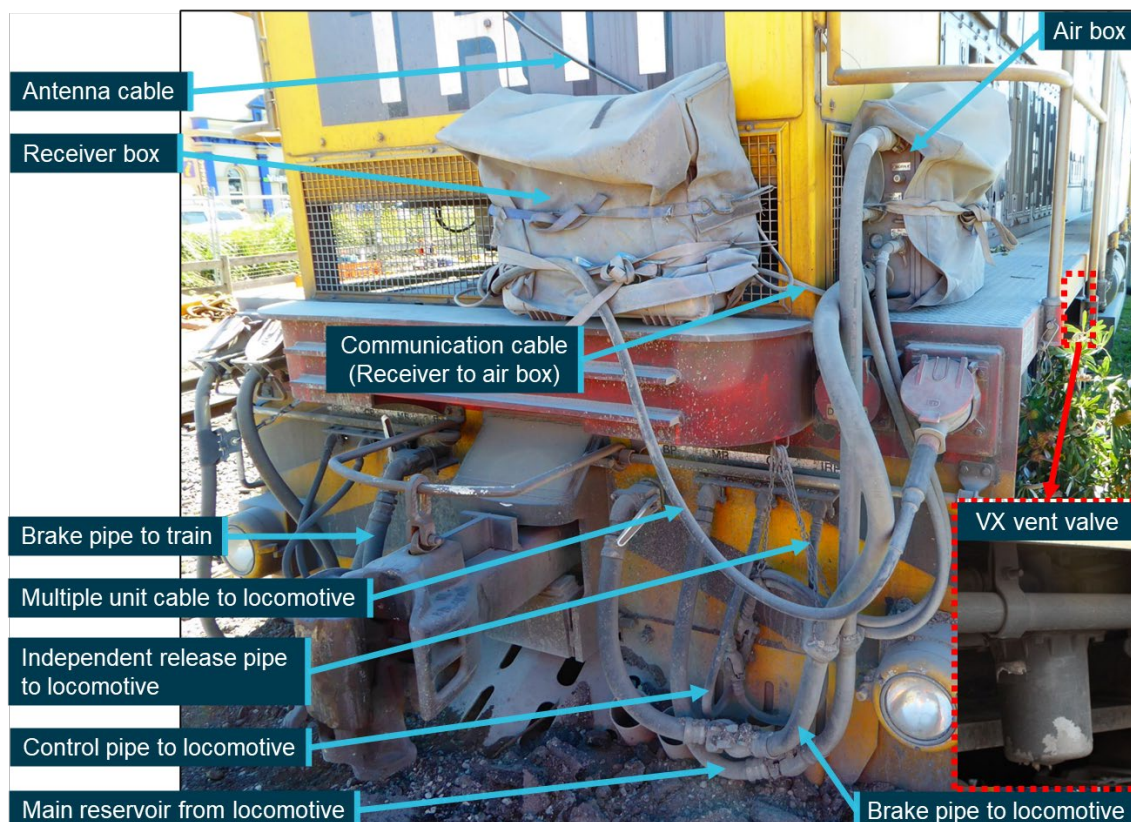
Figure 11: Rear of TR class locomotive, showing interface with generation 3 RCE

In this arrangement, the receiver was placed on the rear locomotive footplate with the air box located on the right-side footplate (Figure 11).

Image taken at the accident site after removal of the wagons. Note: the brake pipe tap which connected the air supply to the train has been closed during the wagon removal process. Operation of the VX vent valve is discussed further in Train braking systems. Source: ATSB

The air box location affected some aspects of the braking system response, due to it being connected to the airbrakes at a different point in the pneumatic circuit (see *Remote control equipment emergency brake reset*).

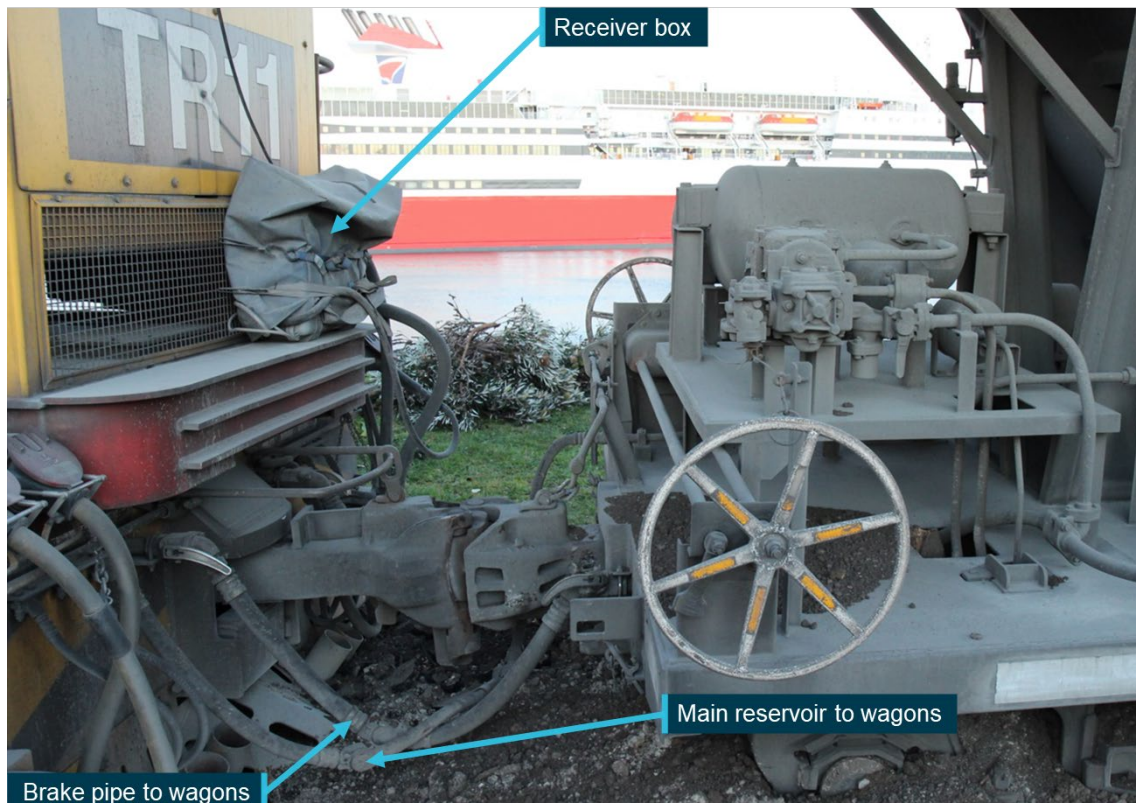
Figure 12: Interface of RCE from rear of TR class locomotive to first wagon

Figure 12 shows the interface between the locomotive and the first wagon. The brake pipe connection shown allowed reductions and increases in brake pipe pressure by the RCE, enacted through the adjacent brake pipe connection (Figure 11), to be registered by the wagons and driver's van. The MREQ air hose connected to the first wagon provided MR1 air supply to the wagon roof hatches, which were operated for cement powder loading purposes at Railton.

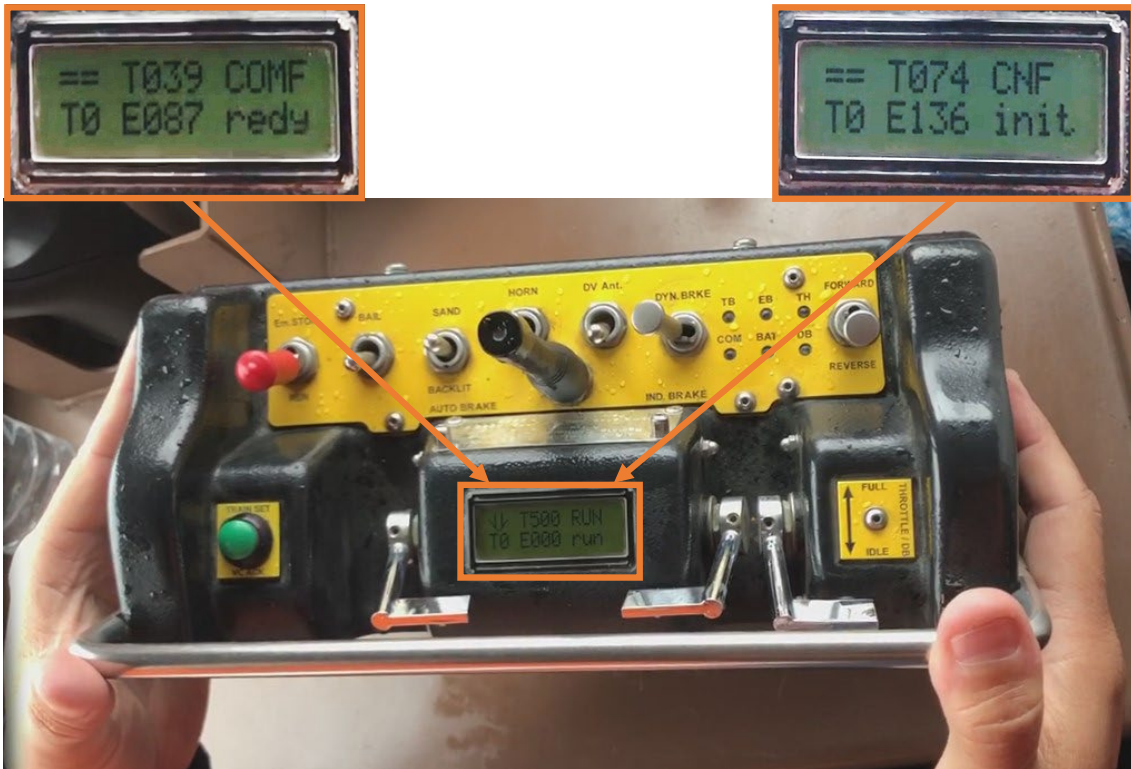
Figure 19: RCE transmitter and display screen

⁶⁶ The network access manager described that a control fault would create an emergency brake application and alarm. While this was the intended response in generation 2 RCE it was not correct for generation 3 RCE as the control fault mode response had significantly changed.

Image shows the RCE transmitter with detail images of communication failed mode (left) and control fault mode (right) presentations on the transmitter screen.
Source: ATSB

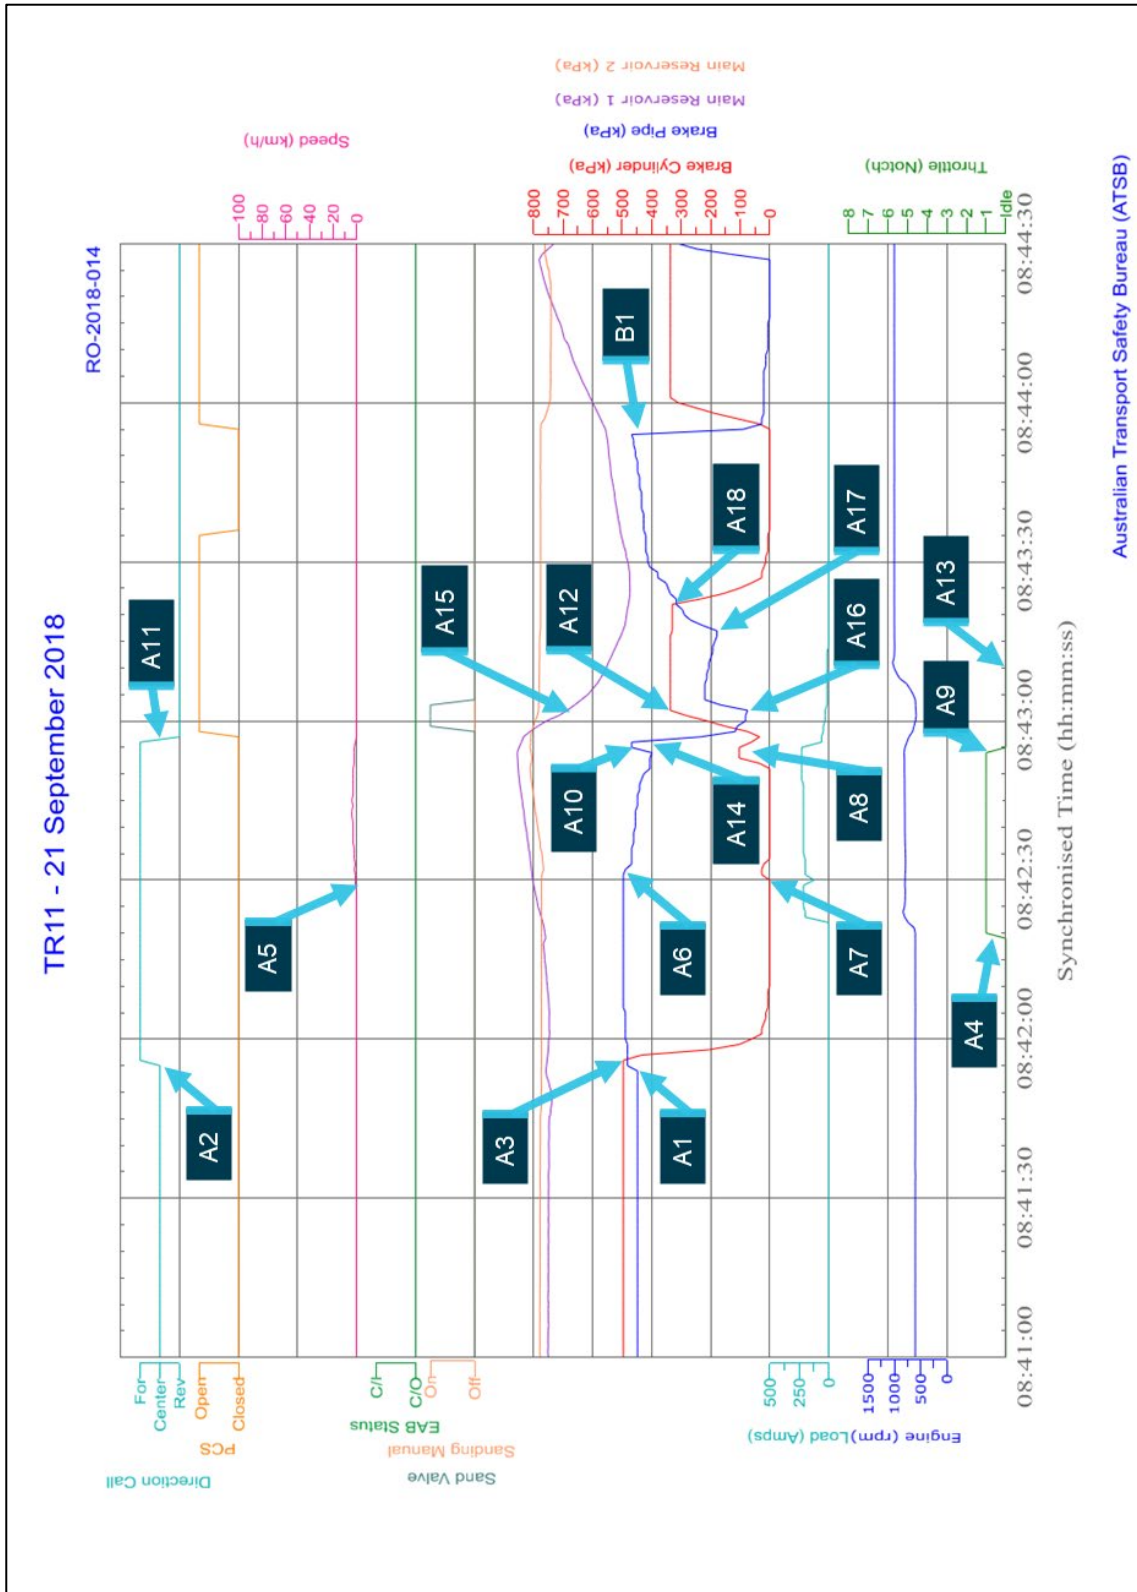
Figure A1: Combined data logger data during remote control equipment failure (0841:00 to 0844:30)

pipe pressure loss. This allowed the RCE to recharge the brake pipe without opposition. The maximum brake pipe pressure reached was 468 kPa.
0843:24	Label A18: locomotive brake cylinder pressure decreased as brake pipe pressure rose above about 320 kPa	The brake cylinder pressure did not begin to reduce in response to the initial rise in brake pipe pressure. Instead, it is likely that the brake cylinder pressure release was delayed until brake cylinder and brake pipe pressures had equalised, an action of the locomotive's electronic airbrake system.
	Note: The ATSB observed the behaviour described (labels A14 to A18) to occur repeatably during testing conducted after the runaway. This was triggered when the driver rapidly made a direction change request on the RCE transmitter.

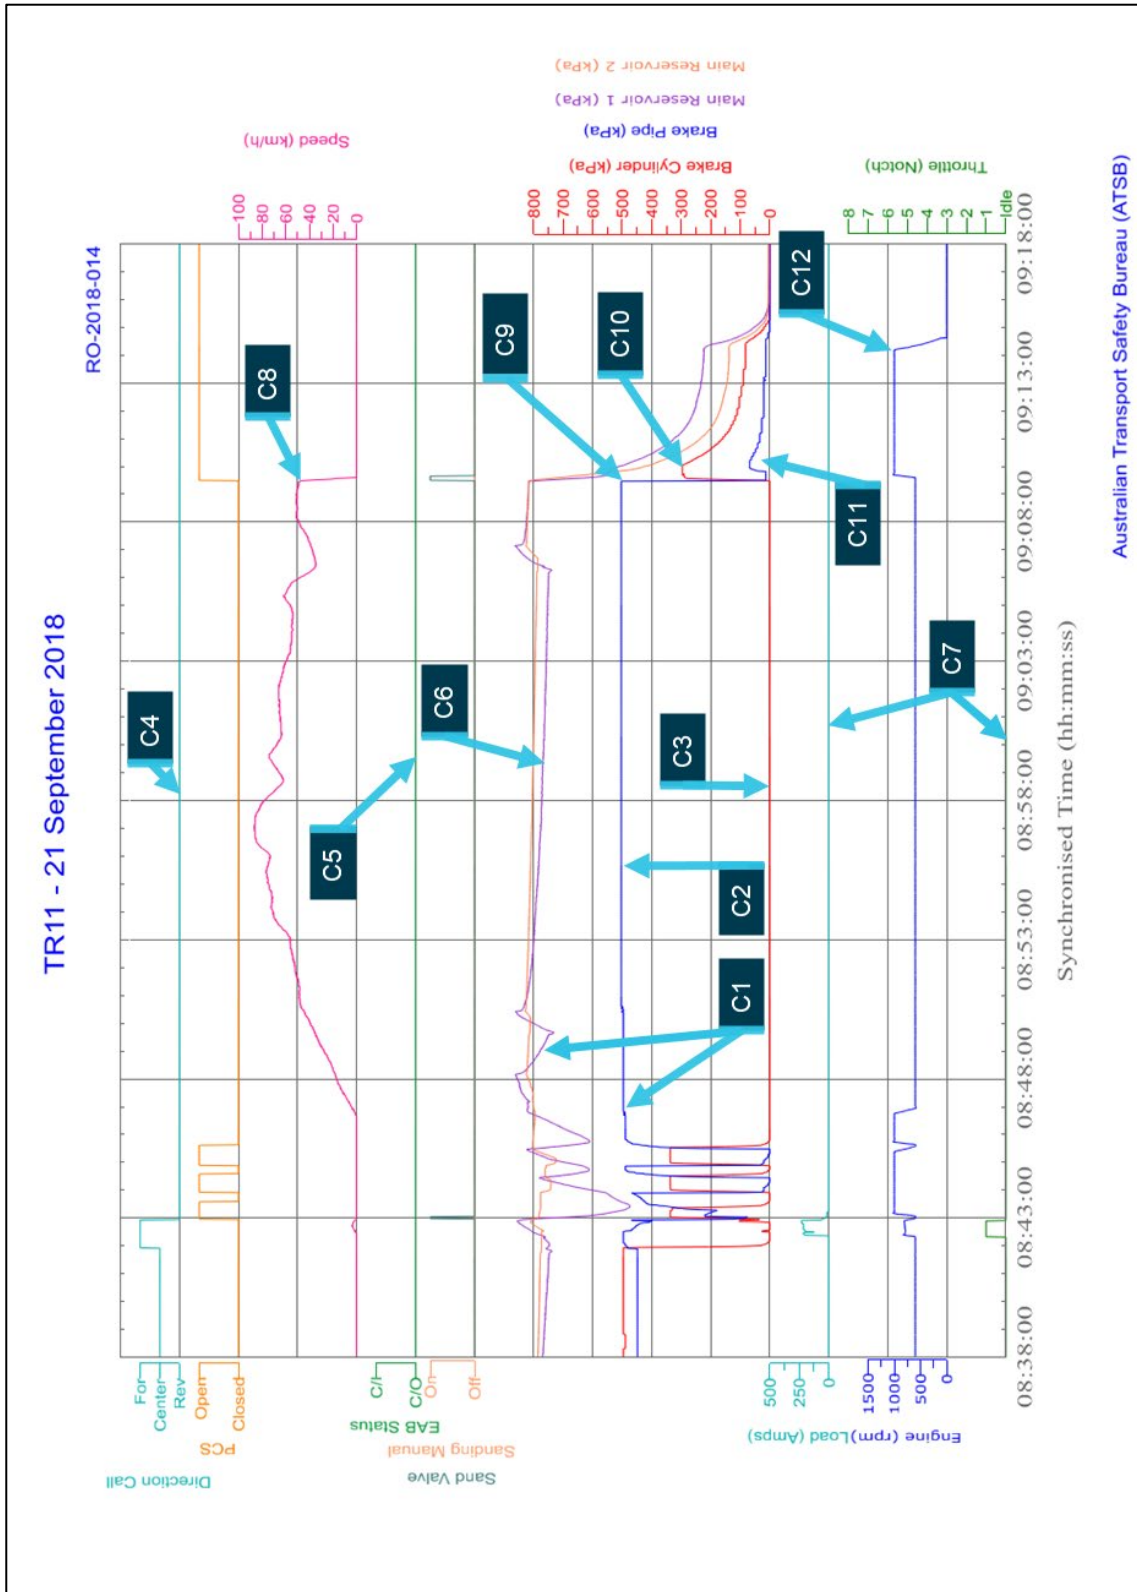
Figure A3: Combined data logger data during continued runaway and derailment (0838 to 0918)

0914:24	Label C12: locomotive engine RPM decreases to zero	The locomotive's engine stopped, corresponding to an emergency shutdown of the TR class locomotive by emergency services at this time. This in turn caused the locomotive's compressor to stop, and remaining air pressure could no longer be maintained.
