Australian Government

Australian Transport Safety Bureau

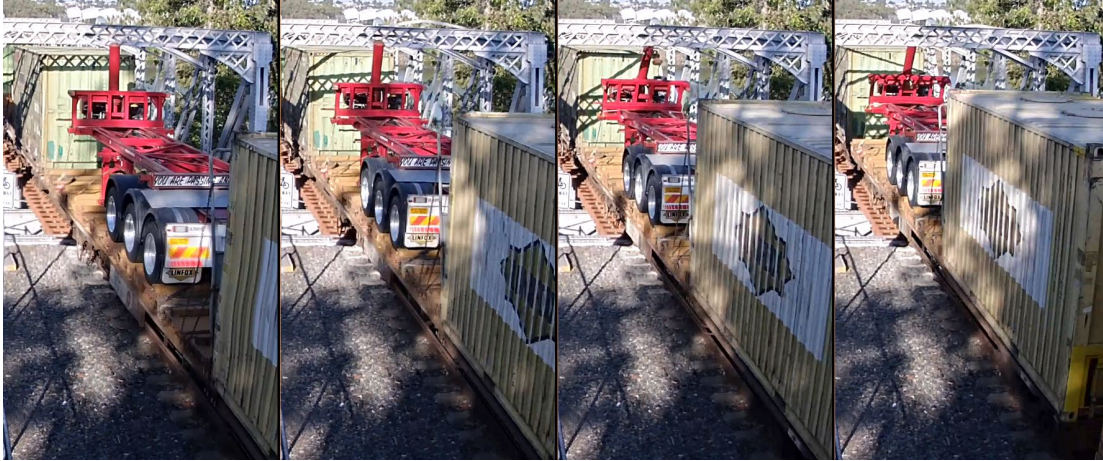
Source: Rockhampton Regional Council

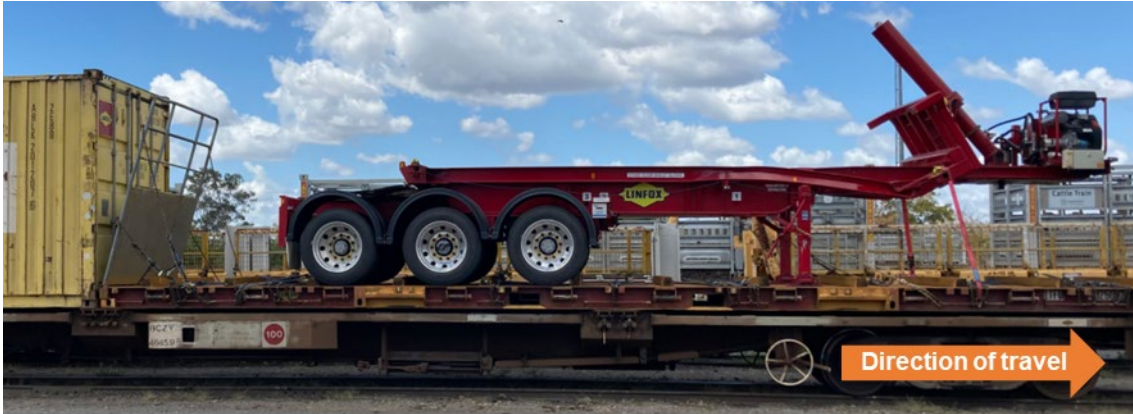
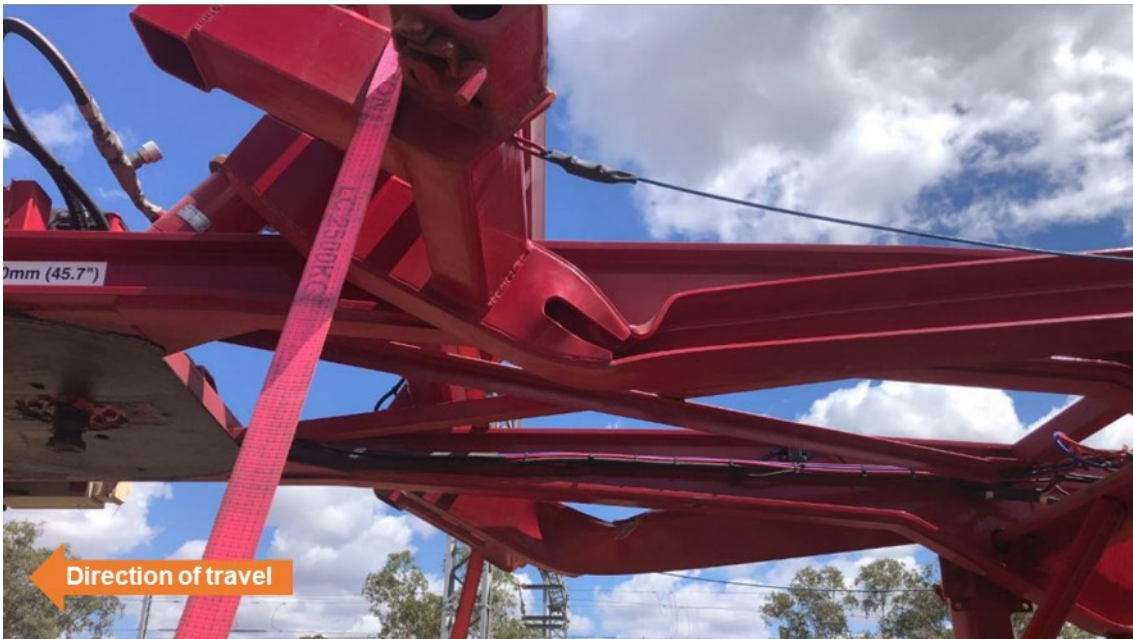
Source: Aurizon (upper), Linfox (lower), annotated by the ATSB

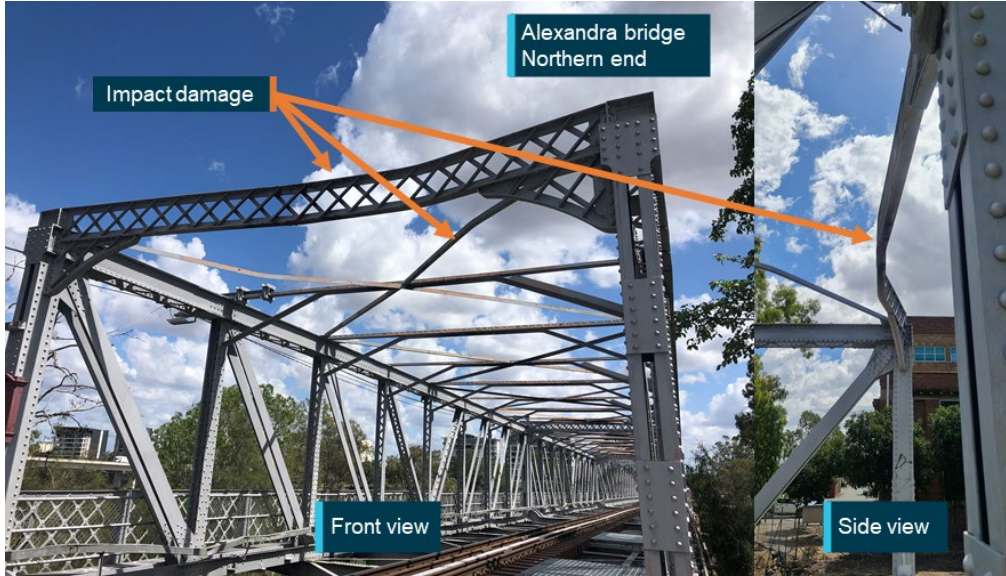
Source: Queensland Rail, annotated by the ATSB
