# Derailment of freight train Y279

Traveston, Queensland, 23 February 2022

## **ATSB Transport Safety Report**

RO-2022-003

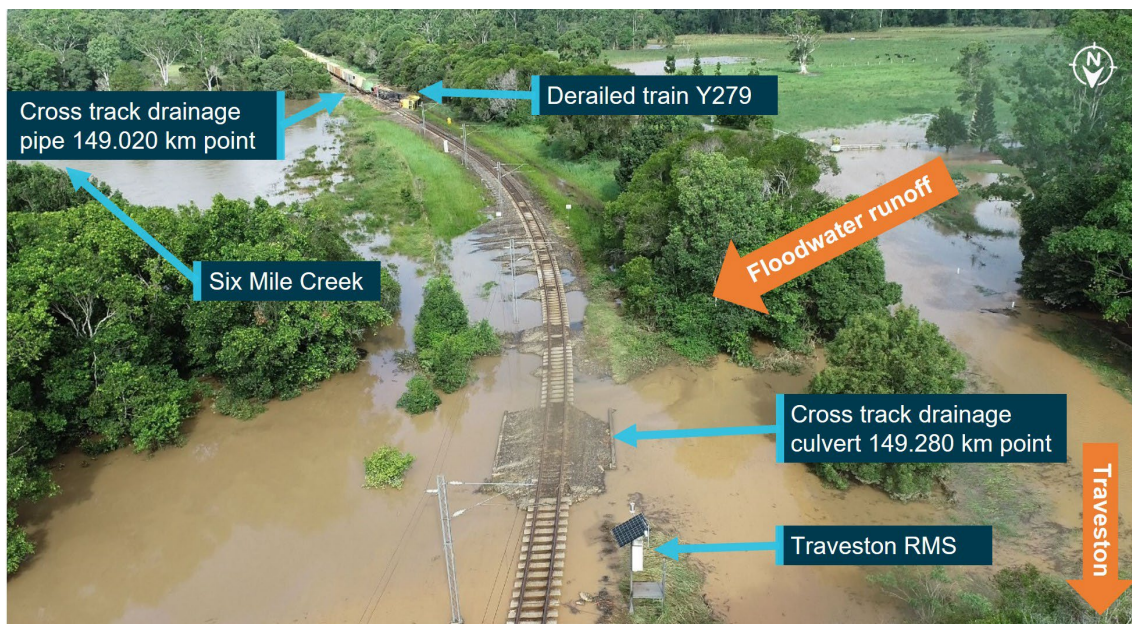
**Figure 2: Location of Traveston wayside remote monitoring station and cross track drains**

At about 0200, Y279 approached Eudlo (92.680 km point). At this time, the Traveston wayside remote monitoring system (Traveston RMS), located adjacent to a cross track concrete box type drainage culvert at the 149.280 km point (Figure 2), recorded the water level in the culvert had risen to 945 mm below rail height.

*The image taken later the day of the derailment shows the relative locations of the derailed train Y279, cross track drains and the Traveston RMS.*  
Source: ATSB

Adjacent the derailment site, there was one 900 mm diameter concrete pipe installed under the track formation at the 149.020 km point. Immediately north of the site there were 2, 2700 mm concrete box culverts installed under the track formation at the 149.280 km point. Rainwater run-off flowed through the under-track drainage from the west to east into Six Mile Creek (Figure 2).

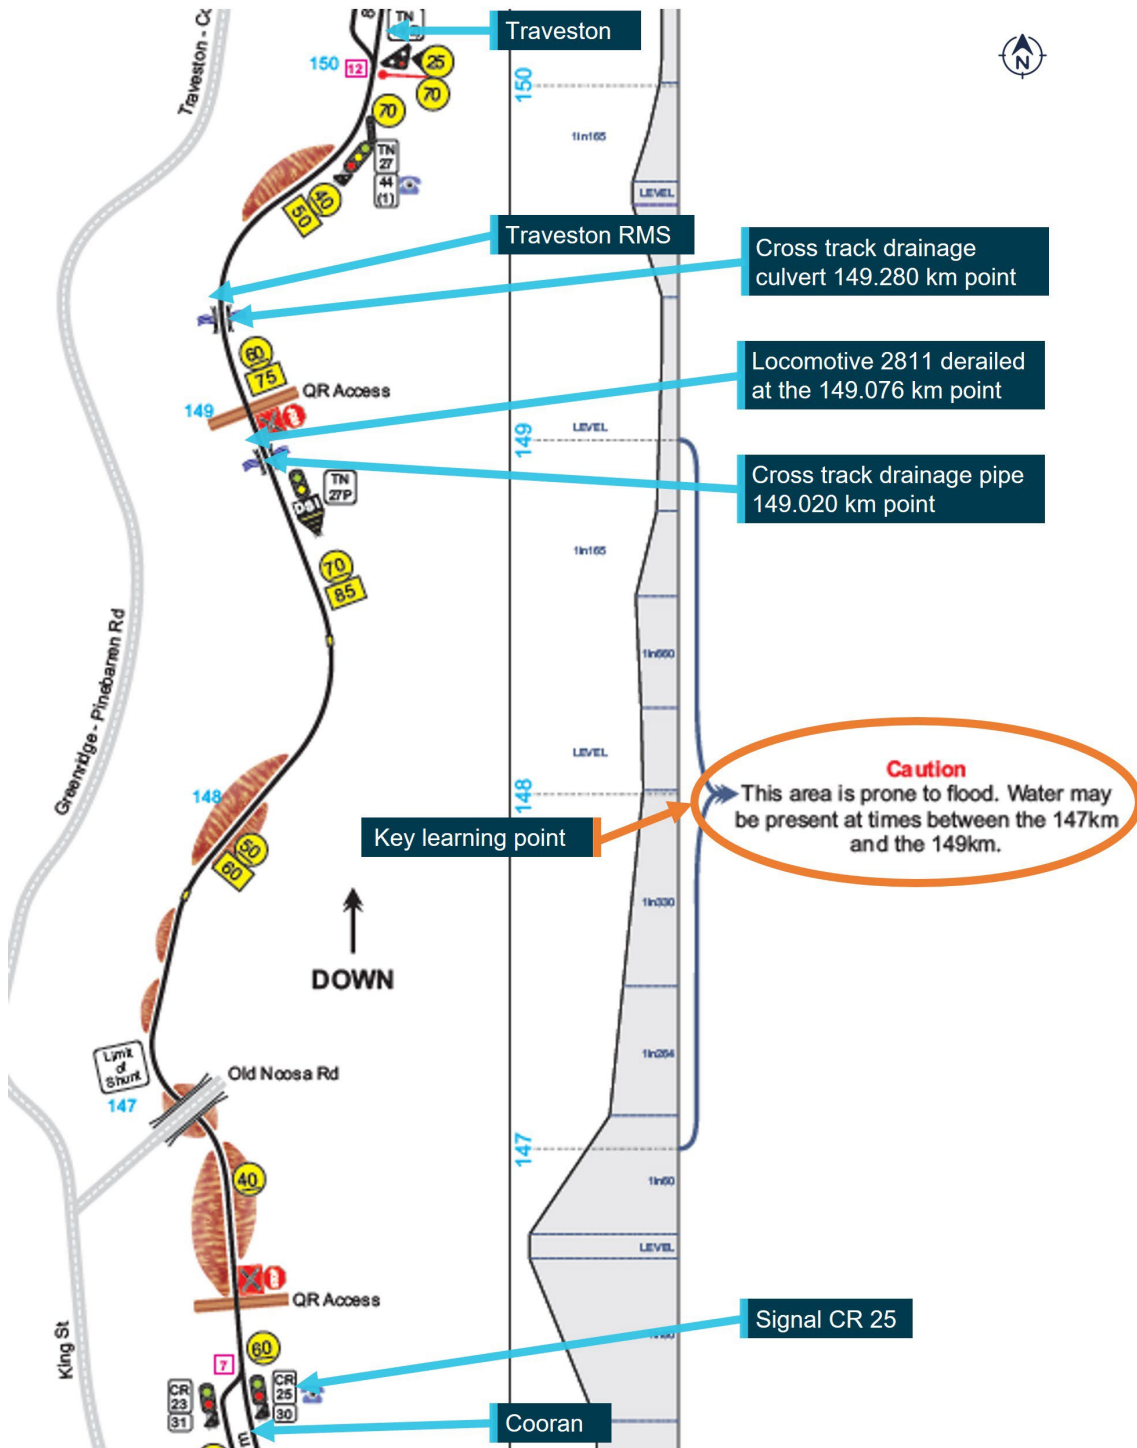
Figure 3: Route map extract showing features between Cooran to Traveston

At about 0310, Y279 passed signal CR25 and continued toward Traveston. The driver initially increased the train speed to 27 km/h. Shortly after, the driver, expecting to encounter floodwaters, reduced the train speed to 15 km/h to travel through an area of track that was known to be prone to flooding (Figure 3). The driver recalled that, although floodwaters were present, they considered there was not enough water to be of concern.

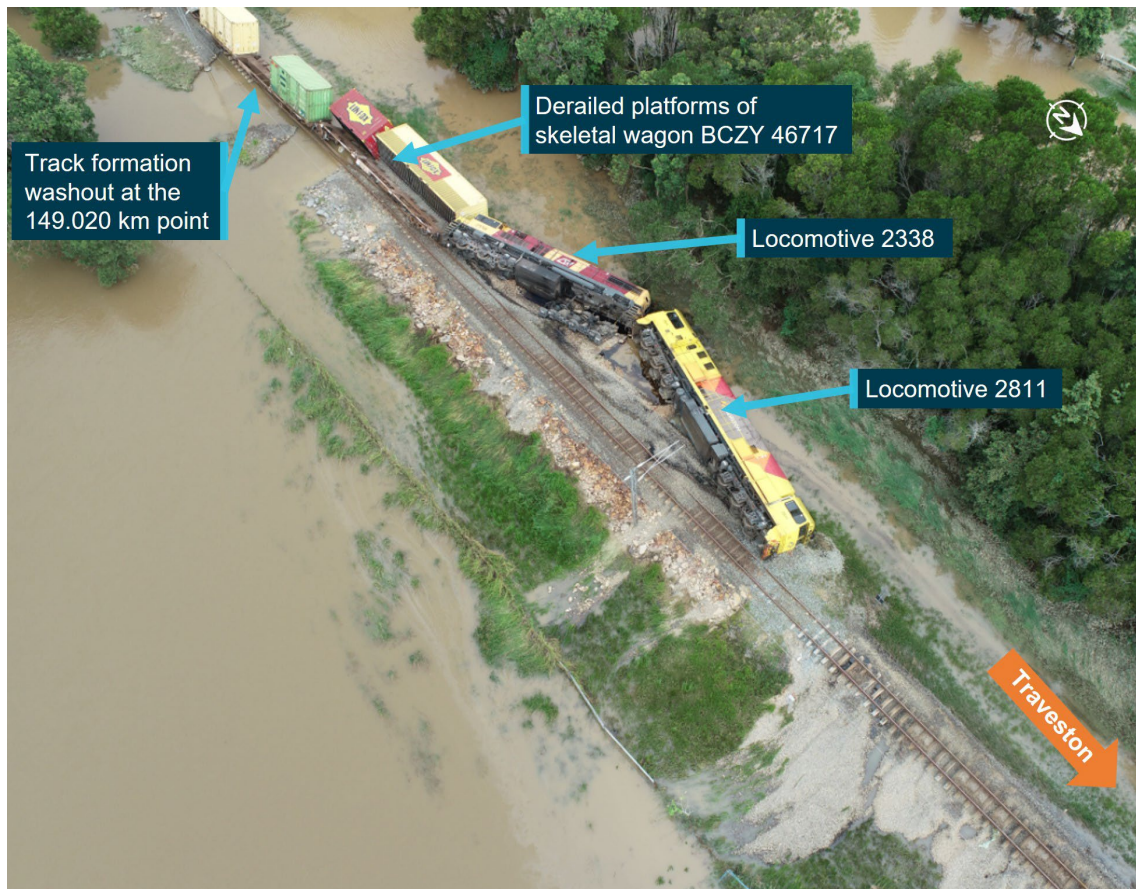
**Figure 4: Derailed rail vehicles from train Y279**

At about 0318 on 23 February 2022, train Y279 derailed at the 149.076 km point after traversing a section of track affected by the floodwater run-off. Both locomotives and 4 rail vehicles of train Y279 derailed. The driver sustained minor injuries during the derailment.

At 0318 the driver moved the throttle to idle and the automatic brake control handle to the emergency position. The driver recounted they initially felt the locomotive dip, before commencing a pitching motion and rolling onto its side. Locomotive 2811 travelled about 56 m between the time

*The image (taken later on the day of the derailment) shows derailed rail vehicles from train Y279, washout and other damage to the track formation.*
