Australian Government
Australian Transport Safety Bureau

Unstable approach involving de Havilland Canada Dash 8 VH-XFZ

Laverton Aerodrome, WA | 17 May 2012

ATSB Transport Safety Report
Aviation Occurrence Investigation
AO-2012-070
Final – 5 December 2013

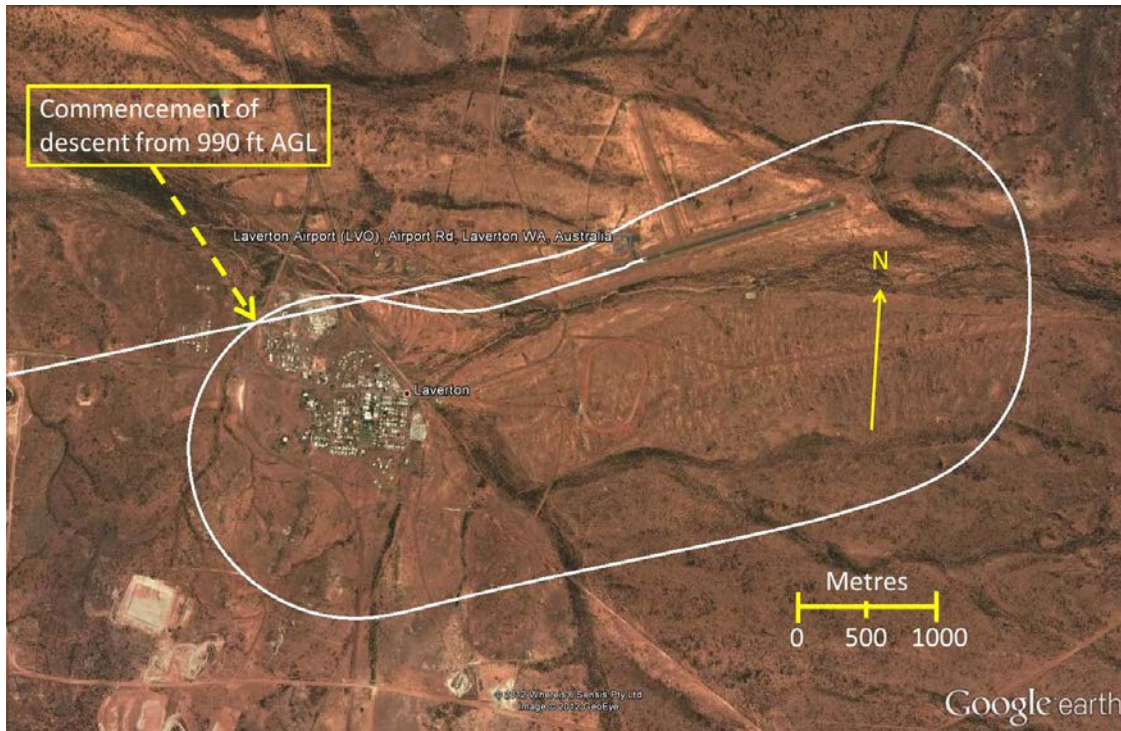
Figure 1: Plot of the recorded approach path from the flight data recorder

The first officer recalled that to maintain visual contact with the runway he commenced a turn from downwind on to the base leg earlier than normal, about 10—15 seconds after passing abeam the runway 07 threshold. The base leg was flown as a continuous level turn but overshot the extended runway centreline, requiring a continuation of the turn to re-intercept centreline from the left. The captain recalled that the approach end of the runway was visible through a gap in the cloud and that a mutual decision was made to continue the approach, but requiring a steep descent through the gap to keep clear of cloud.

At 0751:29, while still in the turn, the autopilot was disengaged, the power was reduced to flight idle and a rapid descent was commenced. Recorded data indicated that at 900 ft the aircraft was

banked 25° to the right and the derived rate of descent was around 1,400 ft/min. The first officer recalled not thinking that the rate of descent was extreme but disclosed that he did not refer to his vertical speed indicator. His main focus of attention was on the runway aspect with occasional glances at the airspeed indicator. He also remarked that he was reliant on the captain to call excessive parameter deviations. The operator’s operations manual detailed the role of the monitoring pilot (in this instance the captain), which included the requirement for a standard ‘sink rate’ call to the pilot flying if the aircraft’s rate of descent on final exceeded 1,000 ft/min. The captain stated that because of the high rate of descent and their proximity to the ground his main focus of attention was also outside the cockpit.

At 0751:36, at 730 ft, the peak rate of descent derived from the recorded data was about 2,500 ft/min. At 0751:48, while passing 300 ft the derived rate of descent was still

about 1,800 ft/min, the speed was 11 kt above the reference approach speed (V_{ref}) and the aircraft was banked 23° to the left as the runway centreline was intercepted. At 0751:55, at 100 ft, the derived rate of descent was about 1,200 ft/min as the landing flare was commenced and a small amount of power reintroduced. The touchdown on the 1,800 m paved runway was normal at 0752:12.

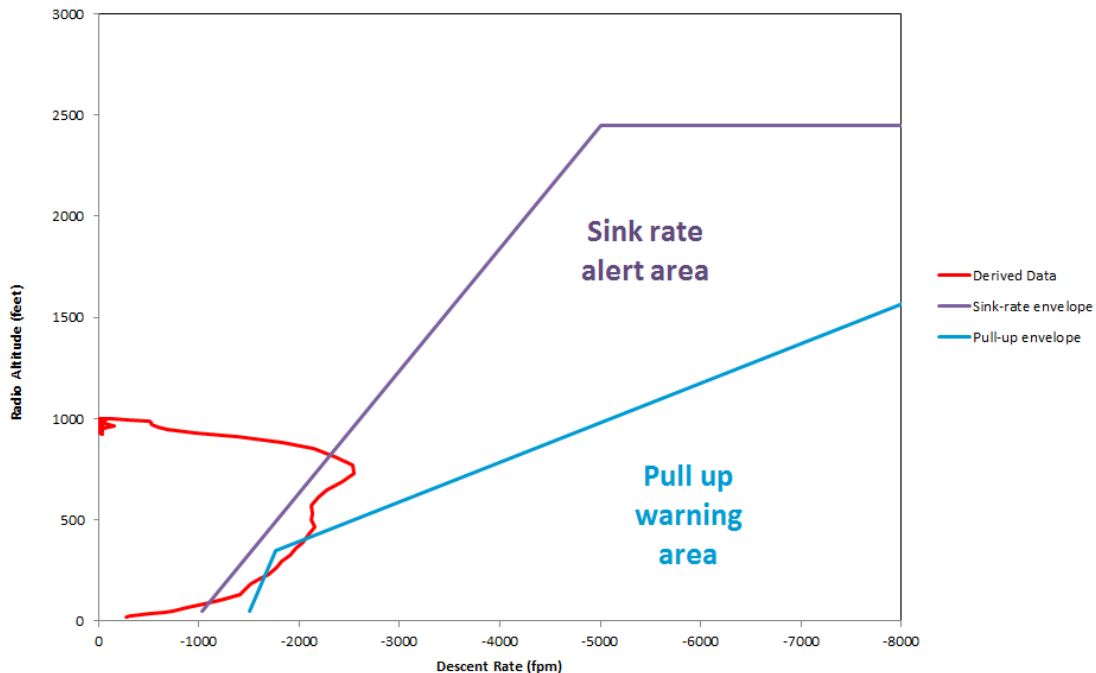
Figure 2: EGPWS Mode 1 alerting envelope

The EGPWS provided a number of terrain alerting modes. Mode 1, excessive descent rate, relies on the aircraft’s radio altimeter system and provides alerts for excessive descent rates with respect to radio altitude above ground level. It has inner and outer alert boundaries, as displayed in Figure 2.

Penetration of the outer boundary activates the EGPWS caution lights and a ‘sink rate’ alert annunciation. Additional ‘sink rate’ messages will occur for each 20 per cent degradation in altitude. Penetration of the inner boundary activates the EGPWS warning lights on the aircraft’s glareshield panel and changes the audio message to ‘pull up’, which repeats continuously until the inner warning boundary is exited.

Figure 2 incorporates XFZ’s radio altitude and derived rate of descent during final approach and shows that both caution alert and warning alert envelopes were penetrated. The crew stated that their recollection of the exact nature of the EGPWS alerts occurring during the approach was unclear.

The recorded data indicated that several EGPWS 'sink rate' cautions would likely have occurred, followed at about 400 ft by a 'pull up' warning. The operations manual provided specific guidelines for those circumstances, but the crew, unaware that a go-around was required for a valid EGPWS warning in day VMC, continued the approach. If the crew had responded to the warning with a scan of the instruments they would have realised that the descent rate of about 2,100 ft/min at the time was excessive for the height above terrain and the warning was valid. By not responding effectively to the EGPWS cautions and warnings, the crew increased the risk of an approach or landing accident.

- the flight standards department formulated a method of incorporating an EGPWS warning event in the Dash 8 simulator training program. As a direct result of this incident, EGPWS training is now carried out twice a year by all Dash 8 crews.
