Engine fire during start-up involving a Piper PA-28-161

Moorabbin, Victoria, on 11 October 2022

Aviation Occurrence Brief

AB-2022-013

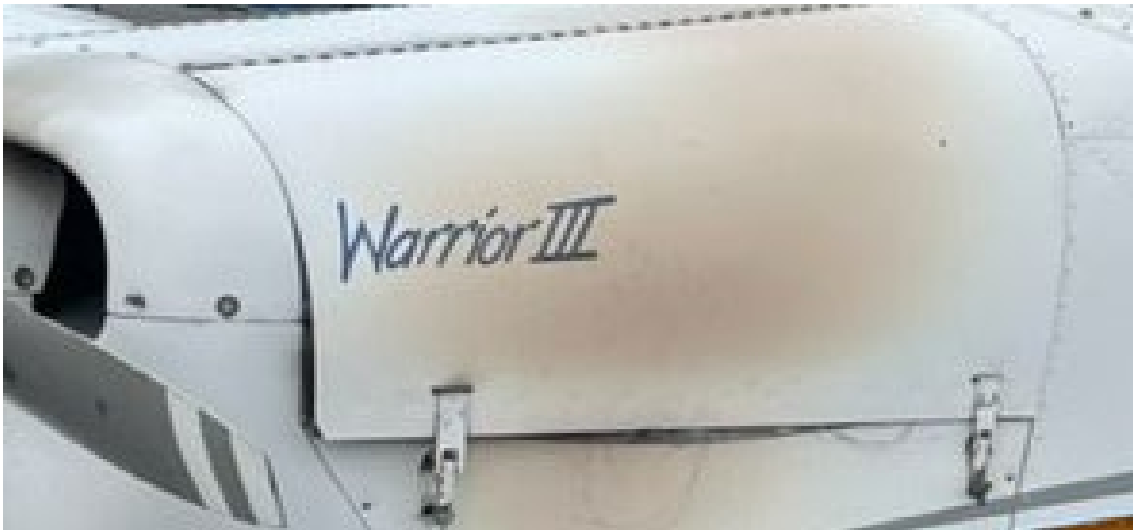
The student actioned the pre-start checklist but reported difficulty starting the engine after using the electric prime for approximately 5 seconds on the first attempt, and another 3 seconds on the second attempt. On the third attempt, a loud 'pop' was heard from the engine, and the student elected to exit the aircraft and ask for help. At this time, smoke was observed emanating from the engine cowling and, upon opening, a fire was found around the carburettor. A fire extinguisher was obtained and the student returned to the aircraft and extinguished the flames. The aircraft sustained minor damage to the engine and surrounding airframe.

Figure 1: Burnt engine cowling

The operator's pre-start checklist called for an engine fire brief prior to starting, which requires fuel isolation and continued engine cranking to ingest and extinguish a fire. In this case, the student had not suspected an engine fire until after exiting the aircraft. The operator has raised the matter at a recent safety training day for students.

The operator is also reviewing the aircraft pre-start checklist which will include monitoring of the fuel pressure after application of the fuel pump to determine possible malfunctions of the carburettor.
