Flight control systems occurrence involving Boeing 737-800, VH-YFZ

Gold Coast Airport, Queensland on 27 April 2022

ATSB Transport Safety Report

AO-2022-029

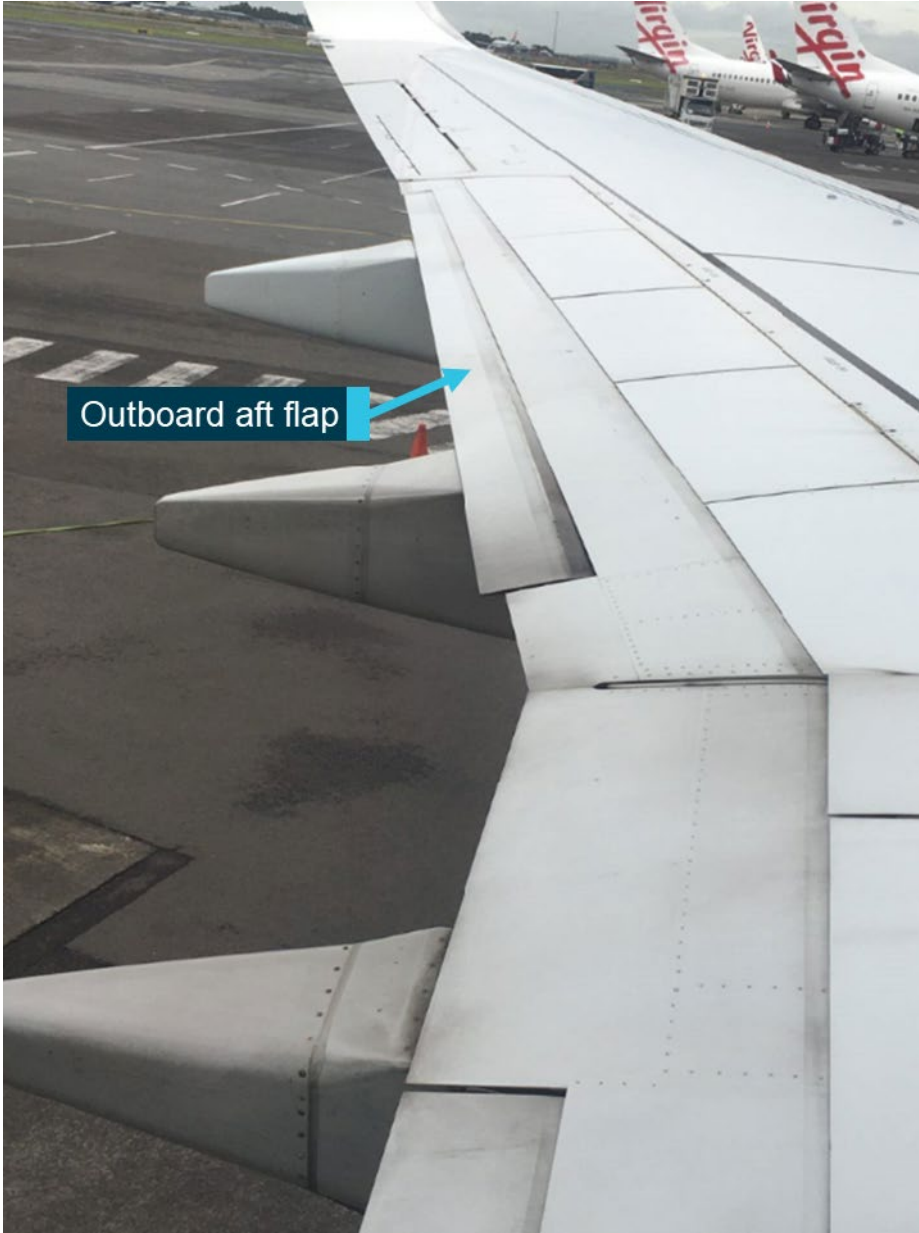
Once the passengers had disembarked, one of the flight crew conducted a walk-around inspection of the aircraft and noticed that part of the left outboard aft flap had not completely retracted after landing, resulting in a skew (Figure 1). The flight crew received no flap asymmetry or flap skew warnings throughout the flight. A subsequent engineering inspection identified component failures in the left outboard aft flap actuation system.

Figure 1: The skewed left outboard aft flap of VH-YFZ after landing in Sydney

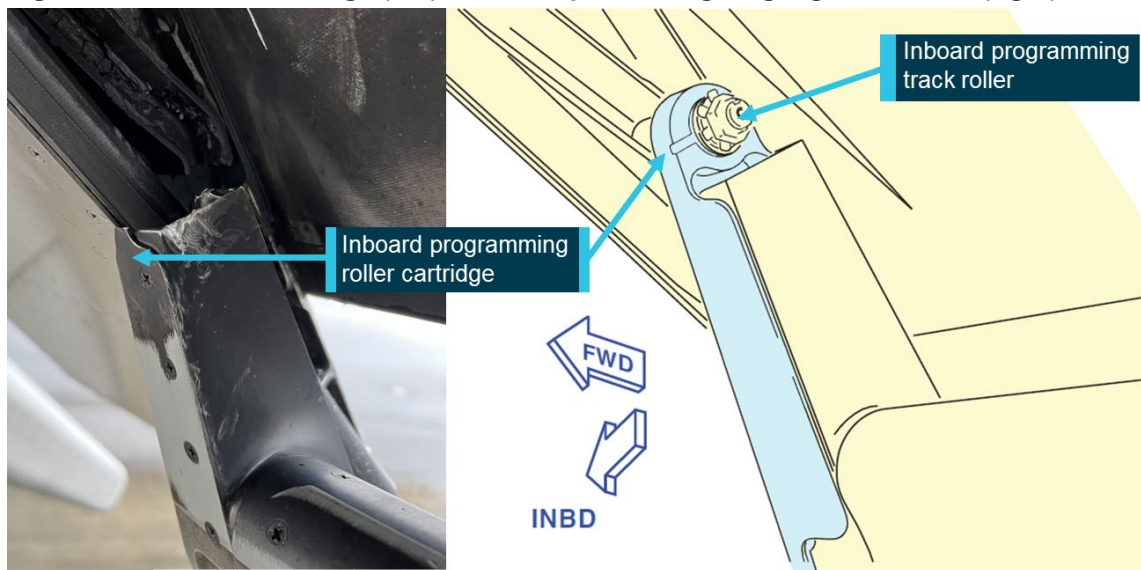
The aircraft's trailing edge flap system contains an outboard aft flap nested within a larger main flap when fully retracted. Upon extension, a ball screw and gimbal transmit forces into pushrods rods to deploy the aft flap. The aft flap is guided by several rollers along tracks connected to the main flap. The roller on the inboard edge of the flap is known as the inboard programming track roller. In this occurrence, a component known as a 'cartridge' securing this roller to the aft flap failed (Figure 2).

Figure 2: The failed cartridge (left) and example cartridge highlighted in blue (right)

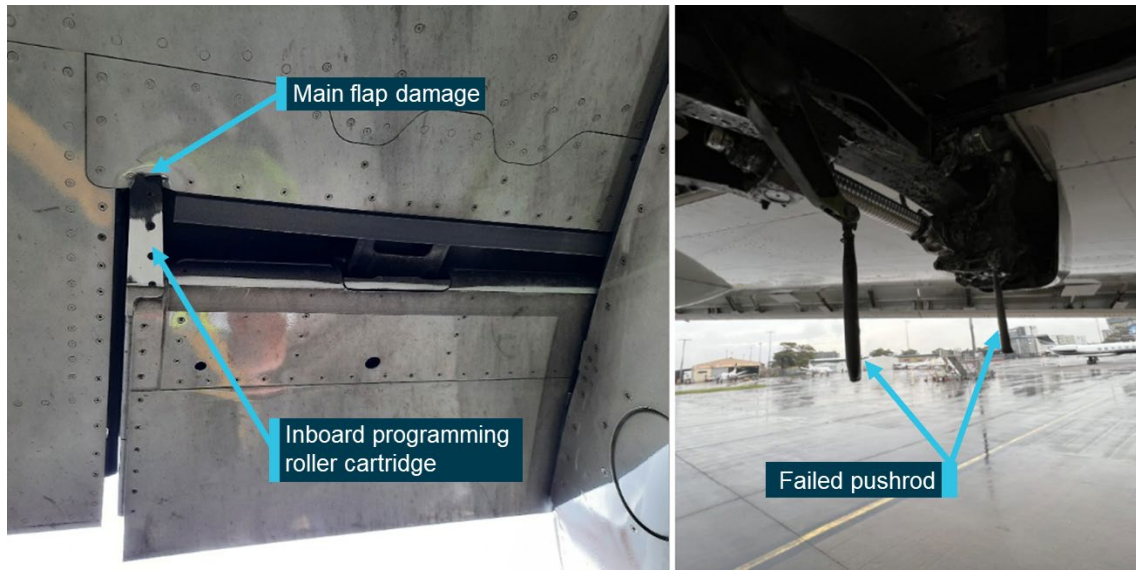
When the damaged programming roller cartridge was found, the section still attached to the aft flap had caught on the underside of the main flap, damaging the skin (Figure 3, left). This contact with the main flap prevented the aft flap from retracting correctly. The other section of the cartridge, including the roller, detached from the aircraft and was not recovered. In addition to the damaged programming roller cartridge, one of the pushrods in the flap actuation system was also found to have failed (Figure 3, right).

Figure 3: The programming roller cartridge obstructed by the main flap (left) and the failed pushrod (right)

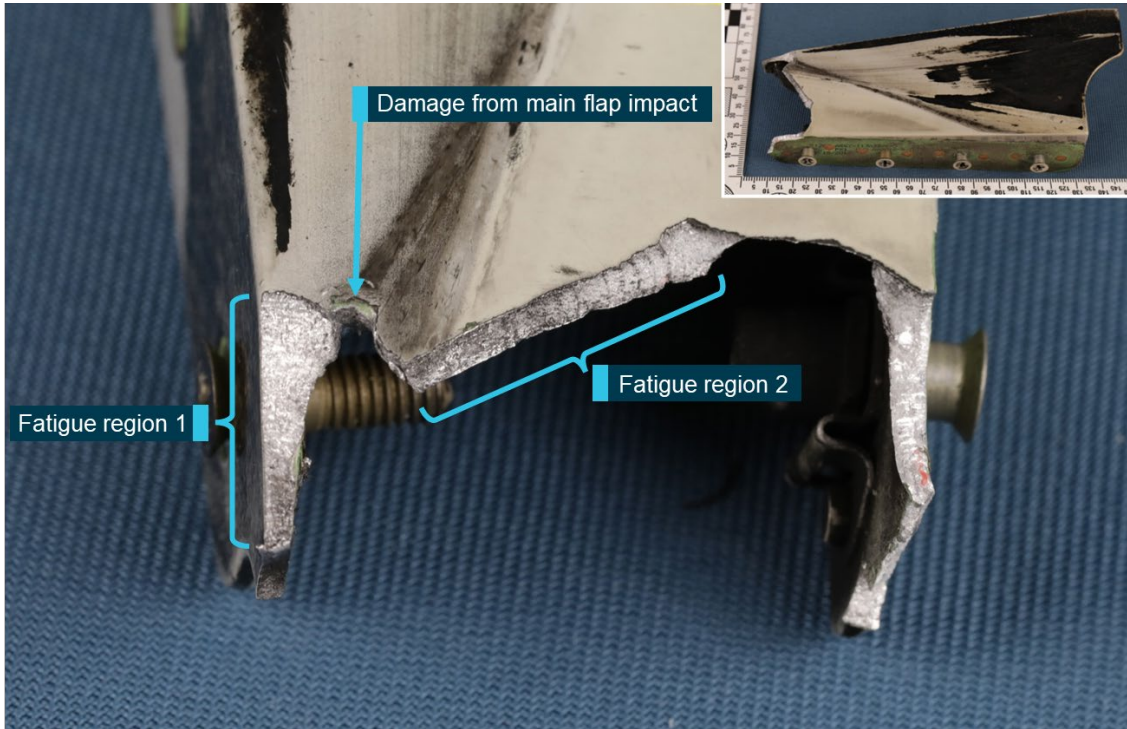
The failed inboard programming roller cartridge and pushrod were sent to the ATSB for detailed technical examination. Two regions of fatigue cracking were identified in the cartridge (Figure 4). These were separated by deformation resulting from contact with the main flap. Outside of these two regions, the fracture surfaces appeared to be consistent with overstress, with no evident fatigue cracking.

Figure 4: The fracture surface of the cartridge, with the entire component inset

Detailed technical examination identified that a fatigue crack propagated through the inboard programming roller cartridge on the left outboard aft flap, eventually resulting in failure of the cartridge. It is not clear exactly when this failure occurred, although the absence of any handling issues in the previous flight suggests that the failure was likely at some point after the previous flight's touchdown at Gold Coast Airport.

The Australian Transport Safety Bureau recommends that The Boeing Company takes safety action to increase the detection of fatigue cracks in the roller cartridges of 737-800 aircraft prior to failure.

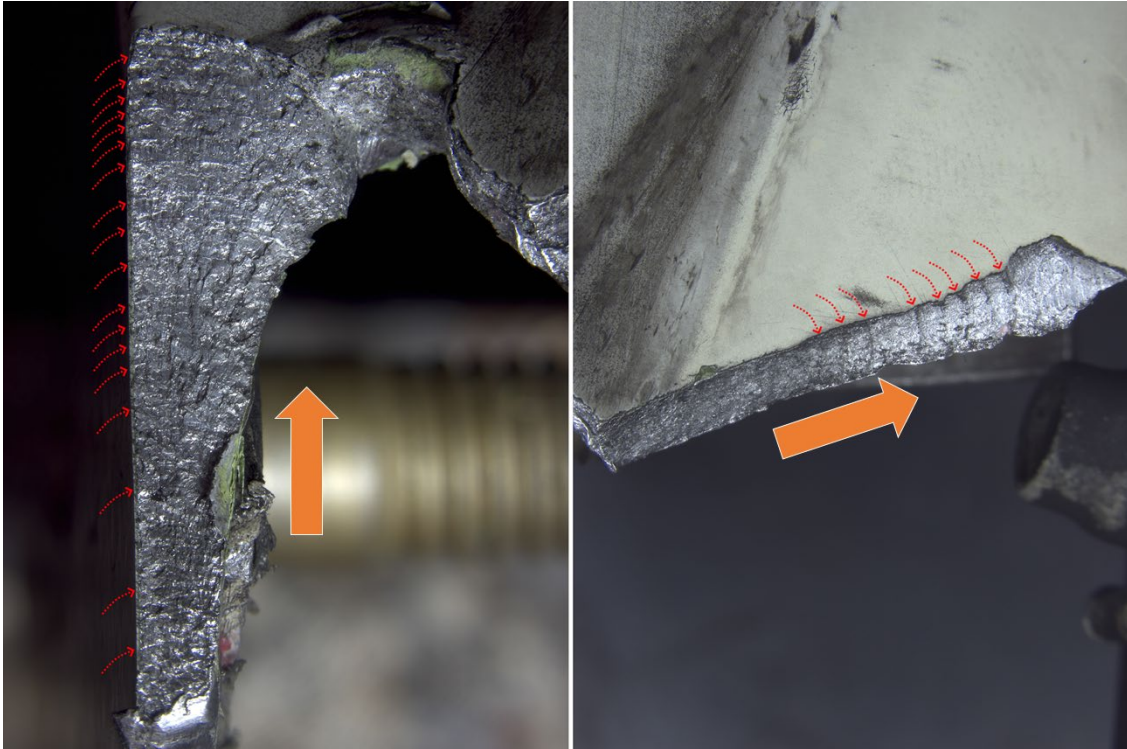
The two fatigue regions were examined using optical microscopy (Figure 5). Red arrows indicate the most obvious beachmarks—evidence of crack progression. The orientation of the beachmarks suggest the crack propagated in the direction indicated by the orange arrows. The crack origin was likely near the bottom of fatigue region 1. It was either obscured by smearing of the metal, or was on the section of cartridge that was not recovered. Blackening and corrosion pitting on the lower half of fatigue region 1 indicate that this portion of the crack had been present for some time.

Figure 5: Fatigue regions 1 (left) and 2 (right) on the failed programming roller cartridge

Red arrows point to observed beachmarks. Orange arrows indicate the direction of crack propagation.
Source: ATSB

Blackening and pitting of the roller cartridge fracture surface suggests that the crack might have been present for some time, but it could not be determined whether any cracking was present at the last general inspection of the left outboard flap in October 2020. The cracking observed was predominantly on the side of the cartridge that abutted the roller track. It would therefore have been very difficult to observe on-wing. There have been 10 similar occurrences involving cracking and/or failure at the aft flap programming roller during flight operations. Of the 6 occurrences where the component age was reported, the aft flap actuation system was old enough to have been inspected for fatigue cracks several times prior to failure, as part of the general visual flap inspection.

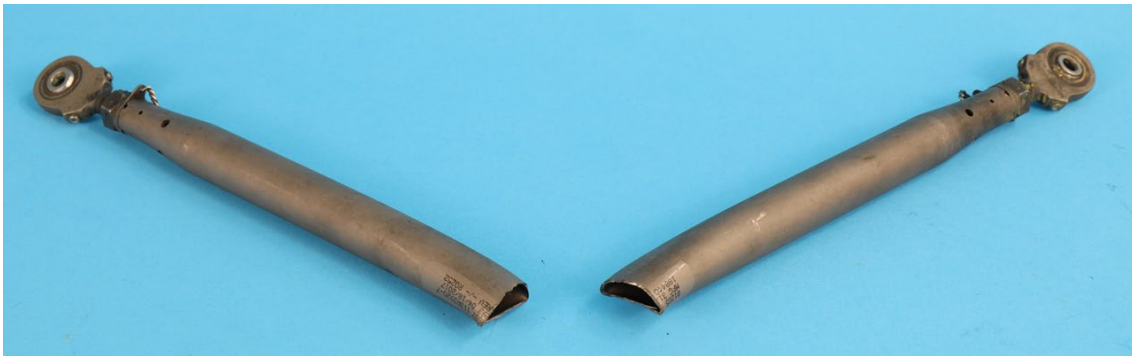
A visual examination of the pushrod revealed no evidence of pre-existing damage. Localised deformation at the fractured ends was indicative of buckling/bending failure (Figure 6). This was consistent with the compressive forces it would have experienced as the aft flap become stuck during retraction.

Figure 6: Both halves of the failed pushrod

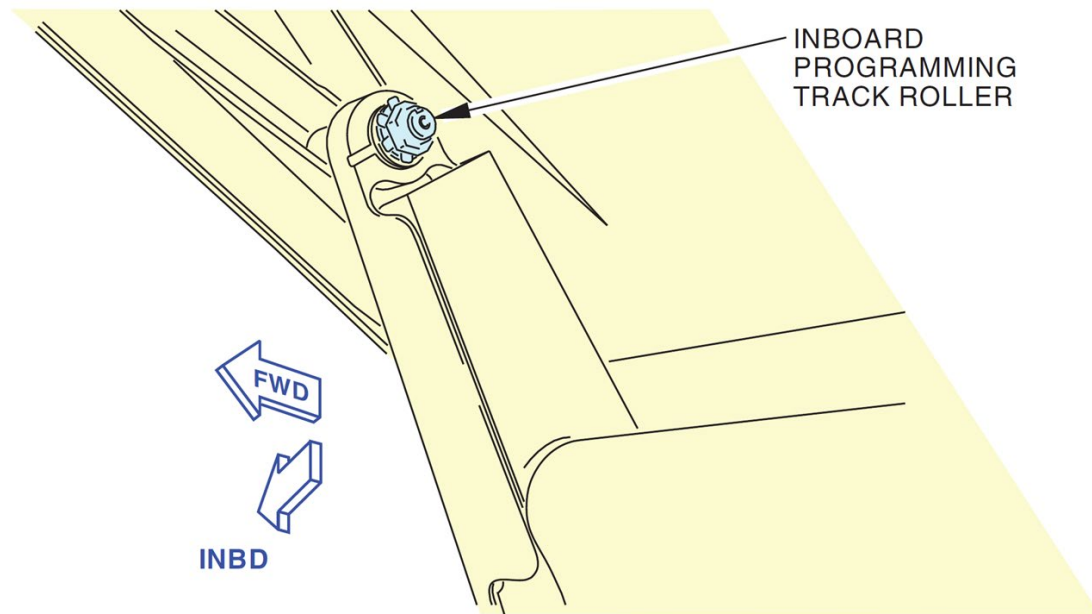
A more detailed on-wing inspection was specified for the flap actuation system, which Boeing recommended every 12,000 flight cycles. In the associated task card, the engineer was required to perform ‘a detailed visual inspection of... inboard and outboard programming rollers’, and a diagram was provided (Figure 7). The roller cartridge was not an intended part of the inspection. This inspection had not been carried out on VH-YZF as it was not was not yet due.

Figure 7: Reference diagram for inspection of the inboard programming roller

The more detailed inspection for the flap actuation system was not due on VH-YFZ for another 5,600 cycles; however, on each of the 6 aircraft mentioned above the programming rollers would have been inspected at least once prior to failure. As with the general visual inspection, this detailed inspection was performed on-wing, restricting observation of the cartridge. Additionally, while the task card specified an examination of the programming rollers, the cartridges that housed them were not included.

The ATSB also notes that a detailed inspection of the flap actuation system already exists, and while it includes the aft flap rollers, it does not include the cartridges that house them. Inclusion of the cartridges in the detailed inspection would provide the greatest opportunity for fatigue cracks to be identified prior to failure.
