# Collision with terrain involving Cessna R182, VH-EHM

24 km north of Royal Australian Air Force Base Amberley, Queensland on  
29 August 2022

**ATSB Transport Safety Report**

AO-2022-041

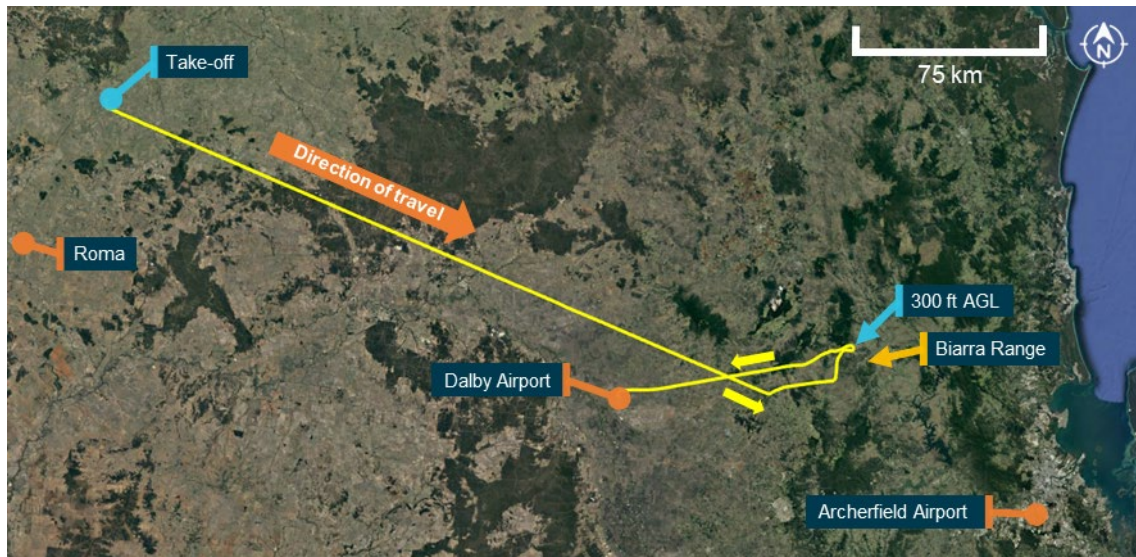
**Figure 1: Flight to Dalby Airport**

At 0715 on the following day, the pilot and 2 passengers departed from the property in EHM for a VFR return flight back to Archerfield (Figure 1). Recorded flight tracking data showed the aircraft was initially established on a direct south-easterly track towards Archerfield at cruise altitudes of between 3,400 ft and 3,900 ft above mean sea level (AMSL). The weather forecast available from the Bureau of Meteorology (BoM) at the time of departure indicated that the route to Archerfield could be affected by low cloud, rain, fog and associated reduced visibility.

At 0828, the aircraft turned left and descended to about 1,800 ft AMSL – 600 ft above ground level (AGL). The flight then tracked north before turning east towards the Biarra Range and into a valley before descending to about 300 ft AGL. Shortly after, the aircraft completed a 180° turn, climbed to 3,900 ft and tracked towards Dalby Airport. At 0901, the aircraft landed at Dalby and was refuelled with about 263 L of fuel.

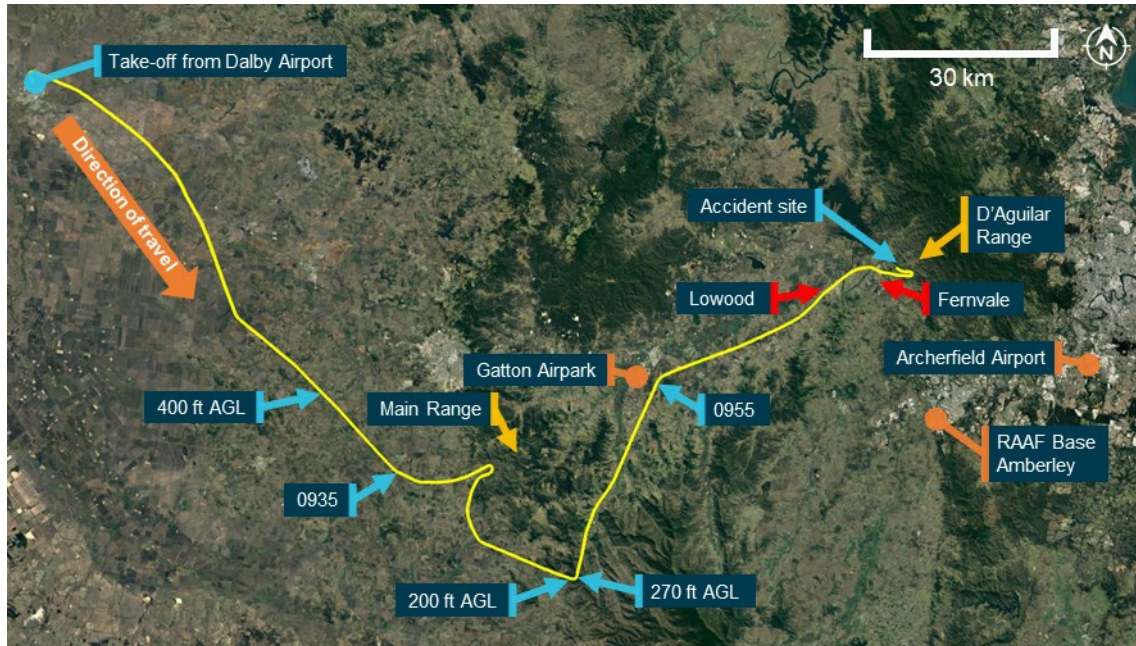
**Figure 2: Accident flight**

progressed over rising terrain and 3 minutes later was operating at about 400 ft AGL (Figure 2). At 0935, the aircraft turned left towards Main Range before completing a 180° turn between 300-500 ft AGL. It then tracked south-east, climbing to about 1,000 ft AGL.

At about 0946, the aircraft passed over a mountain ridge at a height of about 200 ft AGL before turning left over another ridge at a height of about 270 ft AGL (2,900 ft AMSL). The aircraft then tracked north-east, descending down a valley for 8 minutes at an altitude of about 1,200 ft (700 ft AGL).

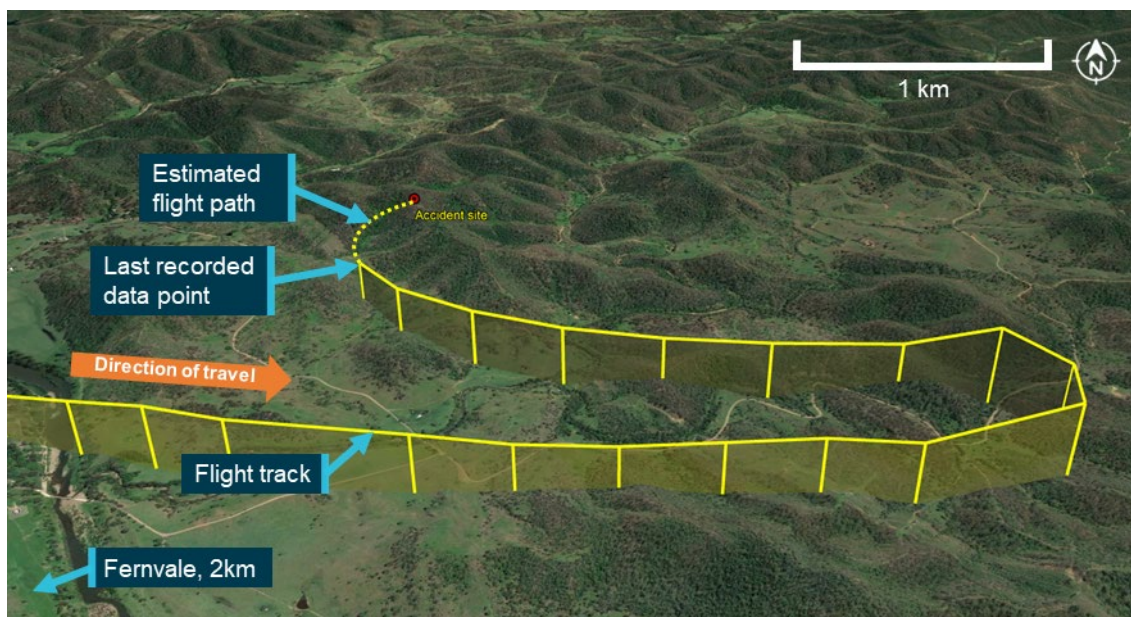
**Figure 3: Flight track and accident site**

The flight progressed down a valley before completing another 180° turn while climbing to 1,000 ft AGL. After the turn, the aircraft descended to 800 ft (600 ft AGL) before turning right, back towards the D'Aguilar Range (Figure 3). During this turn, at 1007, the aircraft impacted terrain at an elevation of about 650 ft AMSL. The aircraft was destroyed, and all occupants were fatally injured.

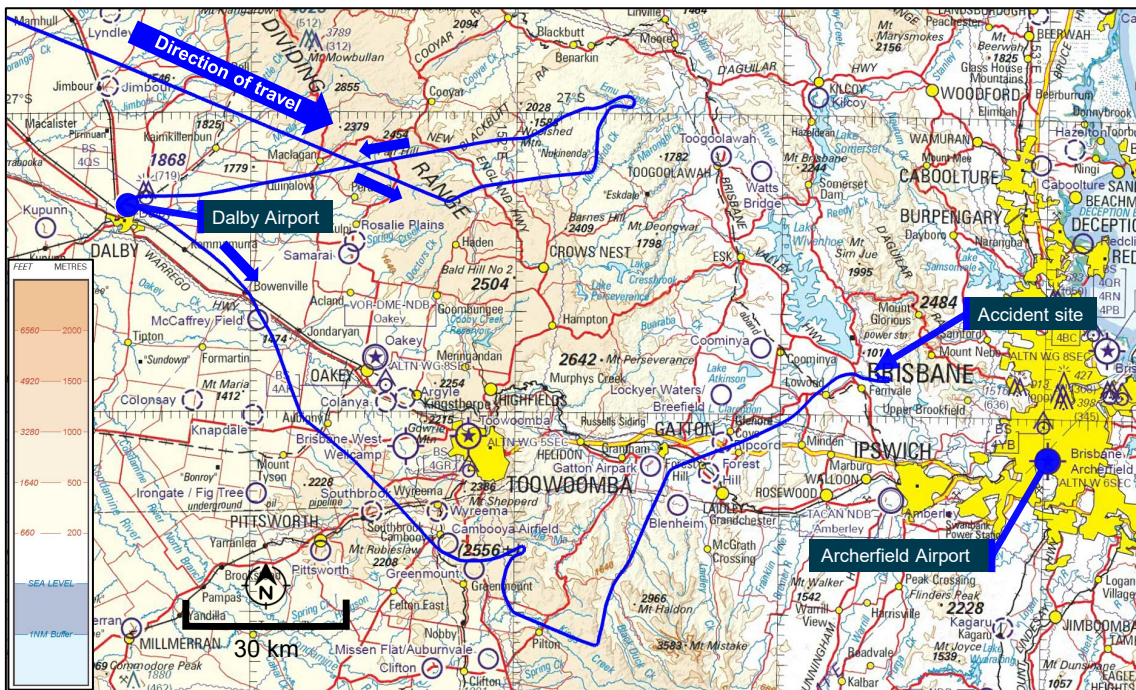
**Figure 4: Visual navigation chart extract showing terrain along the flight path**

The flight's track towards Archerfield took the aircraft across the Great Dividing Range to the west of Brisbane with terrain elevations generally between 1,500-2,000 ft AMSL. This area also contained numerous peaks between 2,000-2,700 ft (Figure 4).

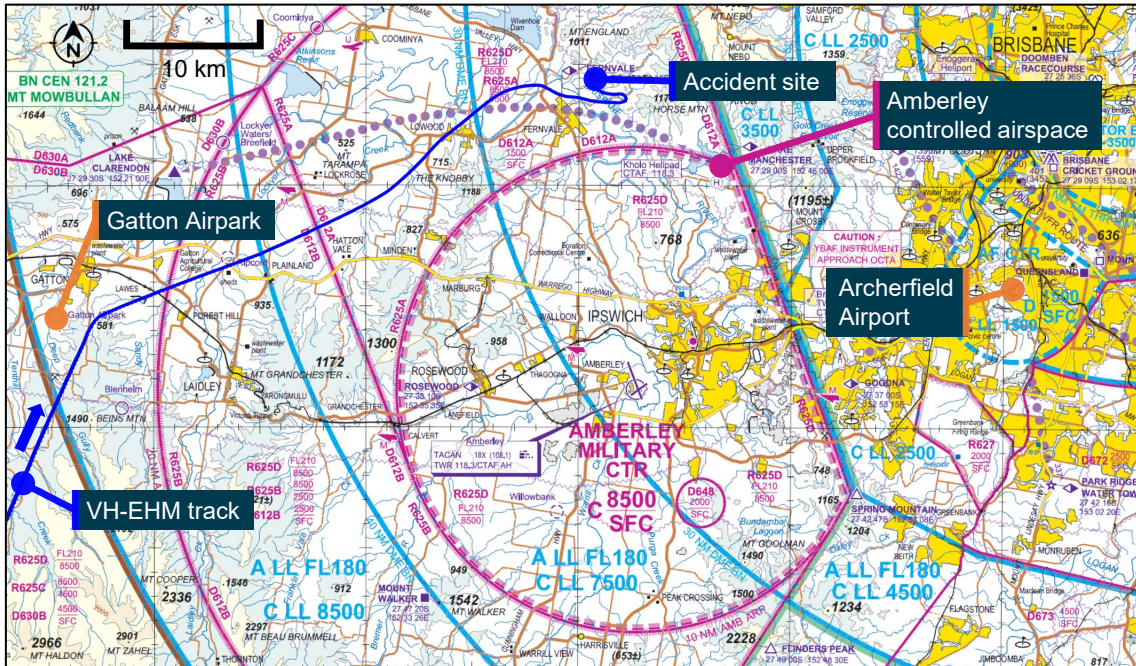
Figure 5: Amberley control area

The Amberley military control zone extends from ground level up to an altitude of 8,500 ft (Figure 5). The airspace was active from 0800 to 2300 on 29 August and required a clearance to transit. Preliminary information indicated no record of a transit clearance request by the pilot, however, additional information is being collected by the ATSB to verify this.

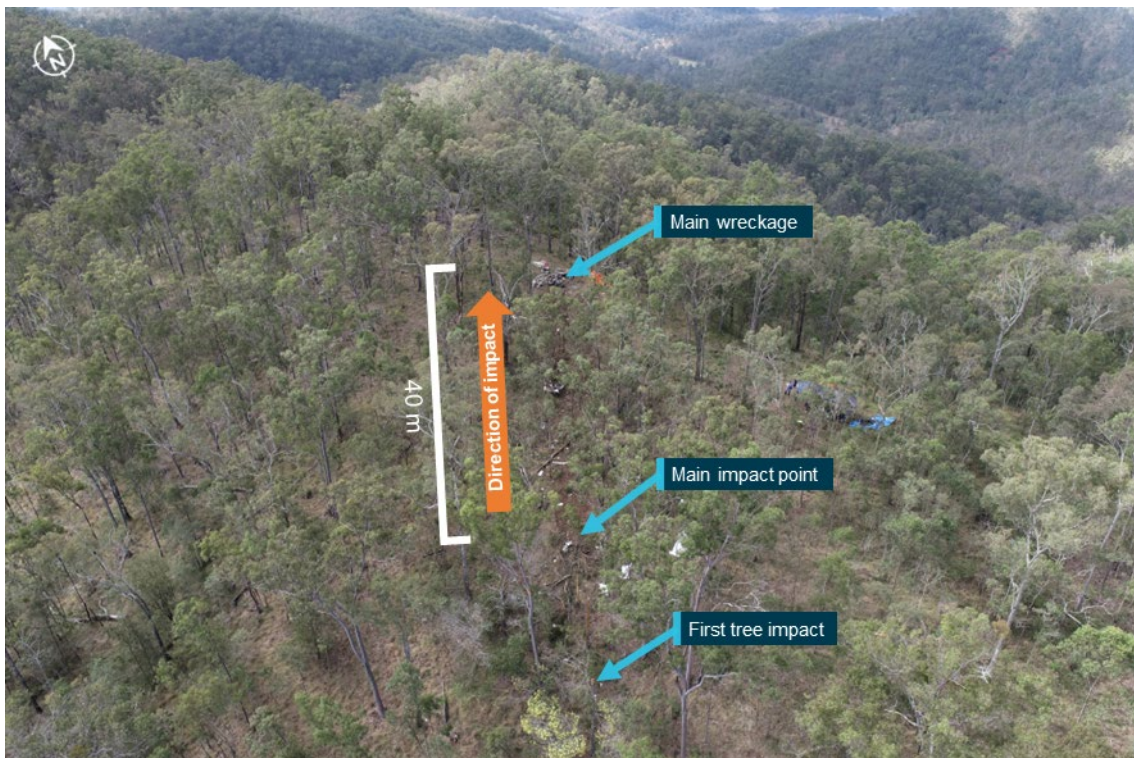
Figure 6: Accident site

The accident site was located within the D'Agular Range on a steep section of mountainous terrain covered with trees (Figure 6).

On-site evidence indicated that the aircraft was in a right turn with an angle of bank of about 47° when it collided with several trees, before impacting terrain about 28 ft vertically below the top of a

ridge. The wreckage trail extended about 40 m from the initial impact point to the top of a ridge where most of the wreckage was located, including the engine. The propeller was located about 10 m forward of the main impact point.

On-site examination indicated that the engine was providing power at impact, with the landing gear and flaps in the retracted position. There was no evidence of an in-flight break-up or a pre-existing defect with the flight controls.
