# Birdstrike and collision with terrain involving Air Tractor AT-502B, VH-KDR

32 km east-north-east of Chinchilla Airport, Queensland, on 19 September 2022

**ATSB Transport Safety Report**  
Aviation Occurrence Investigation  
AO-2022-043  
Preliminary – 16 December 2022

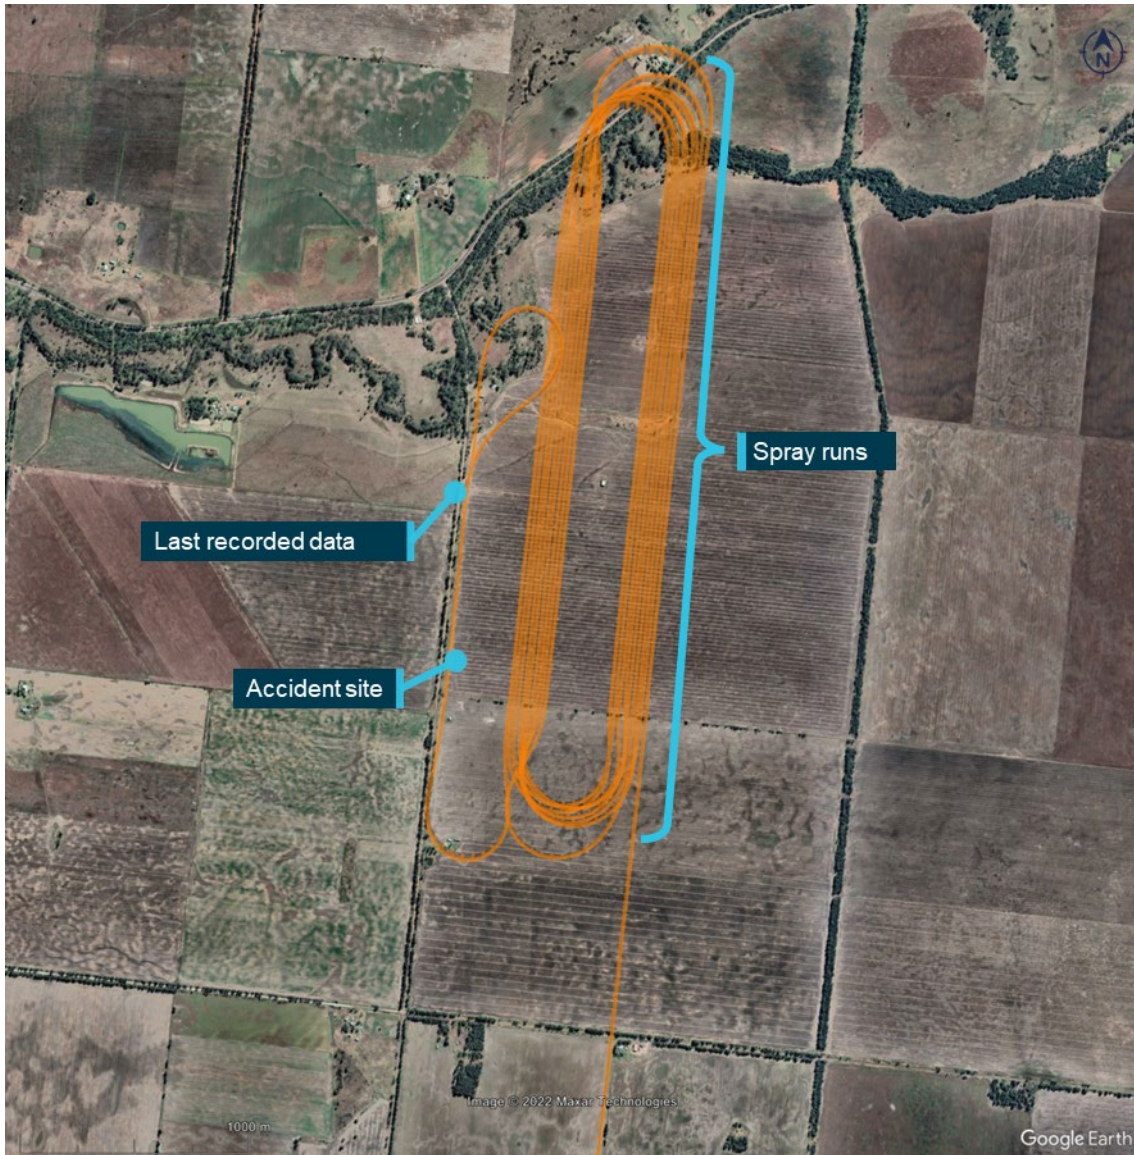
**Figure 2: Accident site and spray runs (orange)**

After completing 17 spray runs on the paddock in a racetrack pattern, at about 1125, the aircraft was turned to track north along the western boundary (Figure 2). The aircraft was then turned at

the northern end to commence the 18th spray run to the south. The last GPS data point was recorded 3 seconds after starting this run.

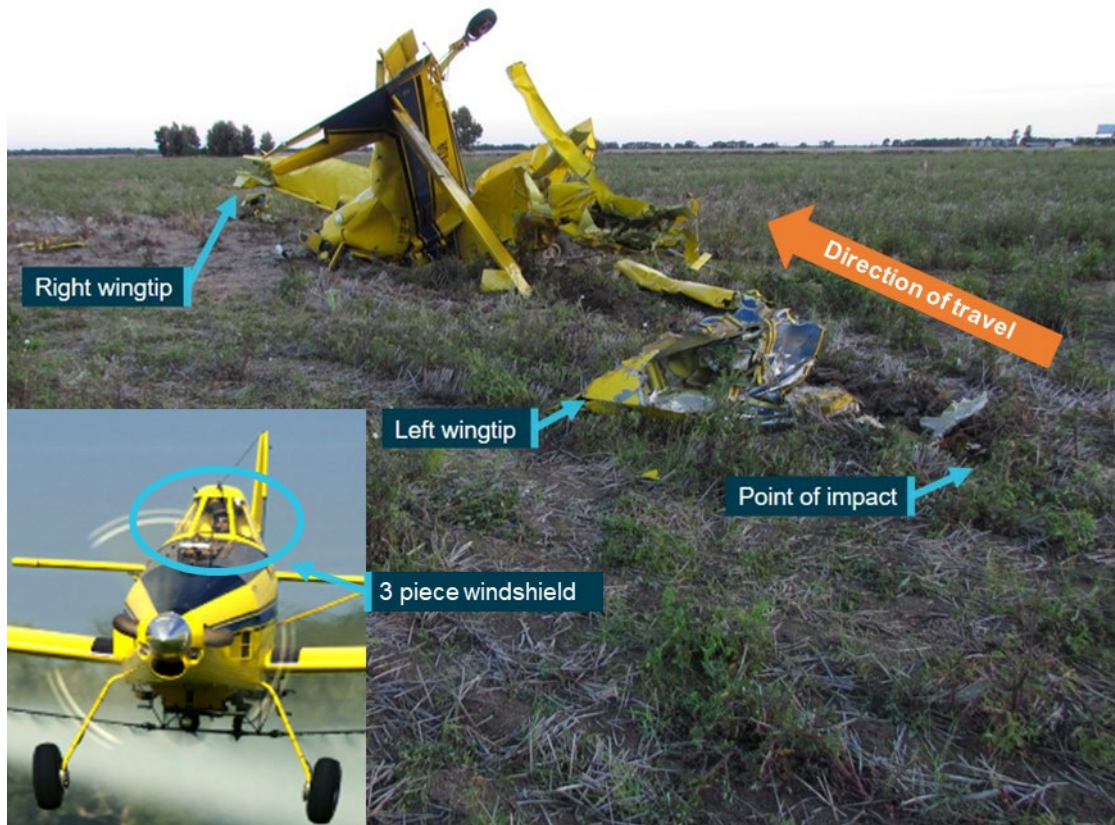
**Figure 3: Aircraft wreckage and exemplar aircraft (inset)**

The ATSB's site examination found that the aircraft had impacted terrain with the fuselage in a near vertical attitude. The propeller and engine were buried in the soft earth, with the wreckage contained to a small area. Ground scars and damage to the left wing indicated that the wing struck the ground at about 30° to the horizontal (Figure 3).

Examination of the propeller and engine indicated that the engine was delivering power at the time of the impact. Fuel and chemical product residues were also found at the accident site, but there was no post-impact fire.

A large bird carcass was found in the cockpit and the bird's wings were located about 300 m north of the wreckage, in-line with the aircraft's track. Biological residue from the bird was found outside the right cockpit window.
