Safeworking irregularity and near miss with crew of train 5936

Hawkesbury River, NSW, on 8 January 2021

ATSB Transport Safety Report

RO-2021-002

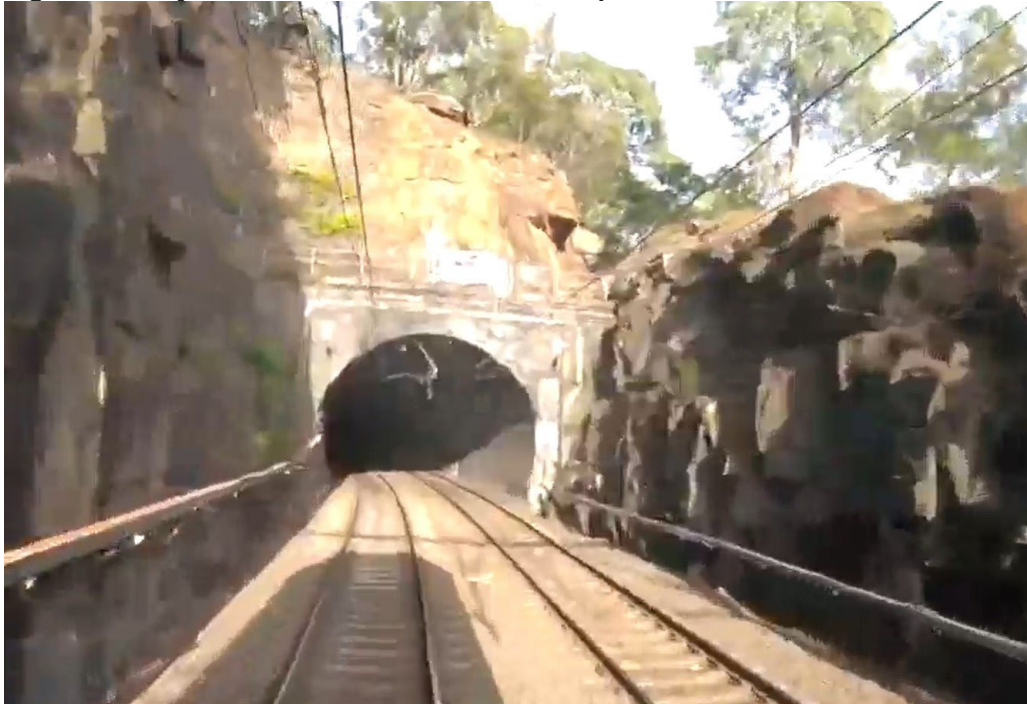
Figure 3: Entry to Boronia Tunnel No. 3 in the up direction

Pacific National train 5936 failed inside Boronia tunnel No. 3 on Cowan Bank in the up direction as a result of wheel slip from excessive lubricant and was unable to lift its load up the grade. The driver of 5936 reported the train failure to the SHN. The SHN reported the incident to the Sydney Trains TSDMCC and their decision on how to manage the incident involved propelling the train backwards down Cowan bank and into the Hawkesbury River Up Refuge siding to clear the main line.

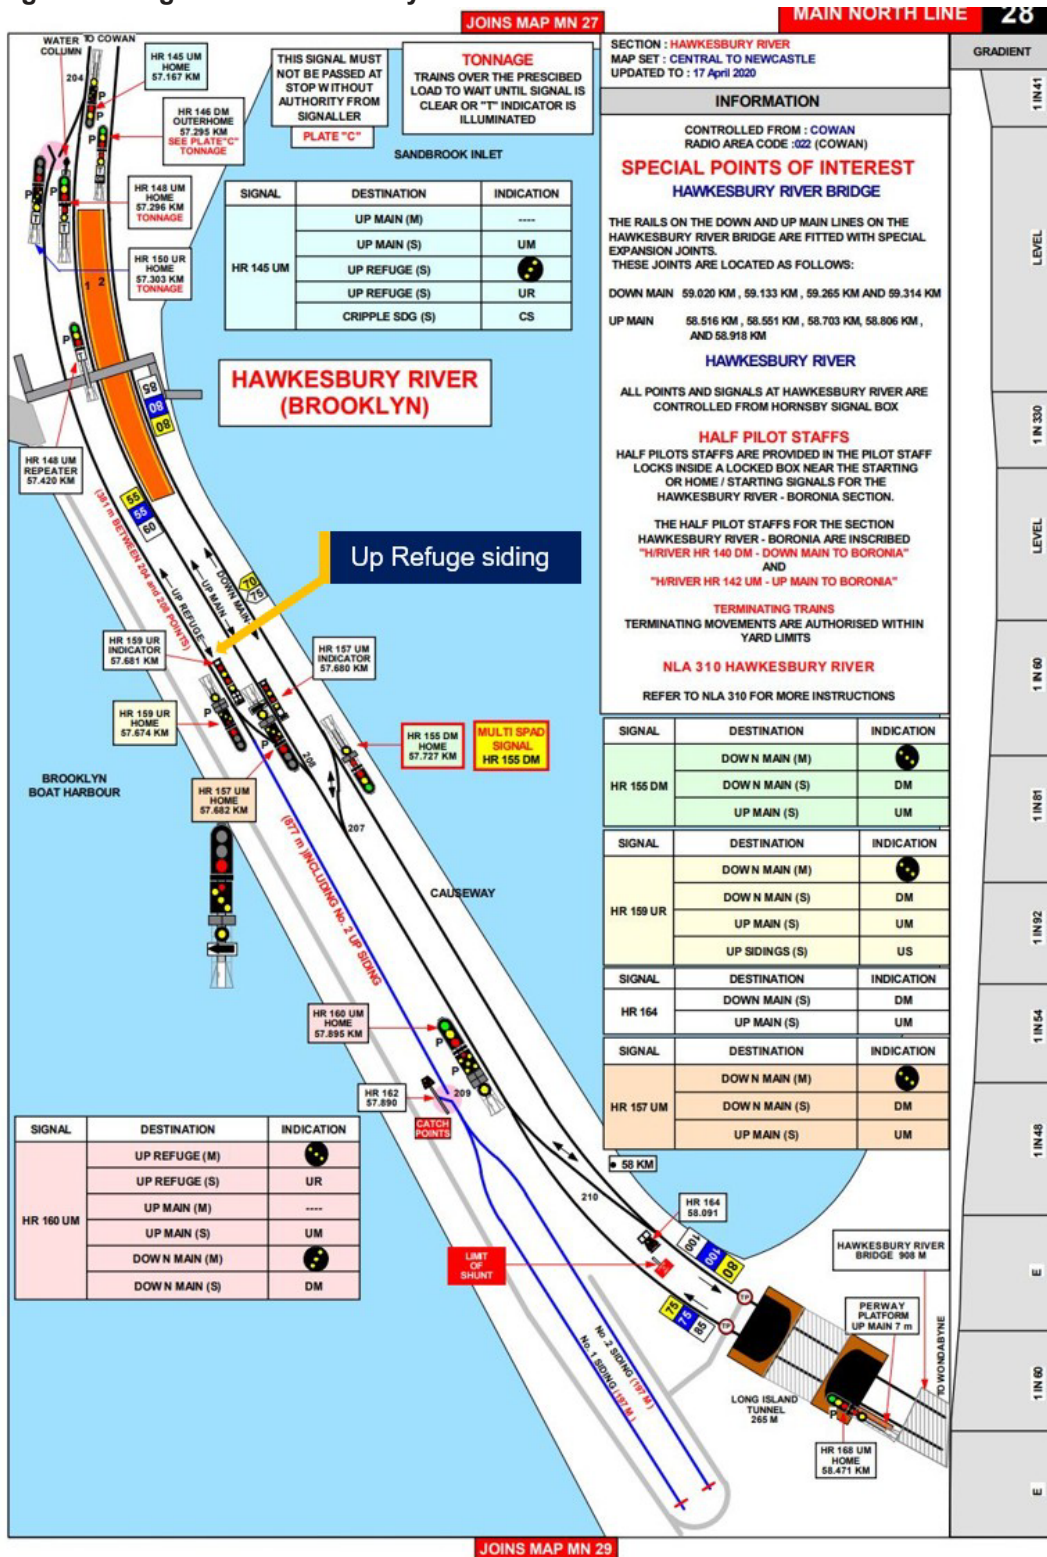
Figure 4: Diagram of Hawkesbury River

The Hawkesbury River Up Refuge siding is located within the Hawkesbury River yard. The yard consists of the Up and Down Main lines, the Up Refuge siding, No. 1 and 2 sidings and various points and signals to permit trains to operate. The Up Refuge siding has a stowing capacity of 877 m including the use of No. 2 siding.

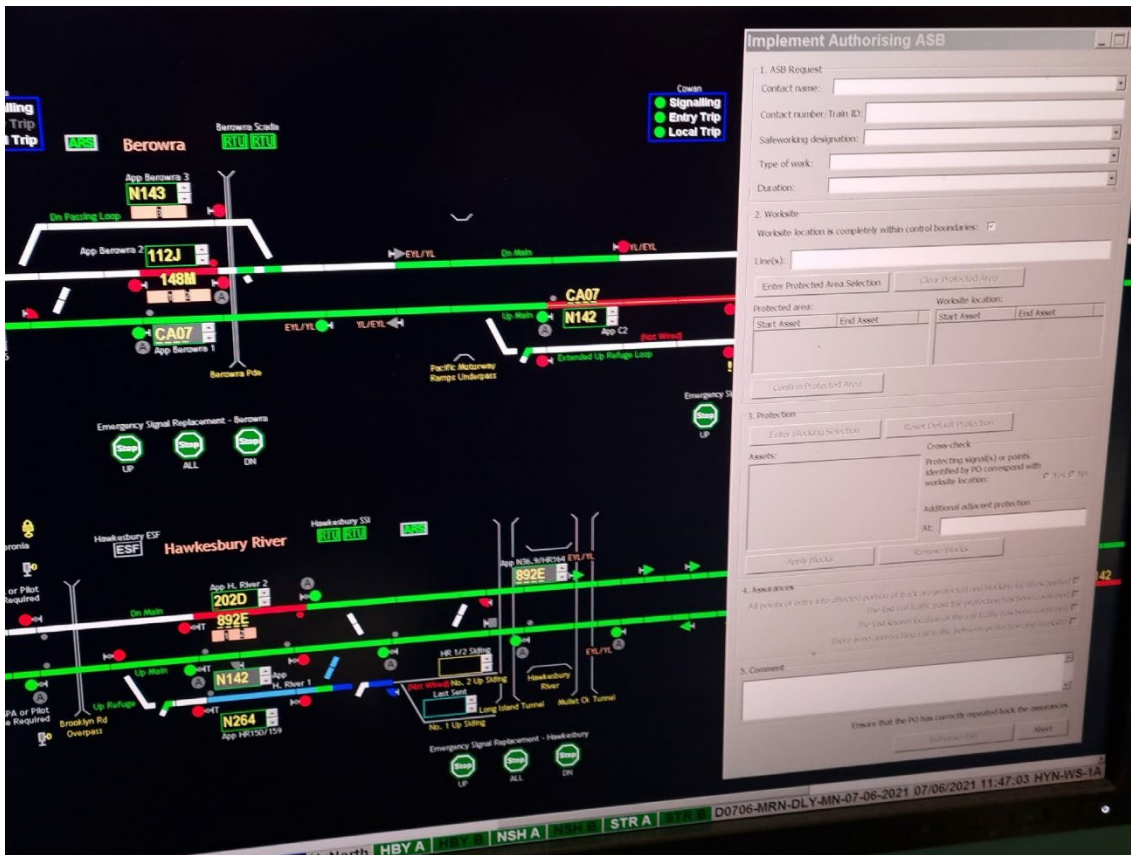
Figure 5: ASB form on ATRICS workstation

NTR 432 requires the use of a system generated form, if it is available, to record the details of the protection. This form is the same as used when applying protection for ASB.
