ACCIDENT INVESTIGATION REPORT

BELL 204B HELICOPTER VH-UTW AT
BARRACOUTA PLATFORM ON 22nd MARCH 1968

AIR SAFETY INVESTIGATION BRANCH
DEPARTMENT OF CIVIL AVIATION

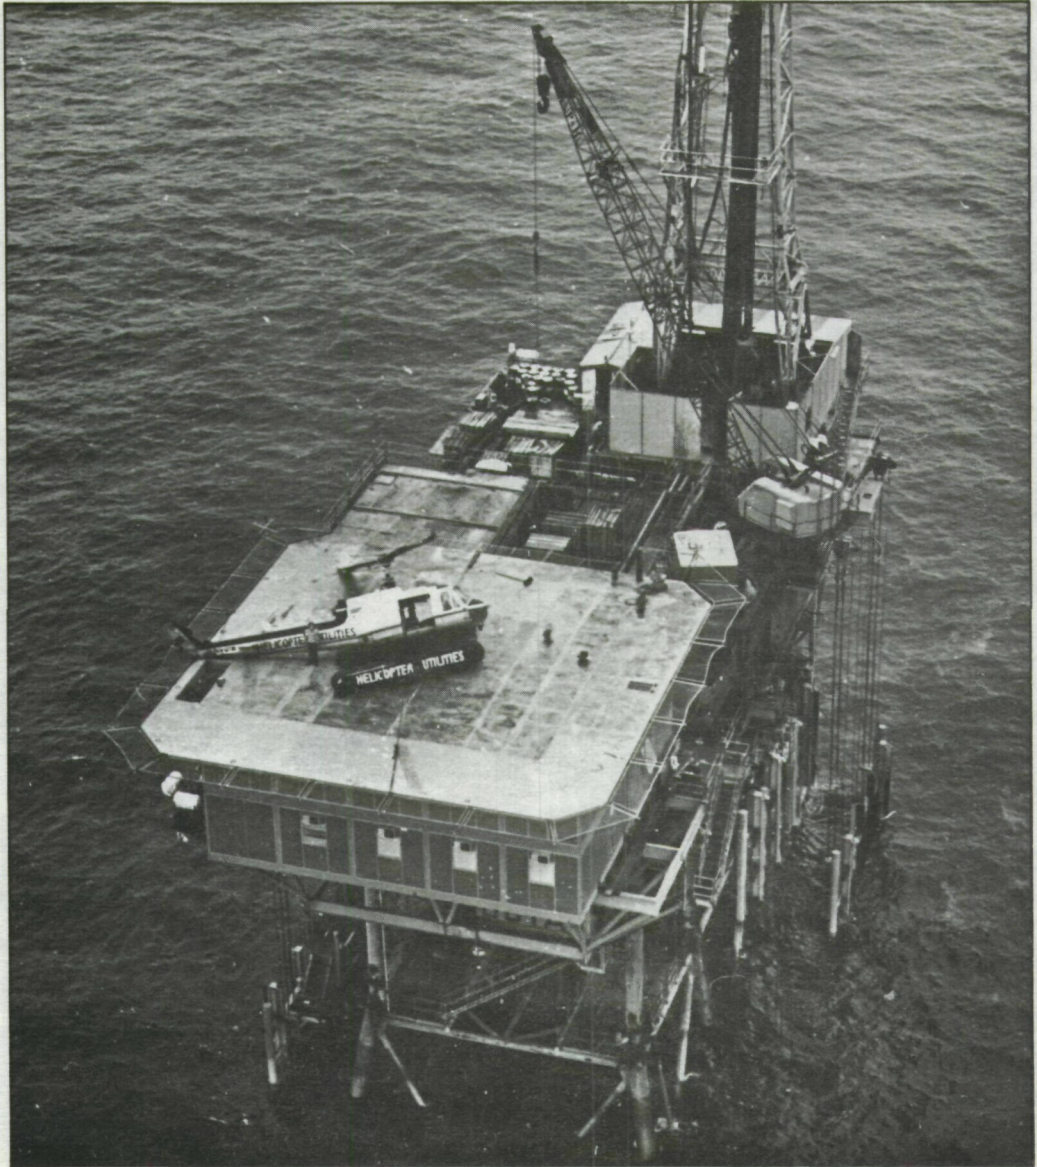
APPENDIX A

View of Barracouta Platform showing the position at which
VH-UTW came to rest on the helipad.

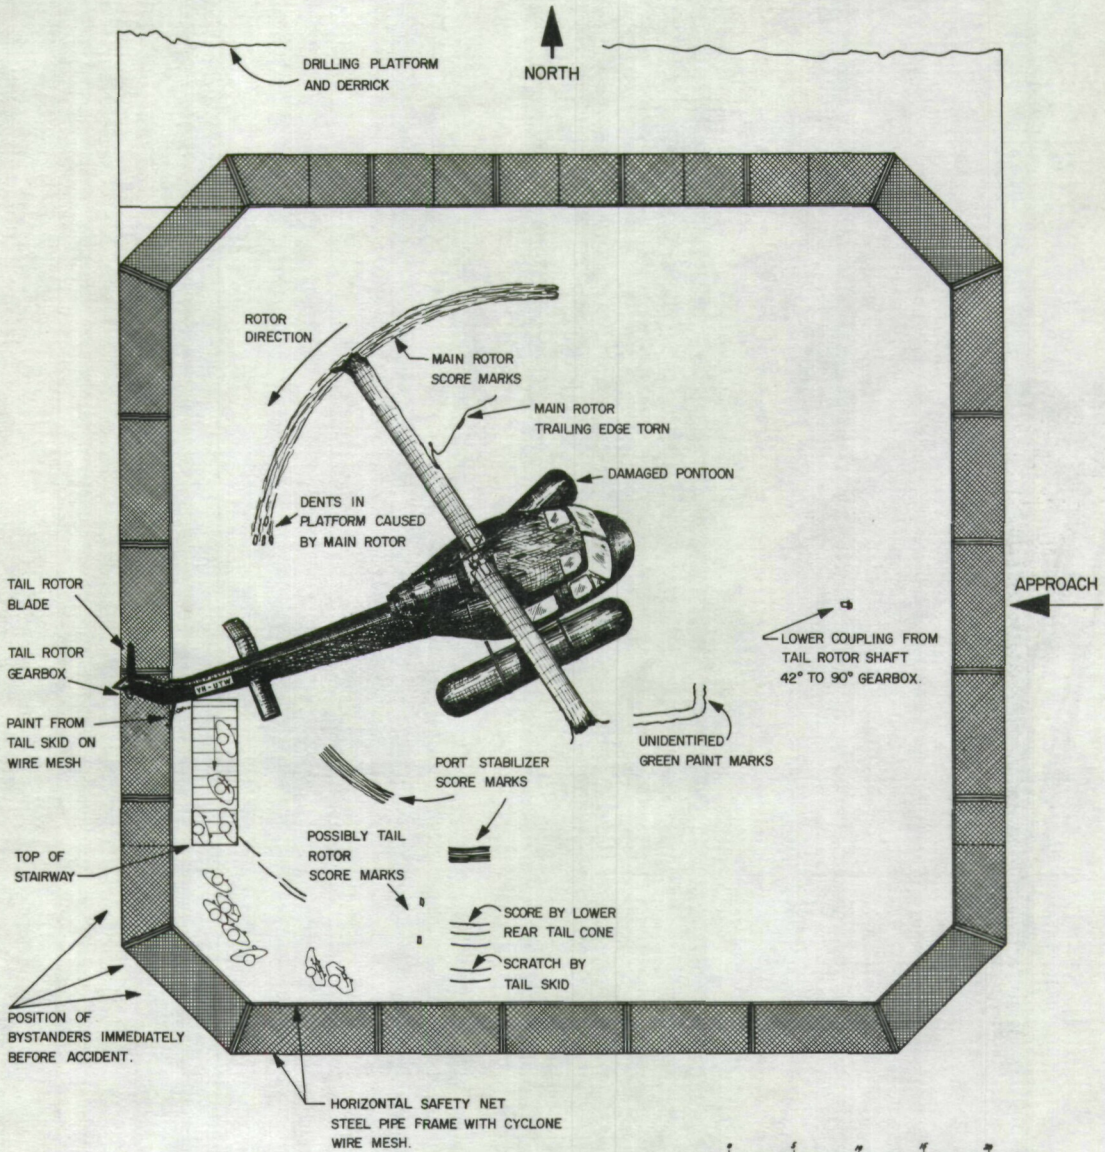
DIAGRAM SHOWING FINAL RESTING POSITION
OF HELICOPTER AND SIGNIFICANT IMPACT MARKS
ON THE HELIPAD

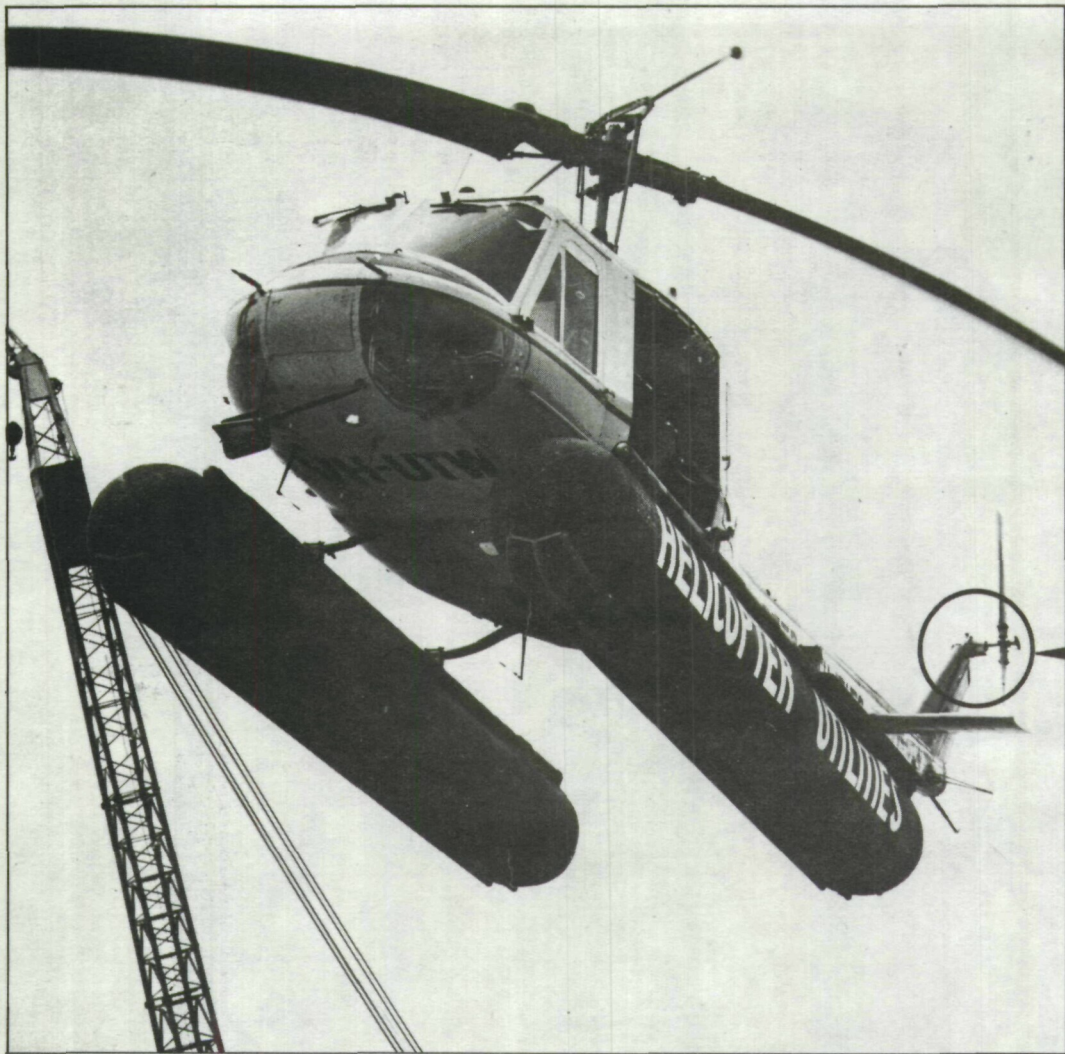
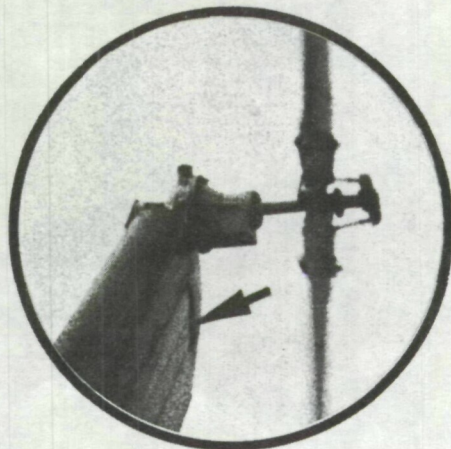
APPENDIX C

number was between two hundred thousand and four hundred thousand. If each striation represents one load cycle and each revolution of the out-of-balance tail rotor generates a load cycle, the propagation time of a fracture exhibiting 300,000 striations would have been of the order of three hours flight time assuming an average tail rotor speed of 1600 r.p.m. This estimate contains no allowance for any major arrests in the propagation pattern and it assumes that there was only one point of origin. The significant feature of this conclusion, however, is that the total crack propagation time was of a relatively short duration and this evidence is quite compatible with the pilot's statement that, when he carried out a daily inspection of the aircraft on the morning of the accident, the crack was not visible in the external surfaces of the tail fin.

2.1.3 The metallurgical examination carried out by the Aeronautical Research Laboratories has shown that the ultimate structural failure of the tail fin occurred only after there had been substantial fatigue cracking of both the tail fin spar and the port side skin. It is also apparent that the cracking arose from the application of cyclic loads considerably in excess of those which the tail fin structure was designed to withstand and in excess of those experienced during normal operations in a serviceable aircraft. The metallurgical examination also suggests that the propagation rate of the fatigue crack outside the initiation area was quite high and most of the cracking could well have been contained within the period of flying conducted on the day of the accident. This view is consistent with the evidence of the engineer who inspected the aircraft on the previous day and with the evidence of the pilot who carried out a daily inspection of the aircraft on the morning of the accident.

View of VH-UTW some ten feet above the helipad. The arrow points to the fatigue crack in the port side of the tail fin opened under flight loads imposed by rotor thrust.

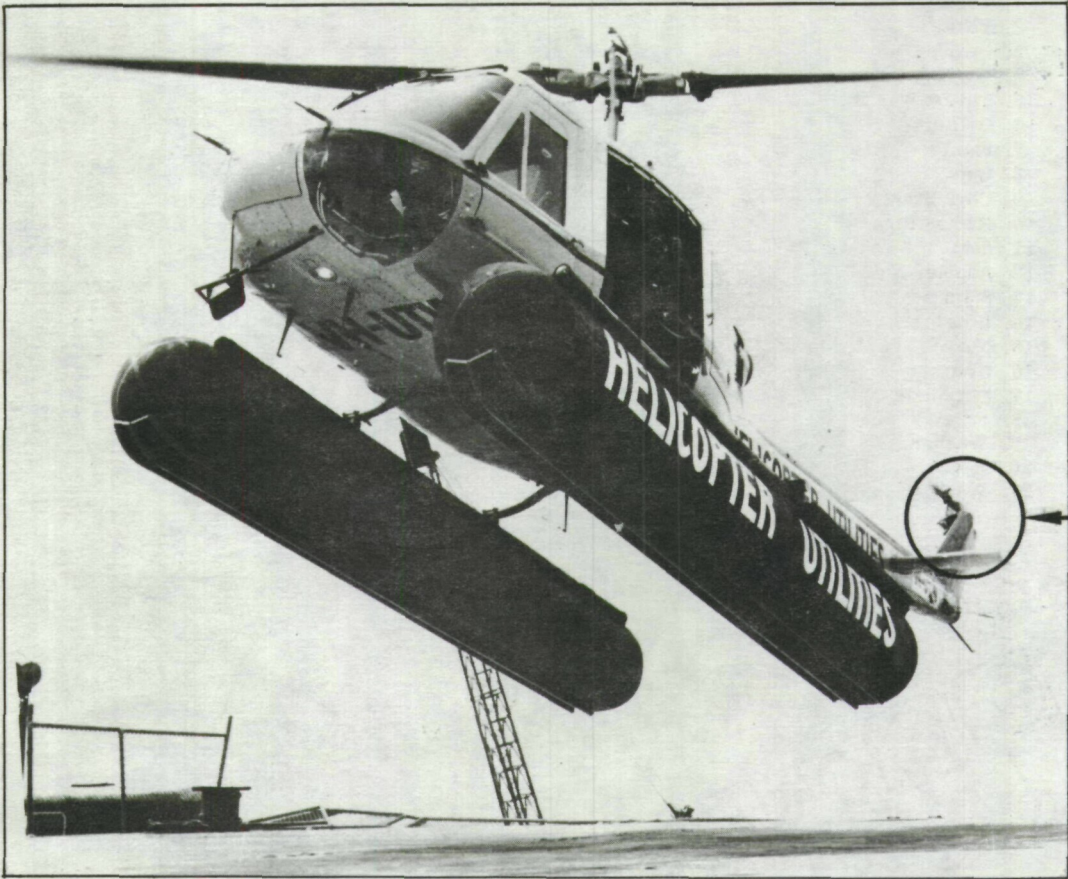
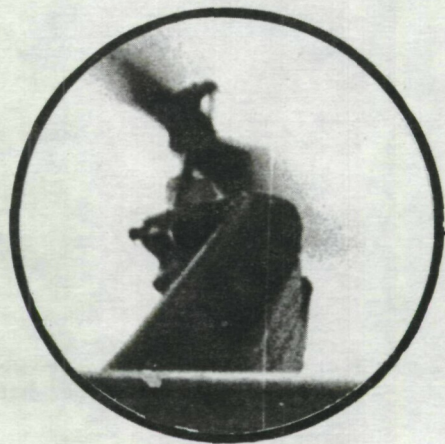
1.12.3 It was found that there had been a complete separation of the upper forward portion of the tail fin to which was still attached the tail rotor gearbox and the tail rotor assembly, minus the single tail rotor blade which was recovered from the water. Although this section of the tail fin had separated completely in a structural sense, it was still connected to the helicopter by the pitch change cables which remained intact, holding the separated components immediately adjacent to the remainder of the tail fin. The tail rotor assembly, including the tail rotor gearbox and the tail fin, were removed from the aircraft for further detailed examination.

2.1.1 It is apparent that the investigation has established the events which took place at Barracouta Platform beyond all reasonable doubt. Apart from the wealth of circumstantial evidence the photographs at Appendices C and D show clearly that there was a structural failure of the tail fin when the aircraft was in the hover position above the helipad, and that this failure progressed from a crack to complete separation of the upper forward portion of the tail fin in a very short space of time. It is equally obvious that such a failure would lead to an immediate loss of drive to the tail rotor thus depriving the pilot of directional control over the helicopter and that this would permit the fuselage to spin under the influence of the torque reaction from the main rotor.

View of VH-UTW some four feet above the helipad. The inset view shows the upper forward portion of the tail fin separating with the tail rotor and tail rotor gear box attached.

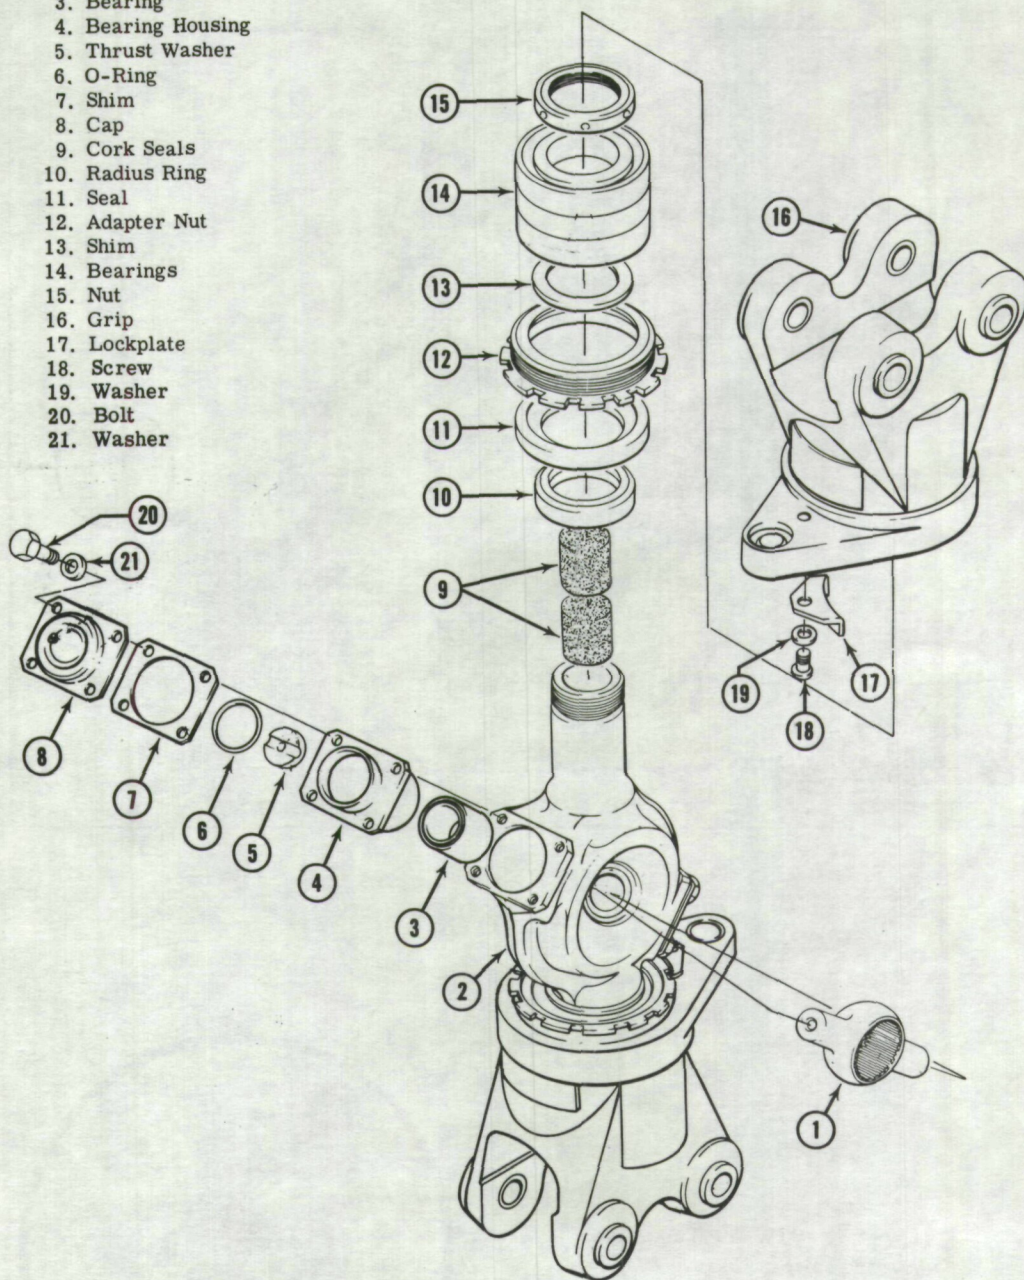
APPENDIX E

1.12.5 An abnormal freedom of movement was found between the yoke and the trunnion in the tail rotor hub assembly and this was measured to be .065 inches. Since a condition of this sort could be a very potent source of damage in the tail rotor area, a careful dismantling of the tail rotor hub was carried out. This revealed that the freedom of movement arose principally from the absence from the assembly of a nylon thrust washer which, in its normal installed position, would have taken up almost the whole of this movement (Refer to item 5 in Appendix E). A search was then made of the area in which the tail rotor hub had been assembled three weeks prior to the accident, and the missing thrust washer was recovered from a recess beneath a bench on the floor of the workshop in this area.

1.12.6 The dismantling of the tail rotor hub also revealed that the two trunnion shim packs (Item 7 in Appendix E) were .027 inches and .049 inches thick respectively and this suggested that, quite apart from any omission of the thrust washer, the trunnion would not have been centrally located in the tail rotor yoke.

2.2.4 Although the engineering personnel responsible for the assembly of the tail rotor on 28 February 1968 in the Helicopter Utilities Pty. Ltd., workshops at Mascot, had previously dismantled and assembled tail rotors for this type of aircraft, this was the first occasion on which they had to do more than re-assemble the components of the previous assembly. Because a difficulty was experienced in balancing the tail rotor after the first assembly, it was decided to replace the tail rotor yoke with a new one drawn from store and, because of dimensional differences, this involves a re-assessment and adjustment to achieve the required fits and tolerances. Although the engineer supervising the assembly referred to the Manufacturer's assembly instructions, it is apparent that the trunnion bearing shims were adjusted in an attempt to achieve the proper blade grip spacing instead of the blade grip bearing shims (Item 13 in Appendix E) as the instructions require.

3.14 The cause of this accident was that, during the assembly of the tail rotor, the inadvertent omission or loss of a trunnion thrust washer was not detected.
