Australian Government
Australian Transport Safety Bureau

Speed restriction not applied, allowing train ST24 to overspeed

Harefield, NSW, 29 June 2021

ATSB Transport Safety Report
Rail Occurrence Investigation (Defined)
RO-2021-008
Final – 3 February 2023

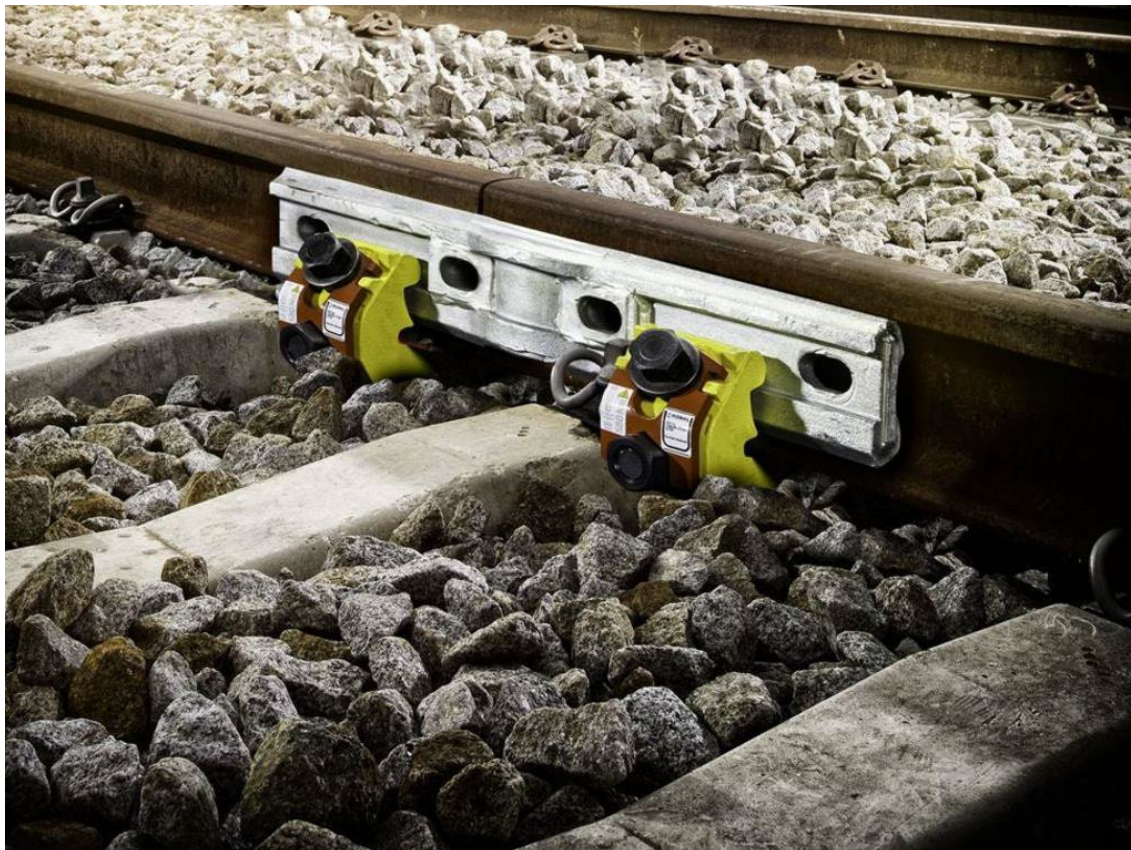
Figure 3: Robel clamp

A Robel rail clamp was a device used to link rail ends in a safe and secure manner until permanent connection by welding is complete (figure 3). The clamp was used by the civil

workgroup at Shepherds Siding to temporarily secure the rail for the low speed, up to 80 km/hr, passage of rollingstock, prior to completion of permanent joining works.

The 40 km/h temporary speed restriction was requested by the track certifier to protect the edge of the unwelded rail joint from wheel damage by passing trains. This speed reduction is consistent with the ARTC engineering standards for this type of join. Irrespective of the engineering

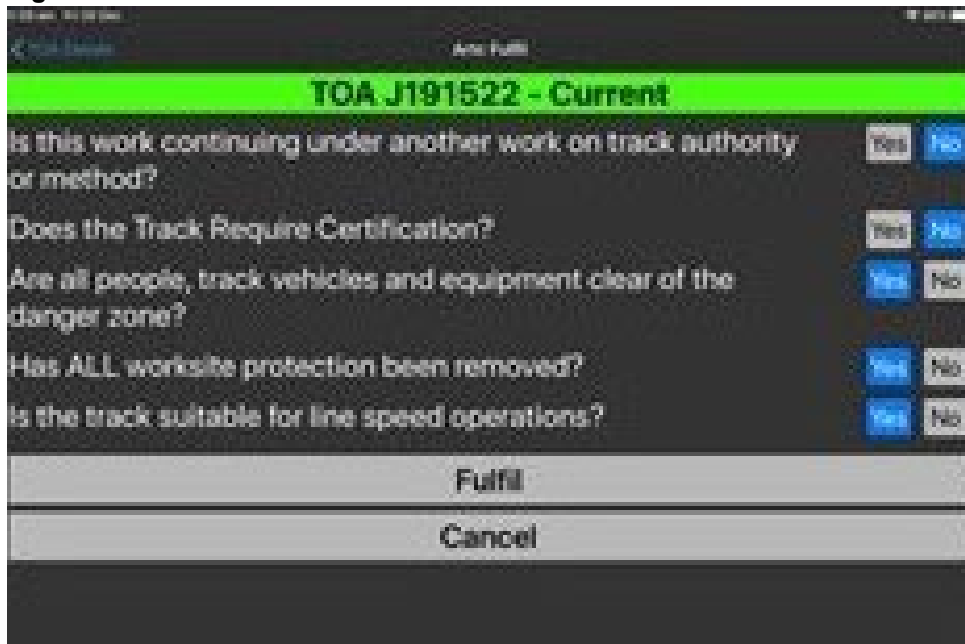
Figure 4: eTAP screen shot for TOA fulfillment on PO device

The PO had arranged the TOA utilising the eTAP application on their mobile phone. They also used eTAP to fulfill the TOA when handing back the track. The PO selected 'Yes' in response to the question *"Is the track suitable for line speed operations?"* in the fulfillment assurance checks, instead of selecting 'No'.

If No was selected, then the application would have directed the PO to call the NC and advise the details of the temporary speed restriction. The PO stated at interview that they had never used the eTAP application to impose a temporary speed restriction after fulfilling a TOA. This was the first time the PO had fulfilled a TOA that required a CAN warning for a speed restriction.

At the time of fulfillment of a TOA, a PO checks off assurance questions in the eTAP application (figure 4). If there is no CAN identified (as indicated by the PO's answers to the assurance questions) then the PO can complete the fulfillment of the TOA electronically. The NC then completes their work to fulfil the TOA by using the fields on their screen (figure 5). However, if any CAN are identified (as indicated by the PO's answers to the assurance questions) then the application requires the PO to call the NC and verbally complete the fulfillment of the TOA.

- The Protection Officer answered “no” to the assurance question on eTAP which asked whether there were any Conditions Affecting the Network (CAN). As a result, the Protection Officer fulfilled the Track Occupancy Authority (TOA) without initiating a temporary speed restriction.

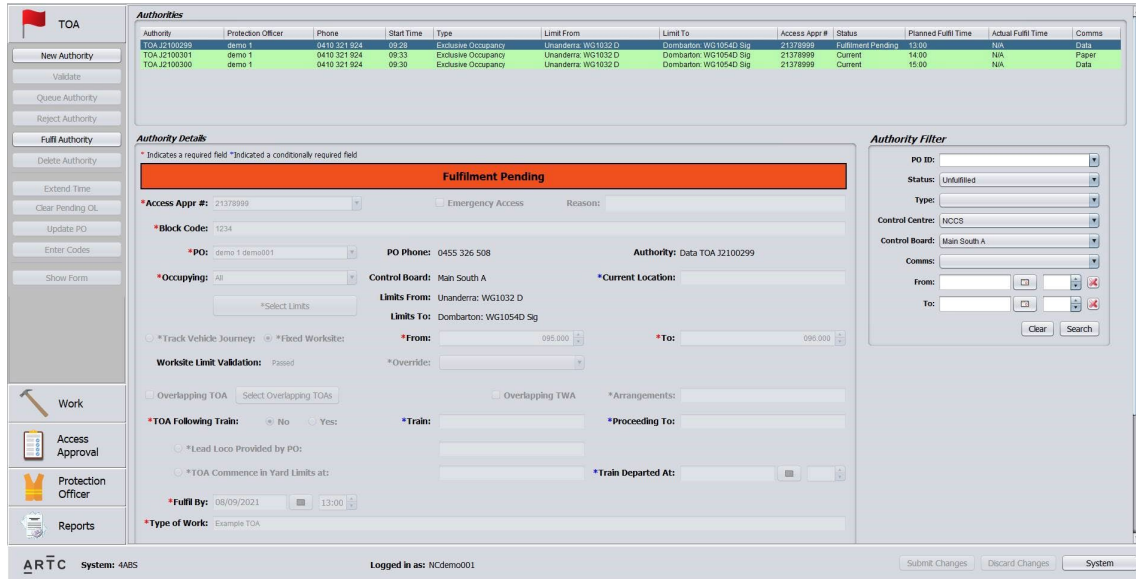
Figure 5: eTAP screen shot for TOA fulfillment on Network Controller workstation

The human factors aspects of using an electronic form to replace what was a verbal exchange between the NC and PO during the TOA fulfilment were not addressed in the design and implementation of the new eTap. For example, there is no repeat back or prompting involved in the eTAP application during the TOA fulfilment.
