Drive system failure and forced landing, involving Robinson Helicopter Company R44 Clipper II, VH-SXC

11 km west of Hamilton Island, Queensland on 3 February 2021

ATSB Transport Safety Report

AO-2021-007

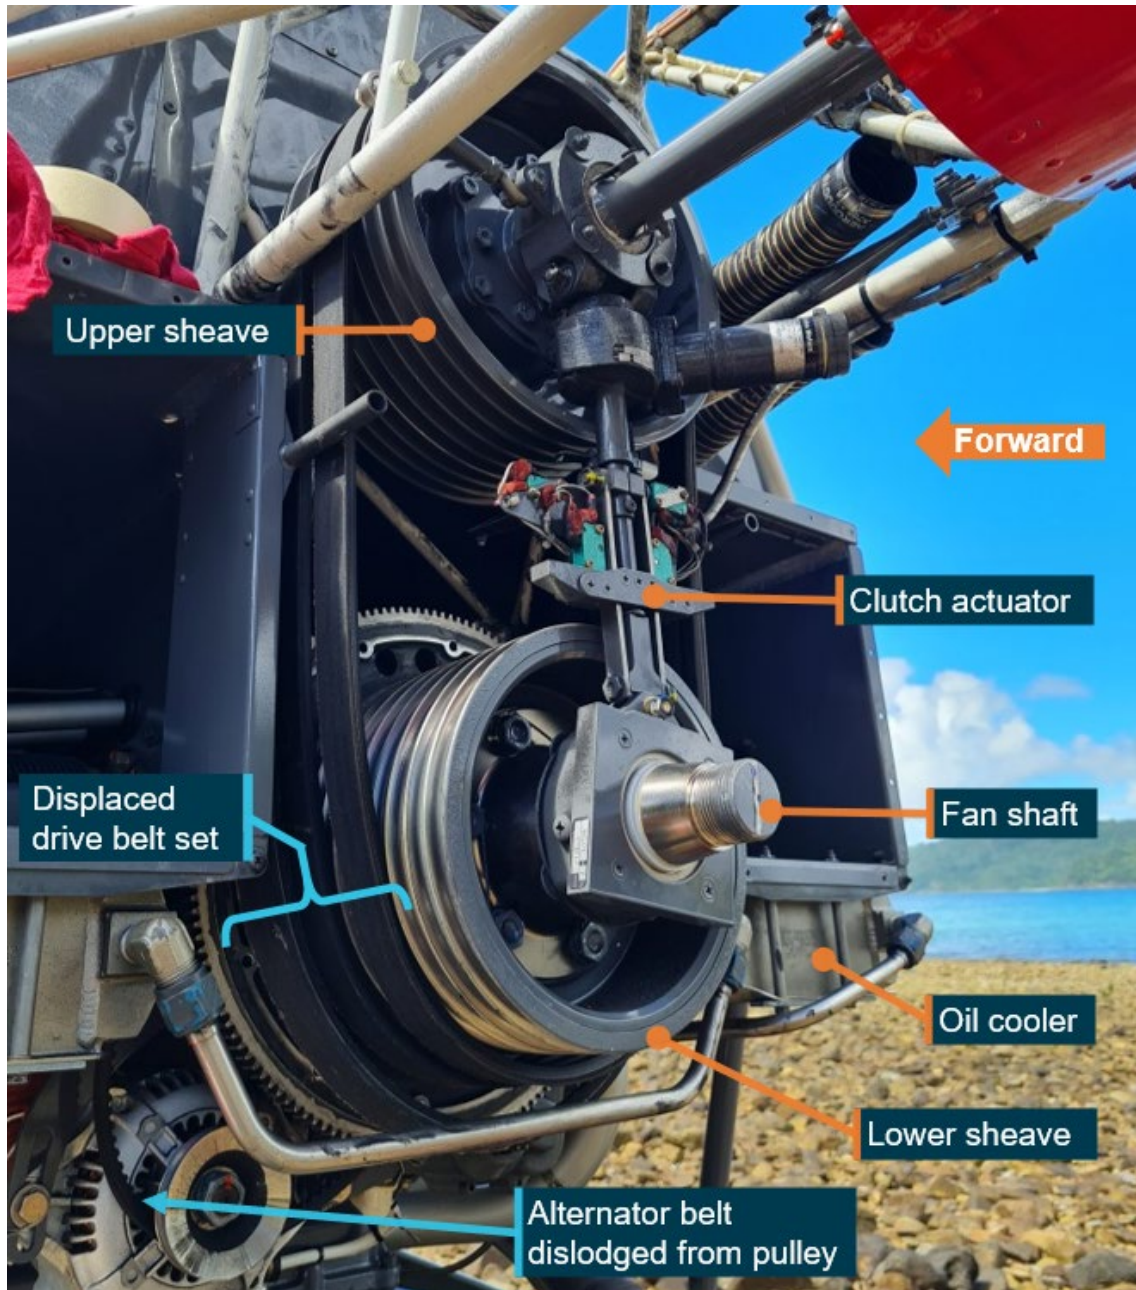
Photographs taken onsite following the event, showed the forward 2 drive belts had dislodged and shifted out of position from the upper and lower sheaves during operation (Figure 2). There was substantial damage to those drive belts. The images also showed a large amount of rubber dust in the area of the upper sheave, indicating the system had continued to operate while abrading the drive belts after they had dislodged.

The other 2 drive belts remained intact and on the upper and lower sheaves but had shifted forward from their original positions. As that occurred, it led to a loss of effective drive to the rotor system, resulting in the observed rise in engine RPM and a reduction in main rotor RPM.

- alternator belt, which was dislodged by the drive belts
- oil cooler and oil supply line
- lower sheave
- fan shaft and bearing
- clutch actuator.

Figure 2: Drive system of VH-SXC showing the rear two drive belts remaining on the upper and lower sheaves

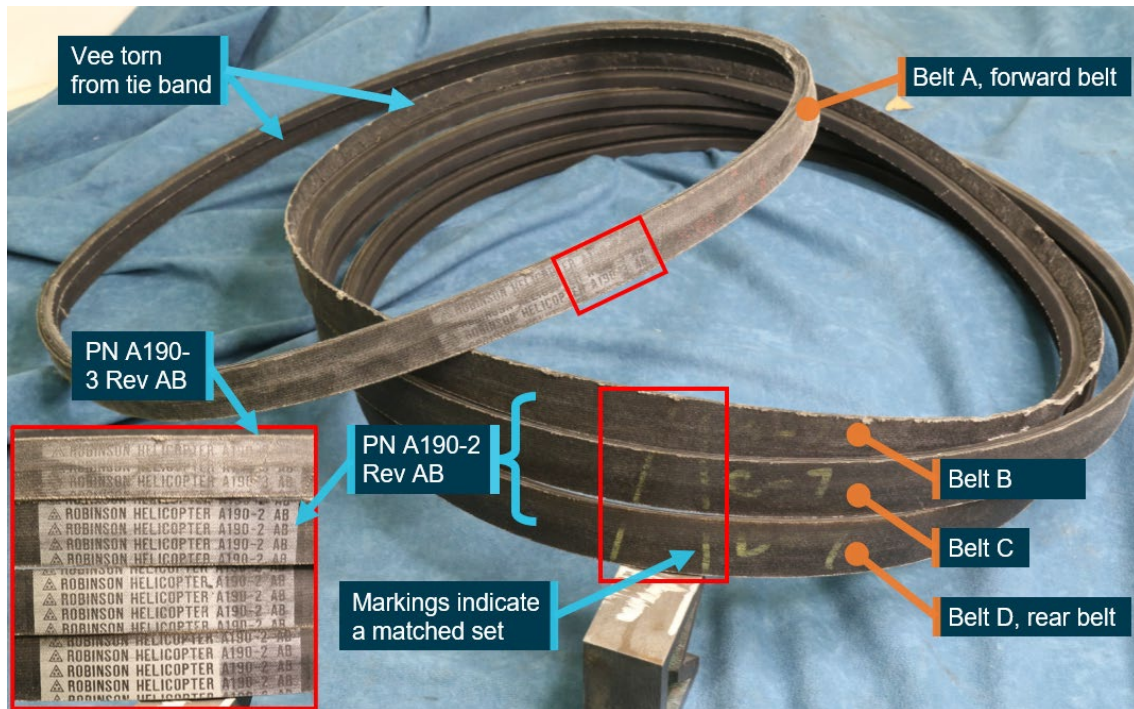
The drive belt set was examined at the ATSB’s technical facilities in Canberra ([Appendix B](#)). The examination found that the 2 forward drive belts had dislodged, leading to substantial damage to the drive belts. The drive belts had also been damaged by the rotating drive system components,

causing rubber to be abraded from the drive belts and a vee section of each drive belt to be torn free.

Both rear drive belts had remained on the upper and lower sheaves but had moved forward from their original locations and not engaged in the sheave grooves. The drive belt set was measured, and the rear drive belts had stretched about 40 mm greater in diameter when compared with the forward drive belts. This indicated that the rear drive belts had continued to operate after the forward drive belts had dislodged and were stretched by the extension of the clutch actuator.

Figure 6: Drive belt set removed from VH-SXC

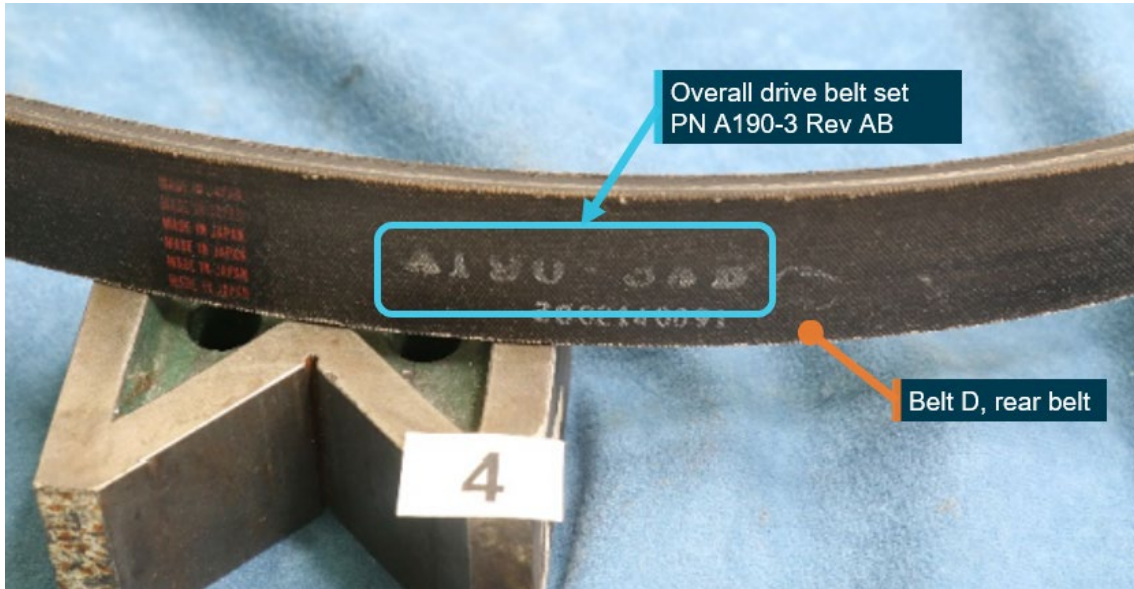
The ATSB examination found that the drive belts contained 2 differing part numbers (PN). The forward drive belt was PN A190-3, while the rear 3 drive belts were identified as PN A190-2. All 4 drive belts were Revision (Rev) AB. Although the drive belts were marked with part numbers that applied to both the R44 and R22 helicopter type, the markings from manufacture indicated they were supplied as a matched set from the RHC factory (Figure 4).

RHC reported that the A190-2 Rev AB drive belts possess the same dimensions and characteristics as the A190-3 Rev AB drive belt. When the R22 reverted to the Rev Z drive belt, a significant number of A190-2 Rev AB drive belts were re-measured, matched as a set and re-identified as A190-3 Rev AB and categorised as an R44 drive belt set. The drive belt set removed from VH-SXC had the additional markings of a part numbered set of A190-3 AB, consistent with the information supplied by the manufacturer, confirming the correct part was fitted to the helicopter (Figure 5).

Figure 7: Drive belt set part number

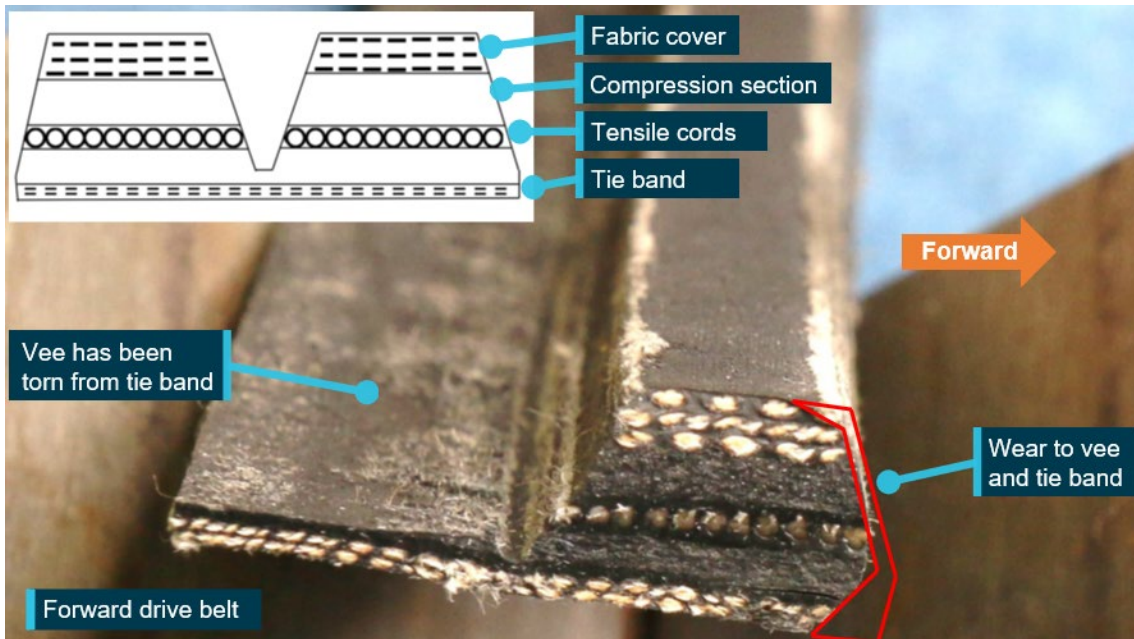
All 4 drive belts appeared to be of a similar construction with 11 tensile cords contained within each 'vee'. Figure 6 shows drive belt A, which had sustained significant loss in overall width and the rear part of the vee torn from the tie band. Belt B was similarly damaged, having the forward vee torn from the tie band. The intact drive belts, C and D, were of larger overall diameter, 40 mm, and 45 mm respectively, than the severely damaged drive belts, A and B.

To maintain the pre-set factory tension settings during the occurrence flight, the clutch actuator is likely to have applied additional load to the rear 2 intact drive belts (C and D). The observed stretching of drive belts C and D may be an indicator that the helicopter had operated with just those 2 drive belts for an extended period during the occurrence flight, after A and B had dislodged from the fitted position and become damaged.

Figure 8: Damage to forward drive belt (Belt A)
