Reduced landing distance available involving Boeing 737 aircraft VH-YIS and VH-YFC

Darwin Airport, Northern Territory on 3 and 19 September 2021

Aviation Occurrence Investigation (Short)

AO-2021-037

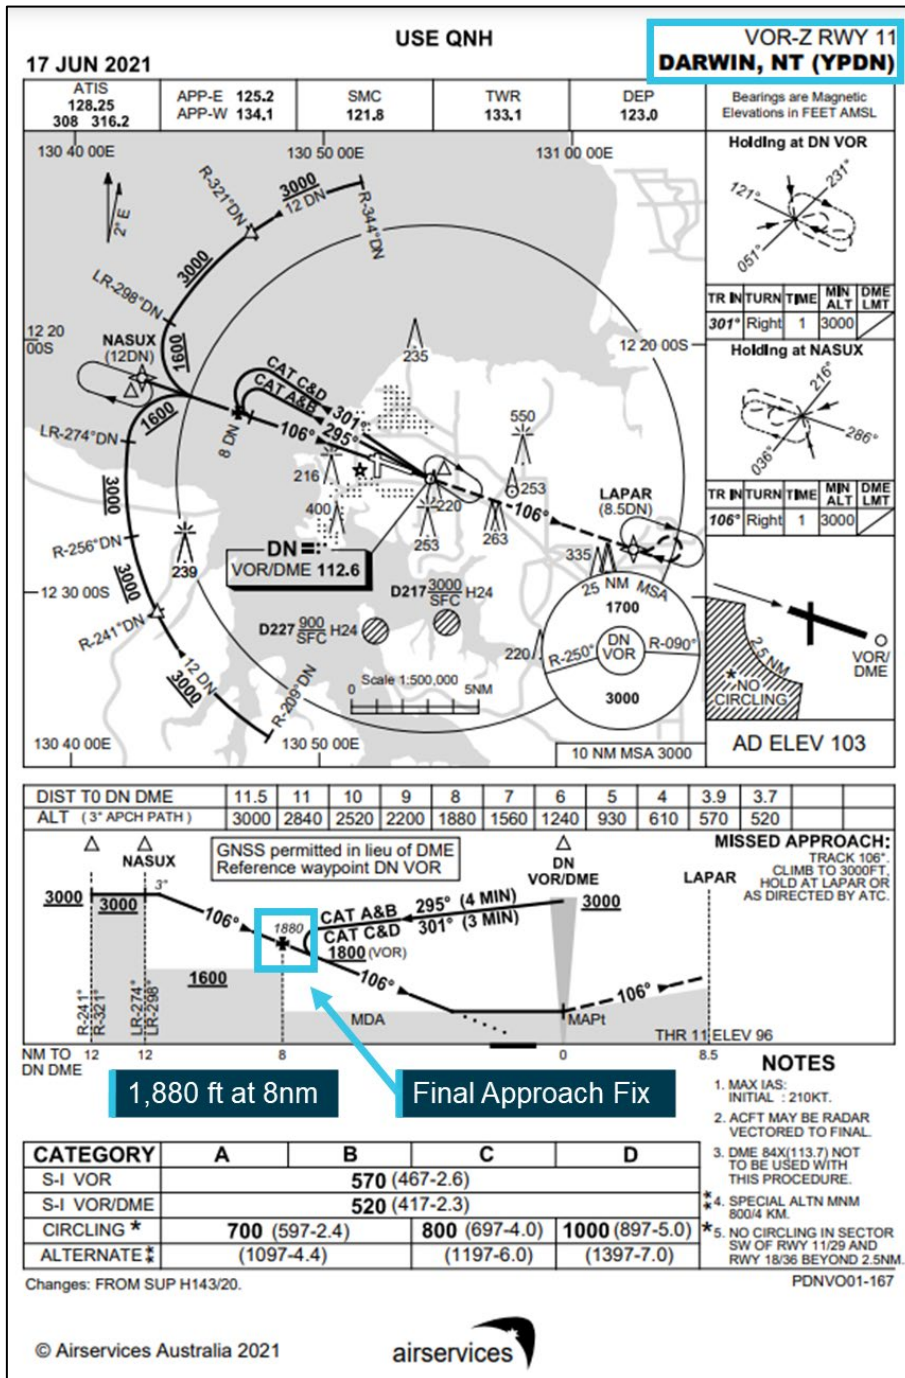
Figure 6: VOR-Z non-displaced threshold approach

The VOR-Z RWY 11 approach was used when the runway did not have a displaced threshold. The aircraft was to be flown down a 3° approach path from an 8 nm final approach fix, indicated by the Maltese cross, from an altitude of 1,880 ft to a touch down point 300 m past the runway threshold.

ATC cleared the flight crew of YIS to conduct runway 11 VOR-Z, non-displaced threshold approach. This approach clearance was unexpected by the flight crew as they had planned the VOR-T displaced threshold approach. The flight crew decided to continue with their planned displaced threshold approach without advising ATC. The captain responded to ATC with 'cleared runway 11 VOR' but omitted the suffix 'Zulu'. ATC did not request the flight crew to read back the suffix as required. A readback request by ATC may have presented an opportunity for the flight crew to identify the error.

- The flight crew of VH-YIS continued the planned runway 11 VOR-T approach despite being cleared for the runway 11 VOR-Z approach by air traffic control. This resulted in reduced runway available for the landing roll.

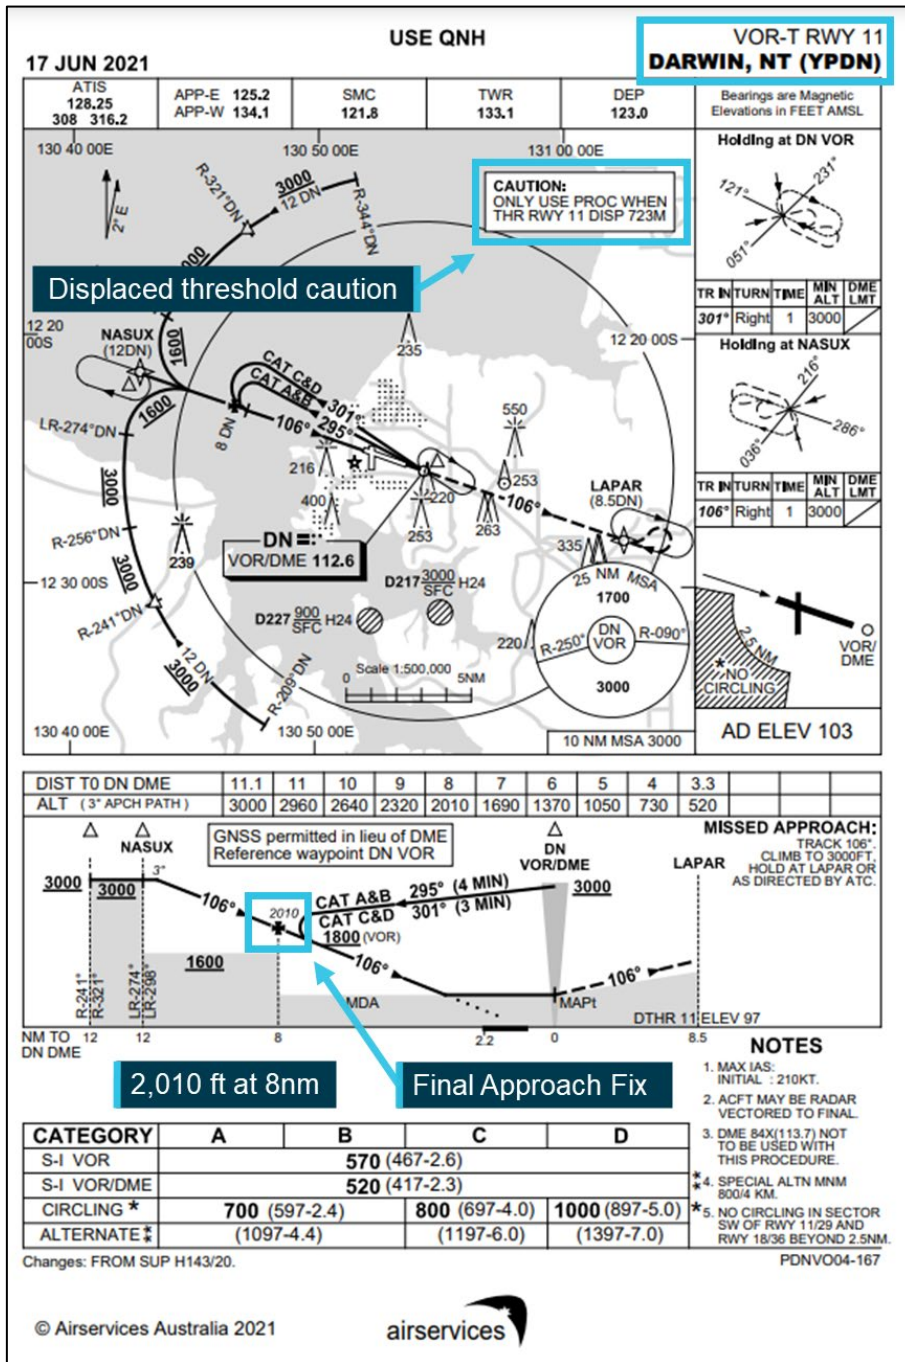
Figure 7: VOR-T displaced threshold approach

The VOR-T RWY 11 approach was to be used when the threshold was displaced 723 m due to runway works. The VOR-T placed the aircraft 130 ft higher at the final approach fix, indicated by the Maltese cross. The aircraft was to be flown down a 3° approach path from an 8 nm final approach fix altitude of 2,010 ft to a touch down past the displaced runway threshold.

The flight crews of YIS and YFC continued with their plan to conduct the VOR-T displaced threshold approach in both instances. The captain of YFC commented that the ATIS was expected to provide further information in flight on the status of the runway, but no further information was obtained from the ATIS. There was no attempt by the flight crews to contact ATC for clarification on either occasion.
