# In-flight propeller loss involving Jabiru J120, 23-1531

Devonport Airport, Tasmania, on 16 January 2022

**ATSB Transport Safety Report**

AO-2022-013

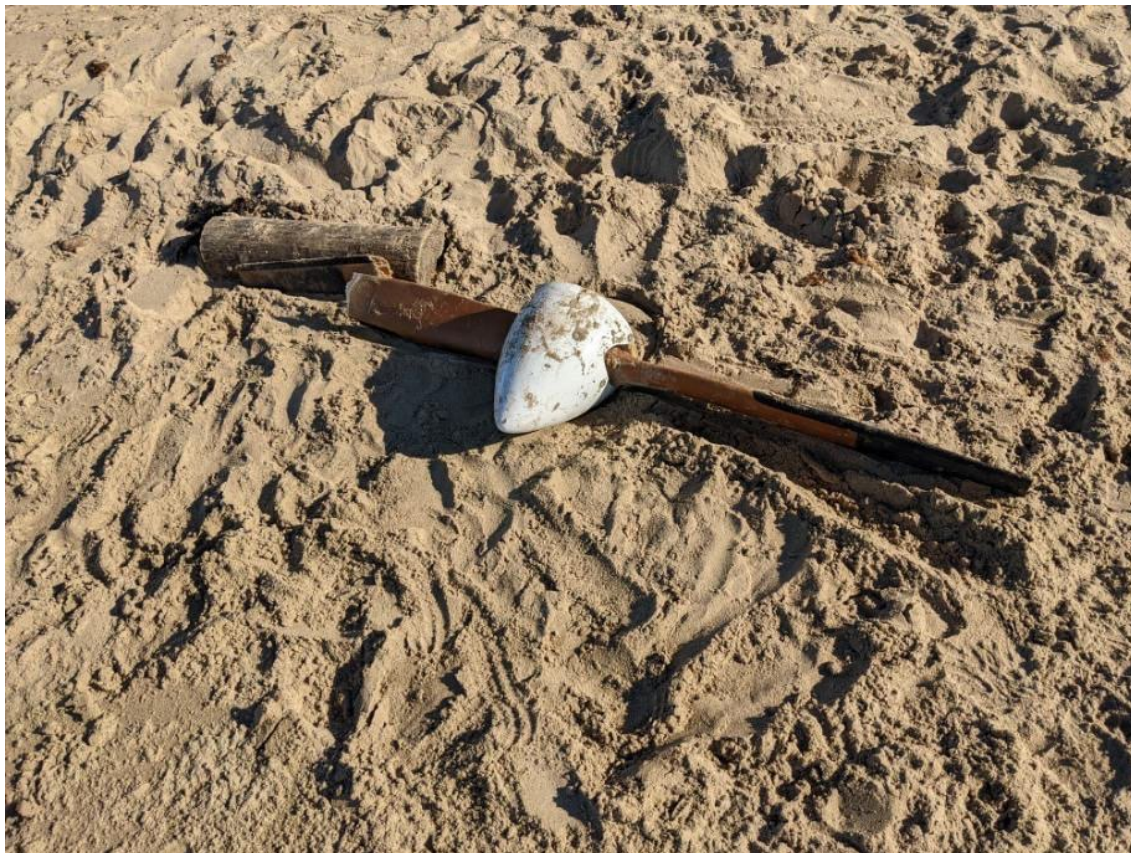
**Figure 1: Propeller as found**

The instructor immediately took control of the aircraft, closed the throttle and conducted an unpowered landing onto the runway. There were no reported injuries or damage to the airframe. The propeller assembly (Figure 1) was subsequently located in two pieces on the beach adjacent to the airport.

The propeller assembly, forward of the propeller flange was found intact, with the exception of the fracture and separation of approximately 35 cm of the tip of one blade (Figure 1). The separated blade tip was located a short distance away from the main assembly. The propeller had been disassembled prior to receipt by the ATSB.

There was no evidence of a propeller blade defect at the fractured tip. There was also no observed organic matter or smearing to indicate a bird strike. A chord segment of the propeller hub, between two boltholes, had fractured. Discolouration of the timber on the flange side, adjacent to the guide bushes indicated a small amount of pre-existing cracking, however the bulk of the fracture was recent. Similar pre-existing cracking through the boltholes was also evident on the intact portion of the hub. The guide bush holes were damaged during the failure sequence and unable to be fully examined, however two holes that were able to be test fitted were snug with a bush inserted to the appropriate depth. The drive side of the propeller and spinner backing plate were blackened and worn, indicating relative movement between the two surfaces.

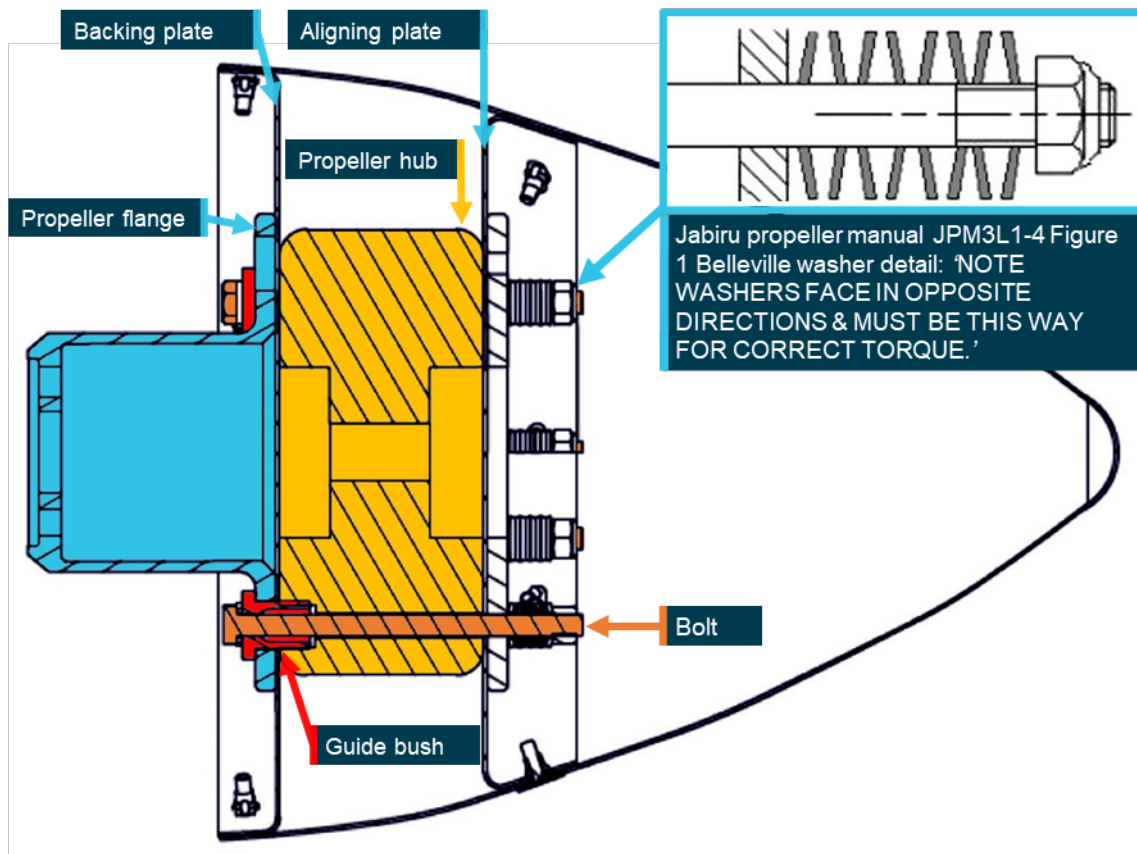
Figure 2: Propeller assembly

The Jabiru C000242-series wooden propeller was attached to the propeller flange by 6 propeller bolts (Figure 2). The bolts were specified as either AN4-37A or AN4-40A.<sup>1</sup> They were installed with the bolt heads facing rearwards, through stainless steel guide bushes inserted into the flange. The bushes were a close fit (no free-play) in the rear of the propeller hub.

A woven fibreglass composite backing plate and aligning plate was positioned either side of the propeller hub and provided for attachment of the spinner. The aligning plate effectively provided a sealed cavity (minus the bolt holes) in the front of the spinner.

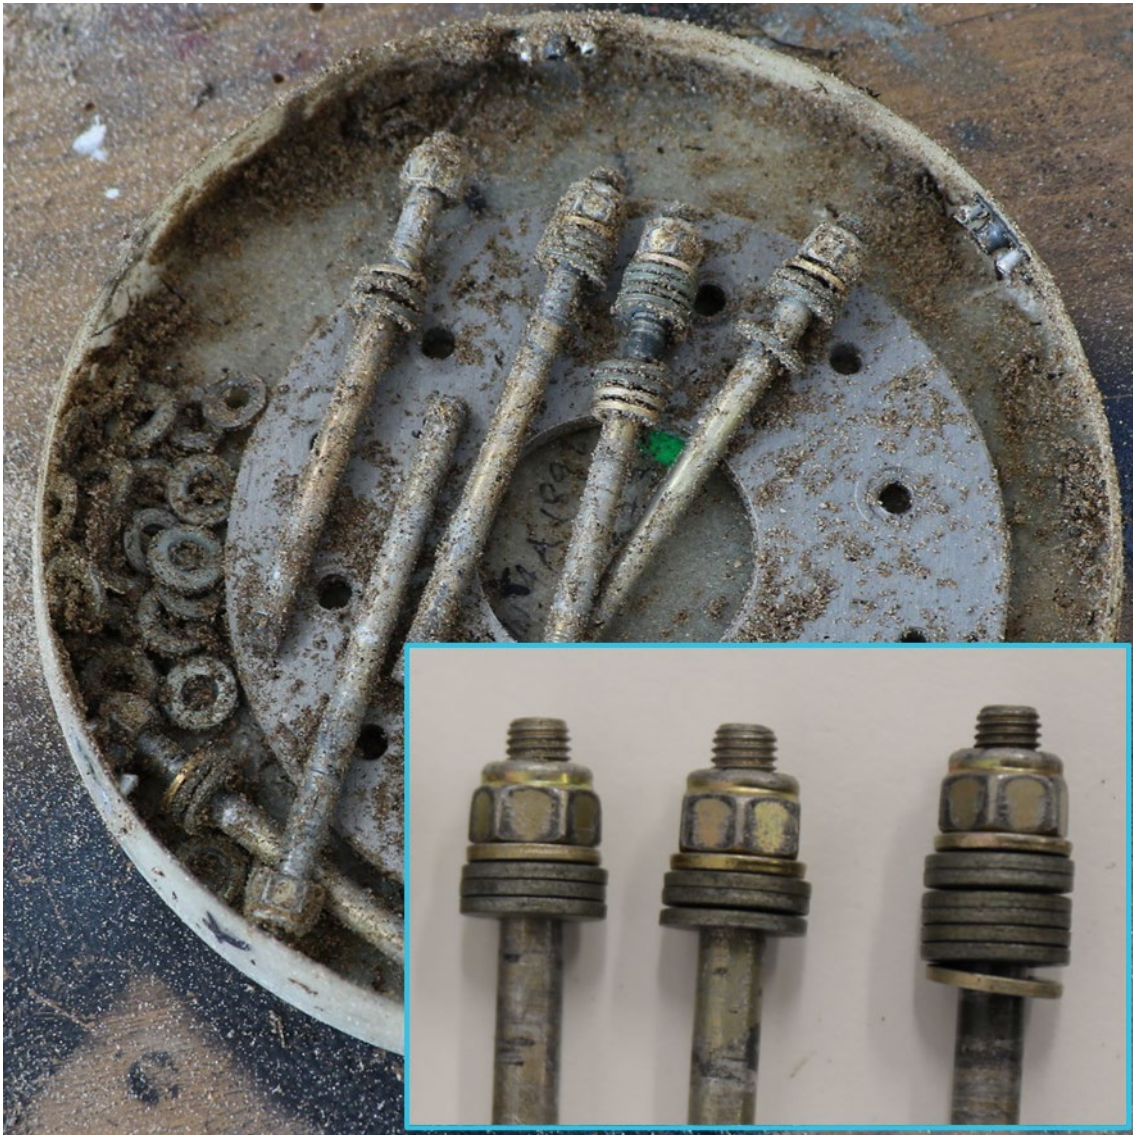
**Figure 3: Propeller bolts and washers as recovered**

The six propeller bolts had fractured under the head. The bolts and two types of washers were contained by the spinner and aligning plate along with a covering of sand (Figure 3). Three of the bolts had retained washers and the rest of the washers were loose in the spinner. There were a total of 36 (dull, grey) Belleville washers recovered out of the 48 required by the Jabiru Propeller Technical Manual JPM3L1-4. There were also 17 (bright) flat washers, with a smaller diameter than the Belleville washers. The reason for the odd number of flat washers was not established. It was possible that one was misplaced during the disassembly. The 18 flat washers would have allowed for six Belleville and three flat washers per bolt, as seen on one of the bolts in Figure 3.

The inset of Figure 3 shows an absence of gaps between some pairs of Belleville washers, indicating that some of the washers were stacked in parallel (nested), rather than in series (facing in opposite directions) as required by JPM3L1-4 and illustrated in Figure 2. Altering the washer stack in terms of the number or orientation of Belleville washers will change the total deflection available (combined height under the individual discs) and/or the spring rate.<sup>4</sup>

The deviation of the washer stack from Jabiru's assembly instructions had the potential to affect the security of the assembly. This was primarily due to the reduction in the environmental

dimensional change (shrinkage) in the wooden propeller hub that could be accommodated before a loss of bolt tension resulted. In this instance, the complete washer stack as recovered was, although marginal, theoretically able to cope with the estimated changes (shrinkage and expansion) from propeller moisture content. However, the partial stacks recovered were inconsistent, which left the possibility that one or more of the washer stacks had a smaller deflection than that tested. With a reduced tolerance for dimensional changes, the risk of movement and fretting of the components increased.

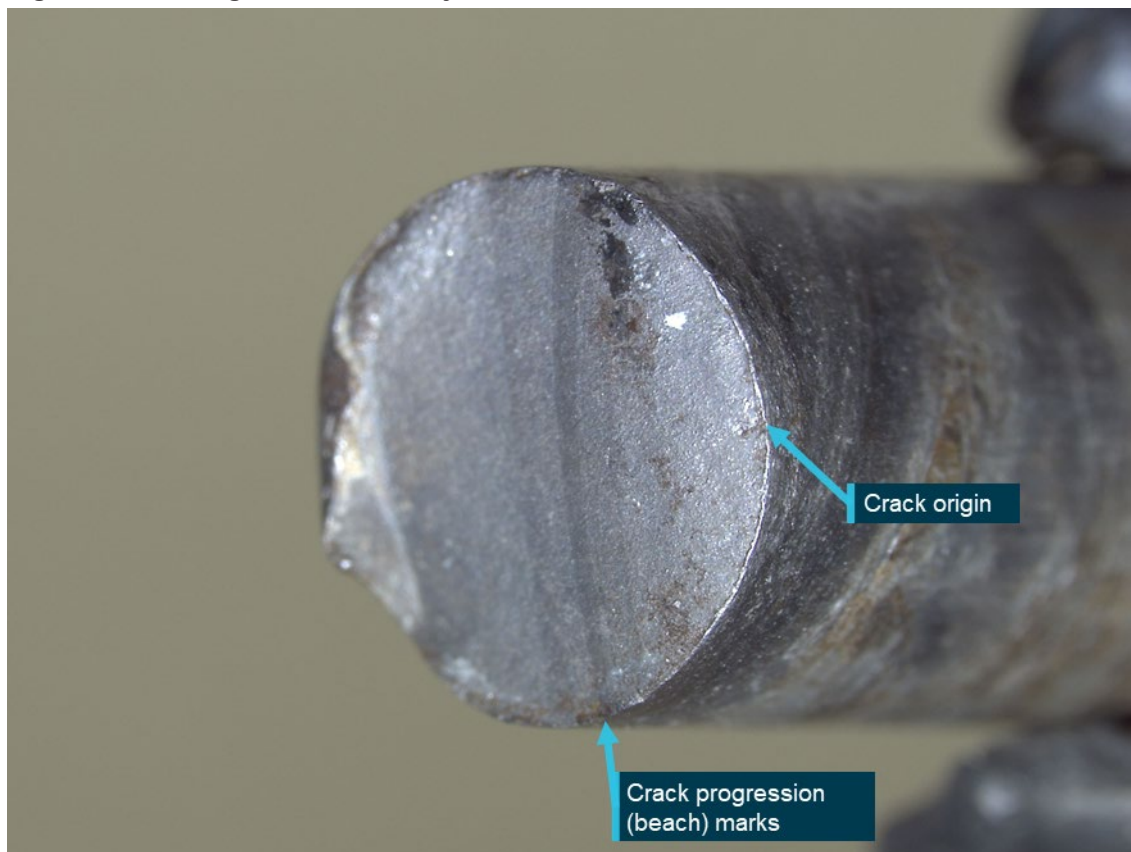
**Figure 4: Bolt fatigue crack and adjacent wear**

The bolt fracture surfaces showed marks consistent with high-cycle fatigue crack progression (Figure 4). Some of bolts had fretting wear adjacent to the fatigue crack origin, as well as helical wear part way along the bolt shank. The wear was coincident with the narrowest section of the bore in the guide bush. The bolt material was consistent with the AN4 specification and there was no observed corrosion or other gross defects.

While there was no physical evidence of a bird strike on the propeller, the student's observations and instructor pilot's previous experience could not be discounted. That aside, and more importantly, the high-cycle fatigue cracking of the propeller bolts was indicative of a latent issue that predated any external influence at the time of the occurrence. It was possible that the propeller separated as a result of the cracking in conjunction with a bird strike. However, the extent of cracking was such that the propeller could also have separated without an external influence, or would have separated with continued operation.

The wear on the bolt shank adjacent to cracking, the spinner backing plate and the propeller mounting plate indicated relative movement between the assembly components, which would typically result from low clamping force / bolt tension, or a lack of security in the assembly. In the absence of material defect in the components or hardware, the possible reasons for this included loose-fitting guide bushes, misassembly and/or loosening of the assembly during operation.

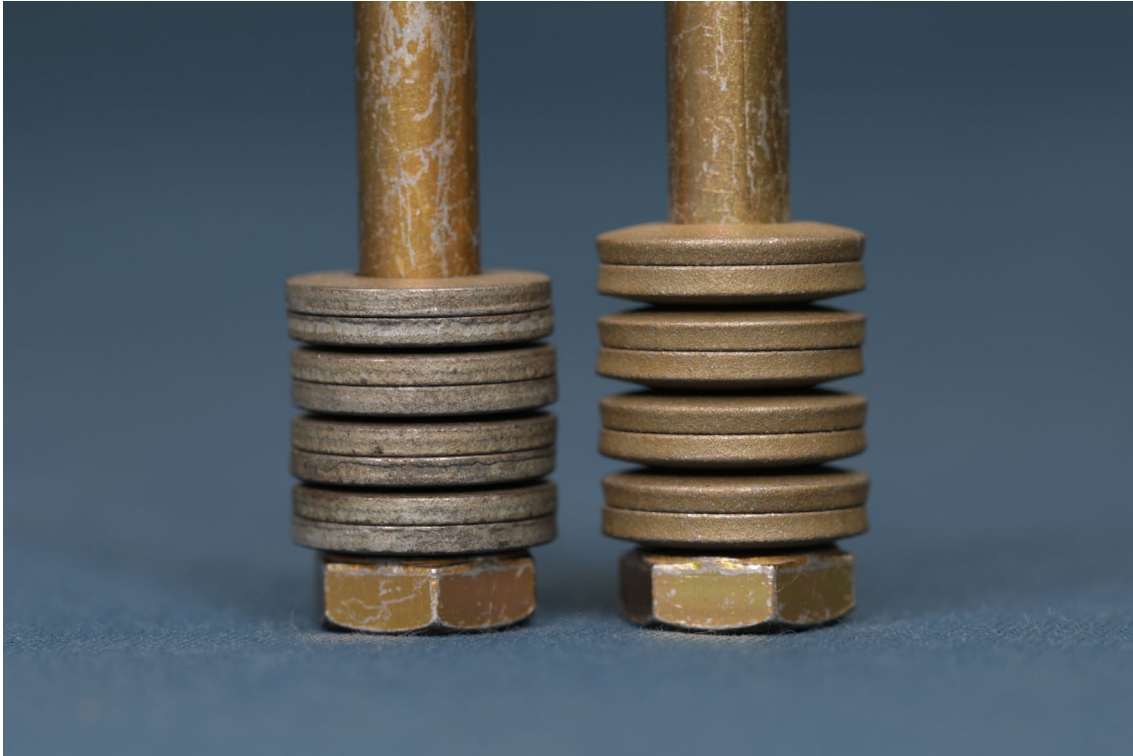
**Figure 5: Comparison between a stack of occurrence (left) and exemplar (right) washers in series.**

A set of exemplar washers were purchased for comparison to those from the occurrence (Figure 5). The occurrence washers were visibly (edge quality and coating) and dimensionally different. They were also a different alloy to the exemplars, however both conformed to the dimension and material requirements of the supplier specifications.<sup>6</sup>

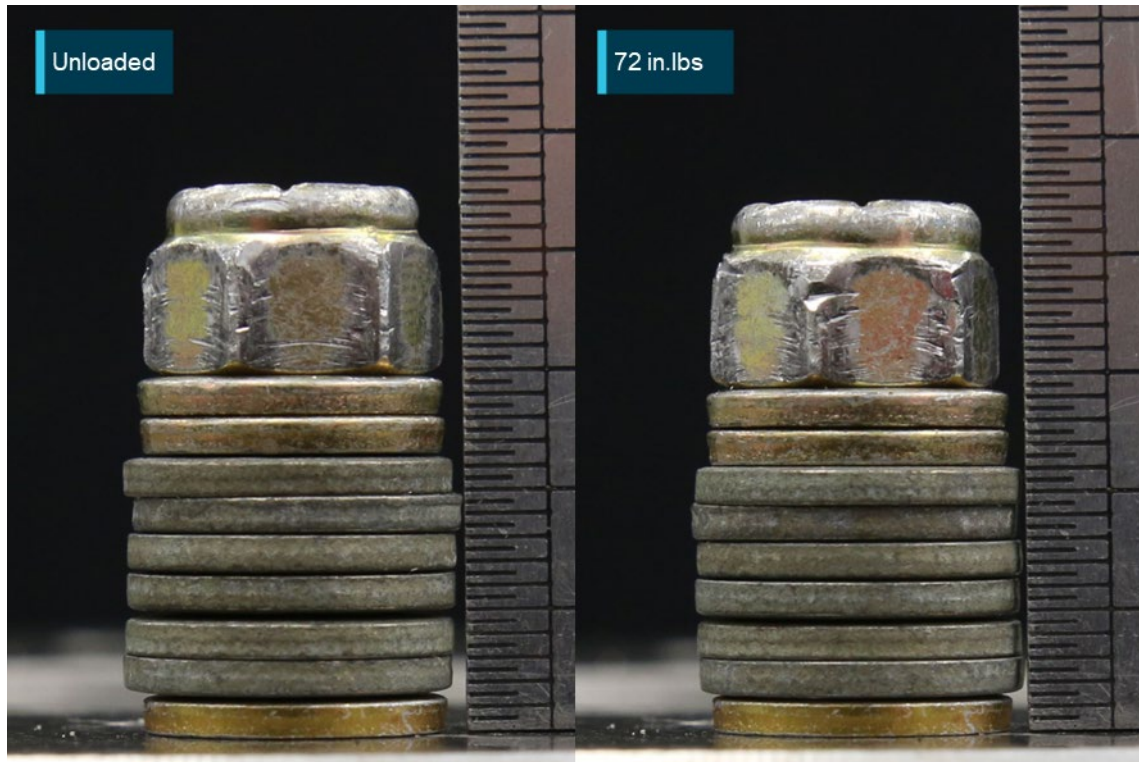
**Figure 6: Deflection test using washers from the occurrence propeller, arranged as recovered**

unloaded condition (nut finger-tight) and then the nut was torqued to 72 inch-pounds (the required installation torque) and remeasured. The washers in series deflected approximately 1 mm before becoming effectively flat. When arranged as recovered, with a number of the washers in parallel, the stack compressed approximately 0.5 mm (Figure 6).
