Wirestrike and collision with terrain, involving Cessna 172, VH-REU

Coonabarabran Aerodrome, New South Wales, on 18 April 2022

ATSB Transport Safety Report

AO-2022-027

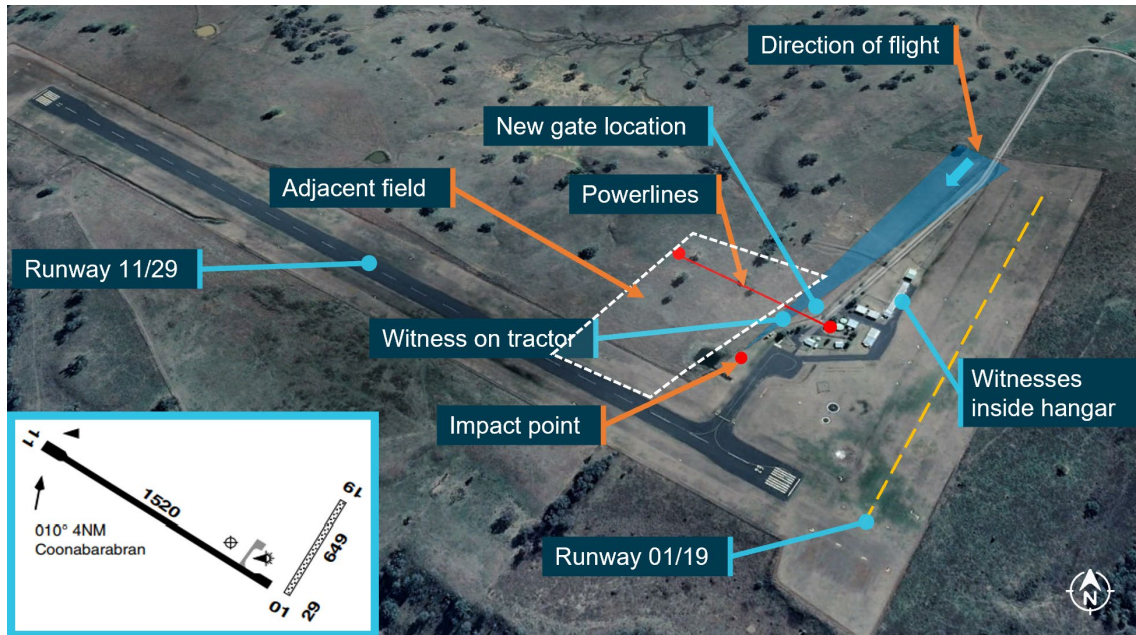
Figure 1: Aerodrome and flight path overview

The witness on the tractor recalled seeing the pilot do 2 touch-and-go landings on runway 11, before travelling to the north behind the witness, and banking right back towards the aerodrome. At the time, the witness initially thought that the pilot may have been going to conduct an approach to runway 19, but then realised that this was probably not the case as the aircraft was not turning left, which would have been normal for the approach to runway 19.

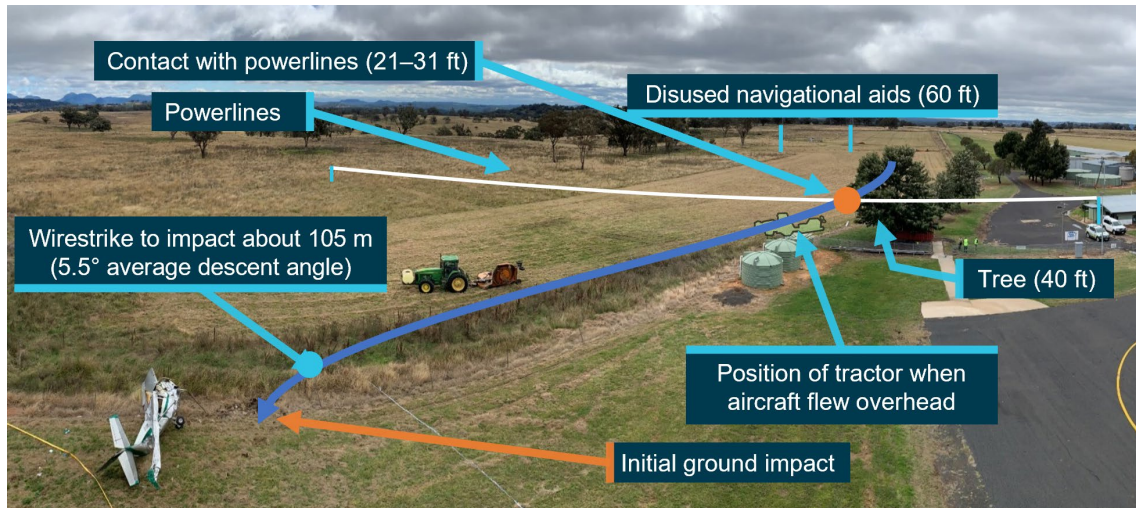
Figure 2: Estimated flight path based on impact with powerlines and witness account

The witness on the tractor recalled that the next time they saw the aircraft, it was about 500 m away and was travelling back towards the field at about 70 ft (or about the same height as some unused navigational aids) (Figure 2). At this time, based on the direction and height of the aircraft, the witness thought that the pilot was likely going to fly directly over the tractor. When the witness turned again, the aircraft was directly behind them, flying straight and level. The witness estimated its speed as about 80–85 kt, or fast enough to maintain control of the aircraft but not at top speed. The witness observed the aircraft contact the powerlines just behind and above the tractor and recalled hearing a whistling and crack as the wires travelled over the tractor cab.

*Flight path of VH-REU indicated by blue line.
Source: ATSB*

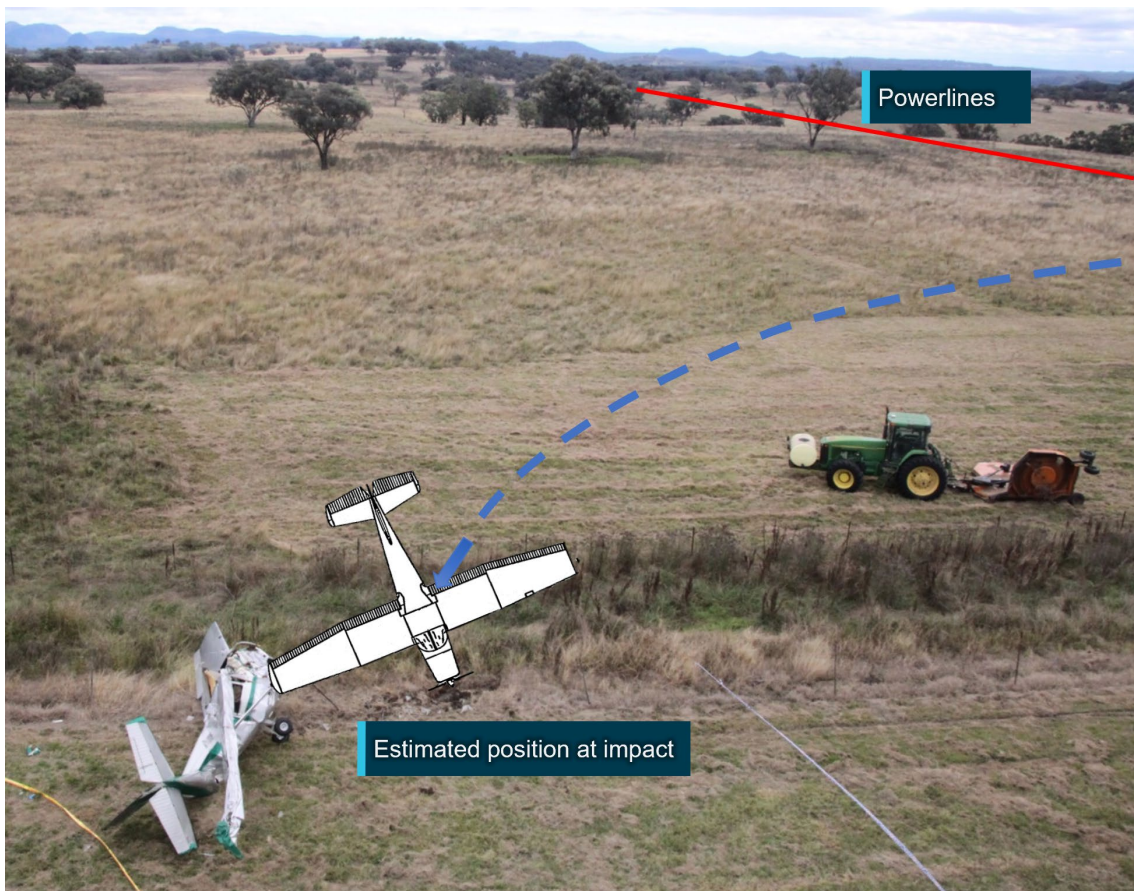
Figure 3: Estimated impact orientation

Damage to the aircraft and powerlines indicated that the aircraft had contacted the powerlines and then travelled about 105 m before ground impact. The aircraft impacted the ground about 57° nose-down, skidding to the right, and yawing to the left (Figure 3).

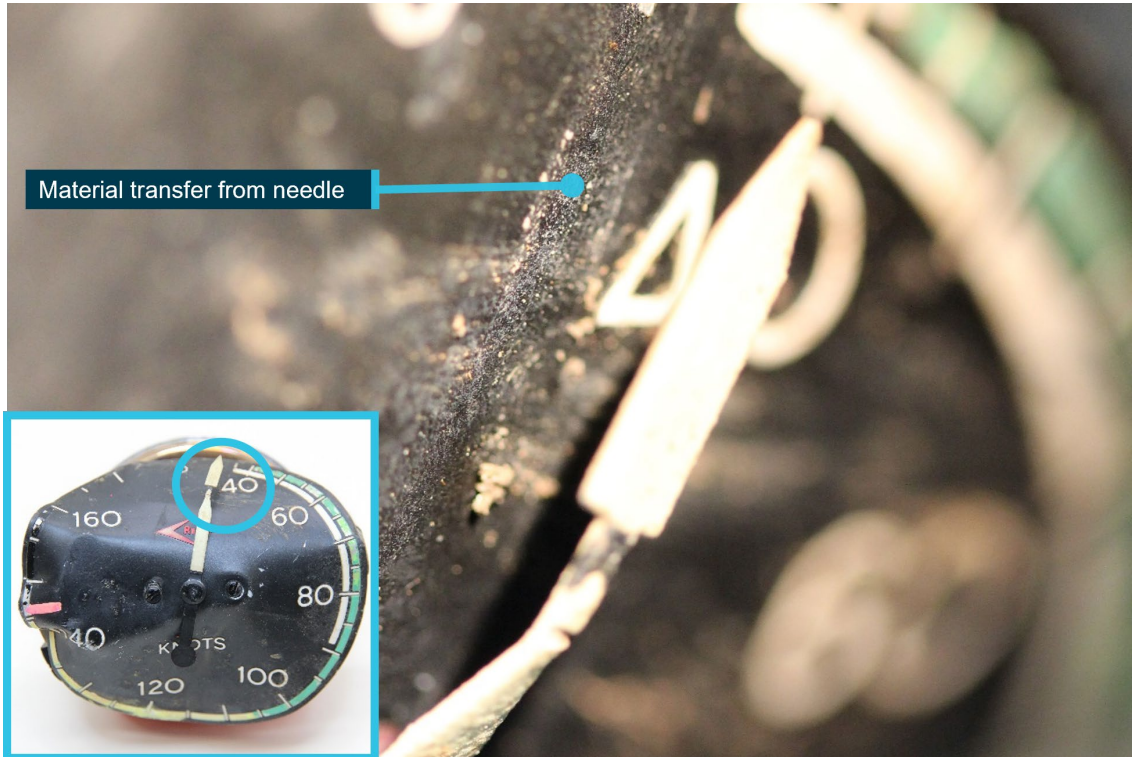
Figure 4: VH-REU airspeed indicator with material transfer

Based on a transfer of material from the airspeed indicator needle to its face, the aircraft likely impacted the ground at about 30 kt (or about 55 km/h) (Figure 4).

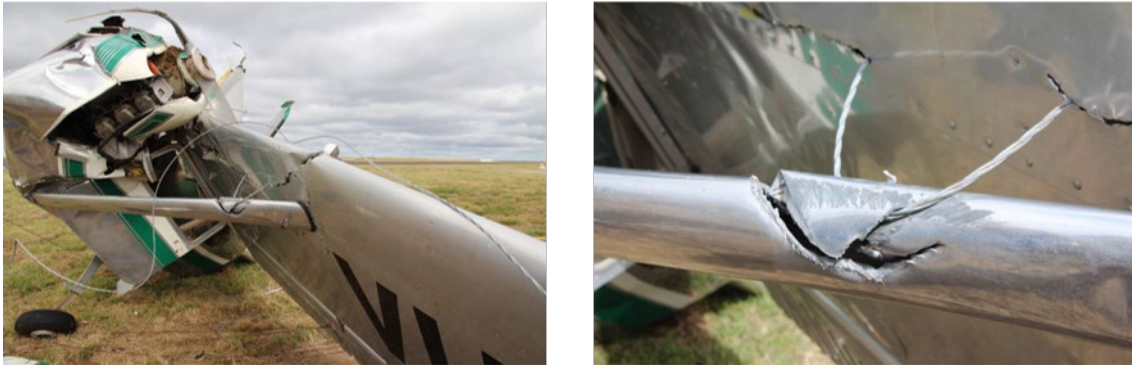
Figure 5: Powerline, left wing and strut

- damage to the left wing and strut indicated that the aircraft was likely close to level flight (about 11–12° right wing low) when it contacted the powerlines, with one of the powerlines remaining entangled with the left wing and left wing strut (Figure 5)
- one of the propeller blades had marks likely from contact with the powerlines, and had a significant forward bend and tip curl, which was consistent with the engine producing power when the aircraft impacted the ground (Figure 6)
- the other propeller blade was bent rearwards and had damage consistent with ground impact during the cartwheeling motion of the aircraft
- liveable space in the cabin was maintained
- the seat tracks were in place and the pilot's seat was still attached to the aircraft structure
- the pilot's upper torso restraint (shoulder harness) was found stowed.³

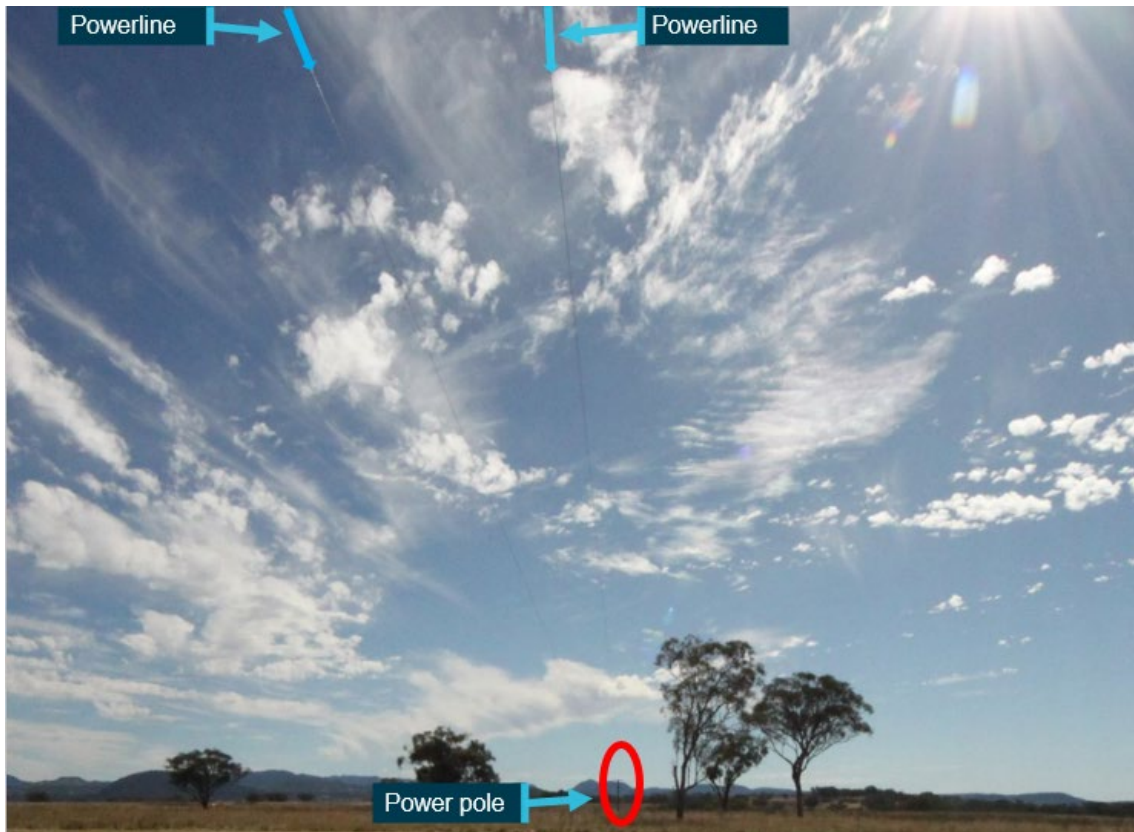
Figure 7: Reinstalled powerlines in the adjacent field

The 22-kV powerlines that were struck by the aircraft consisted of a pair of 3-strand galvanised steel wires. The wires spanned across timber poles that were 314 m apart. The powerlines had to be maintained so that the wires had a clearance of 5.5 m from the ground. The powerlines at the aerodrome (including an allowance for catenary) were reportedly compliant with this requirement, and were estimated to be at a height of 21–31 ft (6–9 m) above the ground at the point of impact

The powerlines were not marked and were not required to be marked by Australian Standards (AS) 3891.1 (*Permanent marking of overhead cables and their supporting structures for other than planned low level flying*) or AS 3891.2.4 (*Marking of overhead cables for planned low level flying operations, addressed the requirements for marking overhead cables, including powerlines*).

Figure 7, looking west-north-west, shows reinstalled powerlines above the field after the accident.

Following the wirestrike accident involving VH-REU and in accordance with its company policy, Essential Energy field workers assessed the risk of another wirestrike to the powerlines that crossed the fields north of Coonabarabran Aerodrome. Subsequently, Essential Energy installed aerial markers to these powerlines.
