Collision with terrain involving Kubicek Balloons BB78Z, VH-RJR

Elwood, Victoria on 20 April 2022

ATSB Transport Safety Report

AO-2022-028

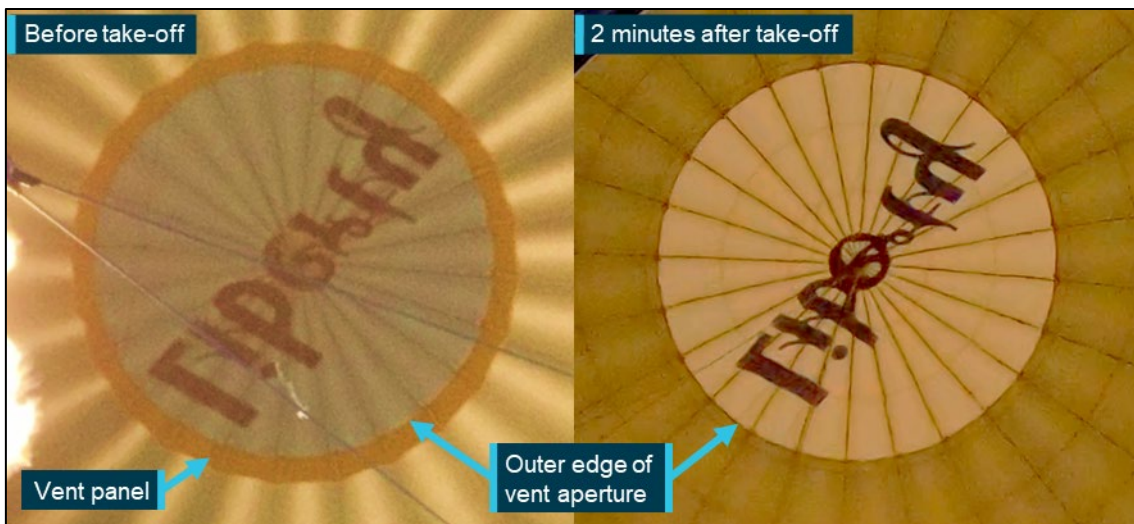
Figure 1: Vent panel before and after take-off (both images to scale)

Passenger images taken during the incident flight showed the vent panel – a fabric panel used to vent air out of the circular opening at the top of the balloon (vent aperture) – before take-off and about 2 minutes after take-off (Figure 1). The image from shortly after take-off showed that the vent panel was almost, or already, pushing through the vent aperture at normal internal envelope operating temperatures.

The images indicated vent panel behaviour similar to that observed in the passenger's video (Figure 1) during the incident flight. The pilot, who attended the test, also reported that the vent gaps were very similar to those observed during the incident flight.

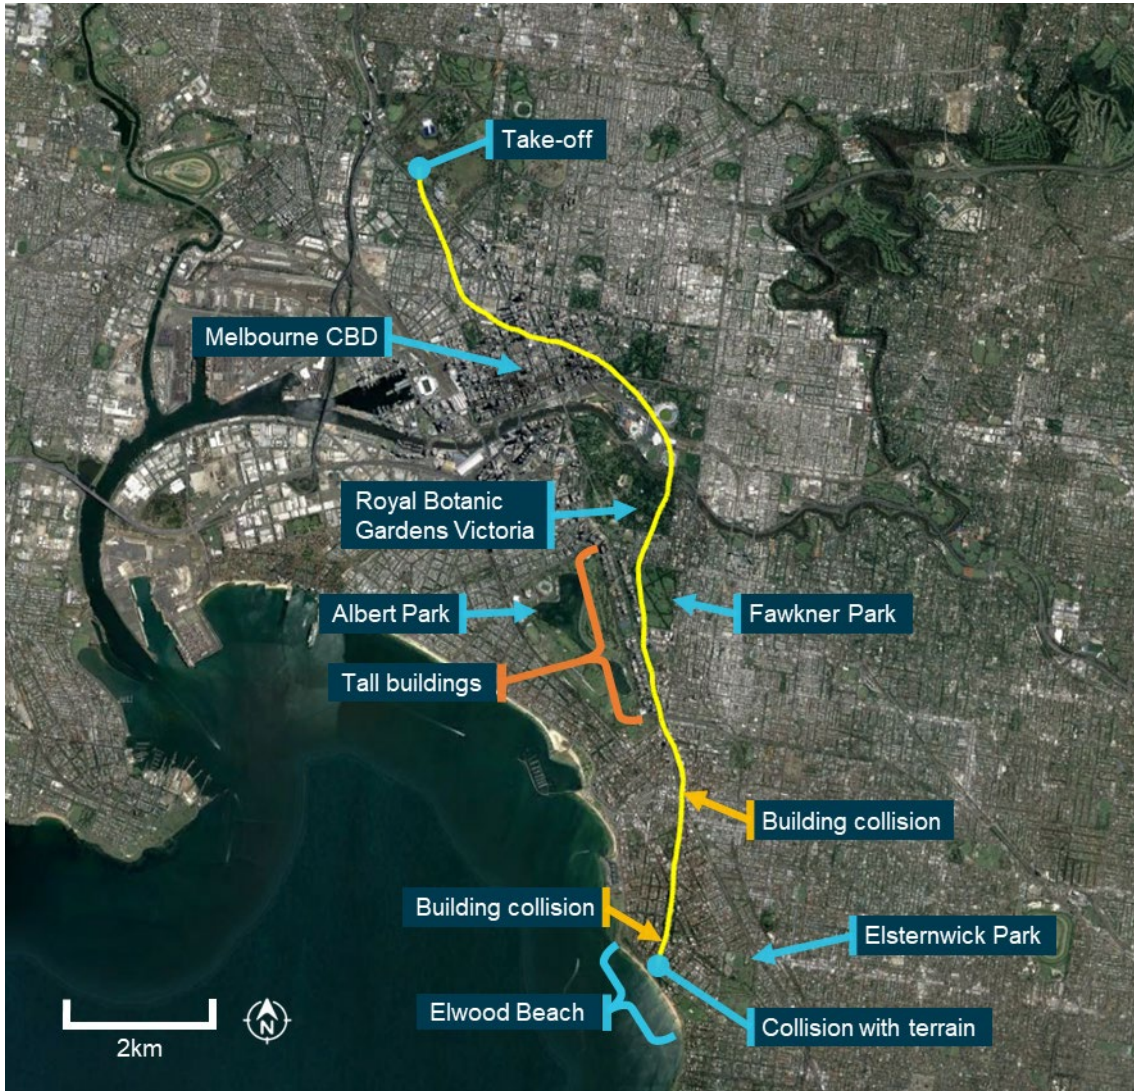
Figure 2: Balloon flight track

At about 0656, the pilot attempted an approach to land at Fawkner Park (Figure 2), but as the balloon descended over the Royal Botanic Gardens it tracked away from the larger central areas of the park. The pilot activated the burners and ascended into north-westerly winds to attempt to track back towards the park’s central area but was not successful. The balloon continued to track south-south-east along the western edge of the park adjacent to nearby buildings.

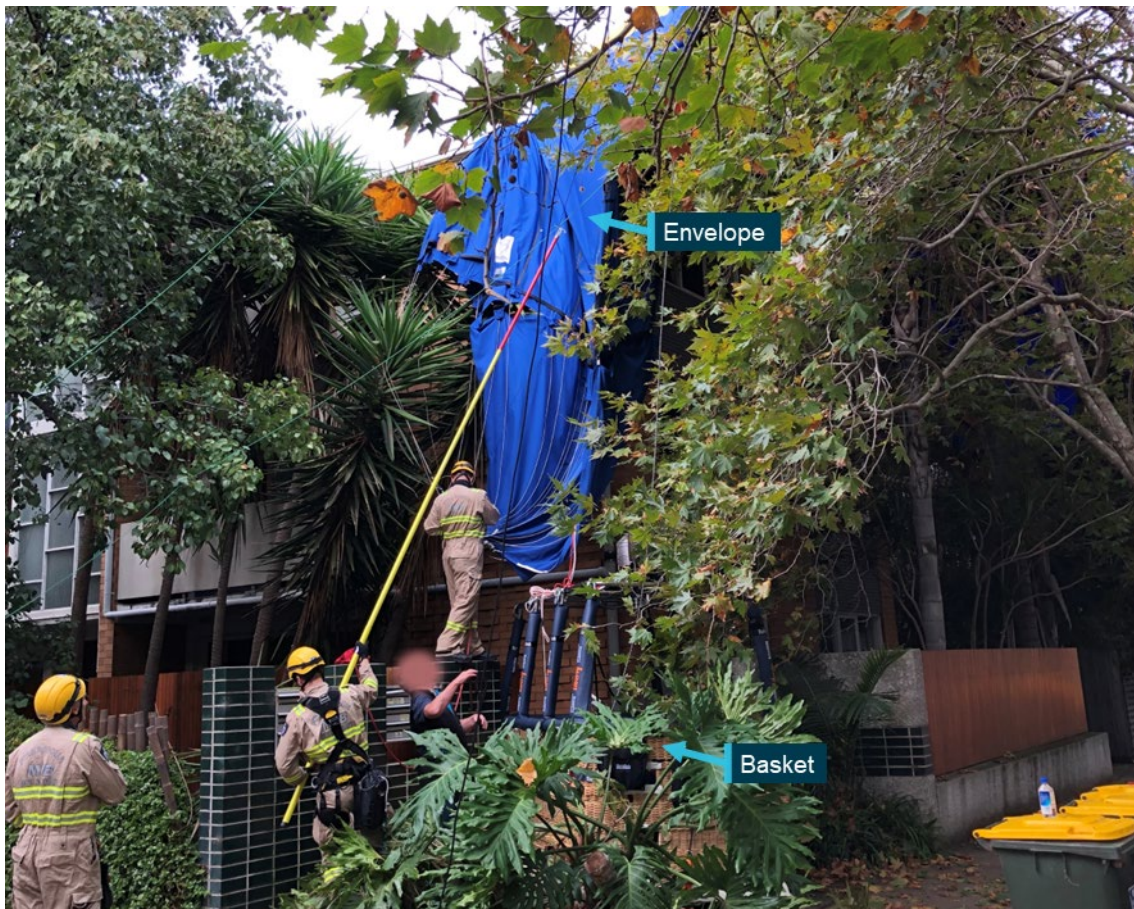
Figure 3: Balloon landing site

The basket landed outside the entrance of an apartment building, and the envelope eventually deflated over the building's roof (Figure 3). The balloon and basket sustained minor damage during the collision, and three passengers sustained minor injuries. During the collision, the basket was not orientated with the long side perpendicular to the direction of travel. Although this was the normal procedure for any landing, the impact with the trees rotated the basket, and the pilot did not have time to correct this using the balloon's rotation vents. Further, using the vents would have increased the rate of descent during the landing.

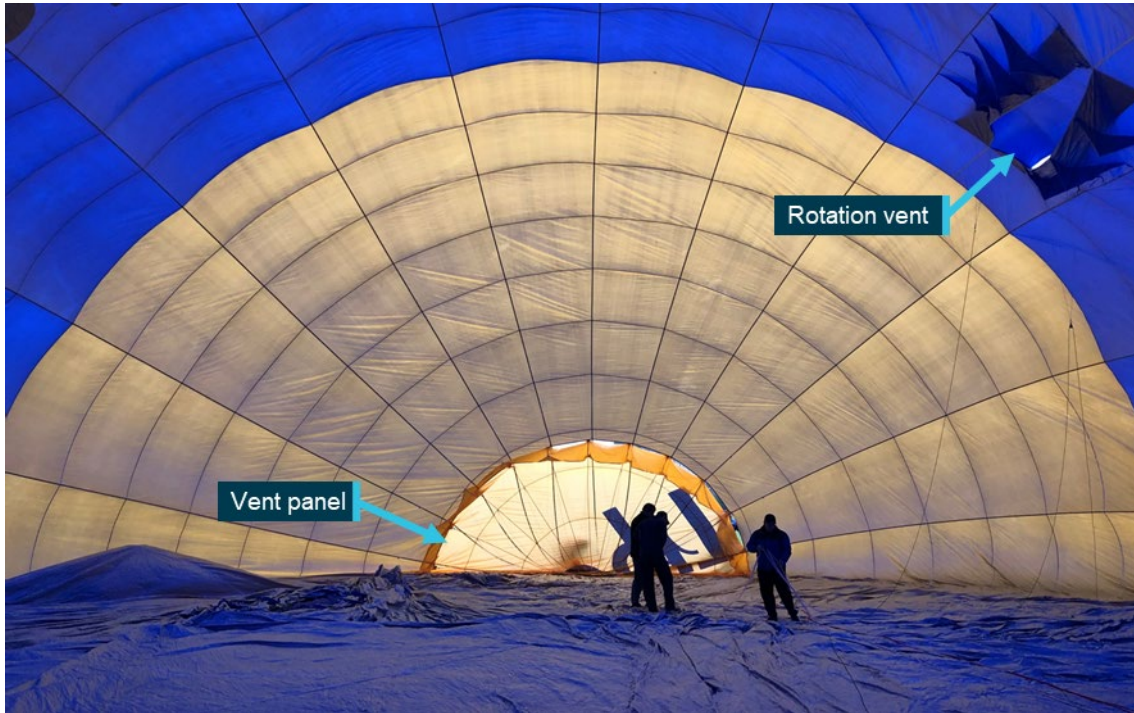
Figure 7: Internal envelope inspection

The envelope was first inflated on the ground using a fan to conduct an external and internal inspection of the envelope (Figure 7), with the following observed:

- white line, shroud centralising lines, and parachute vent line were tangled around the weight
- pulleys and rope lines were serviceable
- there was minor impact damage to the envelope fabric from the landing
- the temperature streamer was intact and the temperature indicator colour was unchanged.

The manufacturer, operator, and maintainer considered the deflation system lines to be very likely caused by the abnormal packing of the disturbed envelope after the incident.⁵ The lines were then untangled to continue with the test.

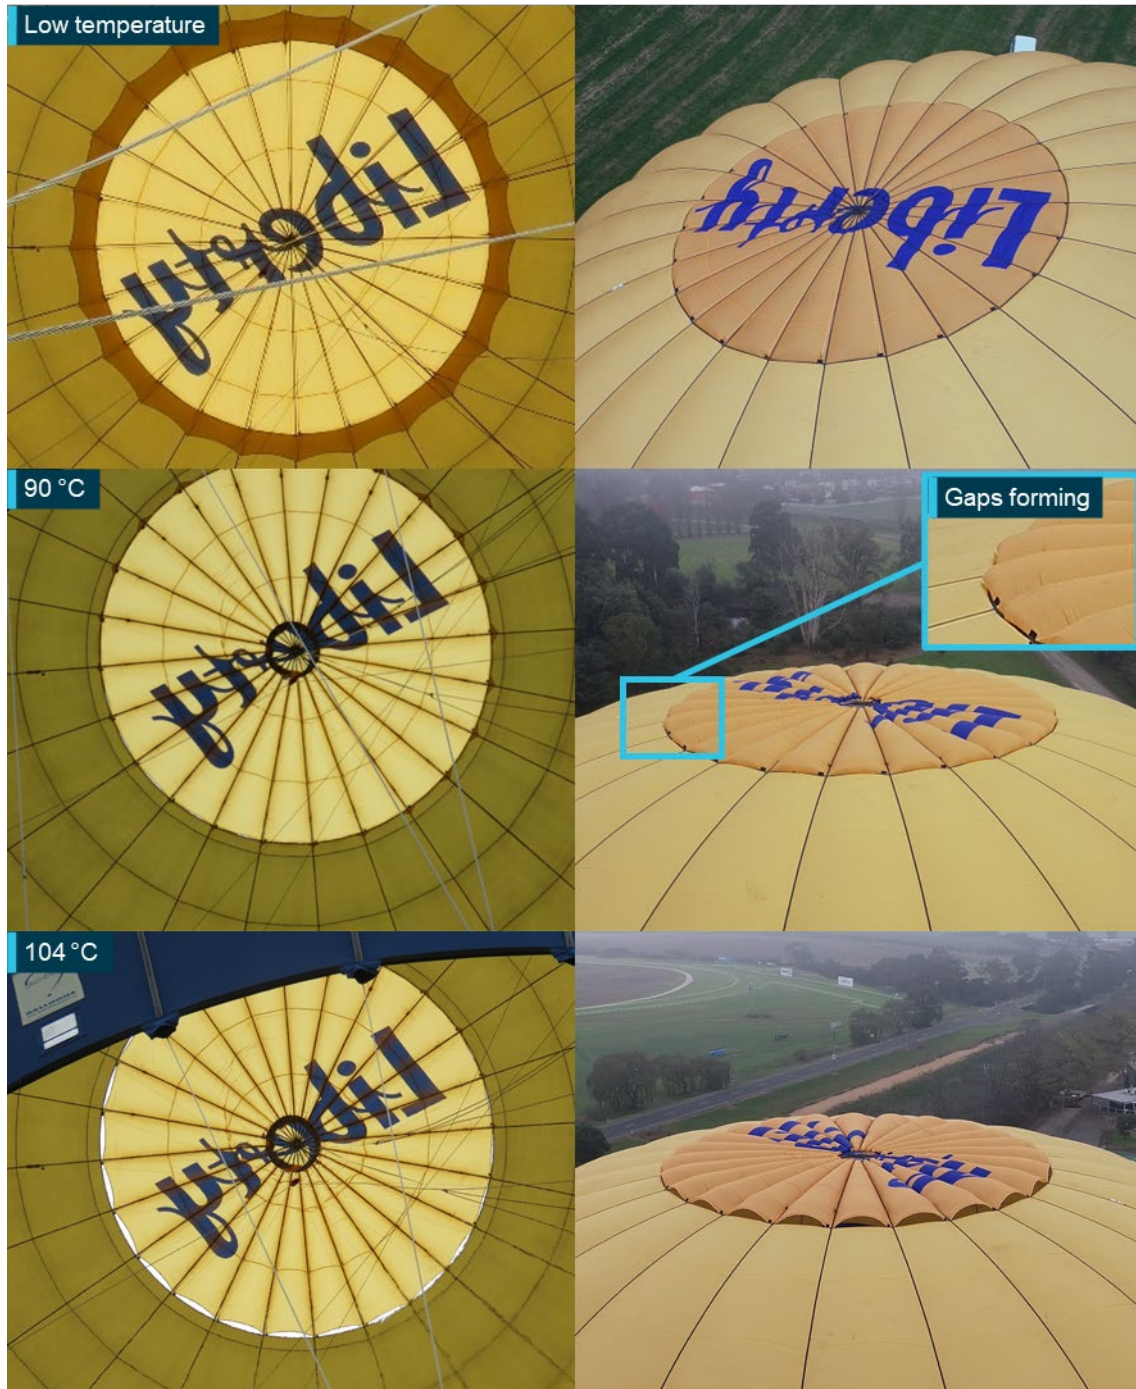
Figure 8: Deflation system testing

The internal envelope temperature was increased while external and internal camera footage of the vent panel was taken (Figure 8). At low temperatures, the vent panel began to push up against the internal envelope and vertical load tapes as designed, creating a seal. At about 90° C, edges of the vent panel between the vertical load tapes pushed up through the aperture creating many gaps for internal envelope air to vent out. Attempts to seal the gaps using the parachute vent line and white line were unsuccessful. At higher temperatures, the gaps became larger and more numerous.

After the test, the manufacturer designed a repair to fix the vent panel sealing issue and evaluated whether the spacing between the vertical load tapes at the edge of the vent panel was adversely affecting the seal. Another balloon test was conducted which showed that the repair improved the seal, however the balloon was not considered airworthy. The balloon envelope was subsequently shipped back to the manufacturer’s headquarters for further examination.

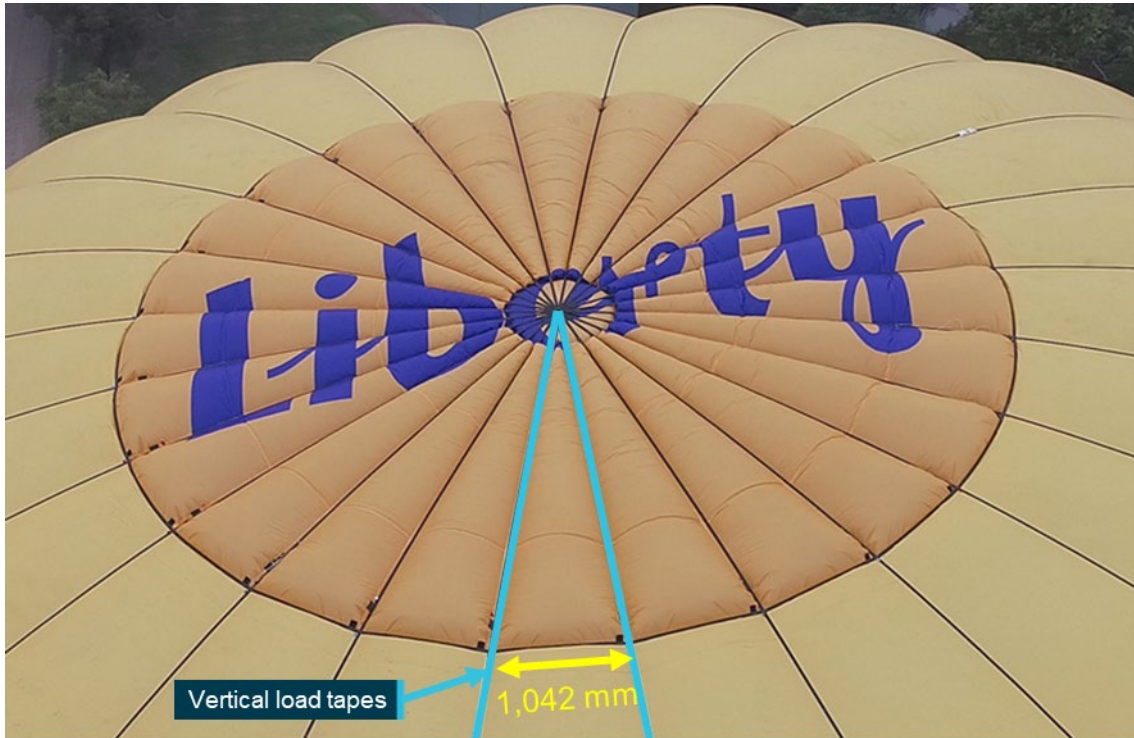
Figure 9: VH-RJR vent panel spacing between load tapes

The envelope’s deflation system dimensions were compared with the design data with no differences found. The design differences between the VH-RJR deflation system and the same size deflation system fitted to the manufacturer’s larger certified balloons was also reviewed. The review found that one significant difference was the vertical load tape spacing at the edge of the vent panel (Figure 9).

- VH-RJR BB78Z with 24 gores and 4.0 m radius vent aperture – 1,042 mm spacing
- Standard BB78Z with 24 gores and 3.6 m radius vent aperture – 940 mm spacing
- Standard larger balloon with 28 gores and 4.0 m radius vent aperture – 893 mm spacing

The modified deflation system on VH-RJR, which increased the vent panel radius from 3.6 to 4.0 m, was based on larger certified balloons which had 28 gores compared to the 24 gores of the BB78Z. This meant that the spacing at the edge of the vent panel between the load tapes on VH-RJR became 149 mm longer than the larger balloons and 102 mm longer than the standard BB78Z.
