# Exceedance of temporary speed restriction by XPT passenger train ST21

Moreland, Victoria on 24 May 2022

**ATSB Transport Safety Report**

RO-2022-005

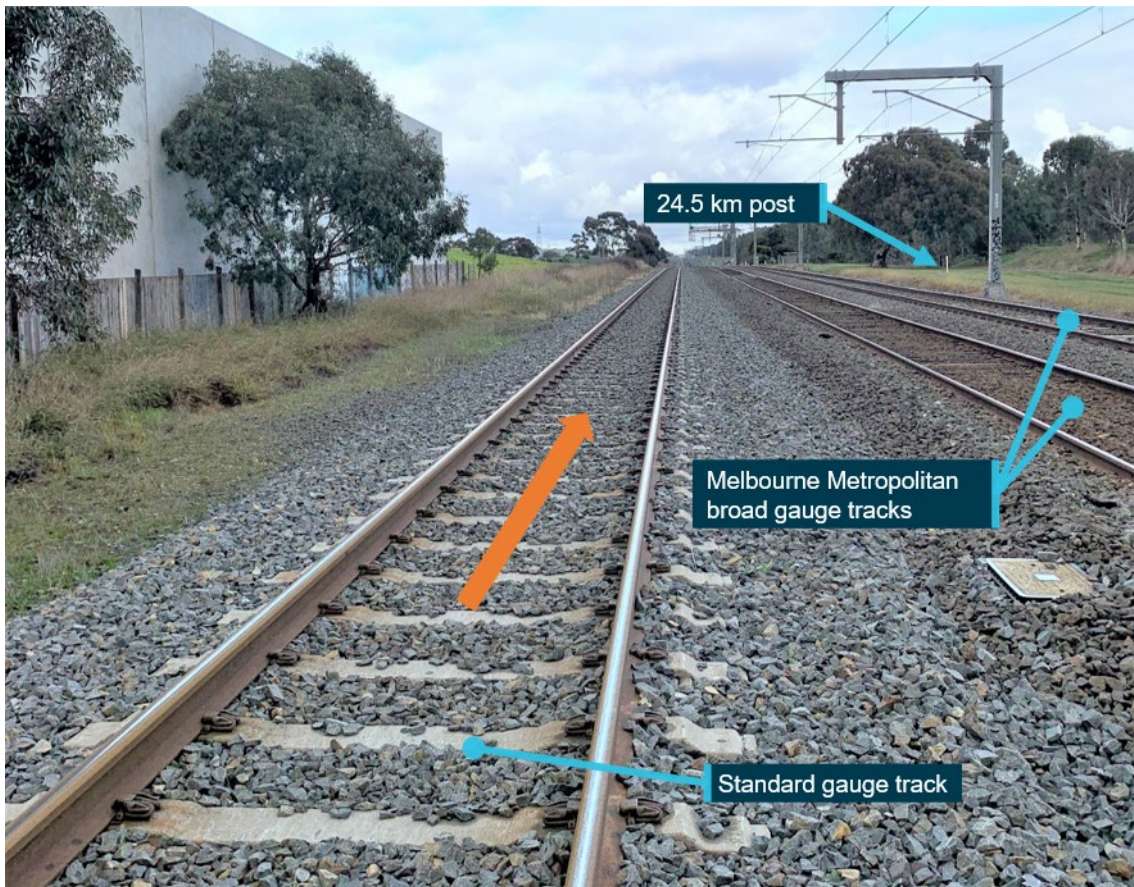
**Figure 2: Looking towards 24.4 to 24.0 km location where ST21 reduced speed.**

After departing Donnybrook, ST21 arrived at the 24.4 km location (north of Somerton) at about 0653. The driver reduced the train’s speed to just under 40 km/h and after passing the 24.0 km mark resumed normal speed. In this section, the standard gauge track on which ST21 was travelling was a single bi-directional track that runs parallel to and on the east side of the two Melbourne metropolitan broad gauge tracks (Figure 2).

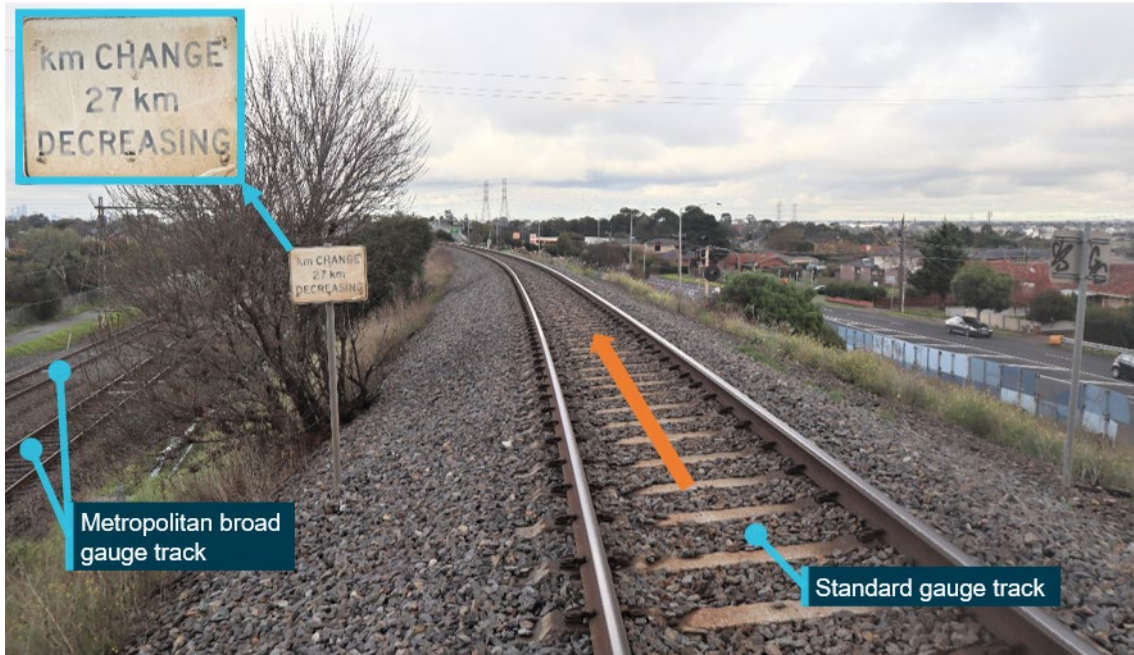
**Figure 3: Kilometre change signboard after track passed over the broad gauge lines**

The train travelled via the Jacana flyover that passed over the broad gauge tracks. On the flyover, kilometrage marking on the standard gauge line changed from 16 km to 27 km, and from this point decreased heading towards Melbourne (Figure 3).<sup>6</sup>

*The figure shows the standard-gauge track a short distance after it had passed over the broad gauge tracks (at the Jacana Flyover)*  
 Source: Chief Investigator, Transport Safety

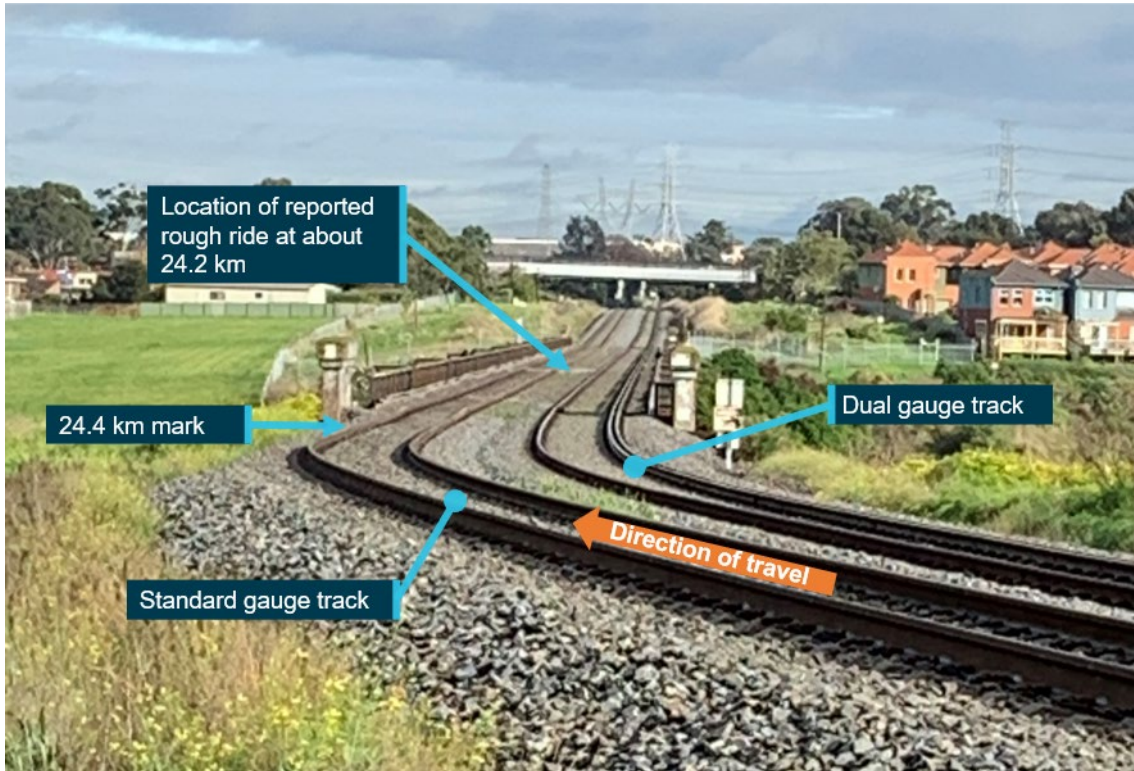
**Figure 4: Moonee Ponds Creek Bridge, looking west towards Melbourne**

After clearing the flyover, the train's speed was increased and at about 0703 ST21 approached the Moonee Ponds Creek Bridge at about 100 km/h. The train speed was not reduced, and the train passed over the bridge and across the rough track location. The 24.4 km mark was at the east end of the bridge, the rough track was at around the 24.2 km mark, just past midway on the bridge, and the 24.0 km mark was just past the west end of the bridge (Figure 4).<sup>7</sup>

*The figure shows the two tracks that crossed the Moonee Ponds Creek Bridge. ST21 was travelling on the standard gauge track.  
Source: Chief Investigator, Transport Safety*
