ATSB TRANSPORT SAFETY REPORT
Aviation Occurrence Investigation AO-2008-053
Final

Oxygen cylinder failure and depressurisation
475 km north-west of Manila, Philippines
25 July 2008
Boeing Company 747-438, VH-OJK

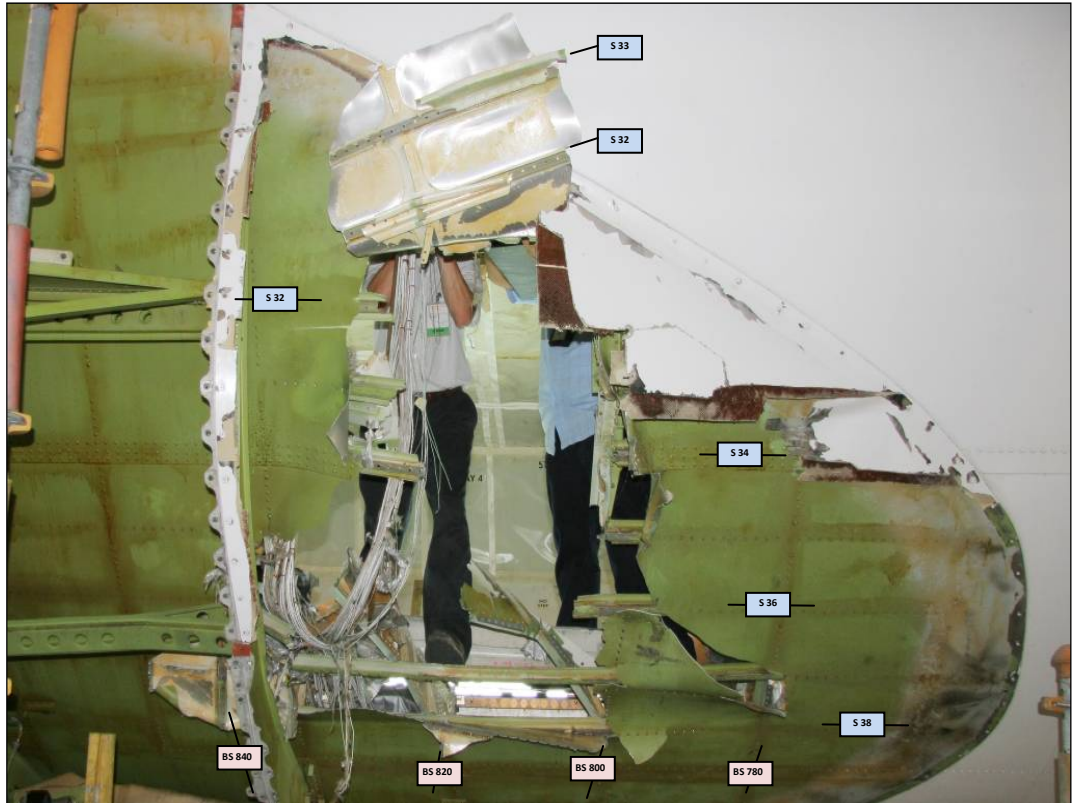
Figure 3: Extent of the fuselage rupture, after removal of further transition fairings. Stringers [S] and Body Stations [BS] are denoted

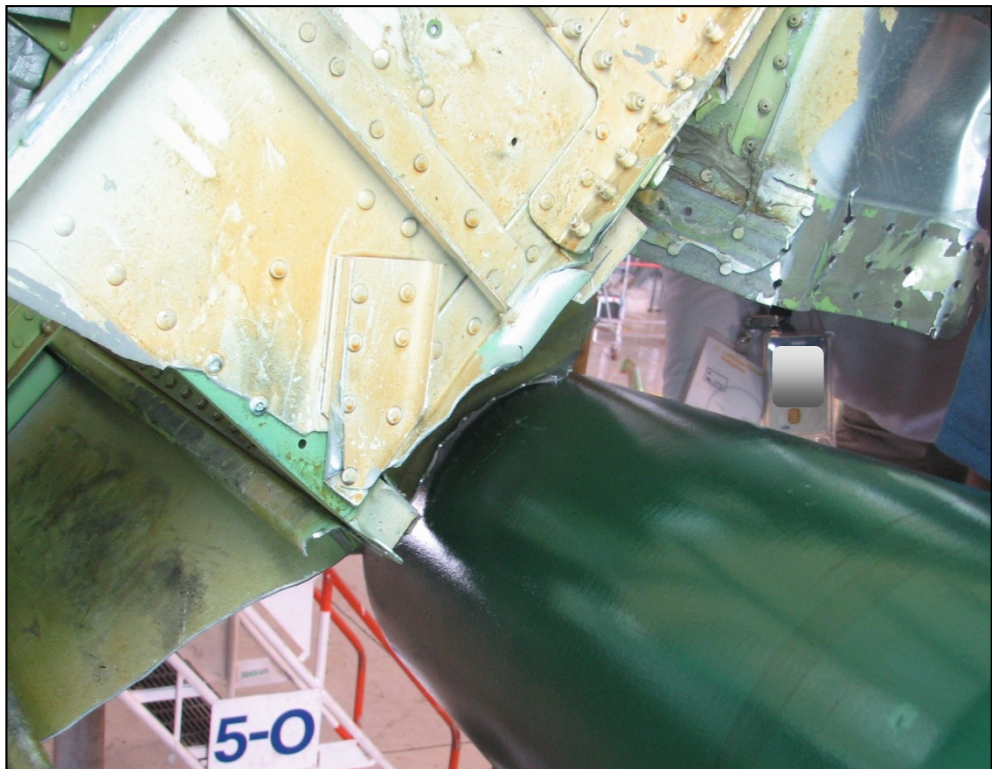
Figure 6: Oxygen cylinder held against skin fold to illustrate conformance

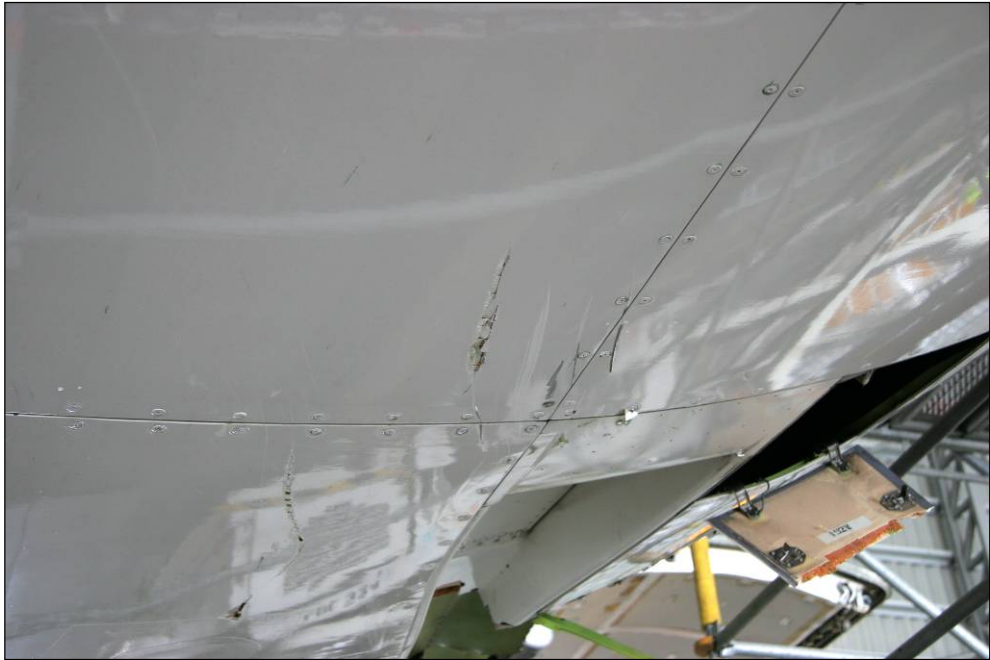
Figure 7: Panel damage to the rear of the rupture site

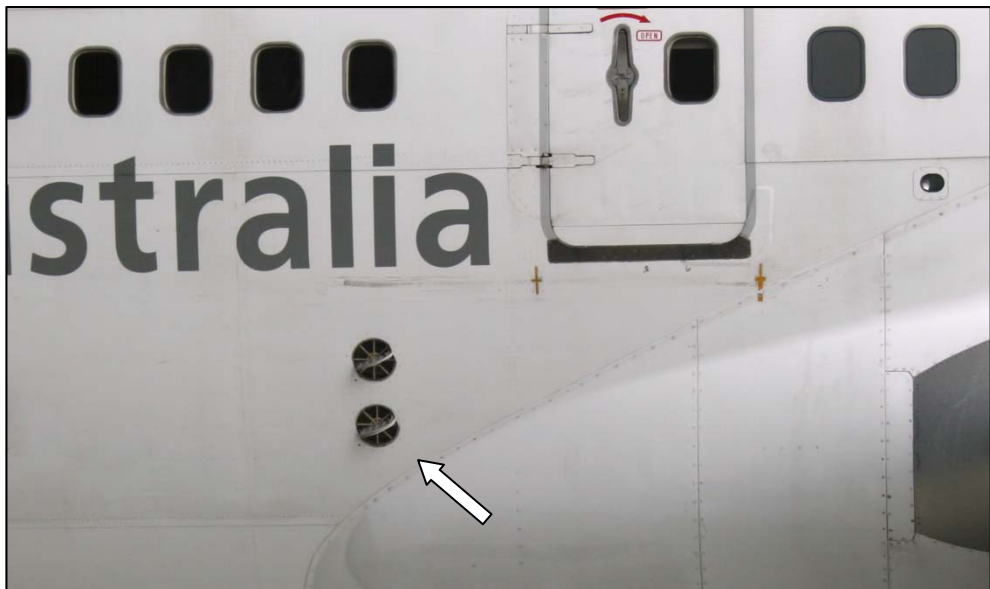
Figure 8: Pressure relief valve blowout doors open (arrowed)

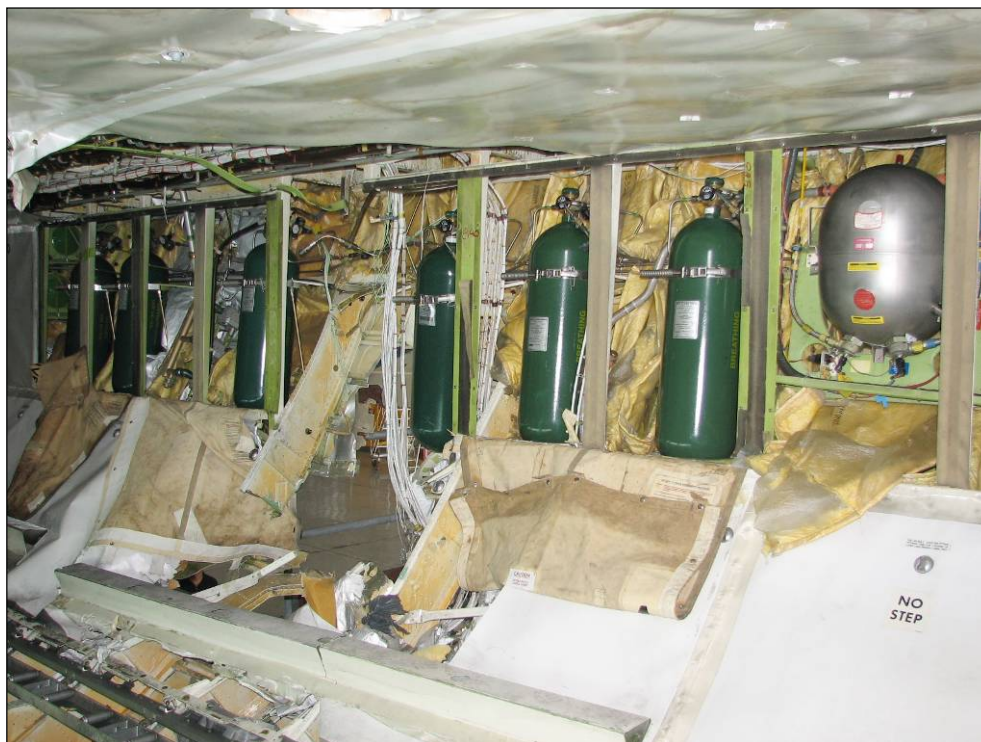
Figure 9: Forward cargo hold wall with remaining six oxygen cylinders

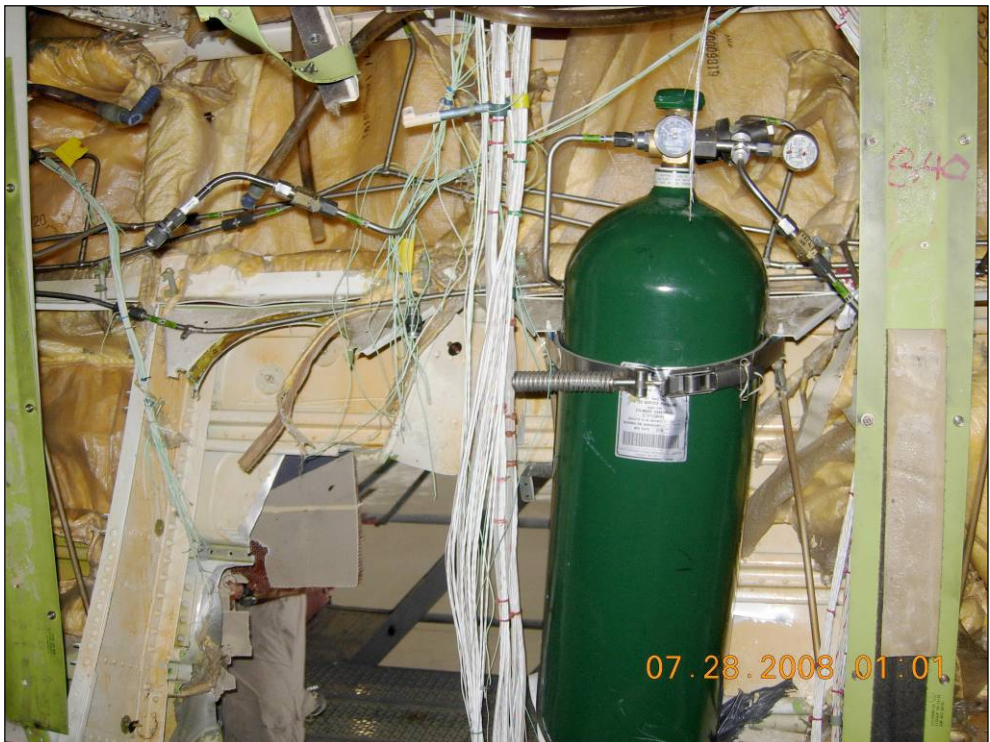
Figure 11: Number-5 oxygen cylinder adjacent to fractured fittings and lines from the number-4 cylinder

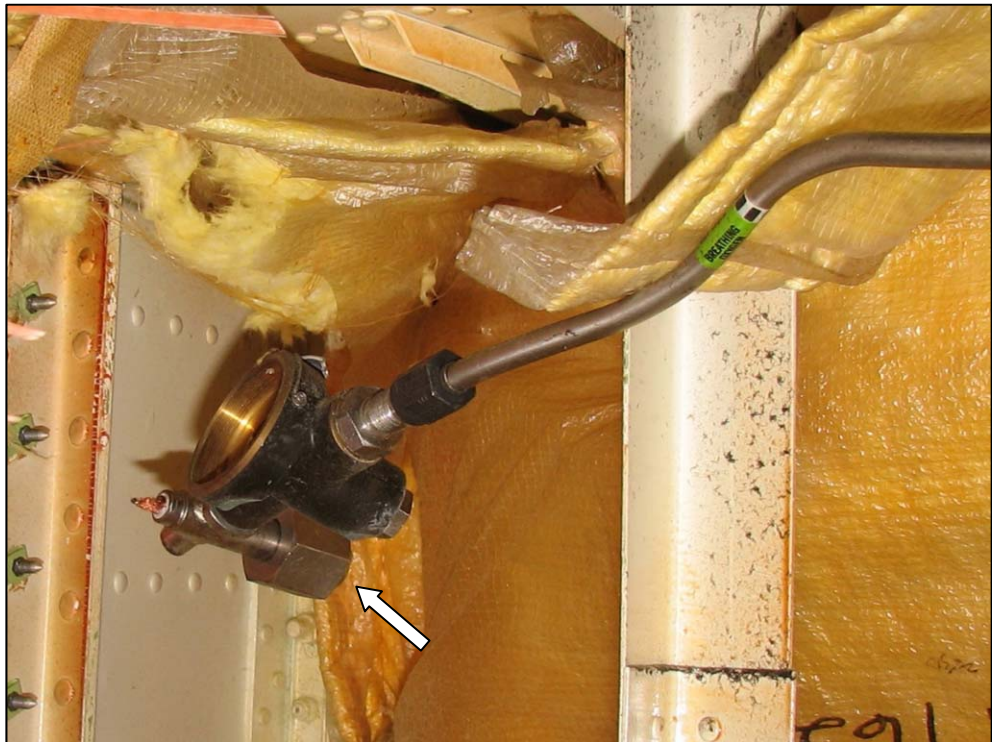
Figure 13: Number-4 cylinder pressure reducer and tee-piece - fractured away from cylinder valve at arrowed connection

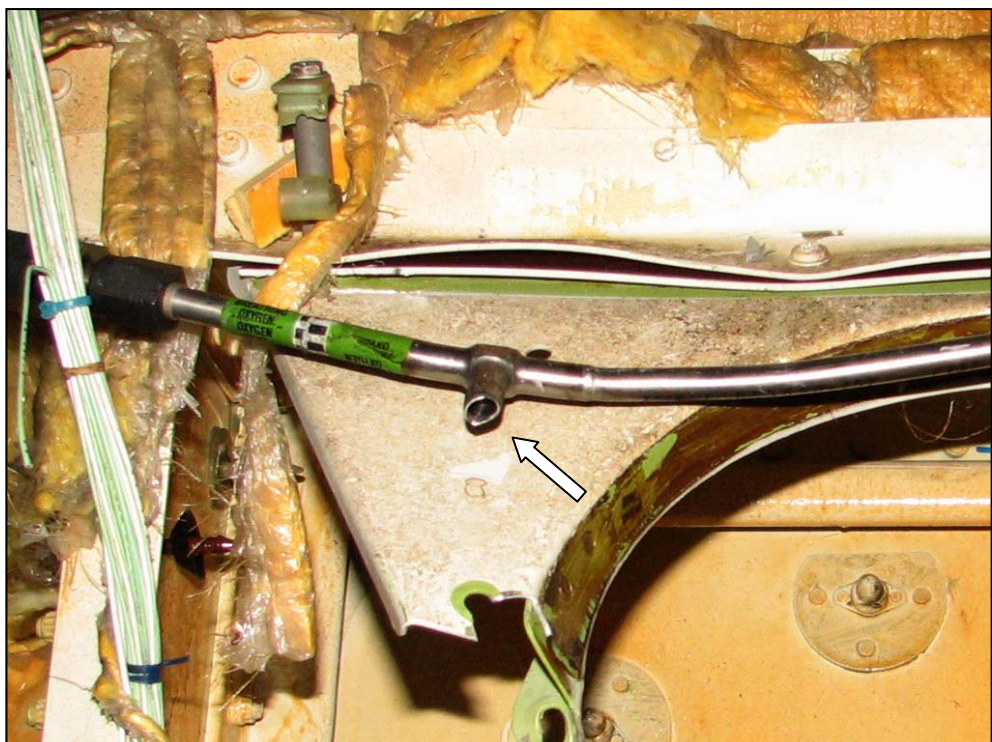
Figure 15: Number-4 cylinder overpressure discharge line fracture (arrowed)

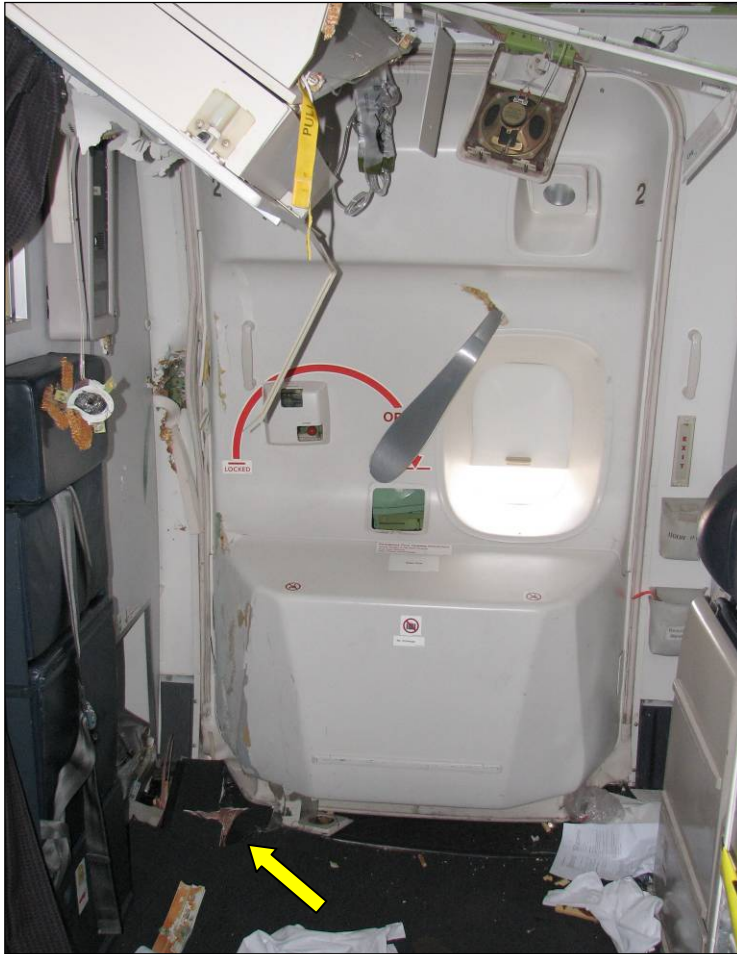
Figure 18: Interior of R2 door and cabin – location of floor hole arrowed

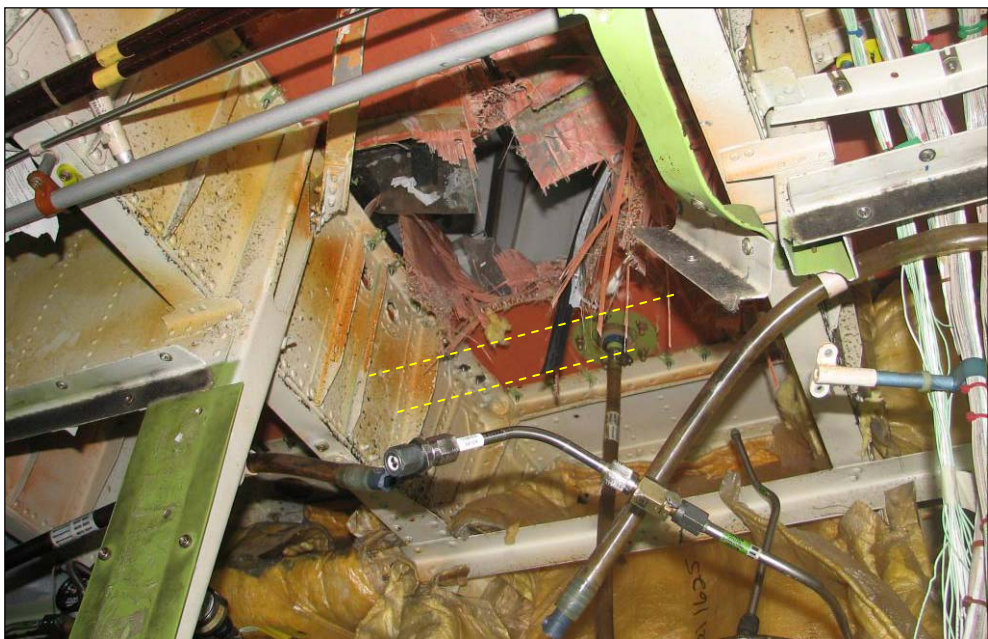
Figure 19: Hole in cabin floor – viewed from position of number-4 oxygen cylinder. Broken yellow lines mark the normal route of the first officer's aileron control cables

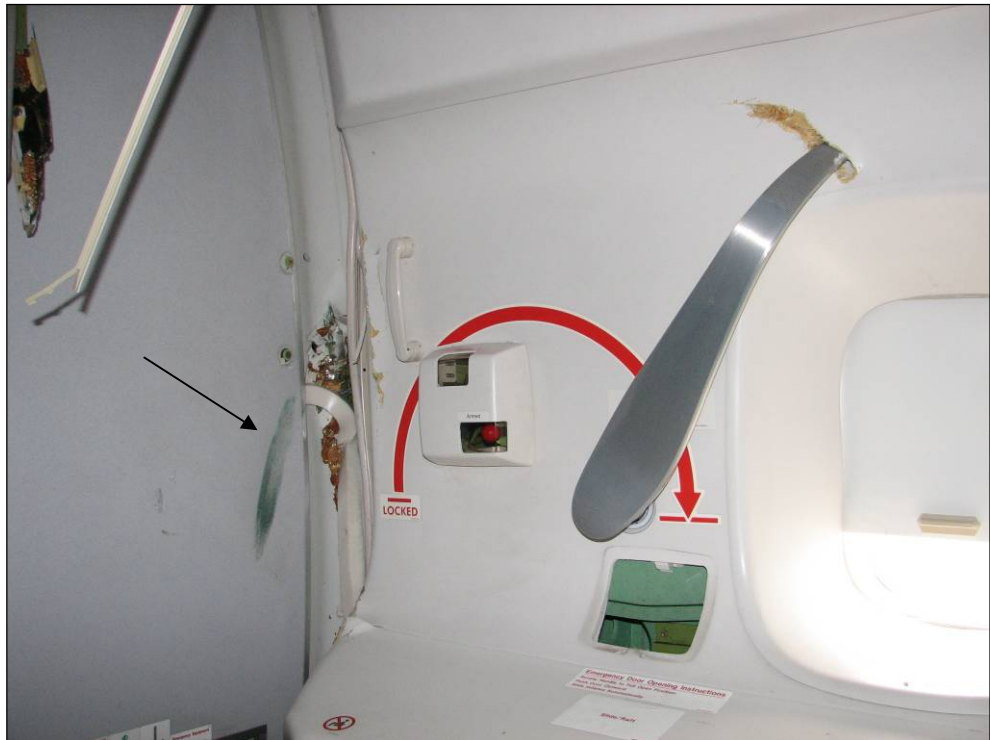
Figure 20: Door frame damage, green paint smear and rotated R2 door handle

The internal door handle was found in approximately the one-o'clock position (looking from inside), with the turned-in handle end embedded into the door lining material. That position was consistent with a movement through approximately 120 degrees from the fully-closed (locked) position. A 180 degree handle movement represented the fully open position. The downward facing surfaces of the handle end (when the door is in the locked position) showed damage and abrasion consistent with impact against another object. Inspection of the internal door systems showed the handle shaft had fractured and the actuating cam plate and retainer had pulled away from its associated mechanism (Figure 21), allowing the handle to rotate freely. As such, the handle position as observed inside the cabin was not indicative of the actual door security.

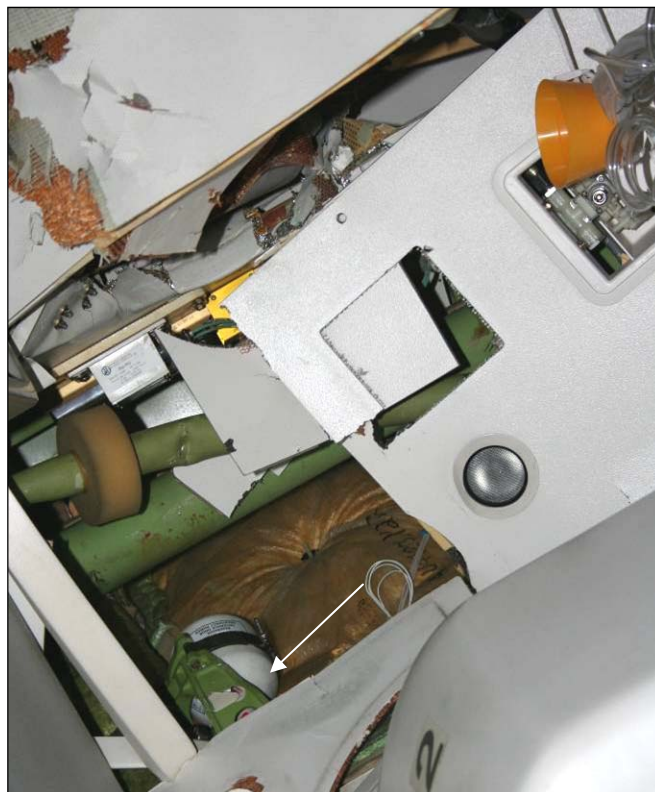
Figure 22: Damage above R2 door, exposing the EPAS cylinder (arrowed)

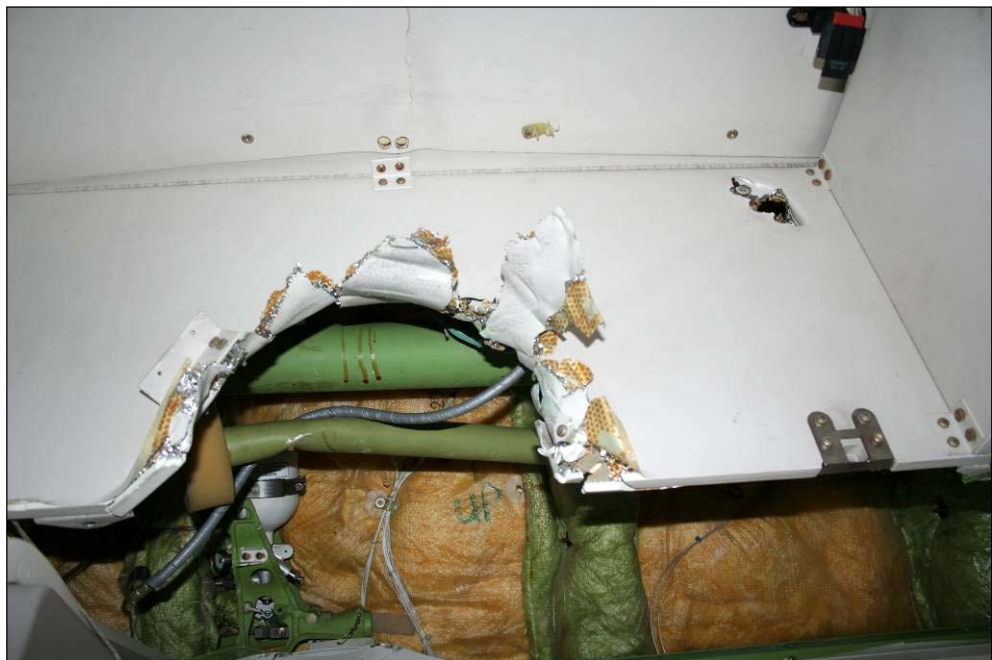
Figure 26: Semi-circular damage in partition of compartment above R2 door

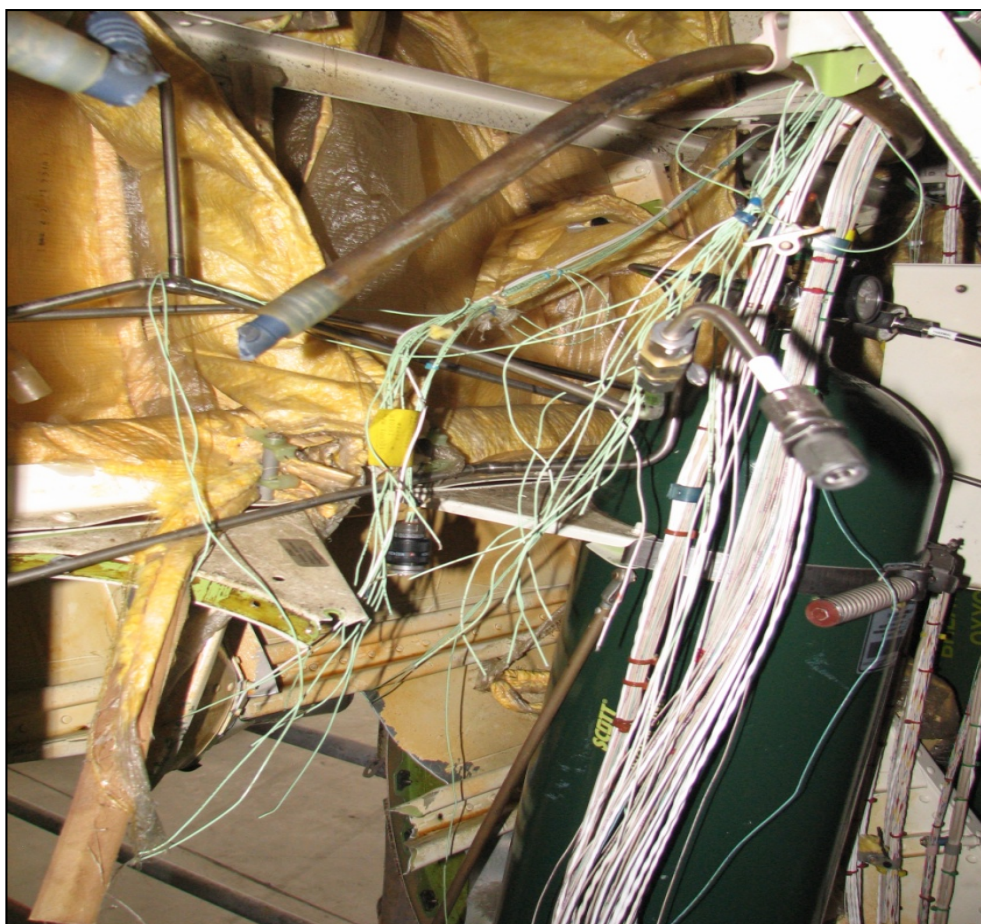
Figure 27: Damaged wiring adjacent to the number-4 cylinder location

Several fractured wires would have affected the functionality of the oxygen system flow control units (FCU) and the system reset solenoid. According to the manufacturer's analysis, the fractured wires would have impaired the flight crew's ability to:

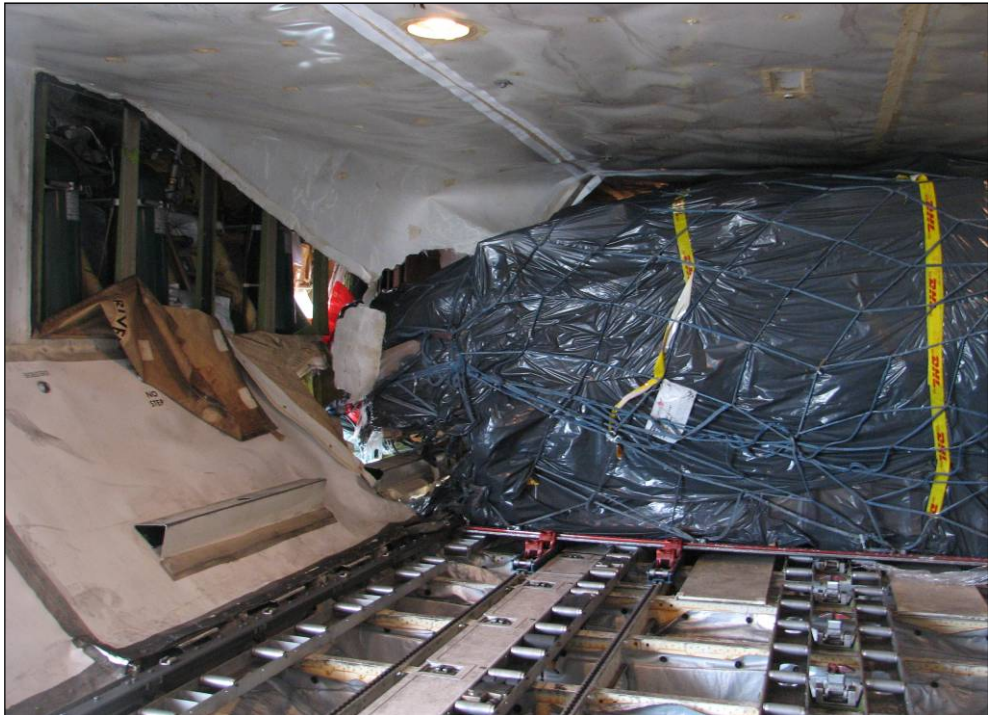
**Figure 28: Cargo pallet adjacent to the fuselage rupture
(view looking towards the rear of the aircraft)**

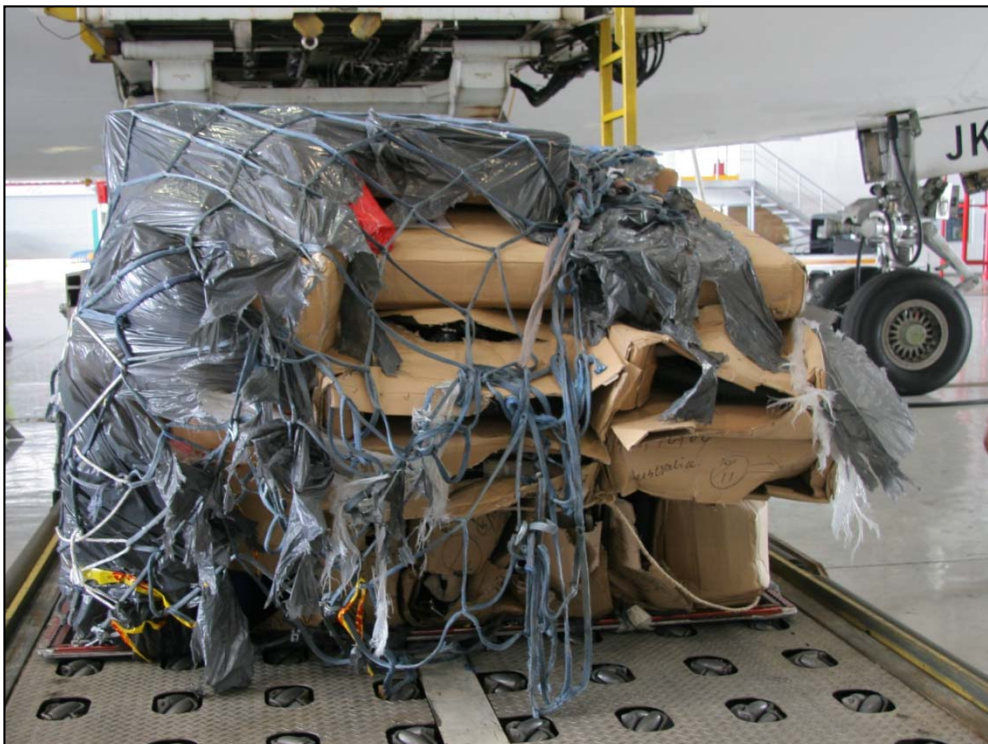
Figure 29: Cargo pallet after removal from the aircraft, showing the end facing the rupture

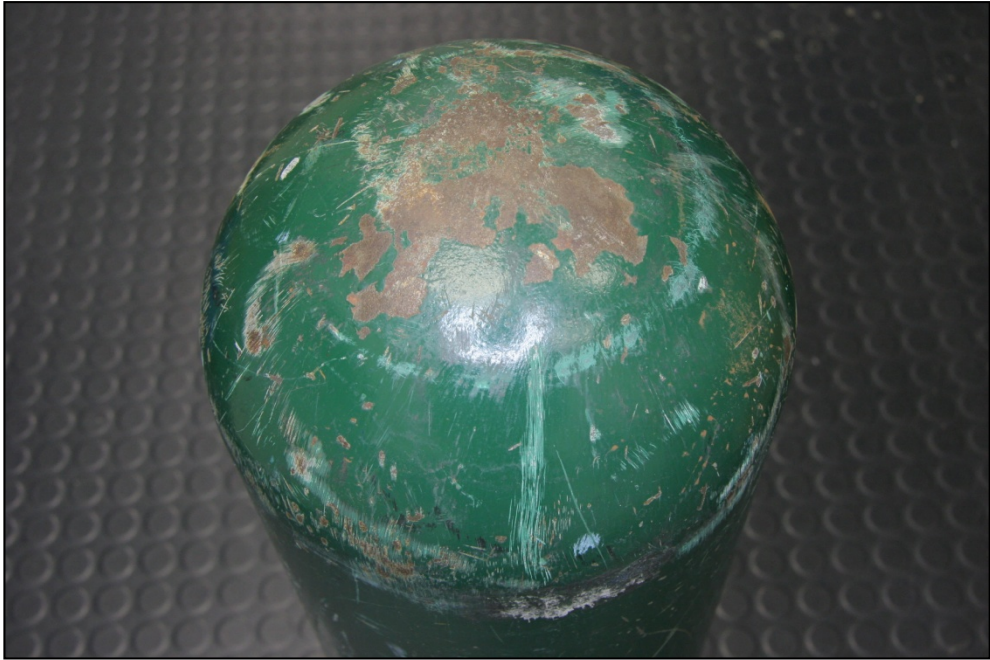
Figure 46: Paint loss and abrasion on lower dome of cylinder S/N 535691

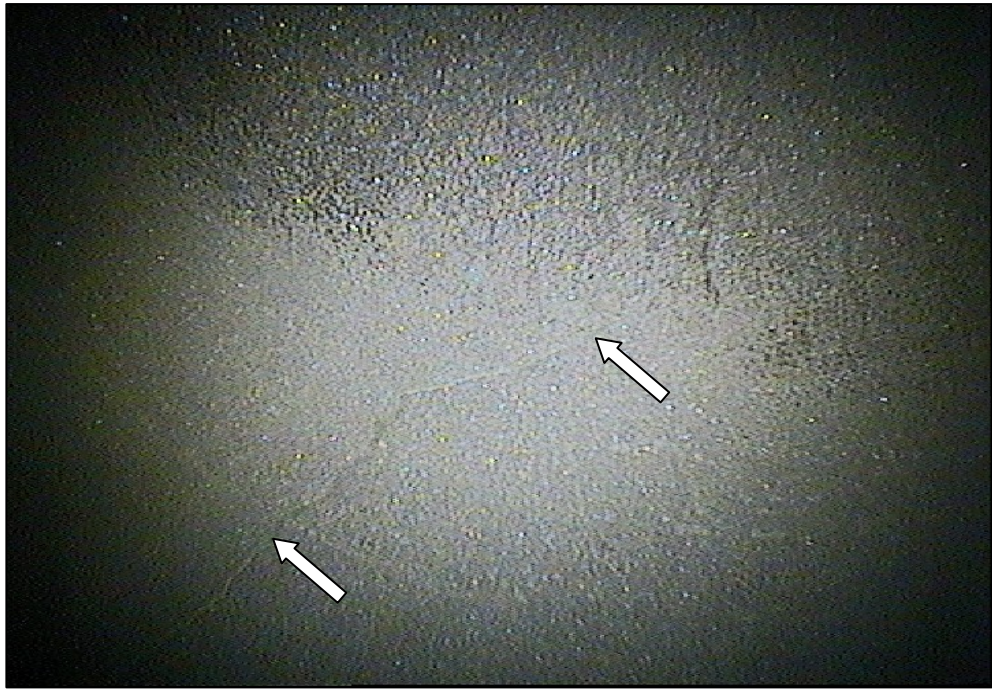
Figure 48: Linear feature observed inside cylinder S/N 535626 (arrowed)

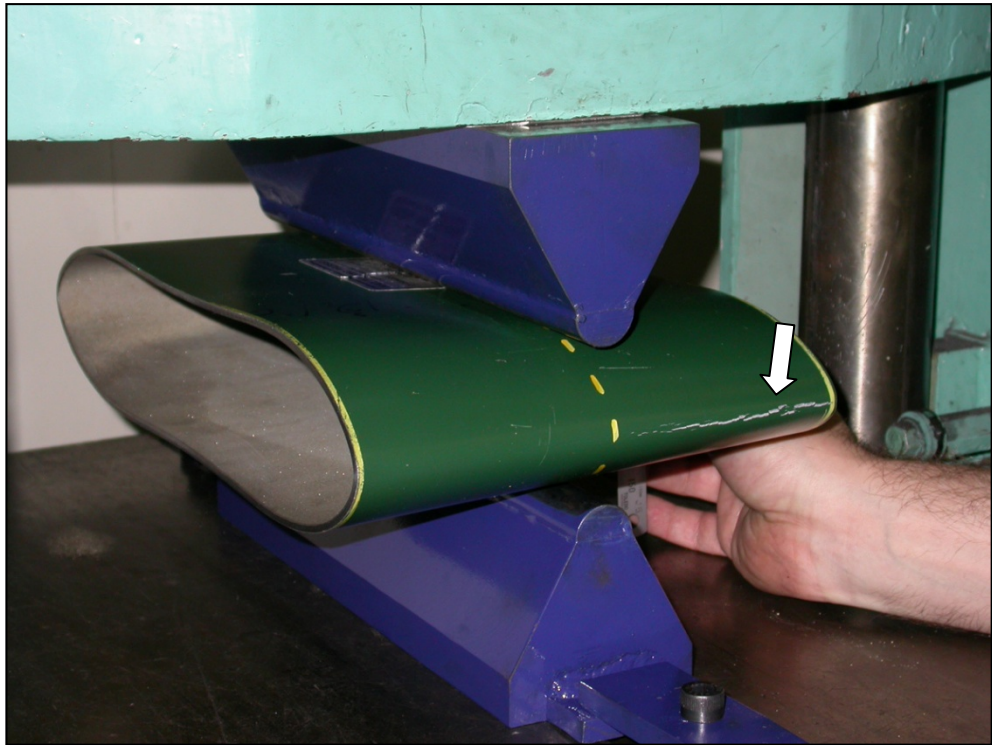
Figure 61: Completed flattening test, with area of cracking arrowed

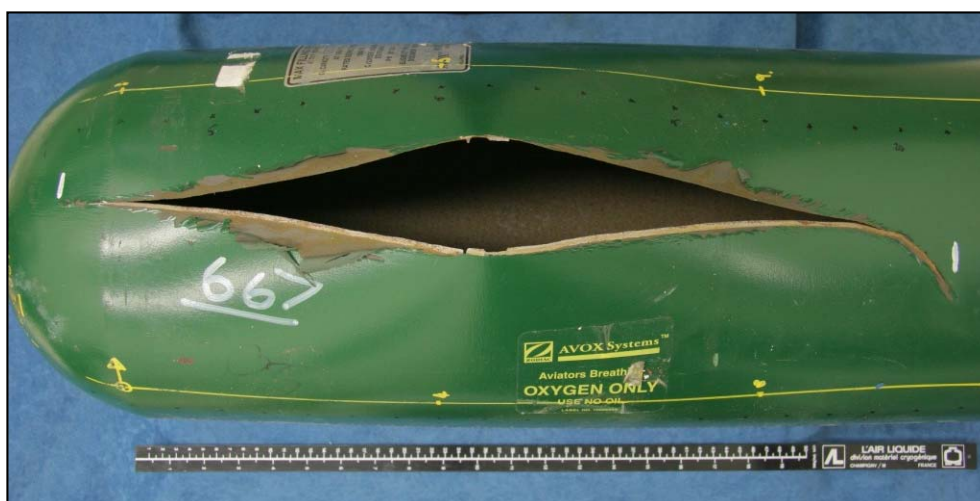
Figure 62: Rupture of cylinder S/N 535667

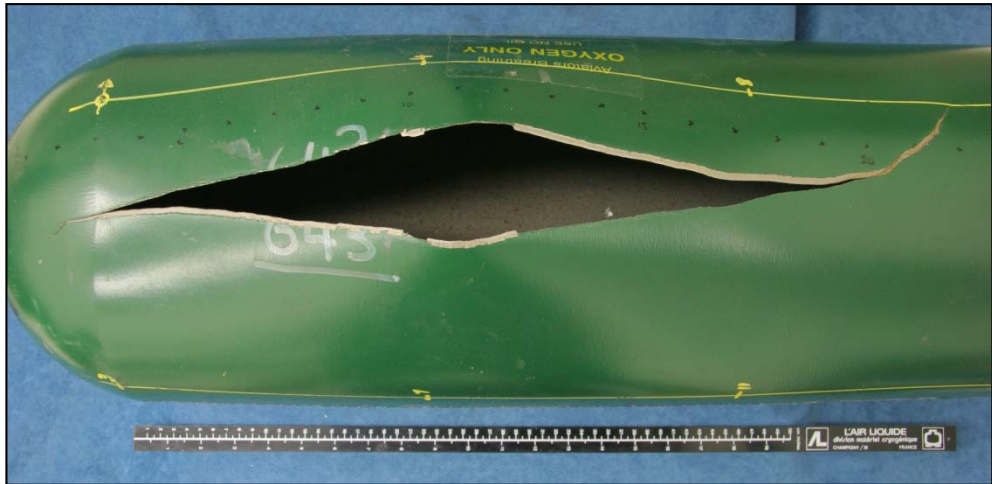
Figure 63: Rupture of cylinder S/N 535643

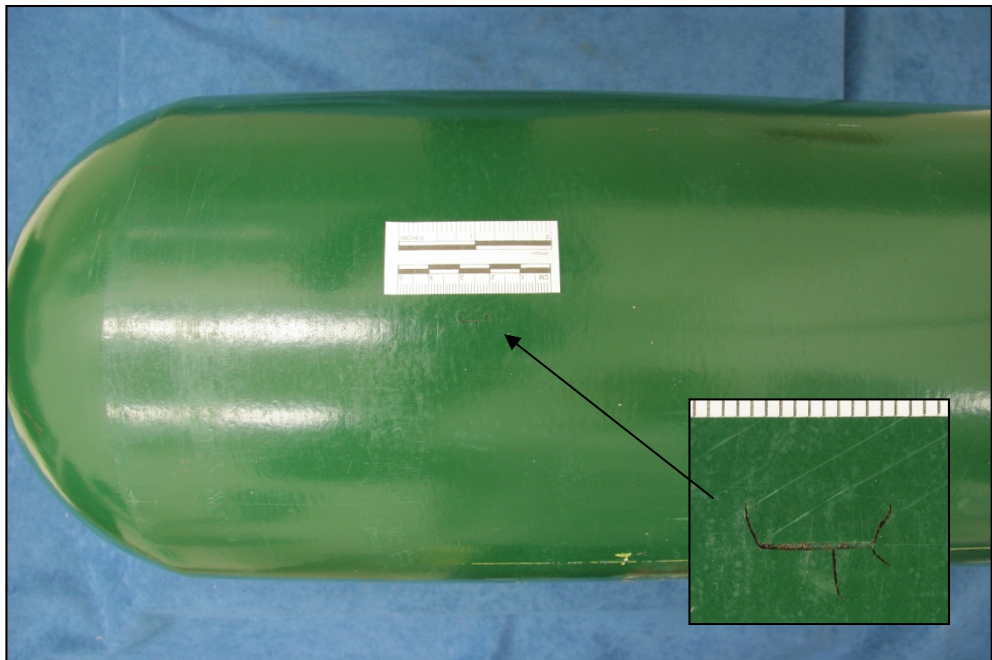
Figure 64: Leak of cylinder S/N 535598

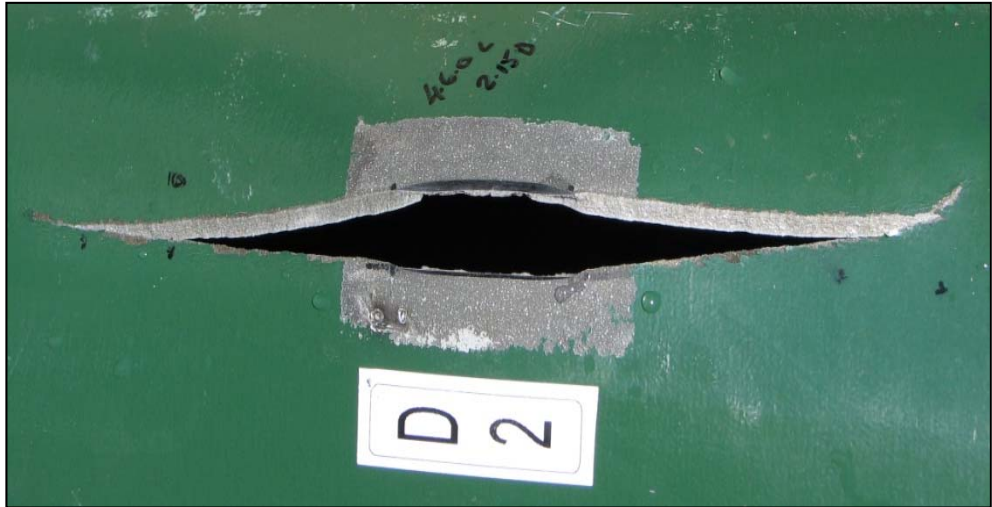
Figure 70: Cylinder 240341 ruptured at a 46.5 mm L x 2.15 mm D artificial flaw (Test No. 7)

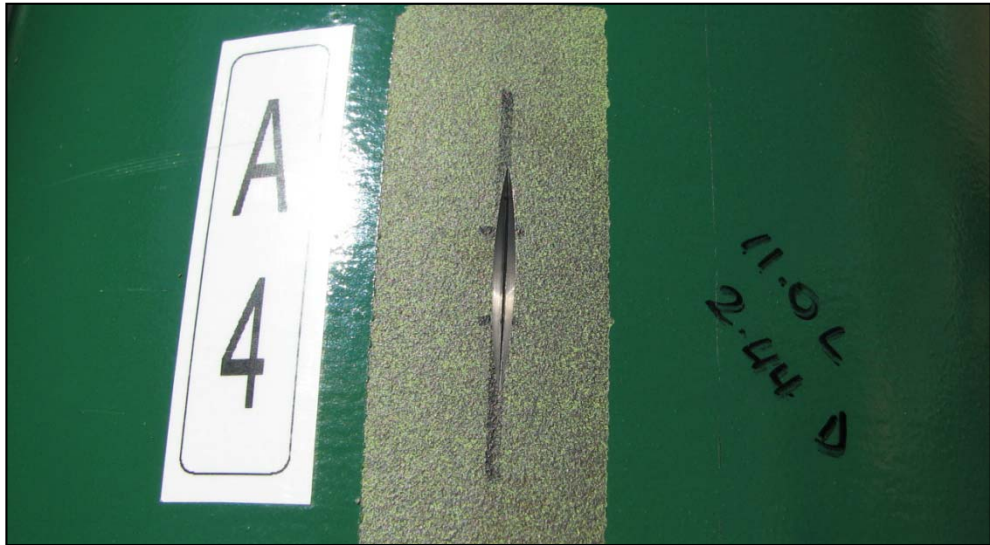
Figure A5: Flaw A4, after testing – failure by leaking

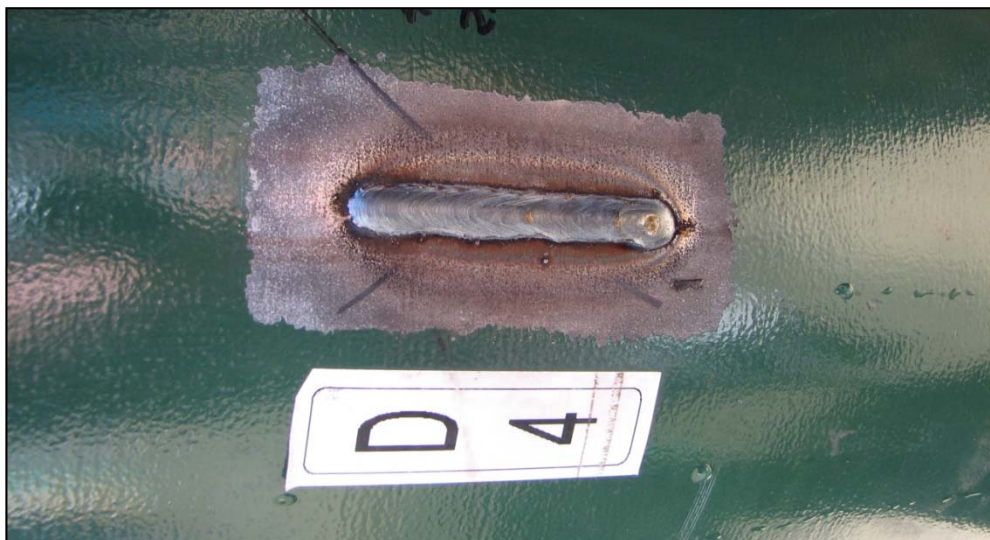
Figure A6: Flaw D4, after failure by leaking and over-welding in preparation for subsequent tests

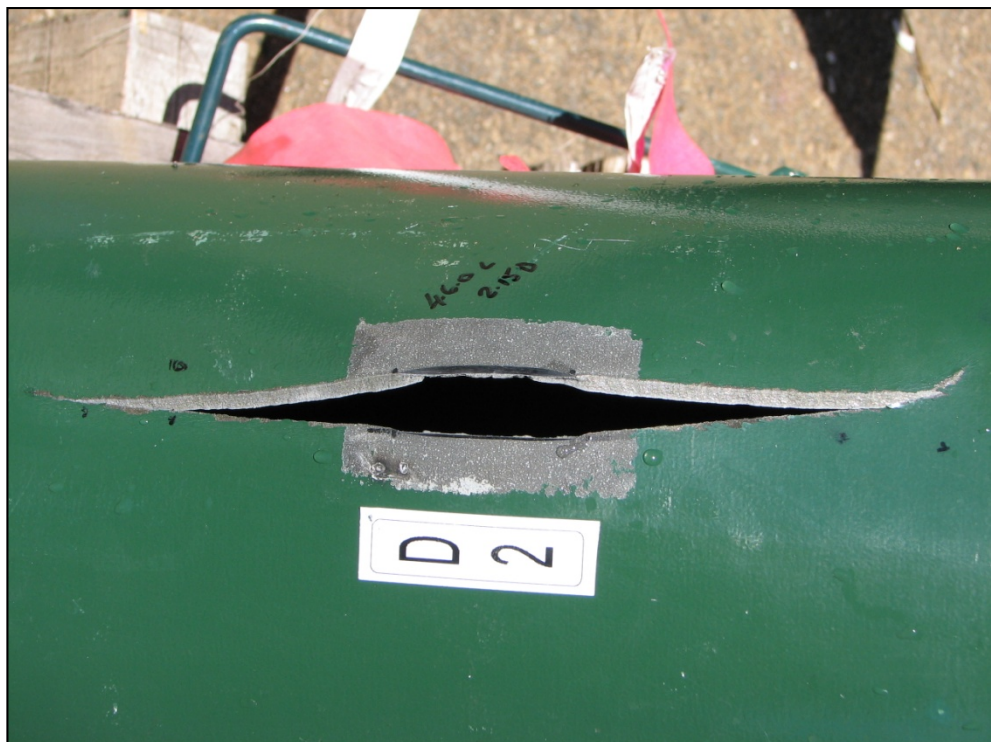
Figure A7: Flaw D2, after testing – failure by bursting (rupture)

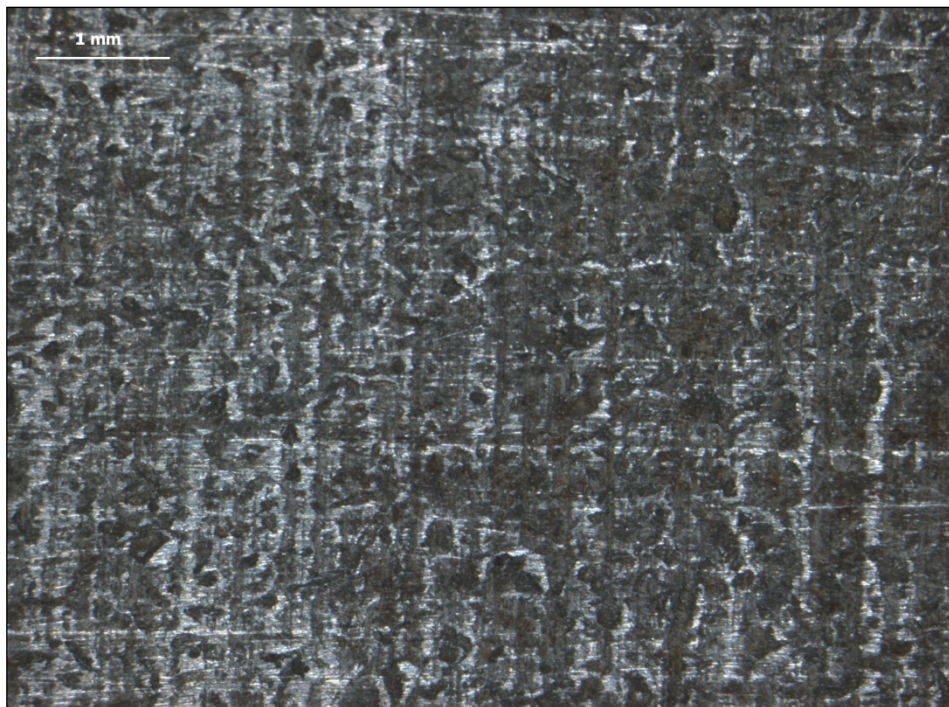
Figure B6: Magnified view of A-Gasol[®] sample shown in Figure B5, showing very minor general corrosion and discolouration

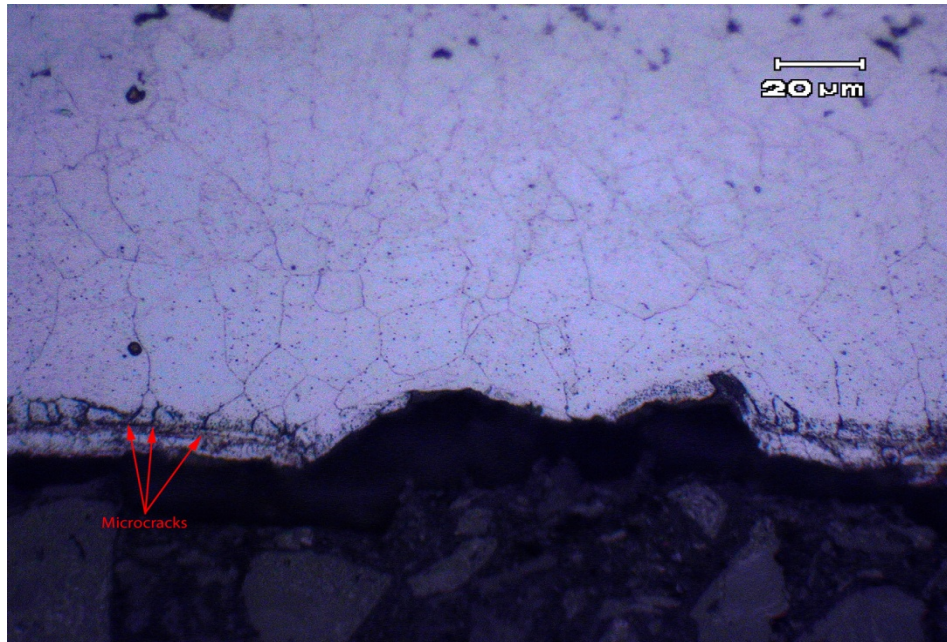
Figure B9: Magnified view of image in Figure B8, showing general corrosion and shallow grain-boundary penetrations
