Ground strike involving Ayres Corporation S2R-T15, VH-IWI

Trangie, New South Wales on 31 August 2022

ATSB Transport Safety Report

AO-2022-042

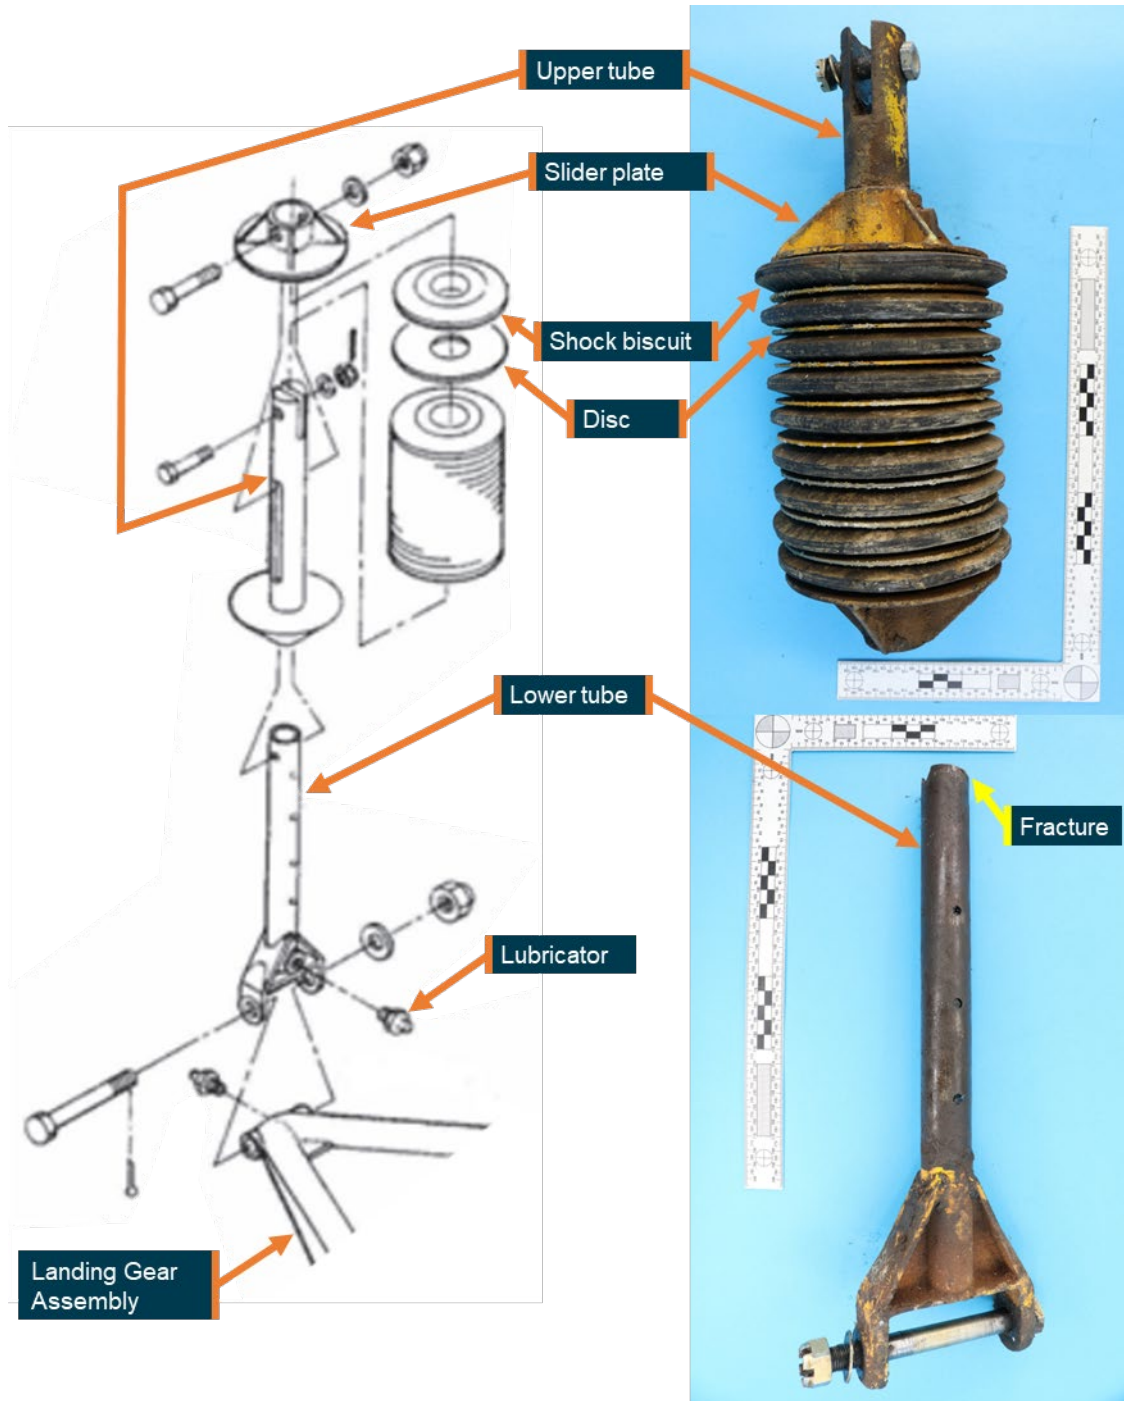
Figure 1: Left main landing gear shock strut assembly

Examination of the damaged main landing gear shock strut assembly was conducted at the ATSB's technical facilities. The overall condition of the assembly was aged, and the rubber shock biscuits were cracked (Figure 1).

Schematic and photo showing the main landing gear shock strut assembly with components labelled. The assembly was dirty and the shock biscuit exhibited cracks.
 Source: Thrush Aircraft (schematic), ATSB (photo and annotations)

The grease between the upper and lower tube was discoloured; however, there was fresh blue grease around the lubricator and within the lower tube near the point of fracture. A substantial amount of new grease appeared to have migrated out of the lower tube during the occurrence.

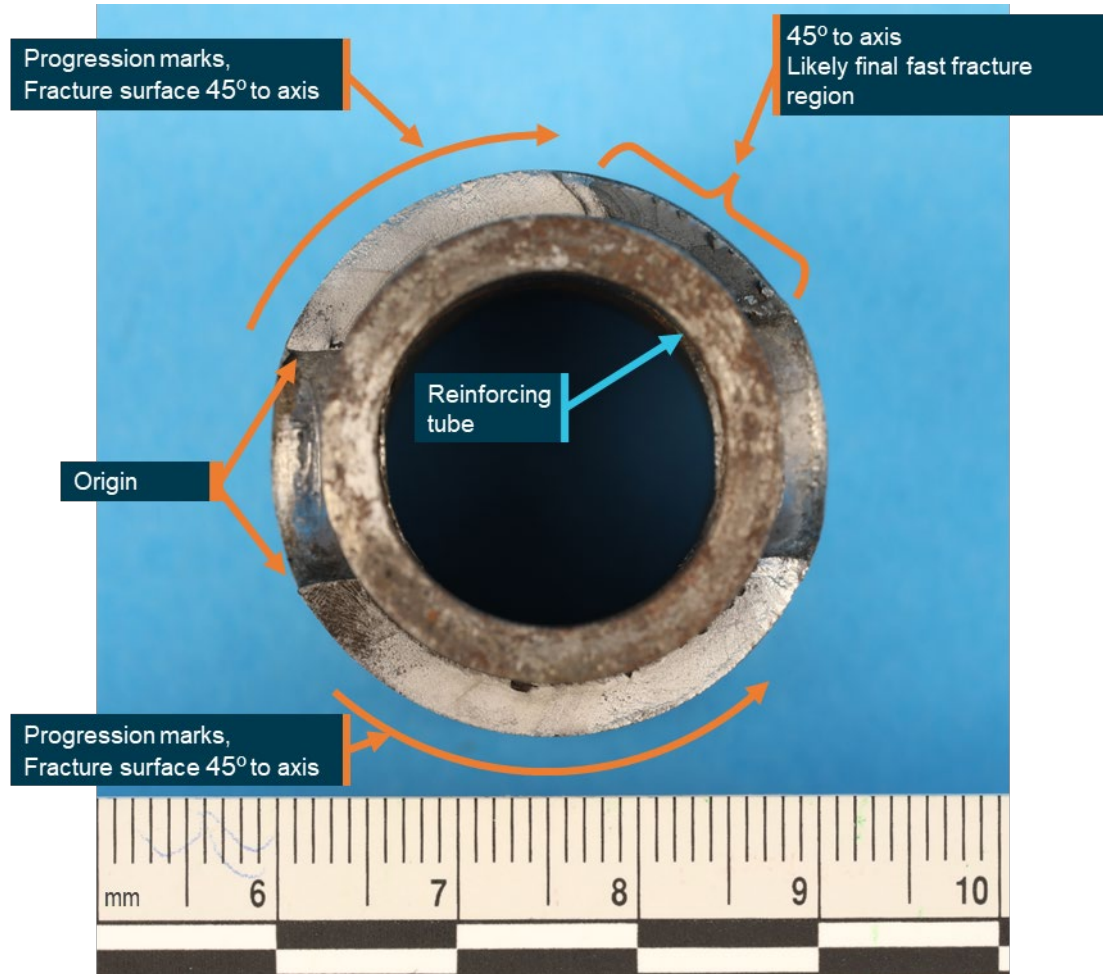
Figure 2: Fractured lower tube exhibiting characteristics of fatigue fracture followed by overstress

The left shock strut fractured at the hole where the lower steel tube attached to the slider plate (Figure 1). This allowed the bottom portion of the lower tube to separate from the remaining shock assembly. The fracture was consistent with fatigue cracking, followed by unstable crack growth and ductile overstress (Figure 2).

*Fracture surface exhibiting characteristic of fatigue cracking followed by overstress.
Source: ATSB*

The ATSB examination identified that the lower tube of the left shock strut assembly failed at a fatigue crack. The crack had initiated from the hole where the lower tube attached to the slider plate and propagated around the circumference of the tube. The final fracture most likely took place early in the take-off roll which led to the collapse of the left landing gear and the aircraft wing striking the ground.

- A fatigue crack initiated in the lower steel tube of the left shock assembly, located at the hole where the lower tube connected to the slider plate. The fatigue crack grew until there was a final overstress failure of the lower tube during the take-off roll.
- For reasons not identified, it was highly likely that the lower tube of the left landing gear shock assembly was not replaced or modified to comply with SB-AG-36, which was issued to prevent similar failures.

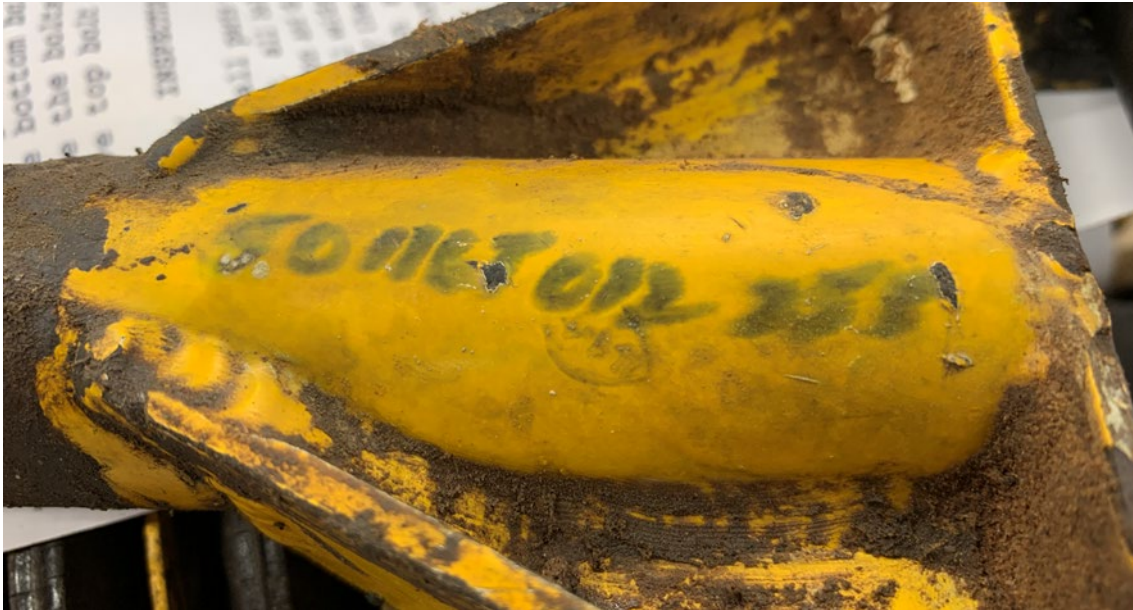
Figure 3: Marker writing on the lower tube

There was a handwritten marking on the side of the lower tube (Figure 3) which was identified as the characters '50116T012 25[?]', with an indistinct character at the end.

*Writing on the lower tube written in black marker. The characters are 50116T012 25[?].
Source: ATSB*

When asked about the writing on lower tube Thrush Aircraft informed the ATSB that first 5 characters represented a drawing number,⁶ the 3 numbers to the right of the 'T' identified the component on that drawing. The drawing number, together with the component identifier, was considered the 'part number' and these numbers, 50116-012, were consistent with the designation of the pre-1994 lower tube design. Thrush Aircraft suggested the final 3 digits might be an employee or serial number.

The dimensions of the reinforcing tube⁷ and the writing on the side of the part were most consistent with the original part, noting that there was no plug. This part was to be replaced or modified to comply with SB-AG-36. It was not possible to determine the exact age of the lower tube. It is very likely that this lower tube was manufactured prior to 1994 and would need to have been replaced or modified to comply with the service bulletin.
