Propulsion failure of *Portland Bay*

Off Port Kembla, New South Wales on 4 July 2022

ATSB Transport Safety Report

MO-2022-006

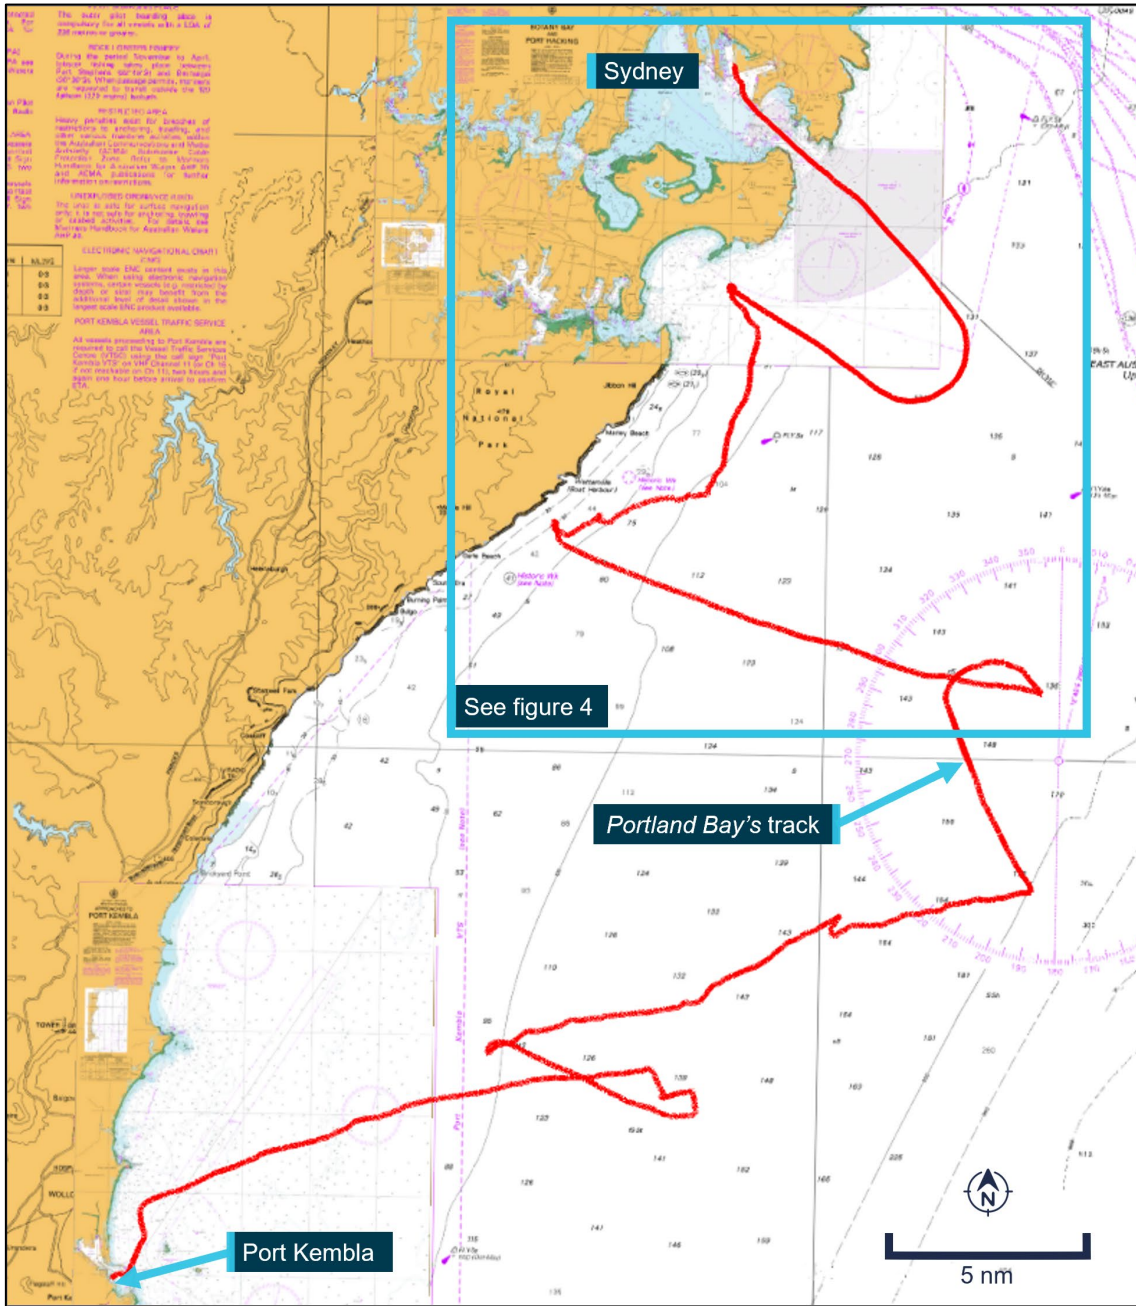
Figure 3: *Portland Bay's* movements from 3- 6 July

At 0917, when the ship was about 1 mile from the nearest coastline and in water depths of about 45 m (Figure 3 and Figure 4), the master anchored the ship, using both the anchors to arrest its drift towards the coast.
