# In-flight break-up involving Cessna 210N, VH-TFT

237 km east-north-east of Katherine, Northern Territory on 24 December 2022

**ATSB Transport Safety Report**

AO-2022-067

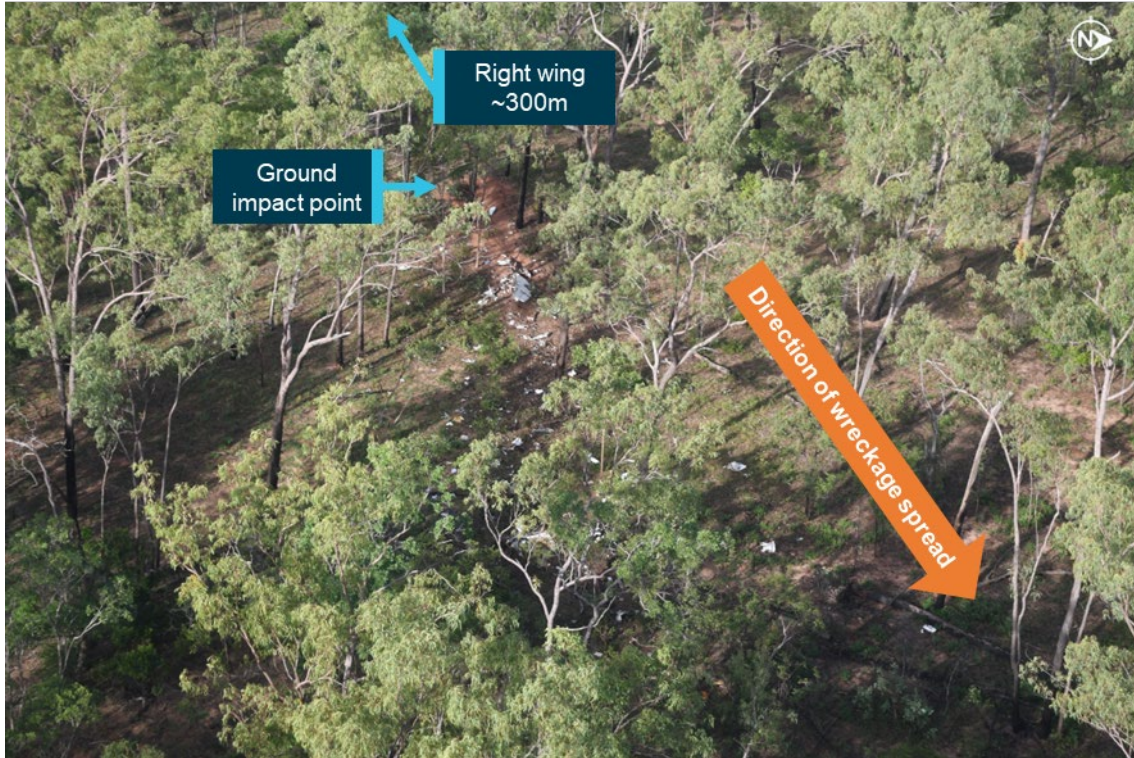
**Figure 2: Aerial view of the accident site showing the spread of wreckage**

- almost complete fragmentation of the aircraft structure had occurred on impact with trees and the terrain
- aircraft components were spread over a distance of 80 m from the primary ground contact point. The propeller, engine, left wing, carry-through structure, empennage, nose gear and cabin components were all identified in the wreckage trail

- the general orientation of the wreckage spread was in a north-east direction, opposite to the intended flight path to Katherine-Tindal
- all major sections of the aircraft's structure were accounted at the accident site

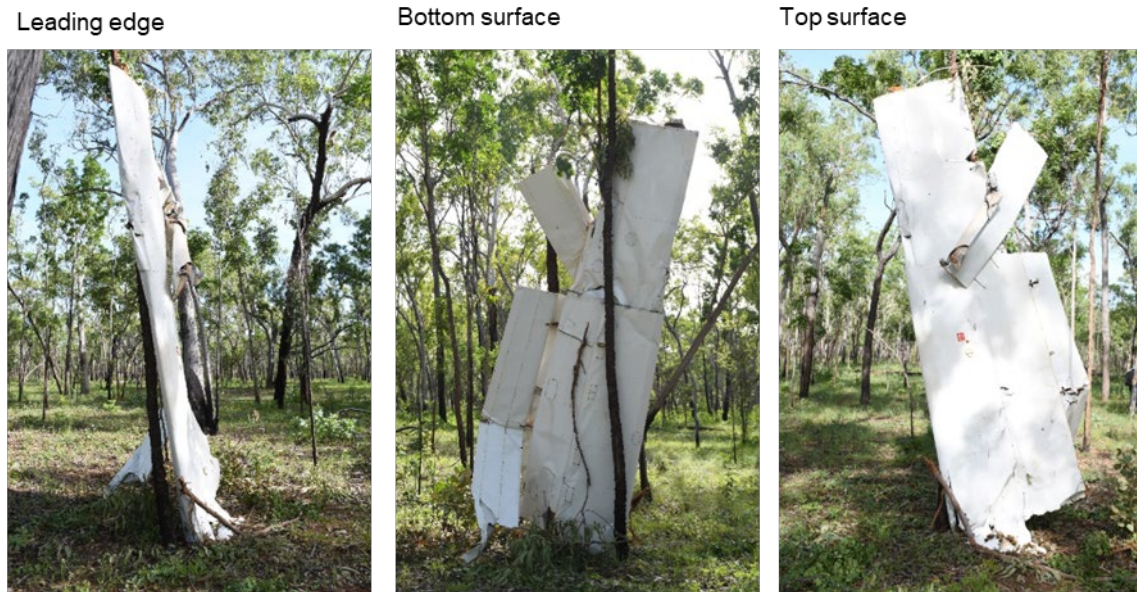
**Figure 3: As found position of the right wing approximately 300m from the main wreckage**

- the right wing and its wing tip (which was not attached to the wing) were the first major components in the wreckage trail
- the right wing was located approximately 300 m before the primary point of ground contact, indicating that it had separated from the aircraft fuselage during flight (Figure 3)

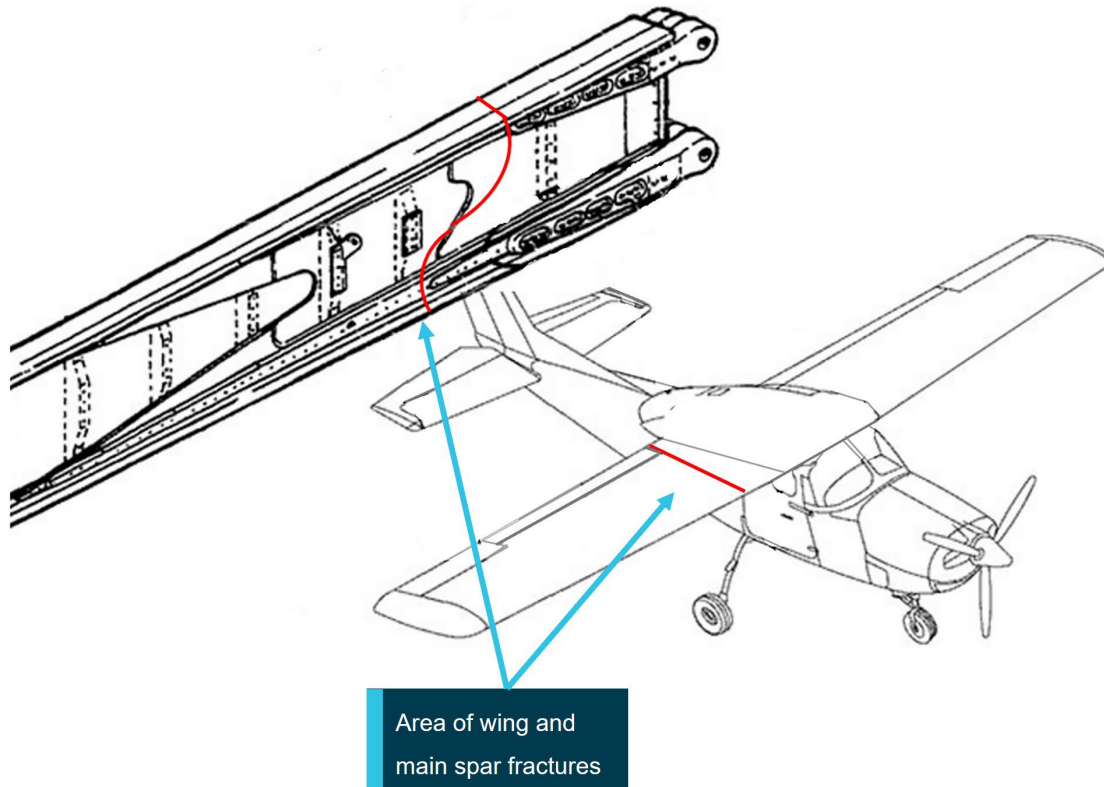
**Figure 4: Illustration of the Cessna 210 and the wing and main spar fracture location**

The right wing and its wing tip were the first items located in the wreckage trail. On-site examination of the main wing spar identified that it had fractured diagonally, about 30-60 cm from the inboard fuselage attachment points (Figure 4).

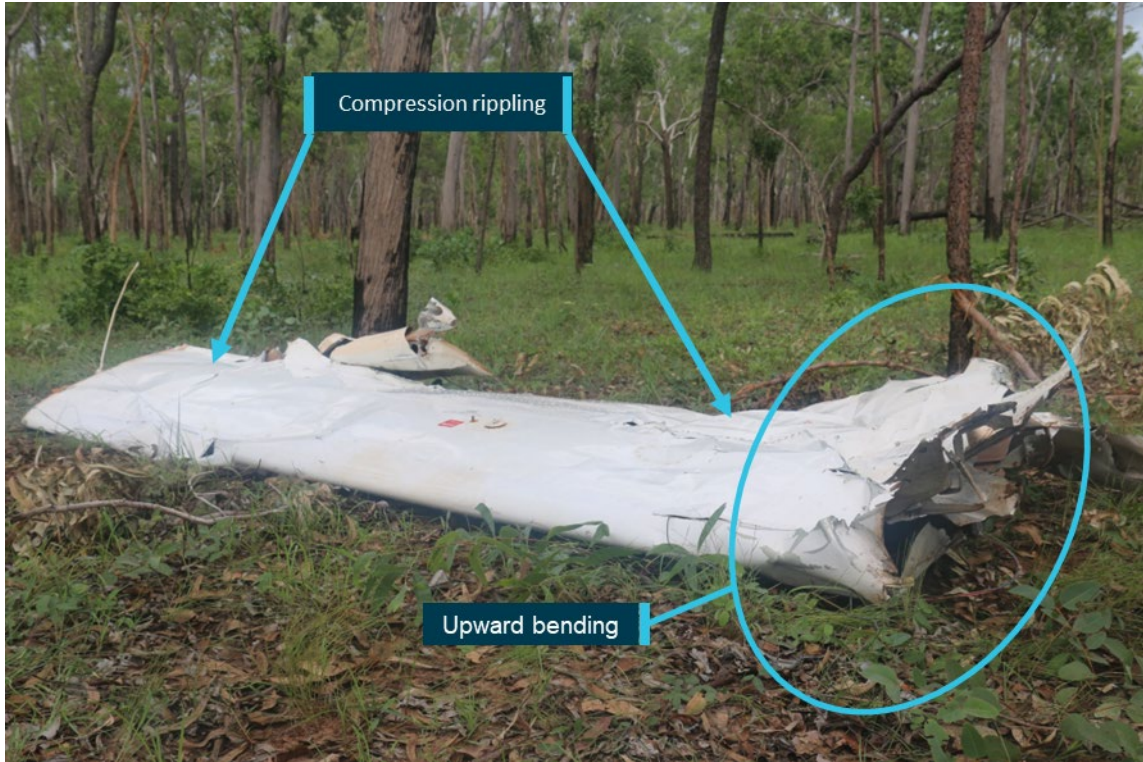
**Figure 5: Separated right wing assembly showing damage associated with significant upward bending forces**

Examination of the right wing showed extensive permanent deformation of the wing surface with associated compression rippling to the upper skin. The damage was indicative of substantial upward bending forces applied to the wing prior to its failure and separation from the aircraft (Figure 5).

The inboard end of the right wing-spar remained attached to the fuselage carry-through structure. The left wing remained attached to the carry-through and was located within the primary wreckage area. Examination of the fracture surfaces from the right wing-spar identified evidence of ductile overstress. The on-site assessment did not identify any regions of fatigue cracking or other pre-existing damage that might have weakened the spar caps, straps, or web.

The outboard tip section from the right wing was found about 70 m from the right wing. Black contact marks on the tip surfaces indicated that the outboard tip impacted the rubberised leading-edge protection on the tail during the break-up sequence.

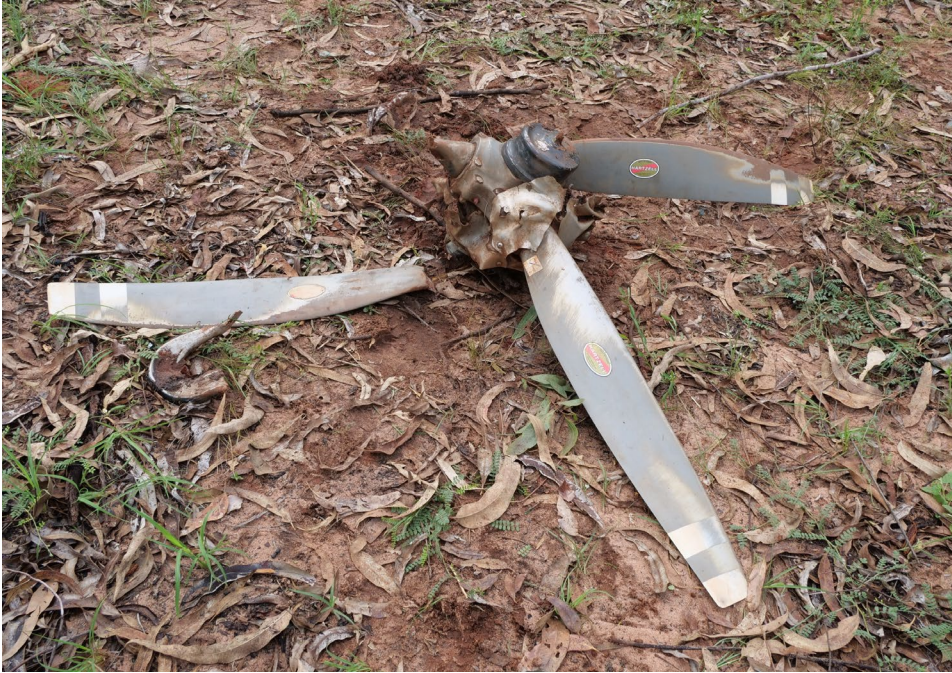
**Figure 6: Propeller assembly as removed from the ground impact crater**

On-site inspection of the propeller identified that the propeller hub had separated from the engine crankshaft due to overstress fracture under predominantly bending loads. One propeller blade had fractured from the hub at its base. All of the blades had sustained forward bending and rotational abrasion damage. One of the blades displayed chordwise twisting and compound bending. The damage signatures indicated that the engine was likely to have been driving the propeller with significant power when the aircraft collided with terrain.

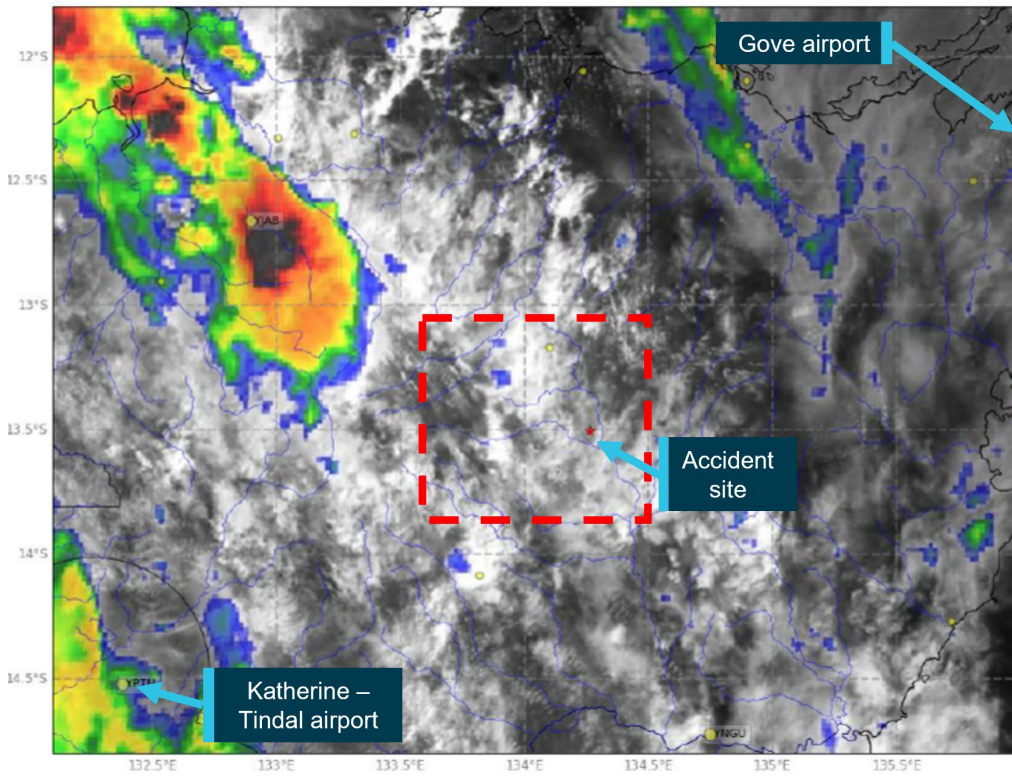
**Figure 7: Weather satellite imagery showing cloud and convective activity over the region of the accident site at 0900. Subsequent changes in convective activity (within the boxed region) are further highlighted in Figure 8**

BoM analysis of satellite imagery<sup>1</sup> indicated that on the morning of 24 December 2022, convective cloud started to develop along the expected flight path of the aircraft, near to the accident site. At around 0900, the cloud development strengthened into thunderstorms, with the first observations of lightning recorded between 0940 and 0950. The satellite imagery in the vicinity of the accident site is shown in Figure 7 and Figure 8. That imagery showed the formation of a thunderstorm near to the accident site from about 0910 and its progression through to 1000. The system persisted for several hours after that initial formation.

The BoM further advised in their analysis of the weather conditions that a thunderstorm could result in severe turbulence, severe icing and wind shear with outflows of strong and gusty winds, not only in the immediate vicinity but also at some distance away from the storm. An automated weather station at Bulman, approximately 20 km to the south of the accident site, recorded 12.4 mm of rainfall between 0930 and 1030 that morning.

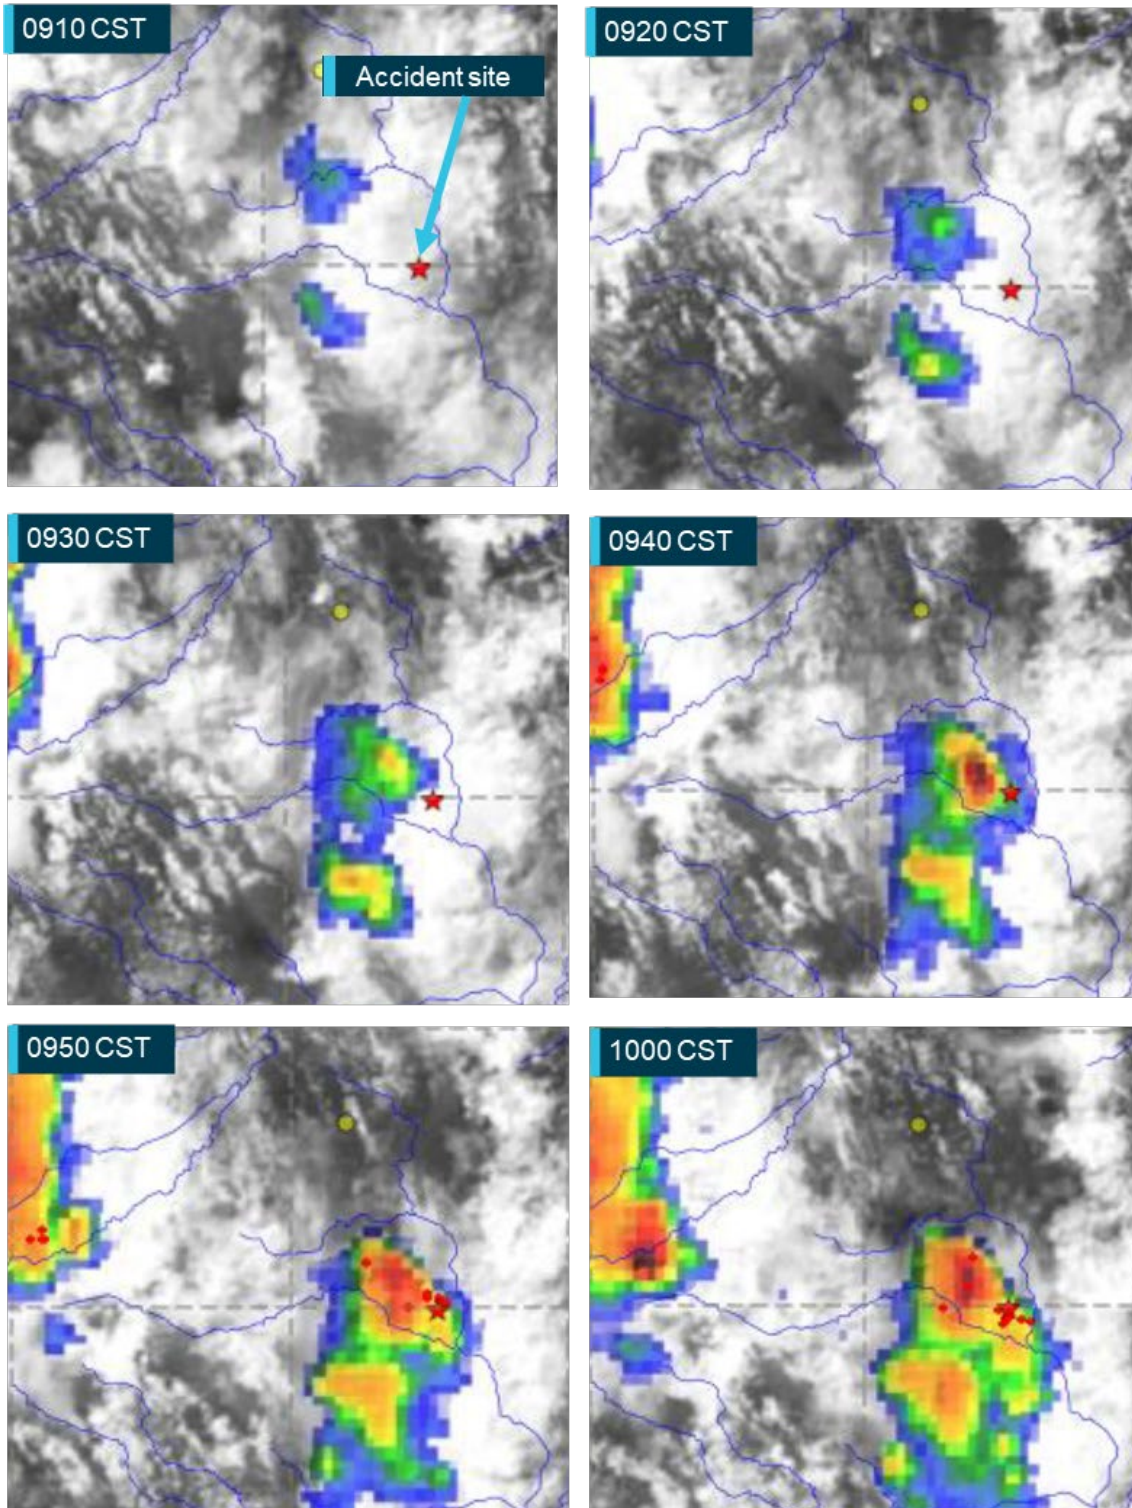
**Figure 8: Close-up montage of satellite imagery and convective activity overhead the accident site from 0910 to 1000**

Red dots in the above images at 0940 Central Standard Time (CST), 0950 CST and 1000 CST are recorded lightning strikes. The accident site is represented by a red star.  
Source: Bureau of Meteorology, annotated by the ATSB
