Collision with terrain involving Boeing Company 737-3H4, N619SW

Fitzgerald River National Park, Western Australia on 6 February 2023

ATSB Transport Safety Report

AO-2023-008

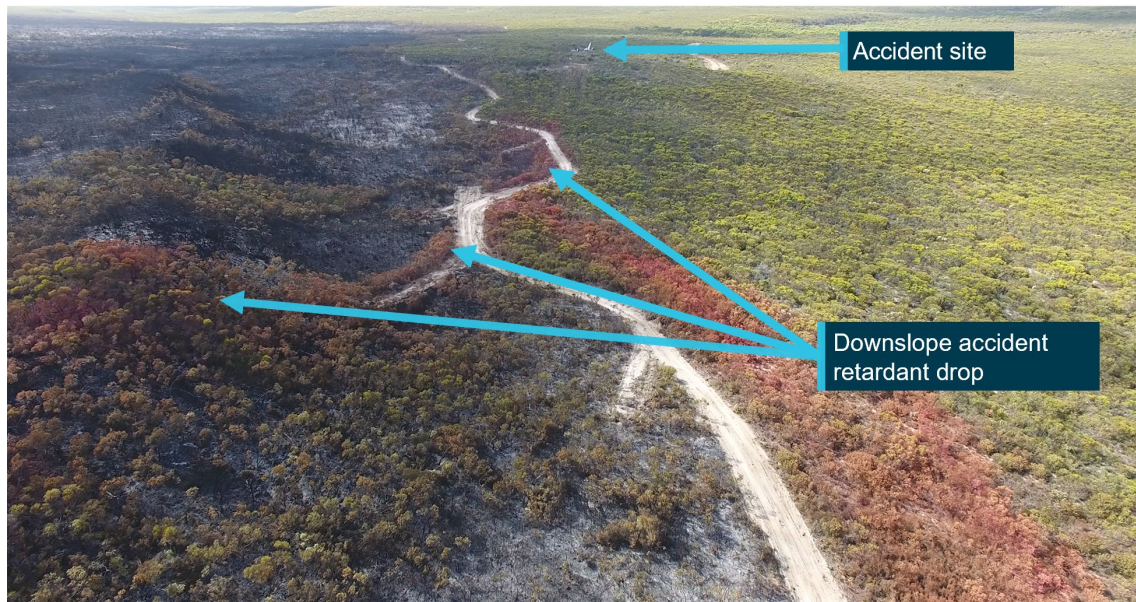
Figure 2: Accident retardant drop

During the second drop, Bomber 139 descended through 400 ft altitude (80 ft radio height) at about 110 kt computed airspeed⁸ and 30% N1 (engines at high idle)⁹ as the retardant line was extended downslope (Figure 2). The captain started to advance the throttle levers about 2 seconds before the aircraft's rate of descent peaked at about 1,800 ft/min and started to pitch the nose up.

The nose up pitch preceded the acceleration of the engines, resulting in a reversal of the rate of descent, but also a decay of the airspeed. The captain then announced 'fly airplane' followed immediately, at about 1614,¹⁰ by the activation of the stick shaker¹¹ and an abrupt vertical acceleration associated with the aircraft impacting a ridgeline at an elevation of about 222 ft at 104 kt computed airspeed with the engines at 85-89% N1.

Following the accident, Coulson Aviation issued operations bulletin 2023-01 advising their large air tanker pilots operating in Australia that their minimum retardant drop heights and V_{DROP} airspeeds had been increased from 150 ft above ground level and $1.25 V_S$ to 200 ft above ground

level and 1.35 V_s . Their B-737 normal checklist was amended accordingly to reflect their new minimum V_{DROP} airspeeds.

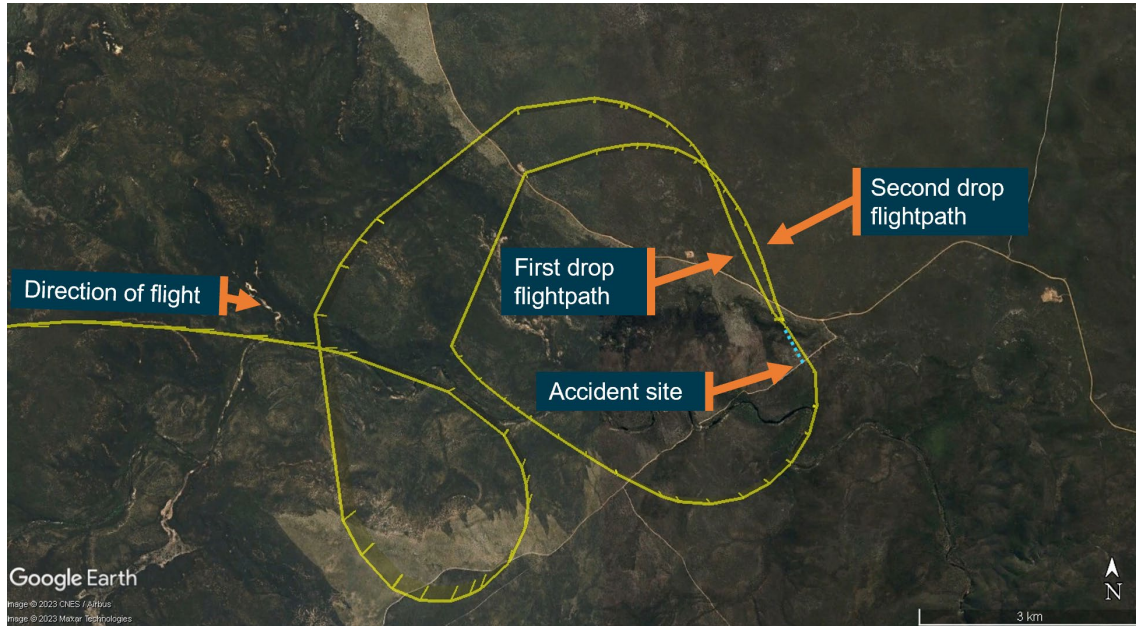
Figure 3: Bomber 139 recorded flightpath at Fitzgerald River National Park

The captain observed out of the left side window that a post-impact fire had started and managed to open that window on their second attempt. Both pilots then exited out of the left window and moved clear of the wreckage and fire. They were subsequently rescued by a helicopter involved in the fire control activities after 2 single-engine air tankers had dropped retardant on the aircraft fire believing the crew were still inside. The crew suffered minor injuries and the aircraft was destroyed. Figure 3 depicts Bomber 139's recorded flightpath at Fitzgerald River National Park.

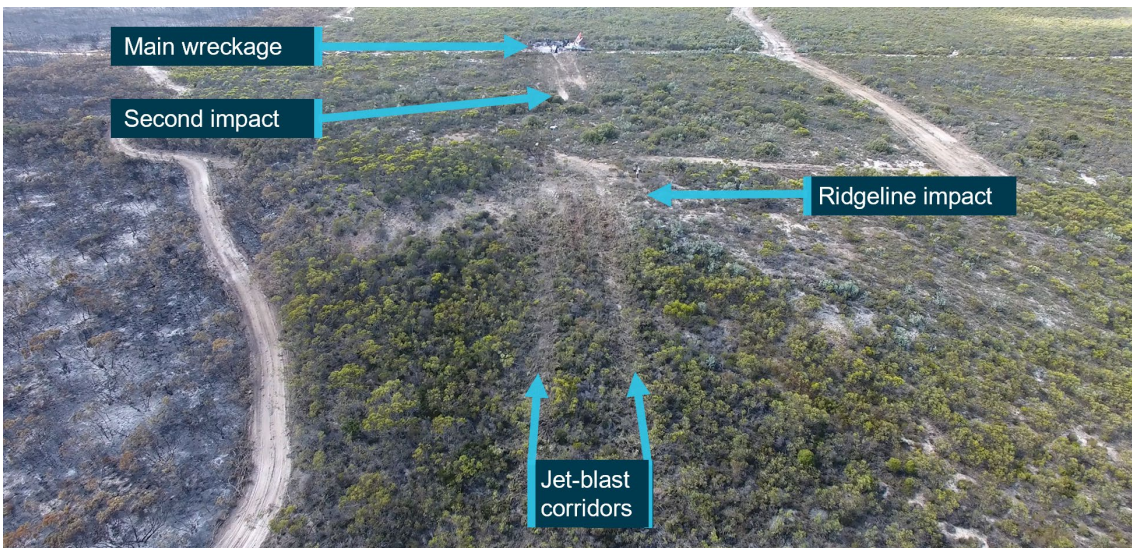
Figure 4: Jet-blast corridors and ridgeline impact

The aircraft’s approach to the ridgeline left 2, distinct jet-blast lines evidenced by trees broken in the opposite direction of travel (Figure 4). Closer to the ridgeline trees were broken in the direction of travel, likely from contact with the aircraft’s engines and airframe with evidence of retardant transfer from the airframe to the foliage just below the ridgeline. The length of the jet-blast lines were about 74 m and 62 m respectively for the left and right engines. After contacting the ridgeline, the aircraft became airborne for about 69 m, shedding engine, wing, and fuselage debris before impacting a second time in a slight nose down attitude on a heading of about 140°.

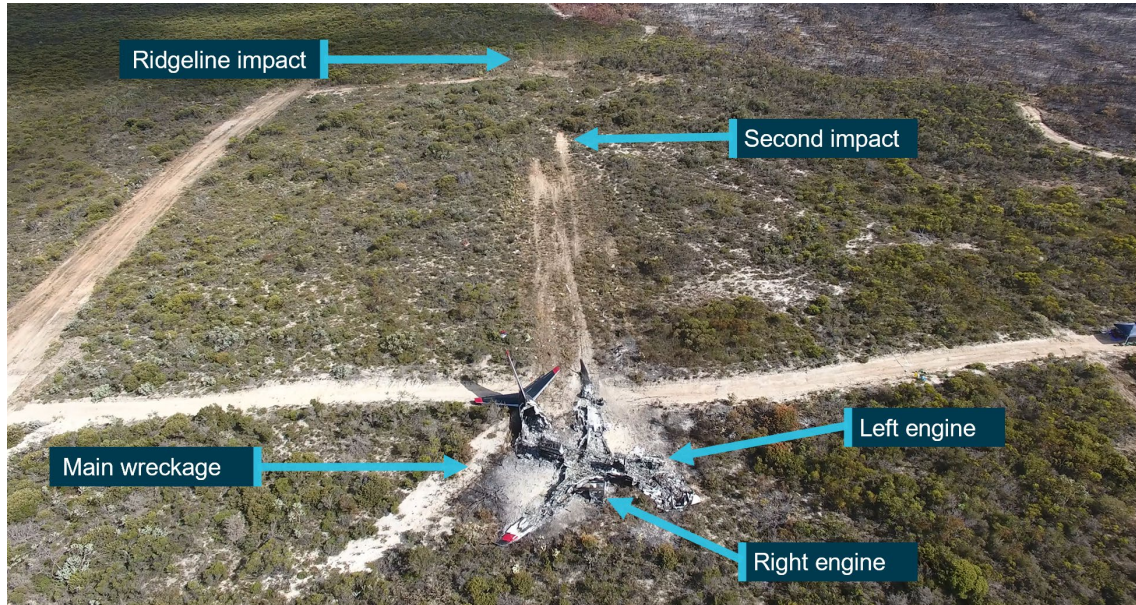
Figure 5: Second impact and main wreckage

The aircraft came to rest about 176 m from the ridgeline yawed left to the direction of travel onto a heading of about 080°. The fuselage had a main fracture near the tail and the left engine had separated from the left pylon and was resting adjacent to the forward fuselage (Figure 5). The left engine pylon exhibited a 70° upward bend, which was likely from the impact with the ridgeline, noting the left engine debris field started from the ridgeline and there was no evidence of left engine drag marks. The aircraft was consumed by fire, but there was no evidence of:

- fire trail¹⁵ or fuel spill before the aircraft came to rest
- any debris separating from the aircraft before it impacted the ridgeline.

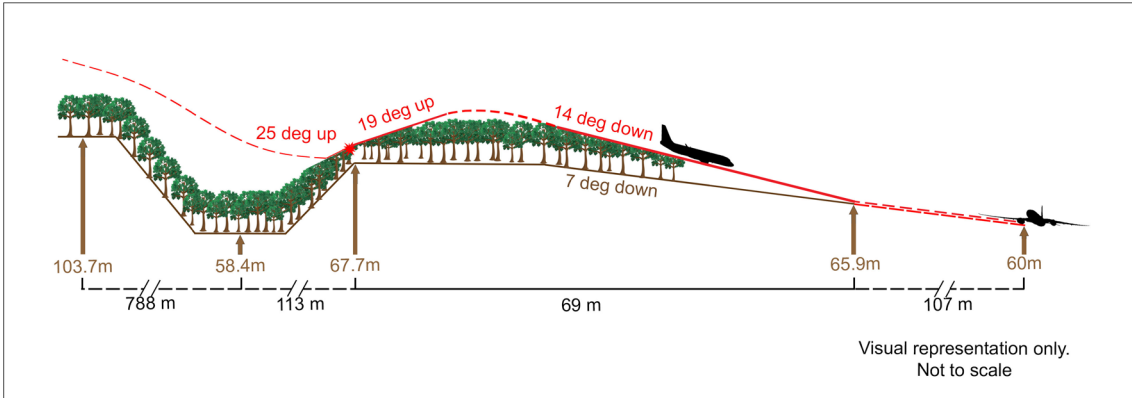
Figure 6: Accident sequence distances and elevations

The left main landing gear was found adjacent to the aircraft and part of its support structure was in the debris field indicating it was torn from the aircraft prior to it coming to rest. The nose and right main landing gear were retracted in place. The extent of the fire damage precluded an inspection of the cockpit and flight instruments. Figure 6 depicts the horizontal distances and elevations (measured with a differential global positioning system), and the angles presented by the foliage damage associated with the accident sequence.

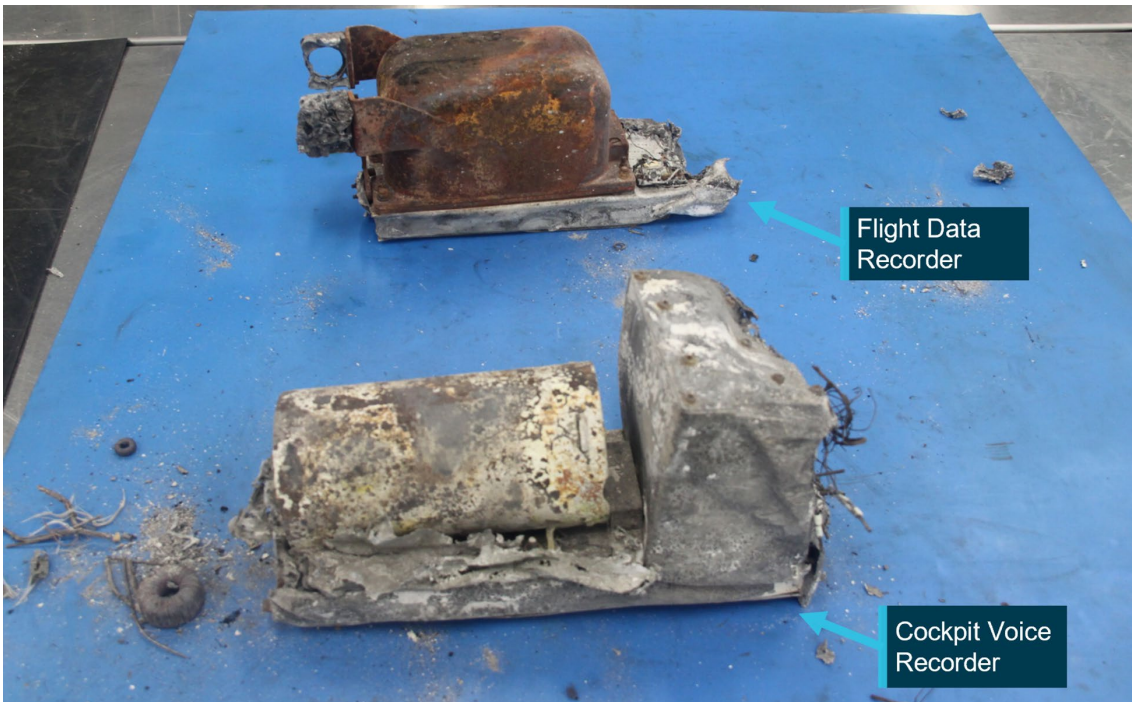
Figure 7: FDR and CVR as recovered and prior to disassembly

The CVR (Honeywell SSCVR P/N 980-6022-001) and FDR (Honeywell SSFDR P/N 980-4700-001) were transported by a recorder specialist from the accident site to the ATSB's Canberra technical facility (Figure 7).

As a result of fire damage to the recorders the data recovery process required disassembly, inspection, and repair of the memory boards inside the crash survivable memory unit. The FDR memory board exhibited discoloration, melting and flow of the conformal coating with multiple controller pins desoldered.

The CVR exhibited discoloration of the heat indicator, several controller pins had separated from the memory board and multiple short-circuits were identified. Following repairs to both memory boards, successful downloads of data were achieved. The FDR provided 25.5 hours of flight data and the CVR 30 minutes of audio on 4 channels (pilot, co-pilot, public address, and cockpit area microphone). A preliminary flight data recorder plot with the first and second drops is shown at

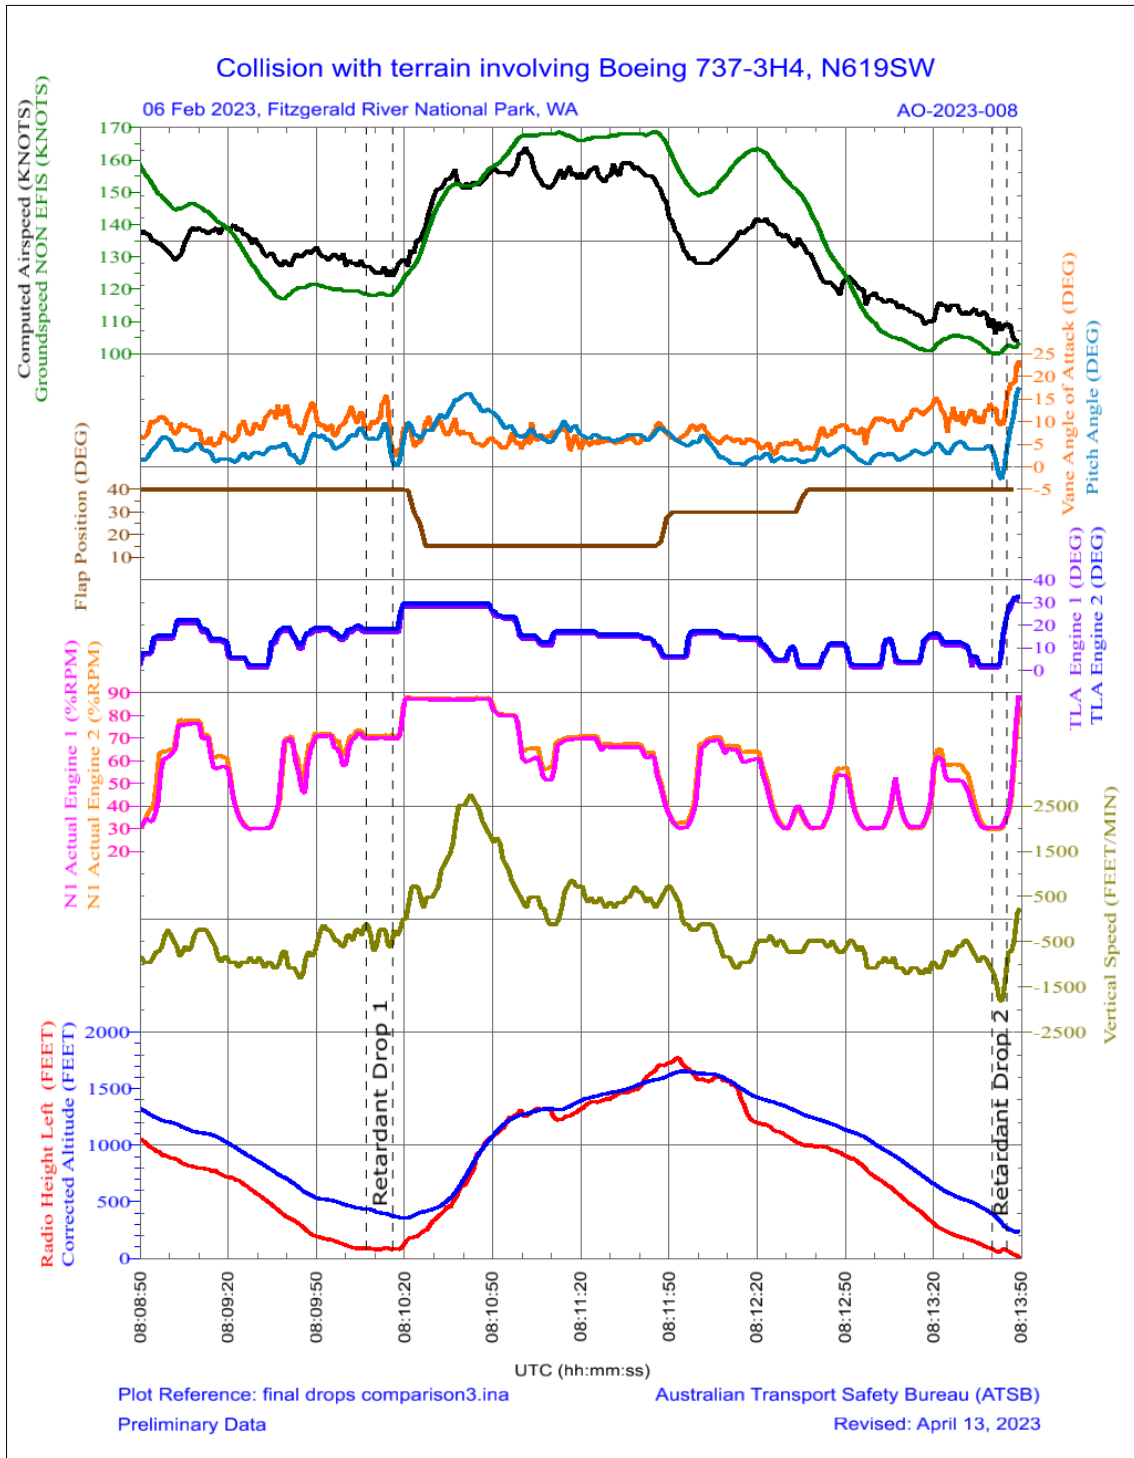
Figure 8: Flight data recorder plot with first and second retardant drop identified

Figure 8. The time parameter (UTC)¹⁶ is an approximate calculation based on the aircraft's auxiliary telemetry unit (ATU) global positioning system recording of the retardant drops.

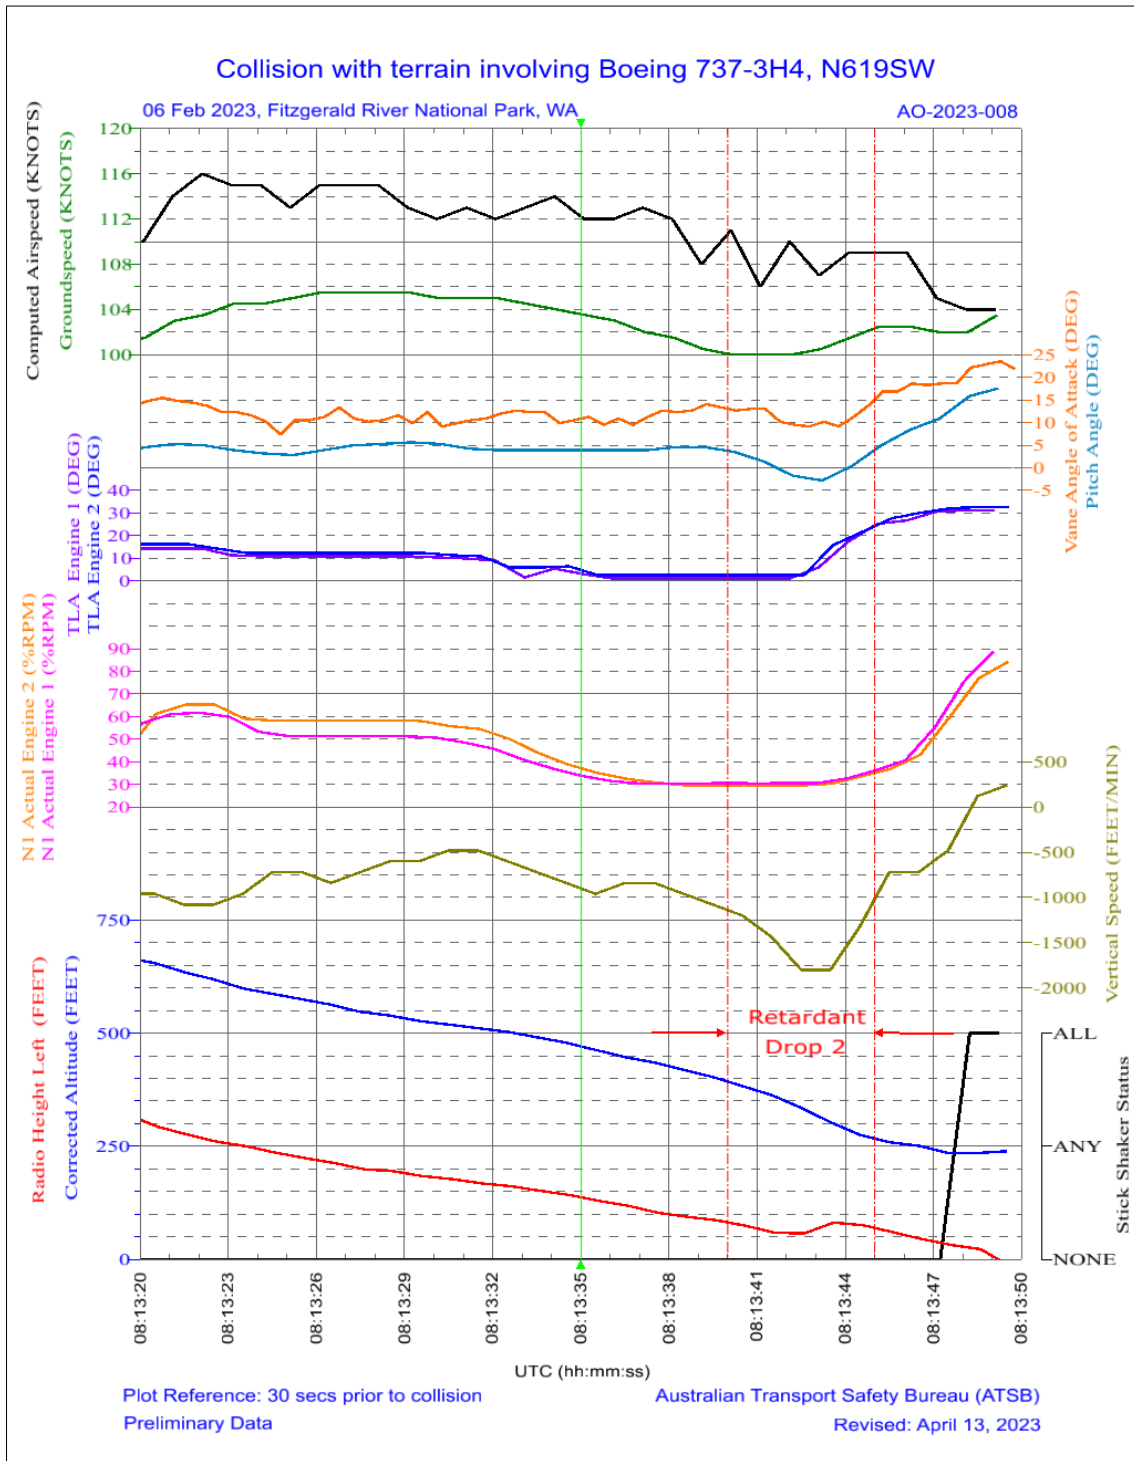
Figure 9: Flight data recorder plot of final 30 seconds

During the final low-level retardant drop the throttle levers (TLA) were positioned at high idle (0°) while at a radio height above the ground of less than 100 ft. As the engine N1 speed decreased to about 30%, the rate of descent increased to 1,800 ft/min before the thrust levers were advanced while the aircraft continued to descend. About 2 seconds prior to impact, at a radio altitude of about 28 ft with the flaps at 40°, an increasing aircraft nose-up pitch attitude resulted in the vane angle of attack exceeding 20°, which triggered the stick shaker. The aircraft only attained a positive rate of climb just before impact with terrain. Figure 9 provides a plot of the final 30 seconds before the impact with the ridgeline with the approximate position of the accident retardant drop inserted.

Final 30 seconds of flight data showing corrected altitude, radio height, pitch angle, angle of attack (same scale), throttle lever angle, engine N1 speed, computed airspeed, groundspeed, vertical speed, stick shaker and approximate position of the retardant drop.
 Source: ATSB
