# Collision involving the bulk carrier *Goliath* and tugs *York Cove* and *Campbell Cove*

Devonport, Tasmania on 28 January 2022

**ATSB Transport Safety Report**

MO-2022-002

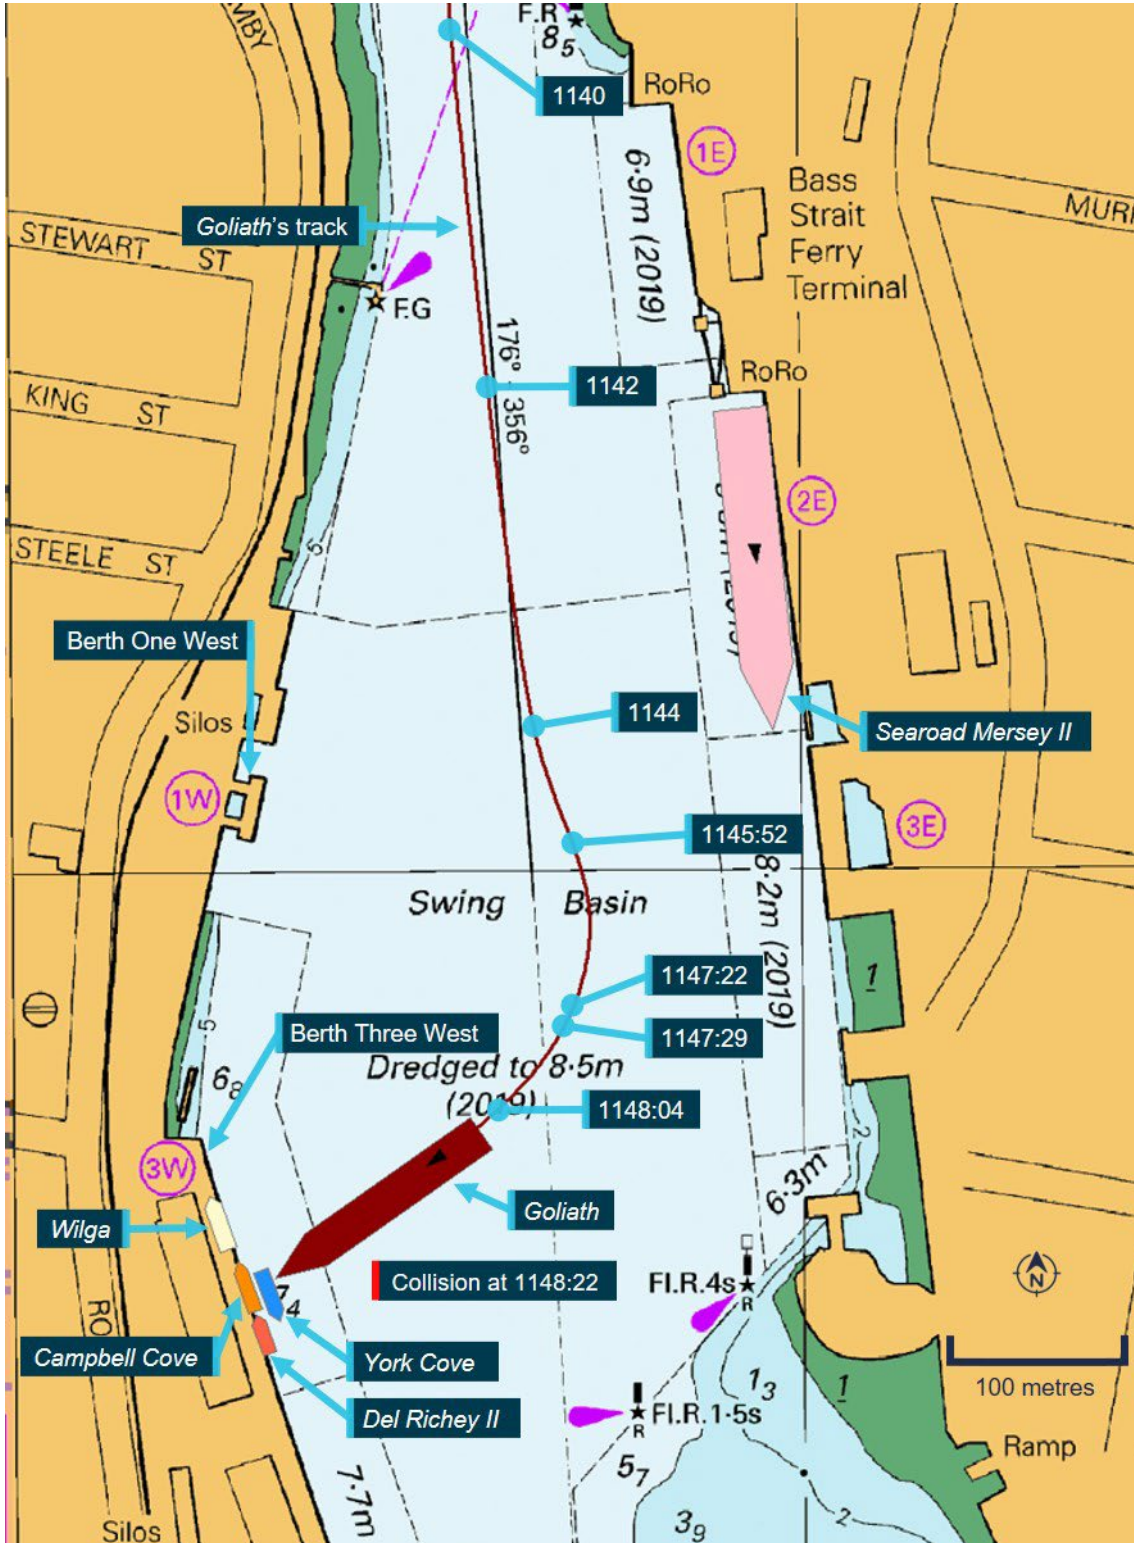
**Figure 6: Section of chart Aus 164 showing Goliath's track and sequence of collision**

As the manoeuvre progressed, the master felt that the ship was not swinging as expected and was closing with 2 tugs, which were moored at berth number Three West ahead. In an effort to

With the ship's speed still increasing, the master checked the rudder angle indicator located in front of the port wing console and then observed that both rudders were still amidships and not at the angles corresponding to the VecTwin joystick setting as expected. The master called out to the second mate that the steering was not in VecTwin steering mode and immediately brought the engine telegraph to 'slow ahead' and then to 'stop'.

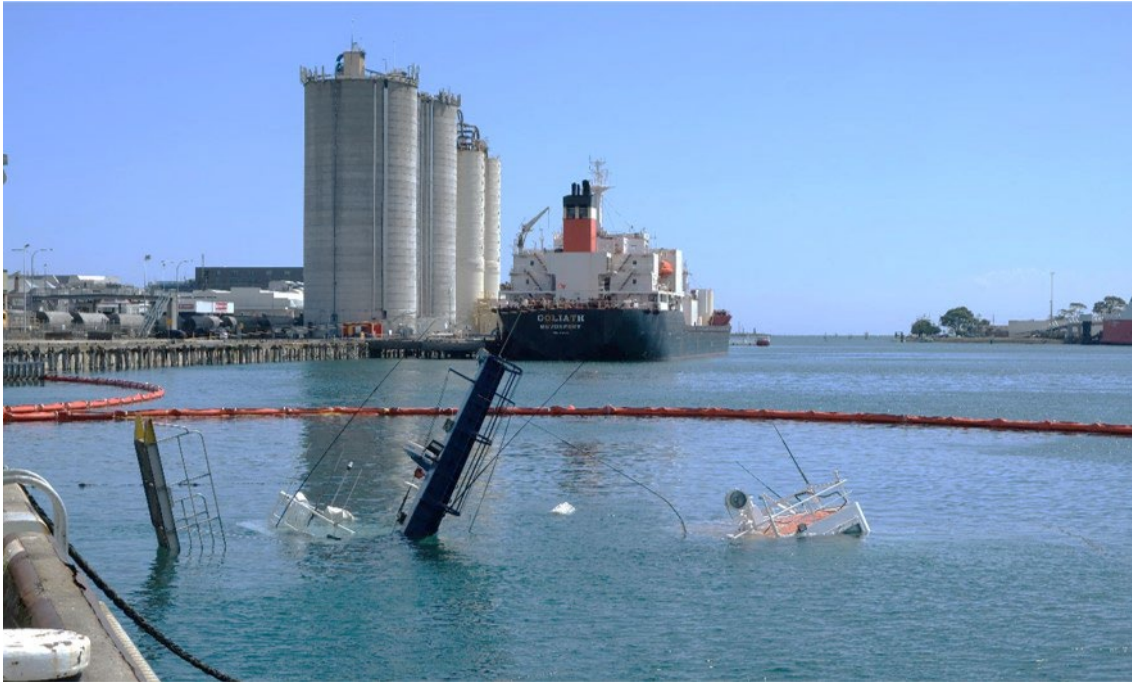
**Figure 9: The submerged York Cove and Campbell Cove**

Both *York Cove* and *Campbell Cove* were declared constructive total losses. On 11 March 2022, United Salvage were awarded the tender for removal of the wrecks of the sunken tugs. In July 2022, the heavy-lift ship *AAL Melbourne* was engaged to lift and remove the tugs' wrecks. The ship arrived in Devonport on 7 August and recovered *York Cove*'s wreck (Figure 10). *Campbell Cove*'s wreck was also recovered by 12 August. During the recovery operation, an unknown quantity of oil escaped the containment area although EPA surveys of the shoreline and water did not detect any affected wildlife. *AAL Melbourne* departed Devonport on 16 August for Brisbane, Queensland where the tugs were to be scrapped (recycled).

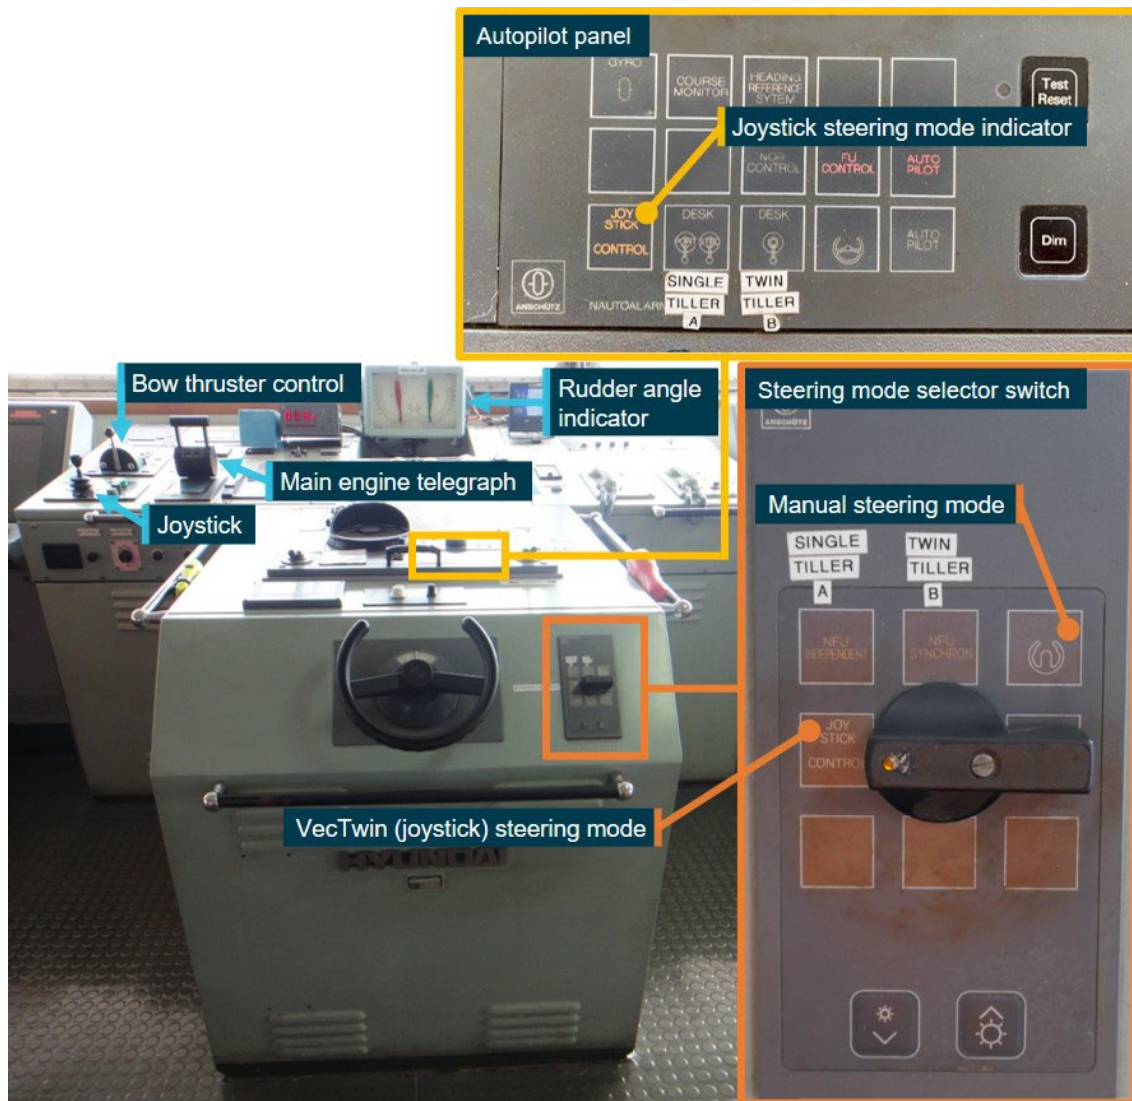
**Figure 11: Goliath's wheelhouse, steering console, and steering mode selector switch**

On board *Goliath*, the second mate had run into the wheelhouse, checked the steering mode selector switch on the steering console and realised that it was still in manual steering mode. The second mate immediately switched it over to VecTwin (joystick) steering mode while the master placed the engine at 'half astern' followed by 'full astern' and, by 1148:31, at 'emergency astern'.
