# Derailment of freight train 82P7 and subsequent collision with coal train 9F02

near Marmor, Queensland, on 29 January 2023

**ATSB Transport Safety Report**  
Rail Occurrence Investigation (Short)  
RO-2023-001  
Preliminary – 6 April 2023

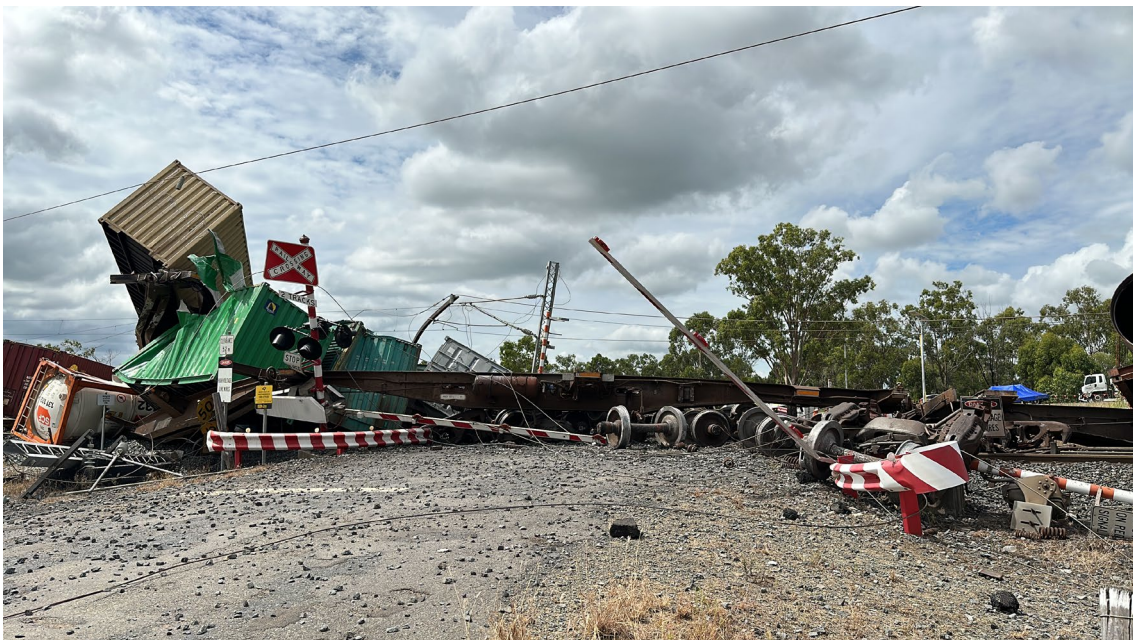
**Figure 1: Main wreckage site of train 82P7**

As the train had approached the level crossing, the driver applied the throttle. The driver reported that the train did not respond as expected and noted a slight drag. The driver stated they checked the locomotive mirrors, noticed sparks coming from the train, and subsequently the emergency brake applied. At 1910:33, as the train was slowing, the driver broadcast an emergency call over the ultra-high frequency (UHF) radio. The train stopped about 1,113 m from the point of derailment. Several multi-pack wagons from train 82P7 had derailed, significantly damaging points, crossings, level crossing equipment, and overhead wiring stanchions (Figure 1).

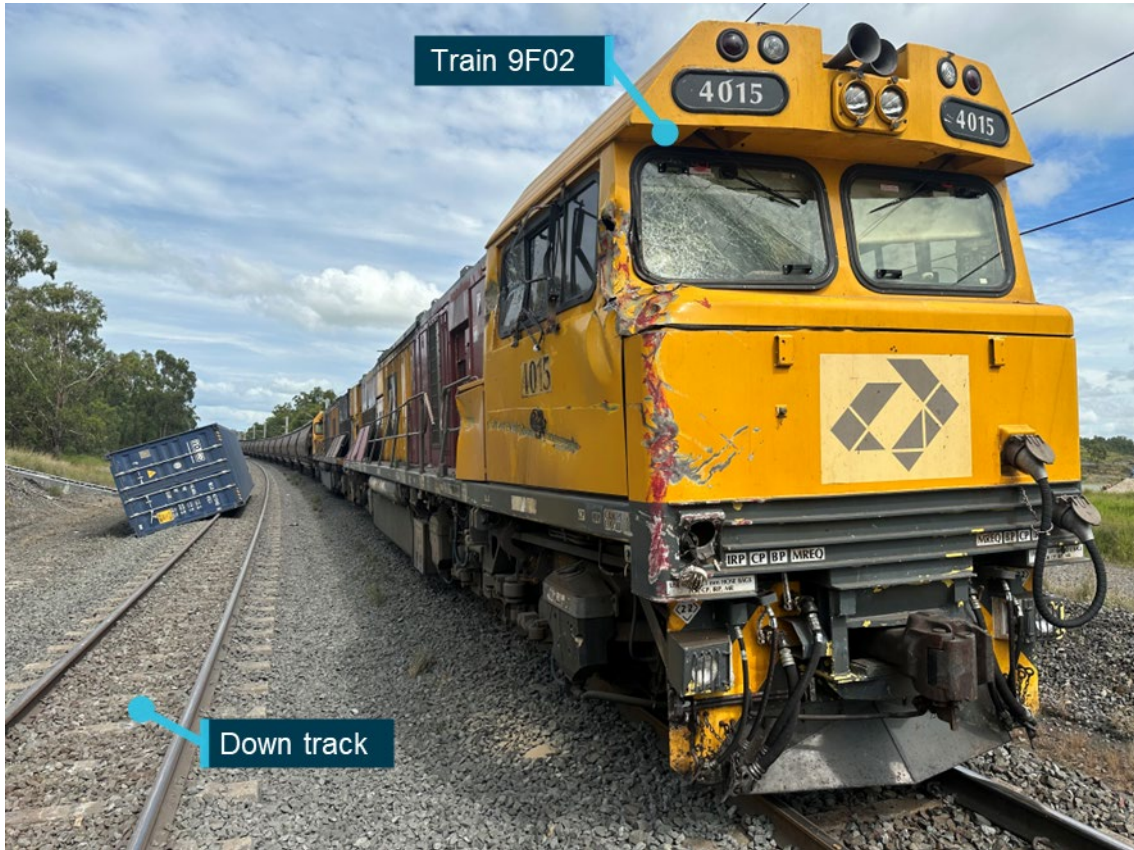
**Figure 2: Damage to leading locomotive of train 9F02**

Train 9F02 sustained significant impact damage to the driver's side of the cabin. Skidding impact damage was also evident along the side of the train (Figure 2).

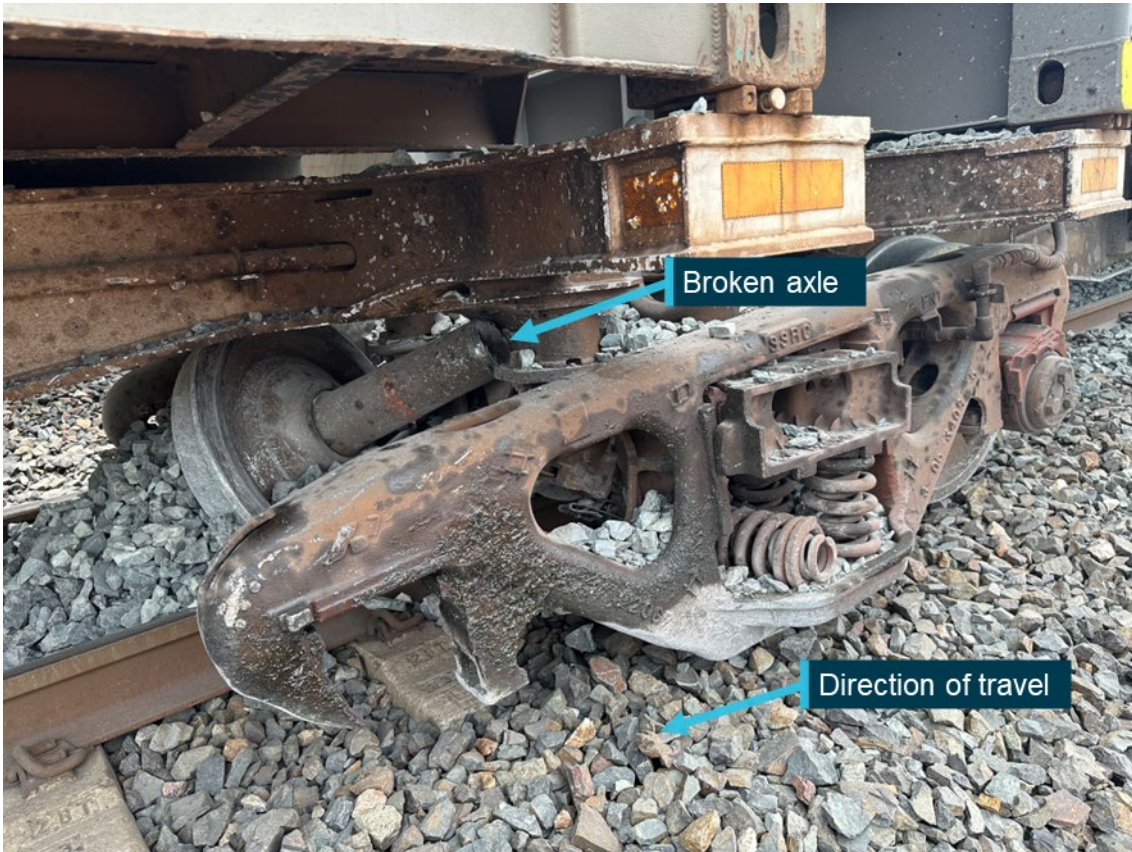
**Figure 3: Damaged bogie showing half of the fractured axle half in-situ**

During on-site inspections, the ATSB found an axle from the sixth wagon (RNCY137-T) had fractured (Figure 3). This evidence correlated with rail wheel field-side<sup>2</sup> marks found on the rail head, identified as the point of derailment. The marks commenced on the field-side of the rail head and ran inwards towards the rail gauge face between both rails (Figure 4). There was no other evidence of derailment found on the approach to the point of derailment.
