Report No 157

Navigation (Marine Casualty) Regulations
Report of the investigation into
the contact between the Maltese flag bulk cargo vessel
Amarantos
and the wharf at
Wallaroo in South Australia
on 10 April 2000

Issued by the
Australian Transport Safety Bureau
December 2000

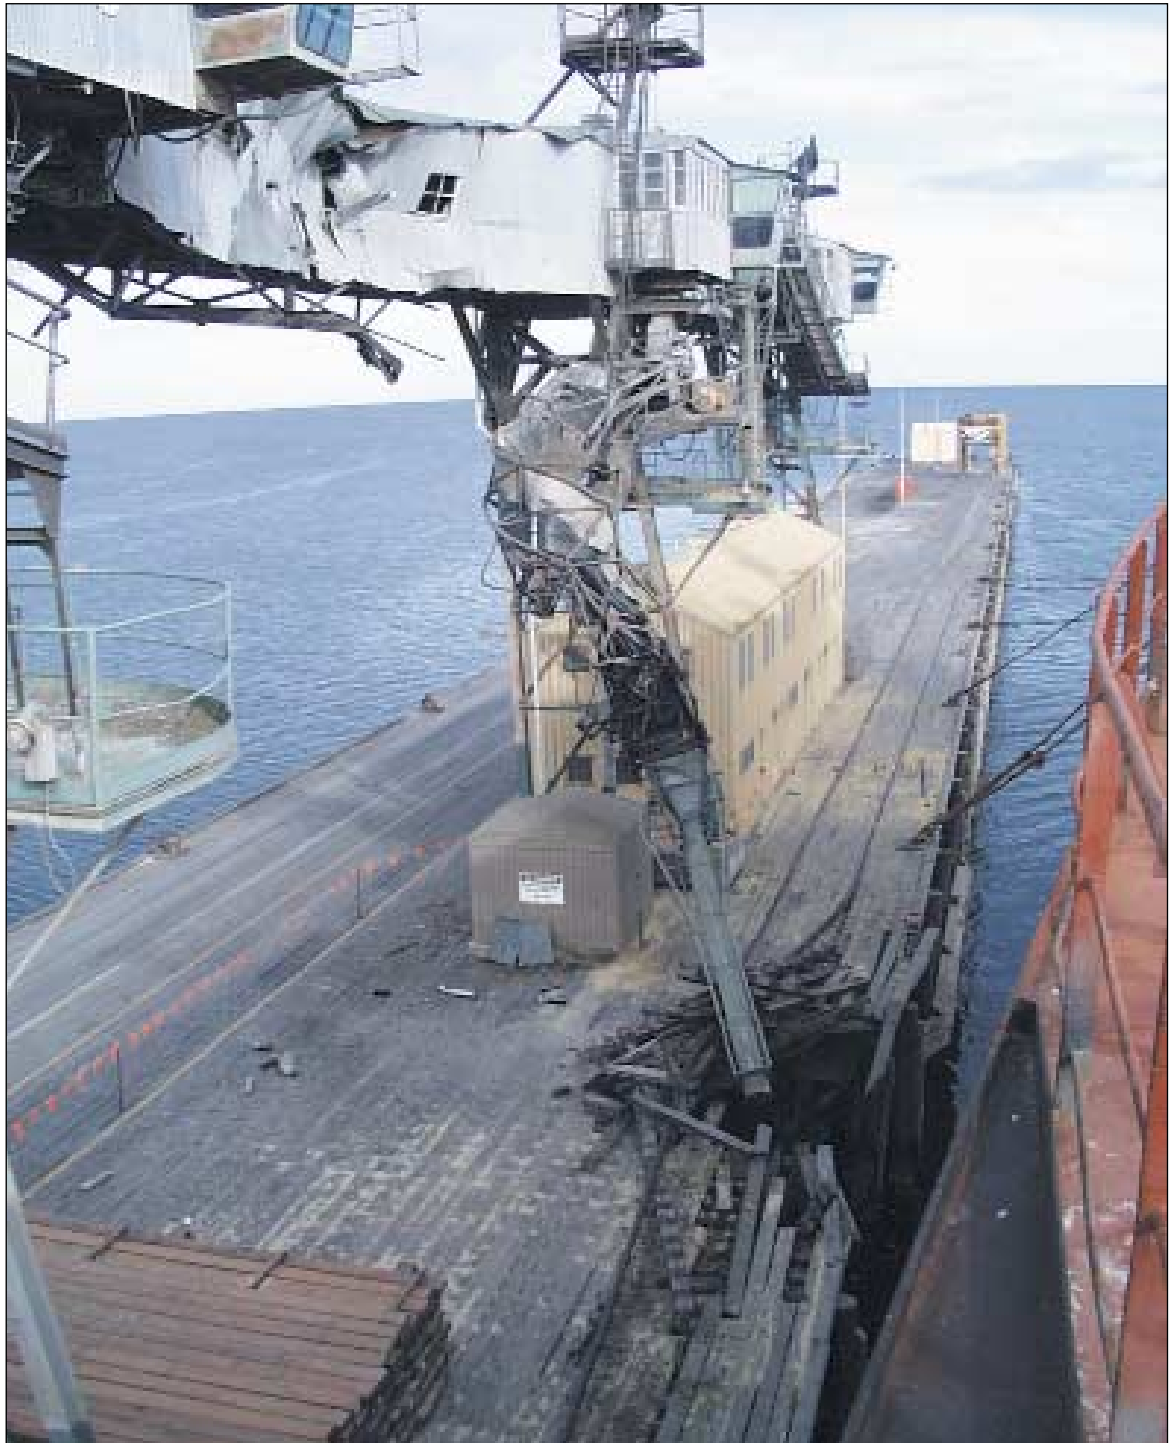
FIGURE 3
Wallaroo jetty and grain loader damage

At a time recorded as 0720 by the ship's crew, *Amarantos* made contact with the Wallaroo jetty and grain loader. The jetty and the grain loader superstructure were damaged substantially by the impact.

Despite significant damage to the jetty and grain elevator, *Amarantos* was found to have sustained only minor damage. There was scratched paint around the stem at, and just below, forecastle head level (about 18 m above the water line) and on the upper part of the bulbous bow, between the 8.4 m and 9.2 m draught marks (4–5 m above the waterline). The handrail at the top forecastle bulwark

Considering the damage sustained by the jetty and grain loader structures, the ship's speed at impact, was probably in the order of 0.5 of a knot.

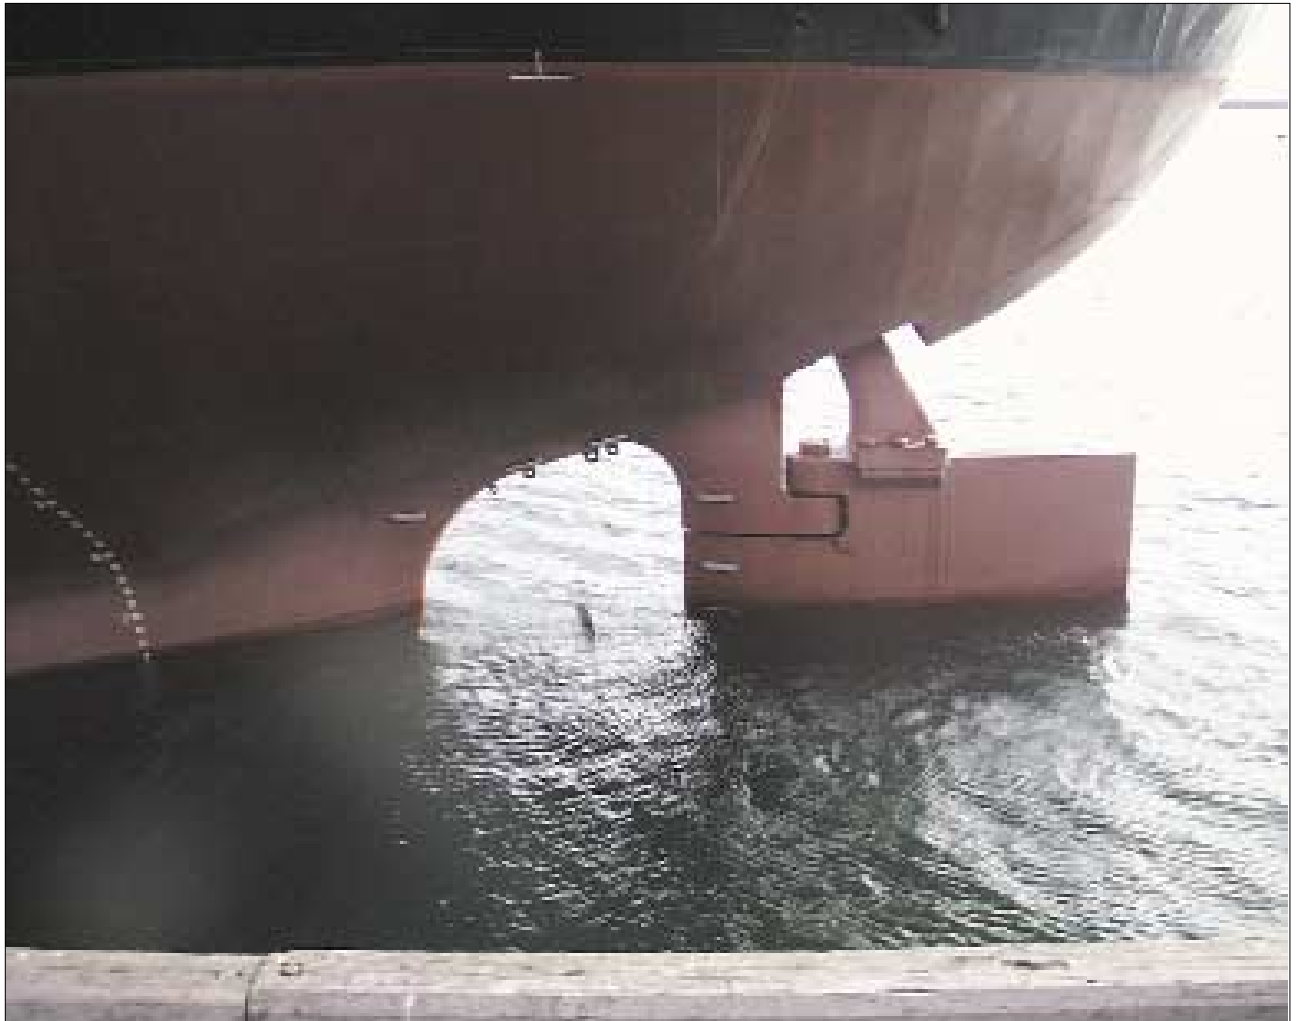
FIGURE 5
Propeller immersion

Fixed pitch propellers are designed to be most efficient when driving ahead at the main engine's rated speed. In *Amarantos's* case, approximately 100 rpm ahead. When going astern, the propeller efficiency is decreased, particularly if the vessel is making forward way. If the relative velocity of the water with respect to the surface of the propeller blades is high enough, areas of low pressure are created on the 'back' of the blades (with respect to the direction of rotation) leading to the formation of 'cavities' filled with water vapour bubbles ie. 'cavitation'. Propellers running astern generally experience cavitation at lower relative velocities as a result of the cross sectional shape of the blades, which is optimised for ahead running. Cavitation leads to a reduction in propeller efficiency and can be further exacerbated if the blade

tips are exposed and air is entrained with each rotation.

....the relatively high revolutions combined with the fact that the propeller had pierced the free surface make it very likely indeed that propeller performance would have been degraded due to aeration and possible cavitation.
