# Partial separation of Express Passenger Train (XPT) ST24

Broadmeadows, Victoria | 11 August 2011

## **ATSB Transport Safety Report**

RO-2011-012

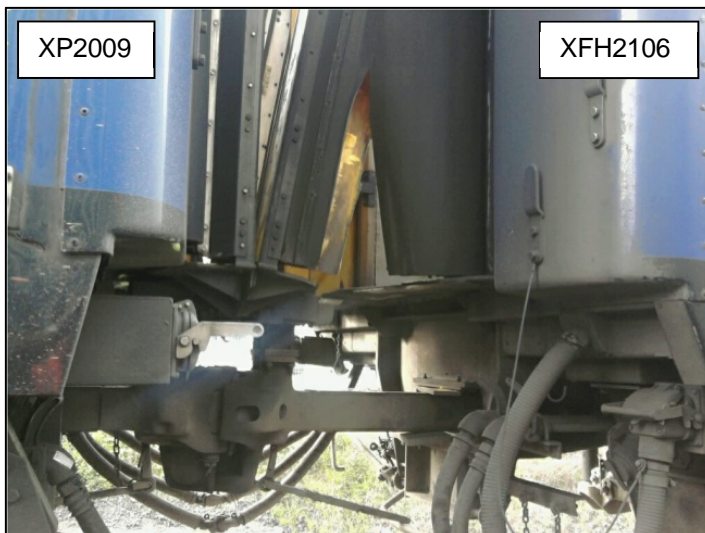
**Figure 1: Overextended diaphragm**

While inspecting the train, the driver found that the coupling between the leading power car (XP2009) and the first passenger car (XFH2106) had been overextended, damaging the diaphragm (Figure 1). While the diaphragm between the lead power car and passenger car was still intact, it had been significantly stretched. He also found that the electrical jumper cable

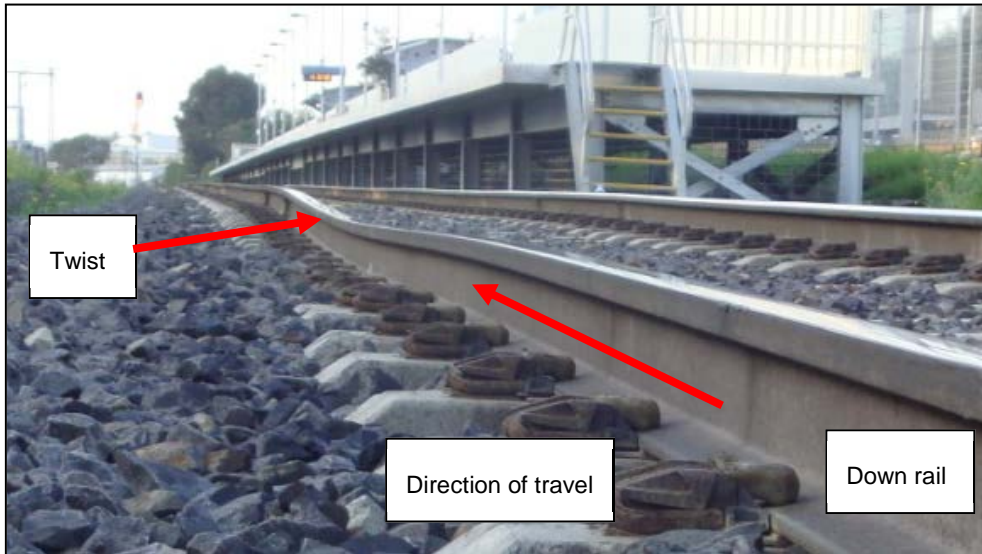
**Figure 3: Twist at 16.790 km**

On 12 August 2011, the ARTC conducted track geometry recordings which confirmed the onsite measurements. The track defect was at a level requiring immediate maintenance intervention. Of note is the fact that no rough riding reports which would have triggered immediate track maintenance action had been received from trains transiting that area prior to the incident.

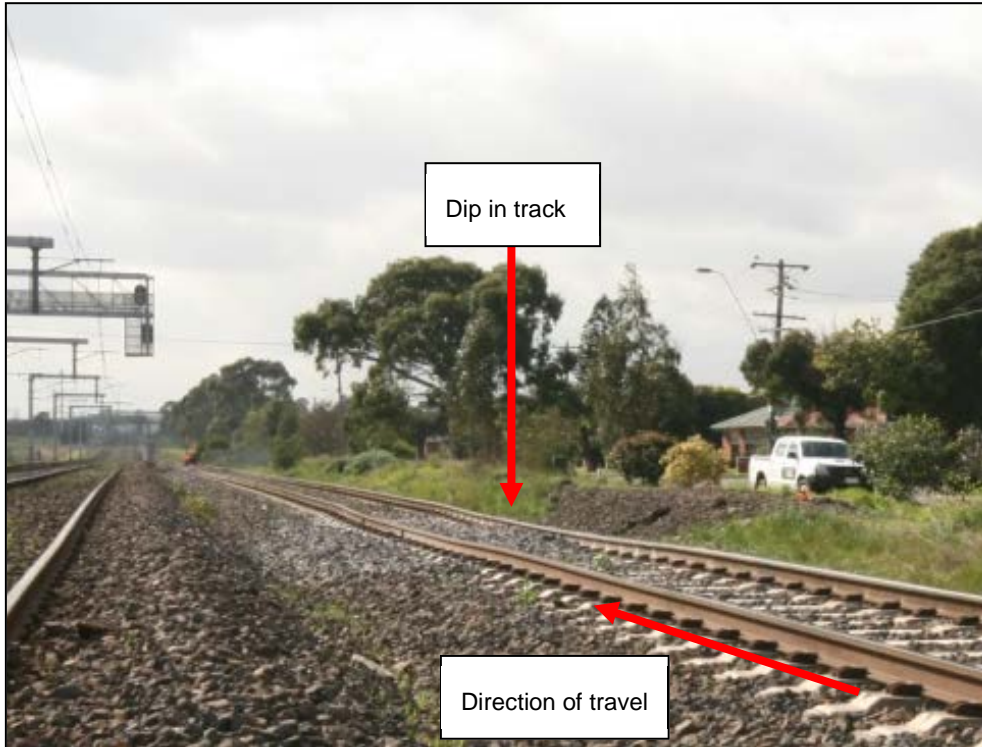
**Figure 5: Dip at 18.150 km**

On 12 August 2011, the ARTC conducted track geometry recordings which confirmed the on-site measurements taken by the investigators. The track had deteriorated to a point that required immediate intervention. Similar to the twist at 16.790 km, no rough riding reports which would have triggered an immediate maintenance response had been received from trains transiting the area in the time preceding the incident.

Post incident site measurements showed that the defects in the track required immediate intervention. While the track had been regularly inspected prior to the incident, no significant faults had been identified in this time. Furthermore, there were no train reports of 'rough track' in the area. The area was known to suffer reoccurring mud holes and, as a result, was regularly rehabilitated with freshly packed ballast. On this occasion, the track had deteriorated rapidly since it was last rehabilitated on 1 July 2011.

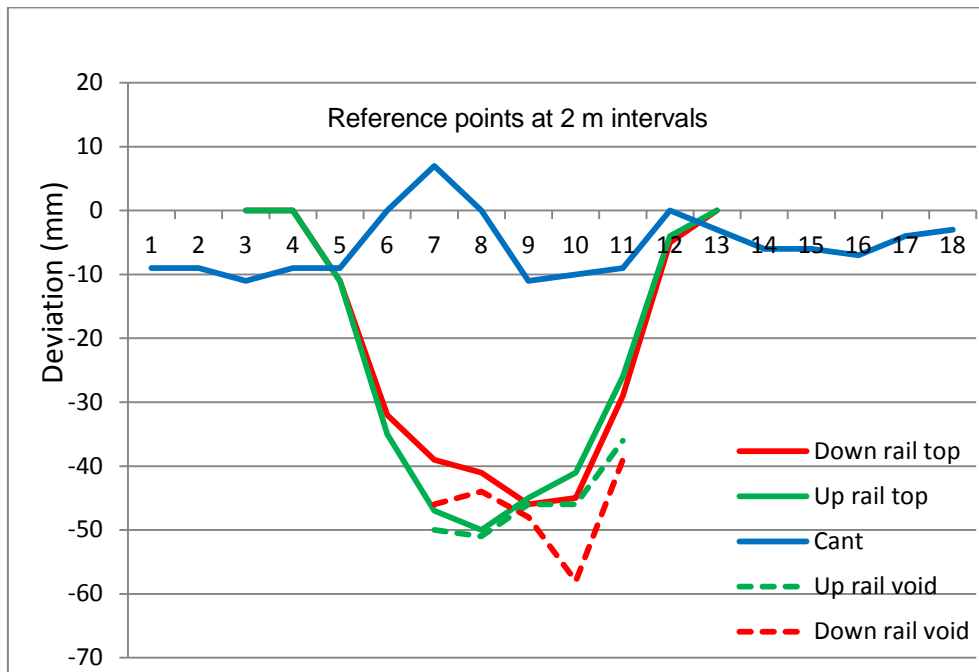
**Figure 6: Dip measurements**

Void measurements were only recorded between 18.157 km and 18.169 km (Figure 6). Track gauge, although not actually measured as the track was concrete-sleepered, was noted to be within tolerance during the measurement of cant and there was no significant lateral deviation in the track.

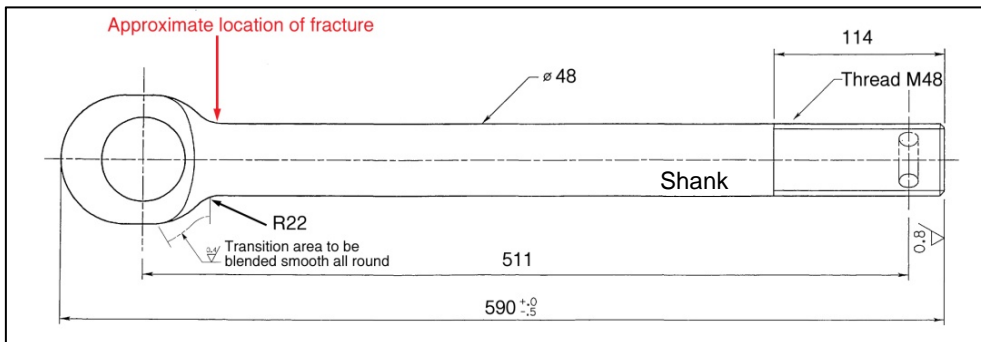
The RailCorp engineering drawing of the drawbar tail pin specified that it be 590 mm in length with a diameter of 48 mm (Figure 8). The drawing also specified that the tail pin be machined from AS 2506<sup>14</sup> steel, a low-alloy steel with a specified hardness of 269-331 Brinell<sup>15</sup> (HBN) and that there be no subsequent heat treatment.

**Figure 8: Drawbar tail pin schematic showing location of fracture.**

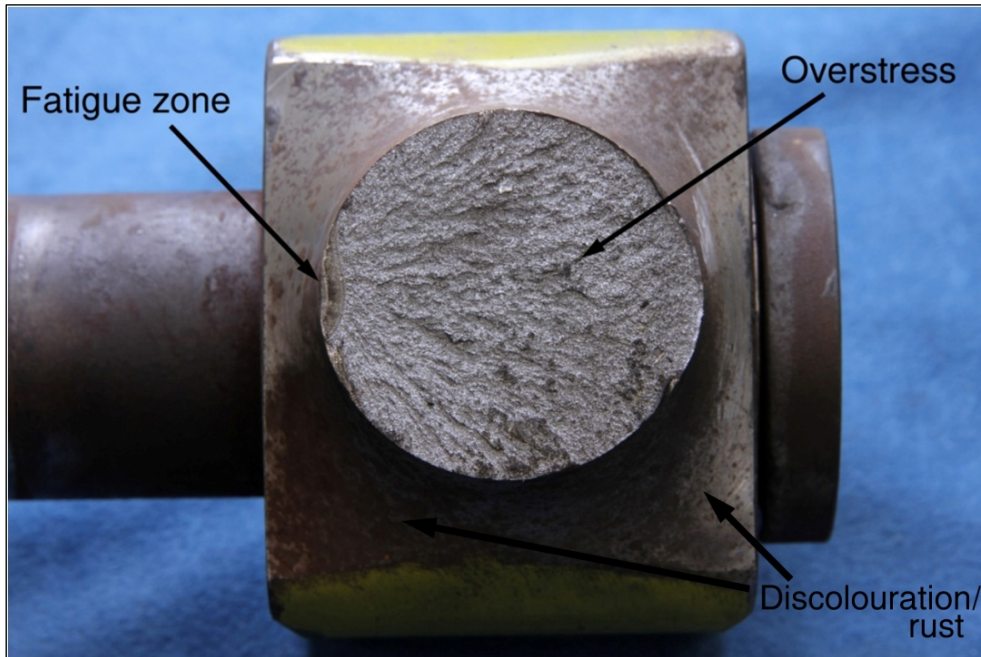
**Figure 9: Fracture face on boss side of the fracture**

The examination<sup>16</sup> determined that the tail pin failed as a result of low stress high cycle reverse bending fatigue that had initiated fatigue cracks on both sides of the tail pin in the region adjacent to the change in section from the boss to the shank. This location was also coincident with the area of the tail pin in contact with the front follower. The fatigue crack (Figure 9) had propagated to a depth of about 3 mm on one side before the final fracture occurred due to a brittle overstress mechanism.

The machined surfaces of the tail pin exhibited evidence of widespread corrosion/rust, which was particularly evident on the boss side of the fracture. A number of additional fatigue cracks identified in the region surrounding the primary fracture surface appeared to have initiated from these small depressions/pits in the surface.

The likely contributors to the fatigue crack initiation and propagation were the normal in-service stresses, the change in cross sectional area, the surface finish and the corrosion that had developed on the surface of the tail pin. The small area of the fatigue zone and the mostly brittle fracture surface was most likely the result of a combination of the inherent low material toughness, and high cyclic load/stress on the tail pin causing the final overstress fracture.

The evidence indicates that fatigue cracking was initiated in the tail pin by normal in service cyclic stressing and that this cracking propagated over time. Then, on 11 August 2011, when the lead power car of train *ST24* passed over a dip in the track, the pin fractured as a result of brittle overstress mechanism.

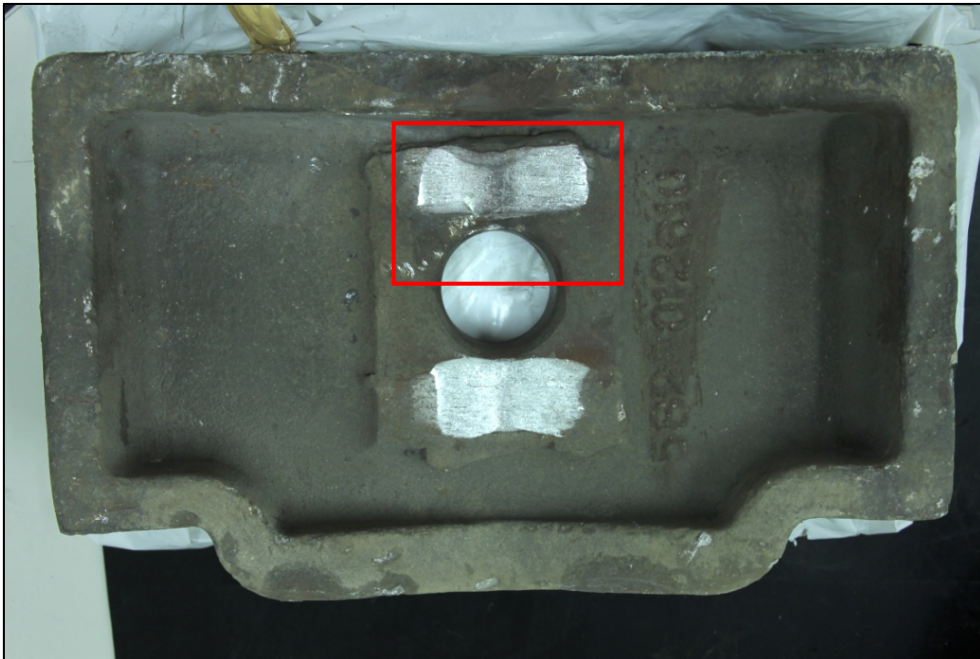
**Figure 10: Overview of front follower**

of the hole, particularly on the lower side of the hole. Furthermore, where present, the radius was not a consistent 8 mm.

- An inspection of all front followers to ensure that the radius has been correctly machined.
- The replacement of tail pins after a maximum of 5 years service, based on the average age of failure being 7 years.

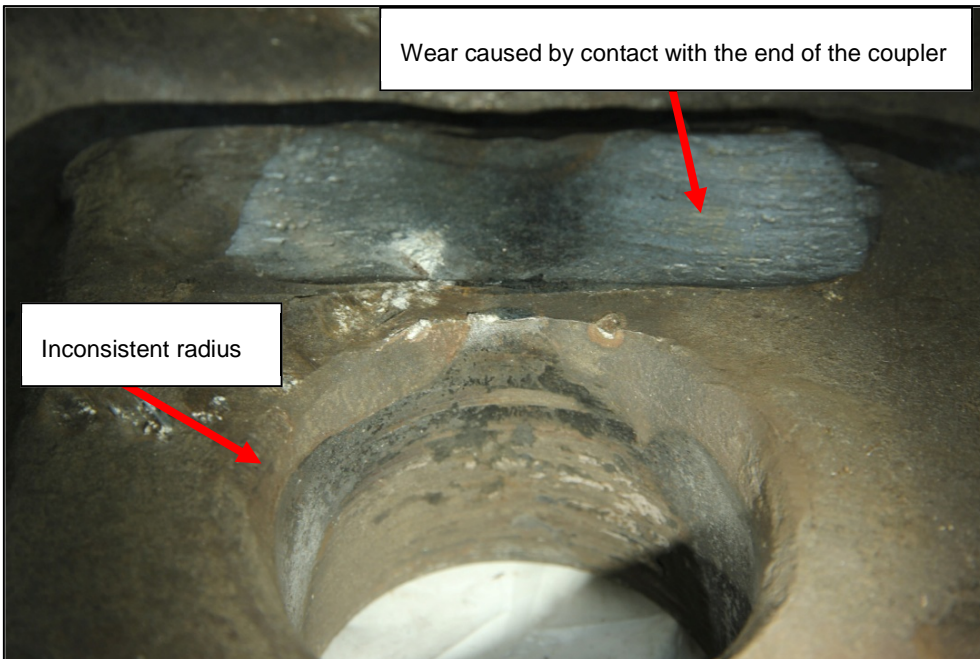
**Figure 11: Magnified view of the front follower hole in contact with tail pin**

Although the ATSB's examination provided no evidence of interference between the front follower and tail pin, the possibility that the missing follower hole radius may have contributed in some way to the stress on the tail pin cannot be completely discounted.

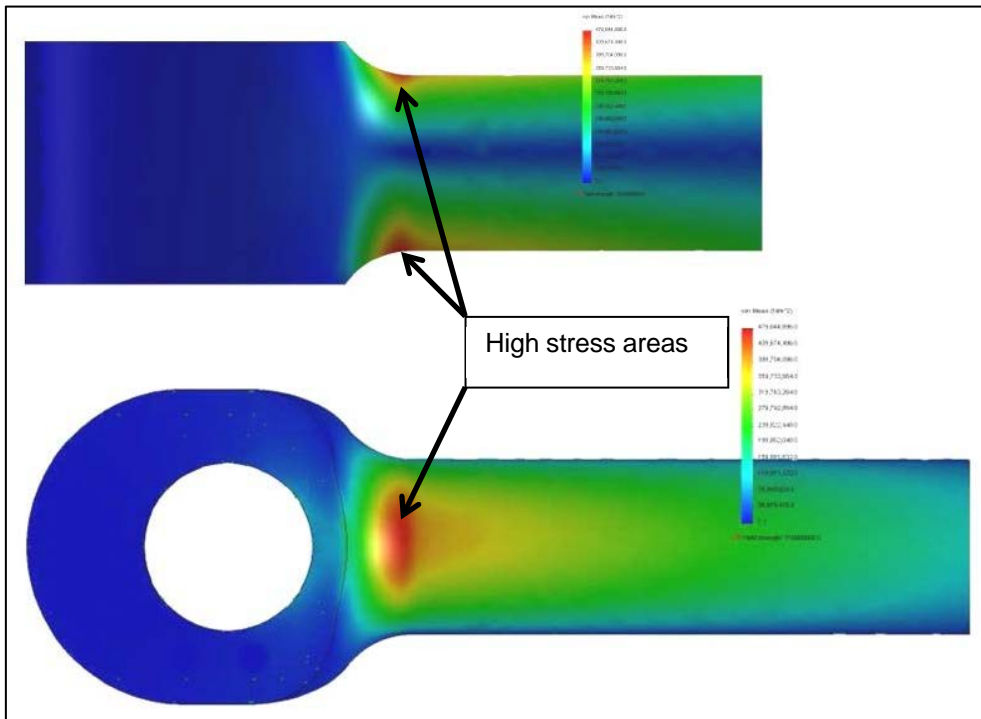
**Figure 12: FEA results of tail pin high stress areas**

- FEA has confirmed that the identified high stress 'hotspots' on the tail pin are the areas where cracks have been found (Figure 12).
- The failure mode for the tail pin has been confirmed as being primarily through vertical and lateral bending near the head of the tail pin.
- Maximum top bending stress of 450 MPa was recorded, which corresponds to 580 MPa in the critical area. Whilst this stress exceeds the fatigue limit but not the yield limit, some damage would have occurred.
- The initial run to Melbourne has shown indications that some plastic deformation has possibly occurred on the tail pin when traversing over sections of rough track (level crossing at Culcairn, and a combination of level crossings and short bridges at Balmattum).

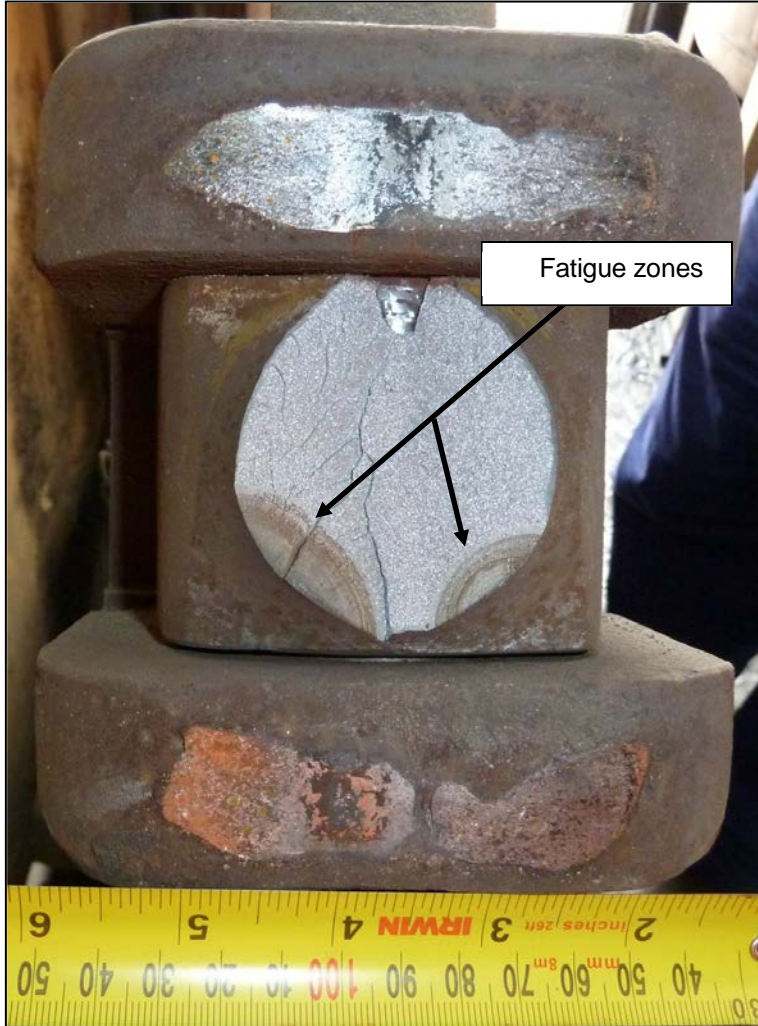
**Figure 13: Fractured tail pin from ST23**

The ATSB examined the failed tail pin from train ST23 and found that its failure was initiated from two areas of fatigue cracking (Figure 13). The failure was very similar in nature to that of train ST24 at Broadmeadows on 11 August 2011.

The subsequent incident at Seymour highlighted the fact that the revised ultrasonic method had failed to detect two large fatigue cracks (Figure 13 on page 12).

While the failure occurred only days after an ultrasonic inspection, the fatigue cracks were not detected. It is likely that the location and orientation of the fatigue zone (further towards the boss end, off centre and at an angle to the principal axis) would have been difficult to detect using the

A fatigue crack had also initiated on the lower side at the generally expected location. However, it had not grown to a size that was large enough to be detected during the scheduled inspection.

RailCorp has since worked on developing an enhanced Non-Destructive Testing (NDT) process to address the failure which occurred further along the tail pin radius than had previously been encountered. The procedure has been modified to include testing using 45 degree probes on the tail pin head for the 12 o'clock and 6 o'clock positions. The new procedure also resulted in revision of the engineering drawing to relocate the manufacturer's marking on the tail pin head. Validation testing of the new procedure has been completed.

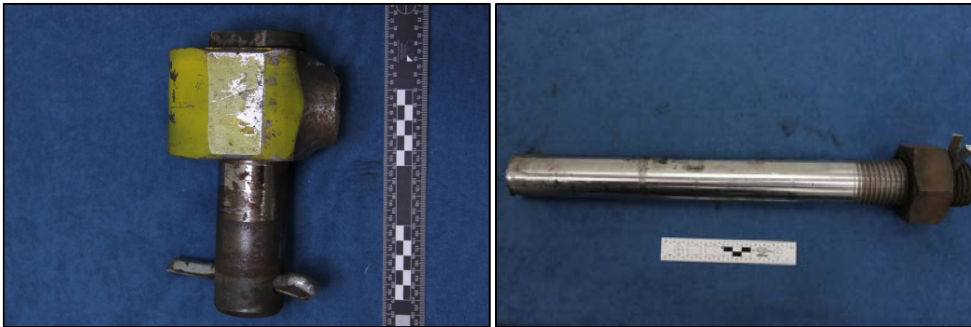
**Figure 14: Fractured segments of drawbar tail pin**

The drawbar tail pin had fractured at a location coincident with the change in cross sectional area at the boss end of the shank (Figure 14).

A number of circumferential grooves/wear marks were also observed along the length of the shaft section of the pin, as a result of their contact with the rubber spring/dividing plates. The external surface of the tail pin exhibited widespread discolouration/rust spots, particularly on the boss side of the fracture (Figure 15). The boss was stamped with BU 06 04, a batch number indicating the manufacturer, the year and month of fabrication.

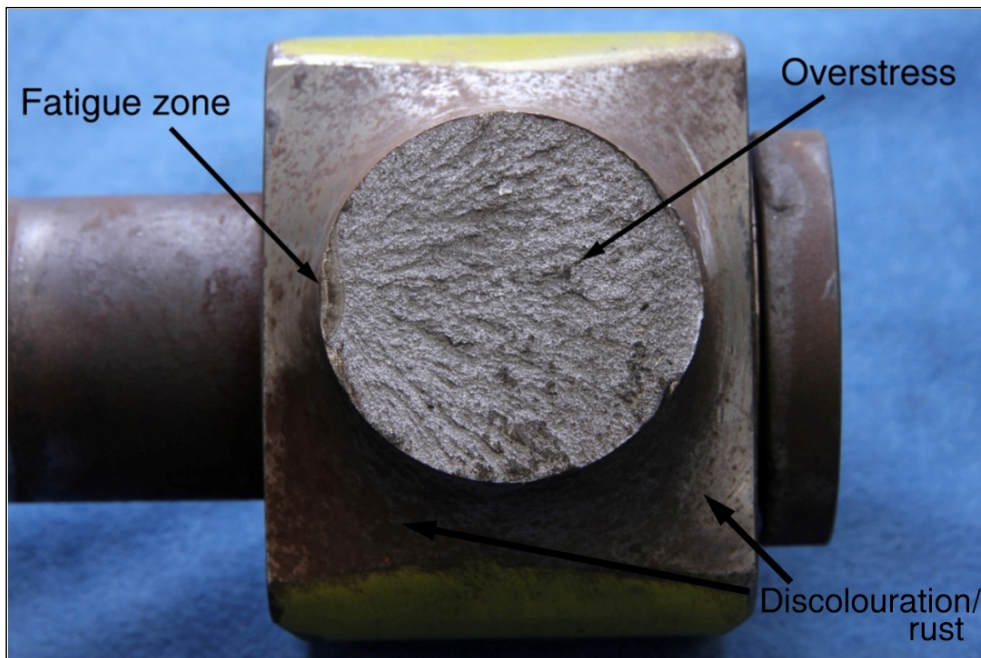
**Figure 15: Fracture face on boss side of the fracture**

The fracture face was perpendicular to the principal axis of the tail pin and was smooth and flat. Evidence of cyclic fatigue crack progression (beach<sup>21</sup>) marks were observed radiating outward from one side of the fracture face, which coincided with the lower side of the pin in situ. The beach marks extended radially from the lower surface and extended across a small area (approximately 3 mm) of the fracture surface (Figure 15). The largest proportion of the fracture surface was consistent with a brittle overstress failure.

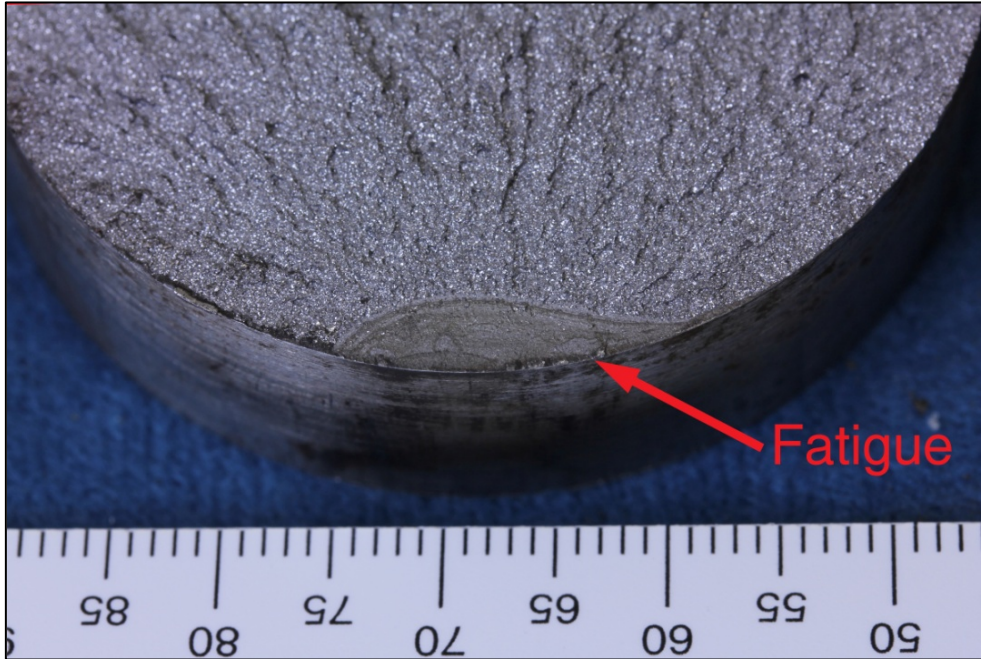
**Figure 16: Magnified view of the fatigue zone on the shaft side of the fracture**

The fatigue zone on the boss side of the fracture face exhibited minor smearing along the edge which is consistent with post fracture mechanical damage. The fatigue area on the shaft side was obscured by dirt, however once this was cleaned, the fracture face was evident. The fracture face was perpendicular to the principal axis of the tail pin and was smooth and flat. Evidence of cyclic fatigue crack progression (beach) marks were observed radiating outward from one side of the fracture face, which coincided with the lower side of the pin in situ. The beach marks extended radially from the lower surface and extended across a small area (approximately 3 mm) of the fracture surface (Figure 15). The largest proportion of the fracture surface was consistent with a brittle overstress failure (Figure 16). Some ratchet marks were observed, but no damage on the surface of the shaft was identified that may have contributed to the fatigue crack initiation.

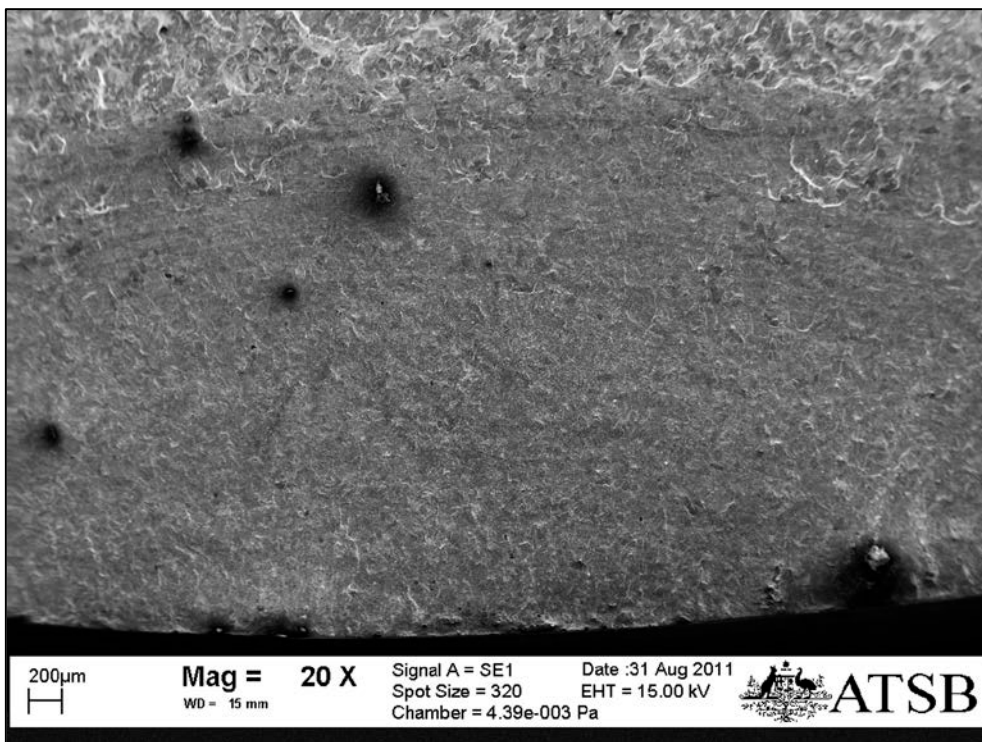
**Figure 18: Scanning electron microscope image of the fatigue area of the fracture face from the shank side of the fracture**

The fracture face was cut away from the shank side (Figure 8) of the tail pin and examined using a scanning electron microscope (SEM). The fracture face exhibited finely spaced striations indicative of low stress high cycle fatigue at the outer edges (Figure 18).

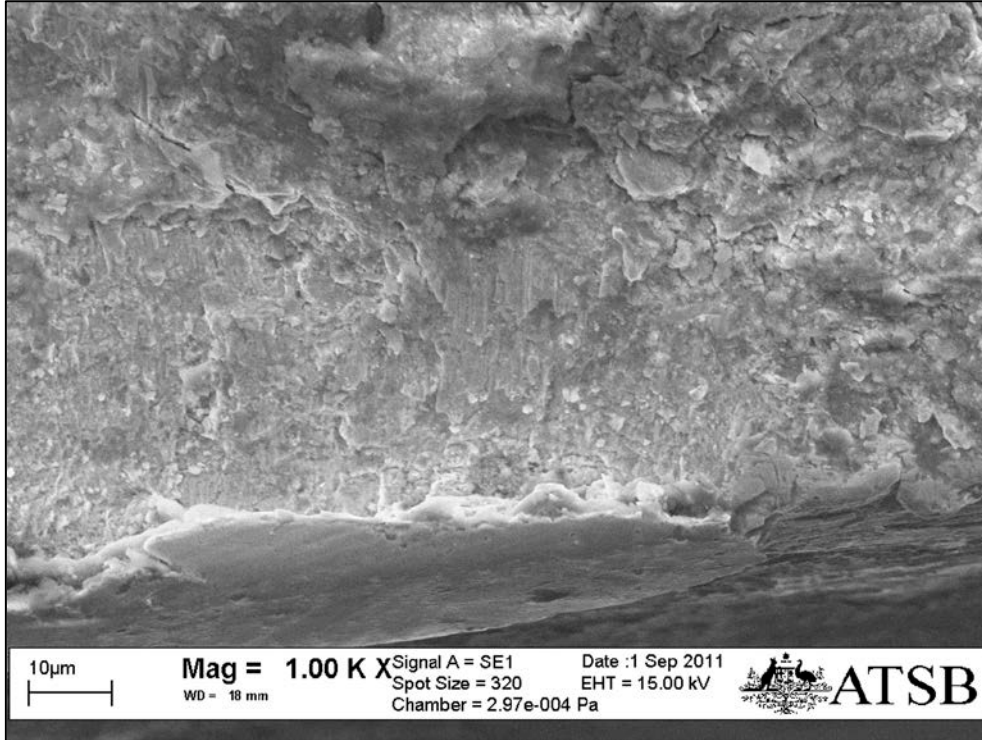
**Figure 19: Magnified view of the outer surface, showing no clear evidence of an obvious initiator**

No anomalies were detected at the likely origin points that may have contributed to crack initiation (Figure 19). However, a brittle faceted fracture surface was observed towards the centre of the tail pin, consistent with an overstress failure.

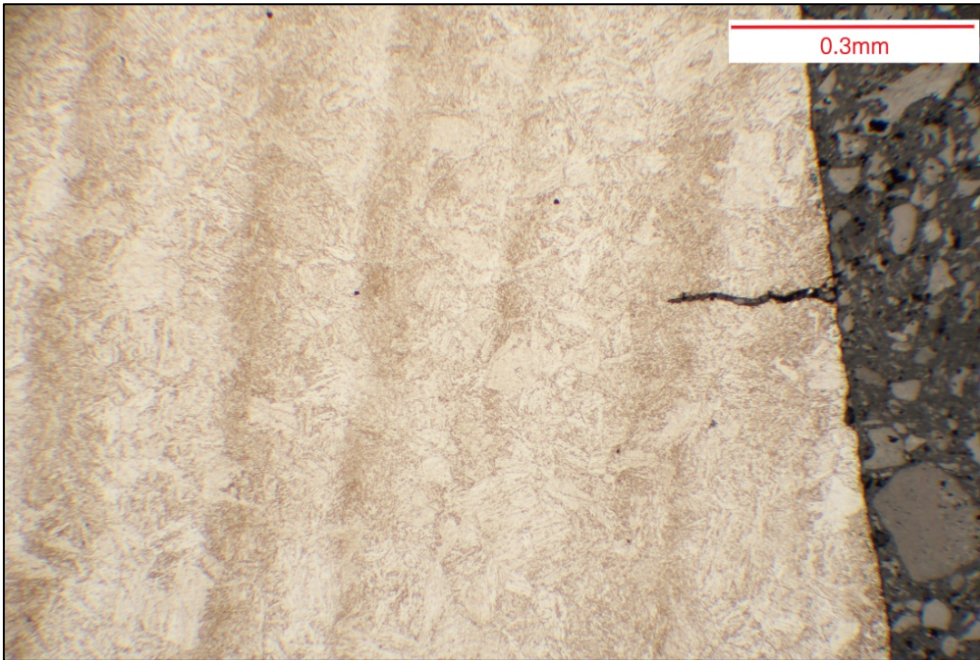
**Figure 20:** Larger crack identified on the boss side of the fracture face, on the opposite side of the tail pin to the observed fatigue crack

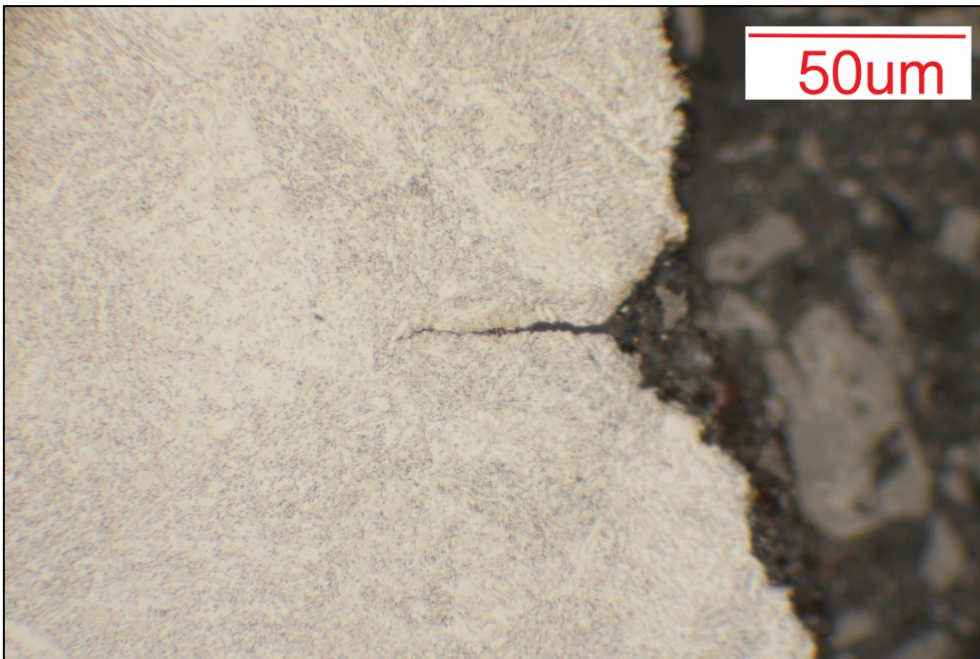
**Figure 21:** Another smaller crack that extended from the external surface. Note the corrosion pit/depression at the external surface

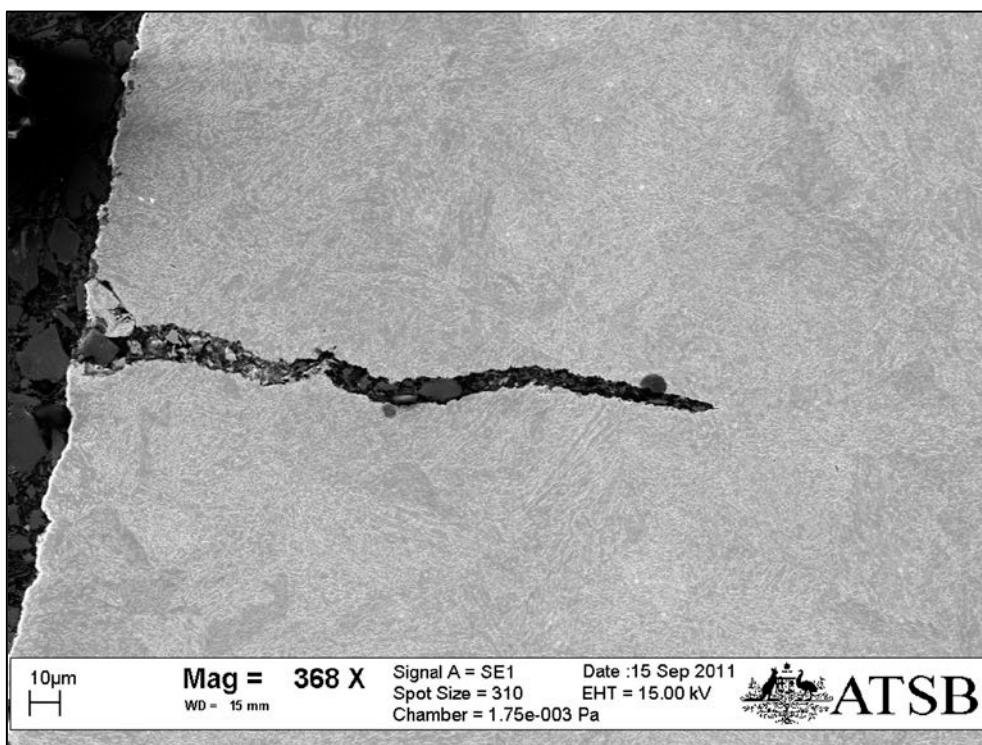
Figure 22: Crack shown in Figure 20 viewed under the SEM

The microstructural sample was also examined using the scanning electron microscope (Figure 22) which was equipped with an energy dispersive x-ray system (EDS). Analysis of the debris product within the crack revealed the presence of iron and oxygen, consistent with a ferrous corrosion product (rust).
