Cabin pressurisation issue involving Boeing B737-36E SF, ZK-FXK

near Darwin Airport, Northern Territory, on 4 November 2021

ATSB Transport Safety Report

AO-2021-047

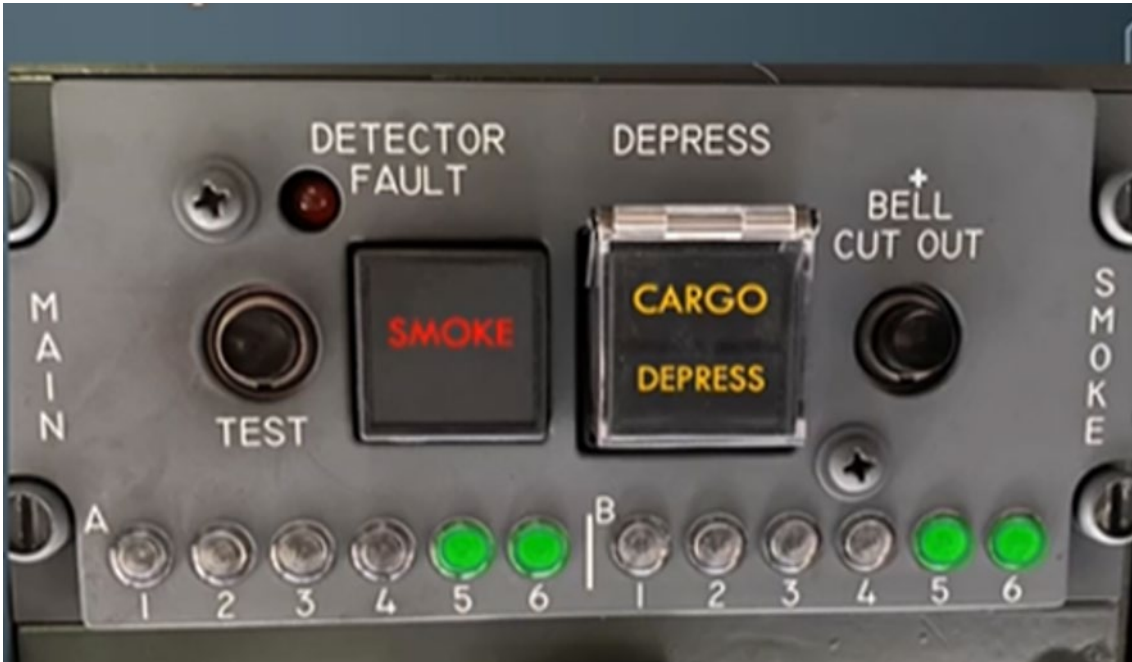
Figure 1: Main deck cargo smoke detector panel

The cargo/depress switch was part of the main deck smoke detection system. It was on the main deck cargo smoke detector panel, which was located on the aft overhead panel of the flight deck (Figure 1, Figure 2). The panel was located behind the flight crew seats and was not within normal line of sight for a flight crew.

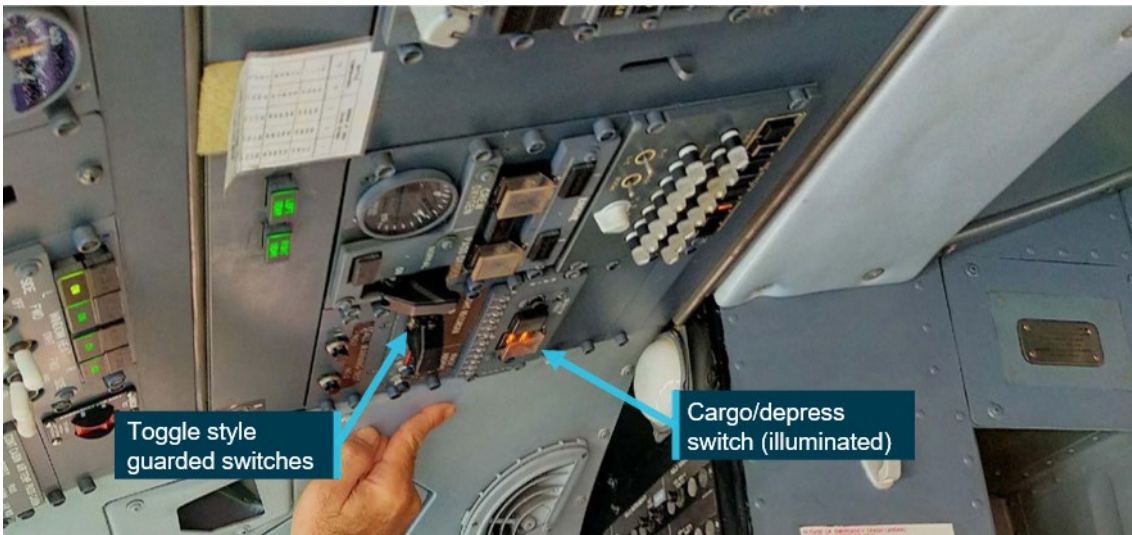
Figure 2: Main deck cargo smoke detector panel (view from left seat)

The cargo/depress switch was a push-button type switch that illuminated when selected ON. It was guarded by a clear, flat plastic cover. The switch could be on or off with the guard in place (Figure 2). This was in contrast to other guarded switches on the aircraft, where the guard had to remain raised to allow the toggle type switch to be on. The only indication that the switch had been selected ON was the illumination of the switch itself.

As the aircraft departed with the cargo/depress switch on, ZK-FXK was prevented from pressurising.

The FO stated that during this scan, in the bright ambient conditions, they did not notice that the cargo/depress switch was illuminated. As the clear plastic guard was able to be closed when the switch was on, and as this was different to the guard on the toggle type switches, the ability to visually determine its state was reduced. The FO recalled that at no stage was the main deck cargo smoke detector panel specifically checked. Following this activity, the FO continued the next section of pre-flight scans from their FO seat on the right side of the flight deck. From this seat, the cargo/depress switch was now behind their head and out of view.
