Birdstrike and in-flight break-up involving a Bell 206L-1, registered VH-ZMF

Near Maroota, New South Wales, on 9 July 2022

Aviation Occurrence Investigation (Short)

AO-2022-034

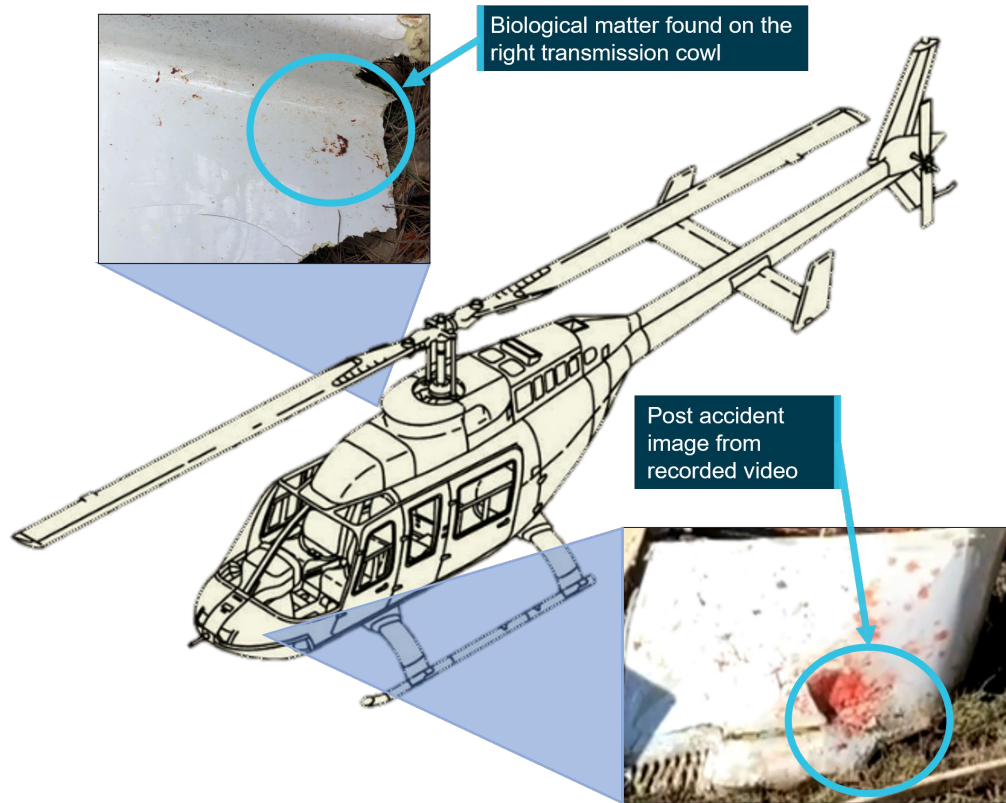
Figure 2: Locations of biological matter

A nearby news helicopter, filming local flooding, was the first to arrive on scene and landed nearby to render assistance. Camera crew continued filming the accident scene before it was consumed by the post-impact fire. Biological matter was observed in that recorded video on the outside of the left nose cowl of the helicopter (Figure 2).

Analysis of biological samples found on external surfaces of the helicopter and nearby the accident site, confirmed the airborne contact with a wedge-tailed eagle (*Aquila audax*). First responder film footage of the cockpit and fuselage impact site, prior to being consumed by fire, indicated a large external impact of biological matter on the front left nose cowl of VH-ZMF, indicating a likely initial impact point of the birdstrike.

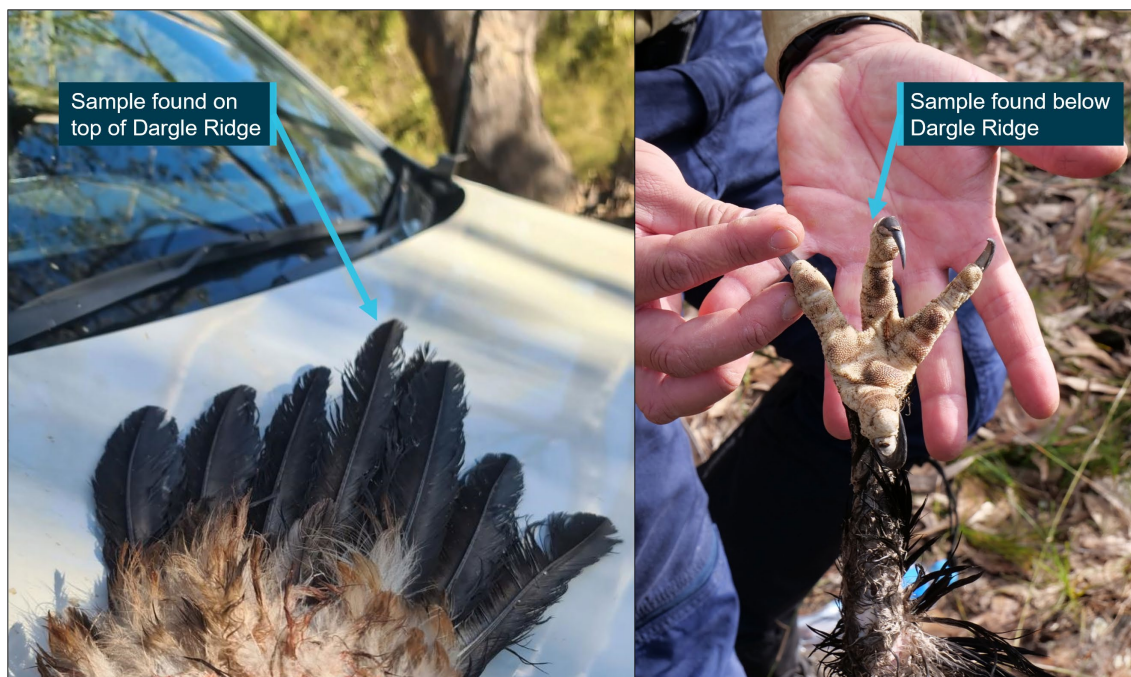
Figure 3: Bird matter found near accident site

The landowner, who arrived at the accident scene on the top of the Dargle Ridge lookout, identified a mass of biological tissue, which appeared to be a tail section of a bird (Figure 3), which was still warm. During the on-site phase of the investigation, further biological samples were recovered below the escarpment.

Recovered biological specimens, including the avian carcass and the biological residue found on external helicopter surfaces, were analysed by the Australian Centre for Wildlife Genomics, Airstrike section of the Australian Museum. The carcass and samples taken from the helicopter's main transmission cowling were identified as *Aquila audax*, commonly known as a wedge-tailed eagle.

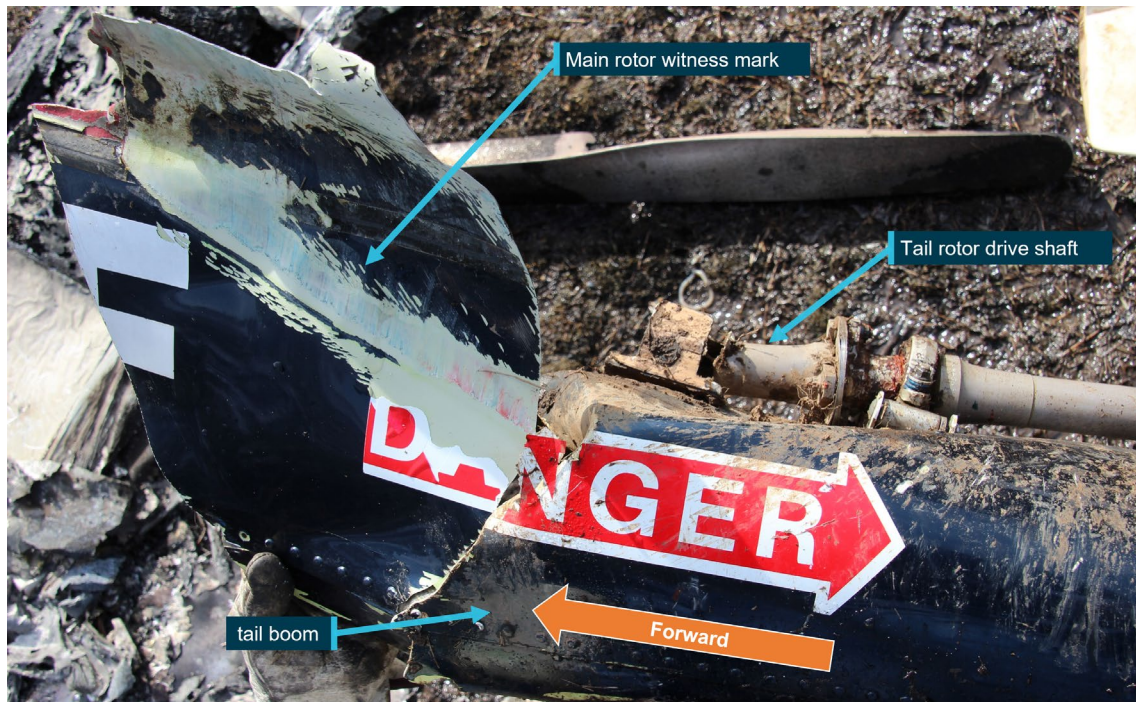
Figure 4: Tail boom impact

The main accident site, including the engine, main cabin, and fuselage, was located in relatively flat and open farmland, between 2 ridgelines (Figure 5). The tail rotor assembly, vertical stabiliser and a section of the tail boom were found about 93 m to the north, with no signs of pre-existing component failure or damage. However, the main tail boom and drive shaft (Figure 4) were both severed at roughly the same fuselage station, consistent with a main rotor blade strike.

Abrupt cyclic inputs and low to negative g rotor loading are a well-documented and accepted limitation of two-bladed teetering rotor head systems commonly used in light to medium helicopters. Analysis of the impact marks on the tail boom of VH-ZMF and the separation of rotor blade tips, indicate that the tail boom was impacted and severed by contact with its own main rotor blades. This led to further break-up of the aircraft in flight, such as the main rotor system and transmission due to severe rotational forces of a compromised and unbalanced main rotor assembly. Numerous witnesses observed and heard the impact of the main rotor blades on the tail boom and described the uncontrolled nature of the in-flight break-up.

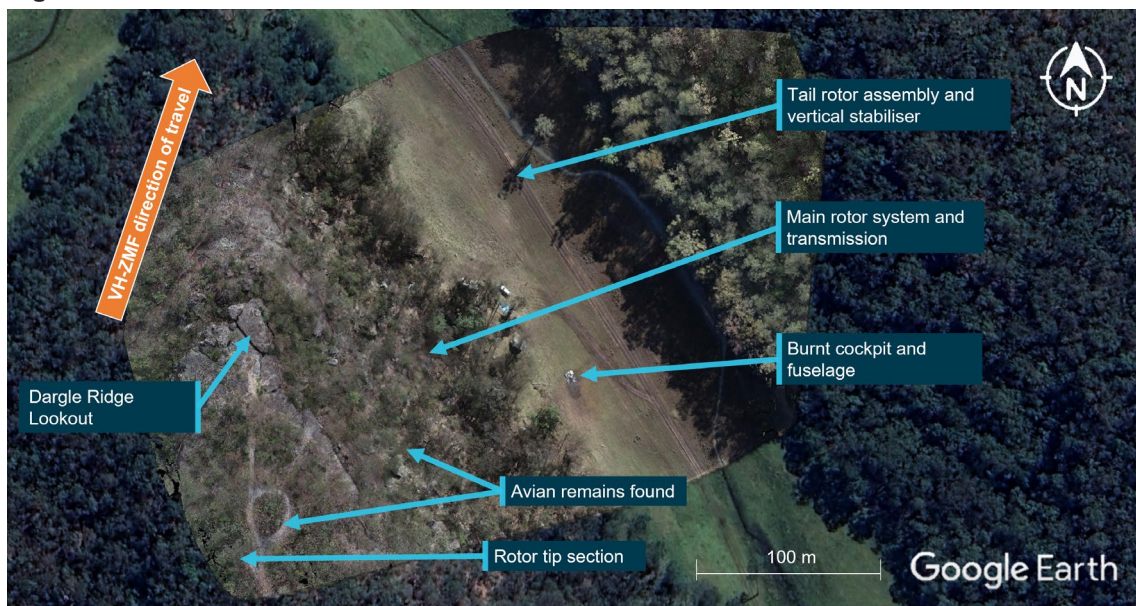
Figure 5: VH-ZMF accident site

The main rotor system, including the transmission cowling, gearbox, and main rotor blades, was located about 68 m to the west in a heavily wooded, sloping escarpment. The teetering main rotor head was still attached to the transmission with multiple severed control rods attached to the transmission mounting structure.

The composite main rotor blades had separated just outboard of the main rotor grips and had impacted heavily with vegetation and delaminated. One of the main rotor blade tips was located about 150 m before the main wreckage on top of the ridgeline.
