Tail rotor driveshaft failure involving Bell Textron 505, VH-VTB

Cairns Airport, Queensland on 15 July 2022

ATSB Transport Safety Report

AO-2022-036

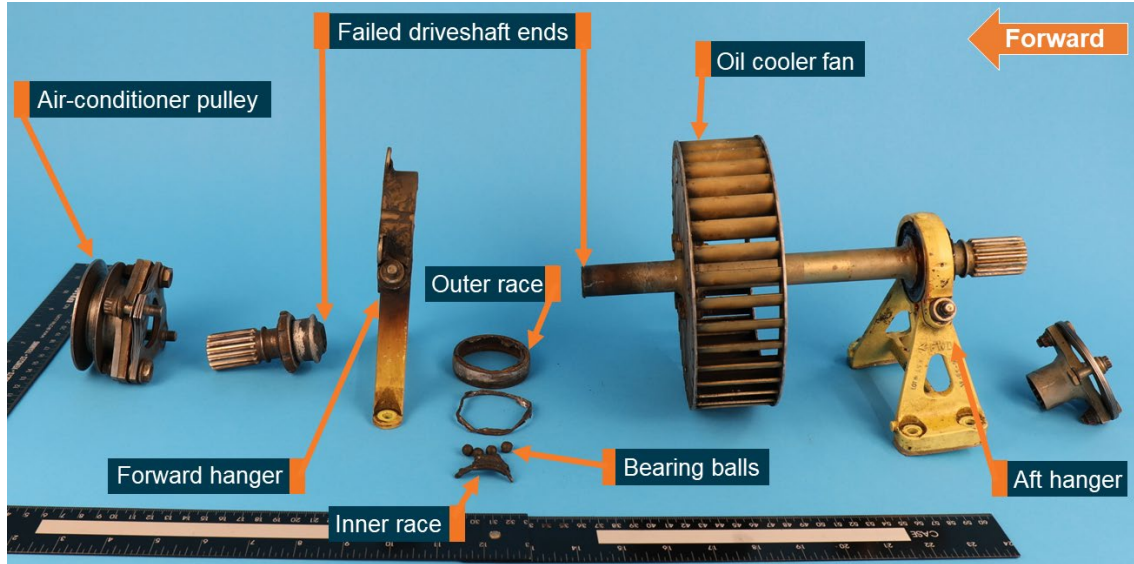
Figure 1: The fan shaft and associated components removed from VH-VTB

A section of the tail rotor driveshaft assembly known as the fan shaft was sent to the ATSB for detailed technical examination (Figure 1). This section of the driveshaft also drove the oil cooler fan, as well as cabin air-conditioning via a pulley and drive belt. In a functional fan shaft assembly,

the engine drives the fan shaft which connects to the rest of the tail rotor driveshaft and ultimately, the tail rotor itself. The forward and aft hangers restrain the fan shaft via ball bearings that are clamped in each hanger using a nut.

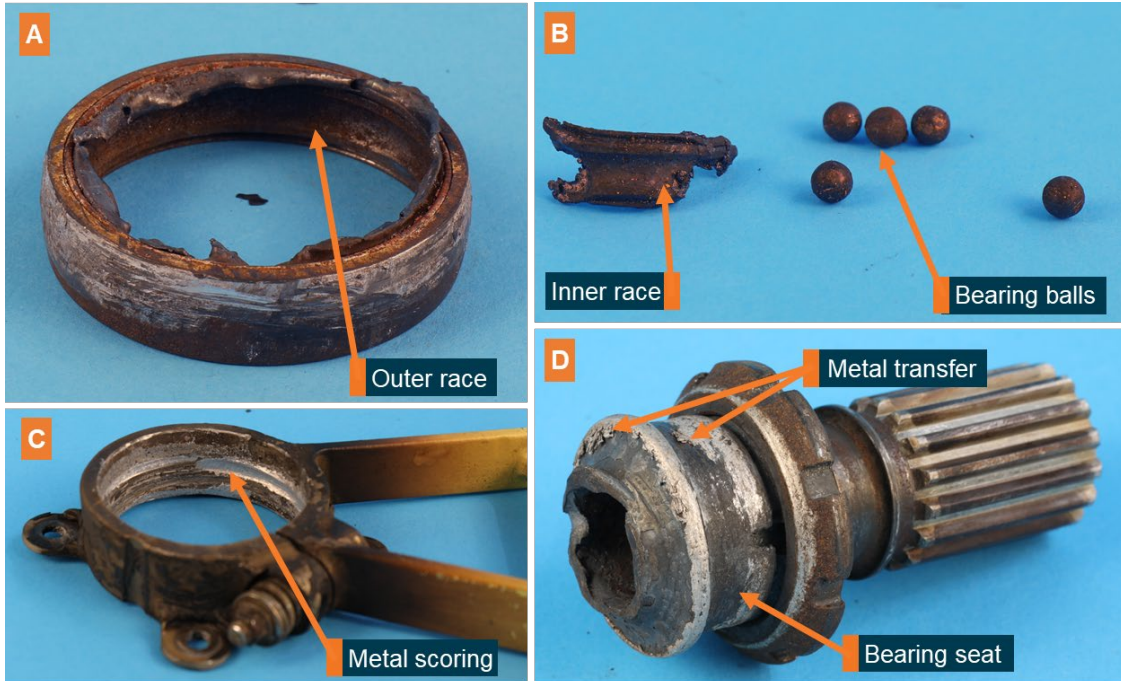
Figure 2: Damaged components of the failed bearing (A, B), hanger (C), and fan shaft (D)

The driveshaft failed adjacent to the bearing seated inside the forward hanger. Blackening of the hanger, shaft and bearing components was present, indicative of exposure to high heat. The fracture surface closest to the bearing also appeared to be deformed due to heat exposure (Figure 2, D). Metal transfer on the bearing seat was likely from the adjacent inner race. No grease was observed in the bearing, though it might have been slung out or dissociated due to the high temperatures.

The outer race of the bearing was intact, but showed signs of corrosion (Figure 2, A). The inner race of the bearing had disintegrated, and only a small portion was found, along with only 5 bearing balls (Figure 2, B). Deep rotational scoring was observed on the inner face of the hanger and the outside of the outer race—normally clamped together during operation (Figure 2, C). The nut used to clamp the hanger to the bearing was still present, and a stripe of torque seal on the nut indicated that it had not backed off since it was last tightened. Metal was transferred onto the surface of the fan shaft, where the inner bearing sat during operation.

During landing, a combination of heat and torque due to a seized forward fan shaft bearing resulted in failure of the fan shaft just aft of the bearing. The bearing seizure was evidenced by the disintegrated inner race, metal deposited on the bearing seat and signs of excessive heat around the bearing components and fan shaft. As a result of the bearing seizure, the fan shaft spun independently of the bearing, resulting in disintegration of the inner race. Scoring on the outer race and hanger indicated that at some stage, the bearing and fan shaft were also spinning together. It could not be determined when the bearing seized, but the noises heard by the pilot were likely either the fan shaft spinning on the bearing, or bearing spinning on the hanger. It could also not be determined whether the noise heard 2 days before the incident was related to the bearing failure.

Due to the amount of damage on the failed bearing, the reasons for its seizure could not be identified. The disintegrated inner race, corrosion within the outer race and damage to the hanger could all have been a result of the seizure, rather than factors contributing to it. No grease was observed following the failure, but it could have been slung out or dissociated due to the excessive heat. If the bearing was not properly greased, it would likely have resulted in abnormal noise or excessive heat when it was visually inspected 2 days previously, but neither were detected.

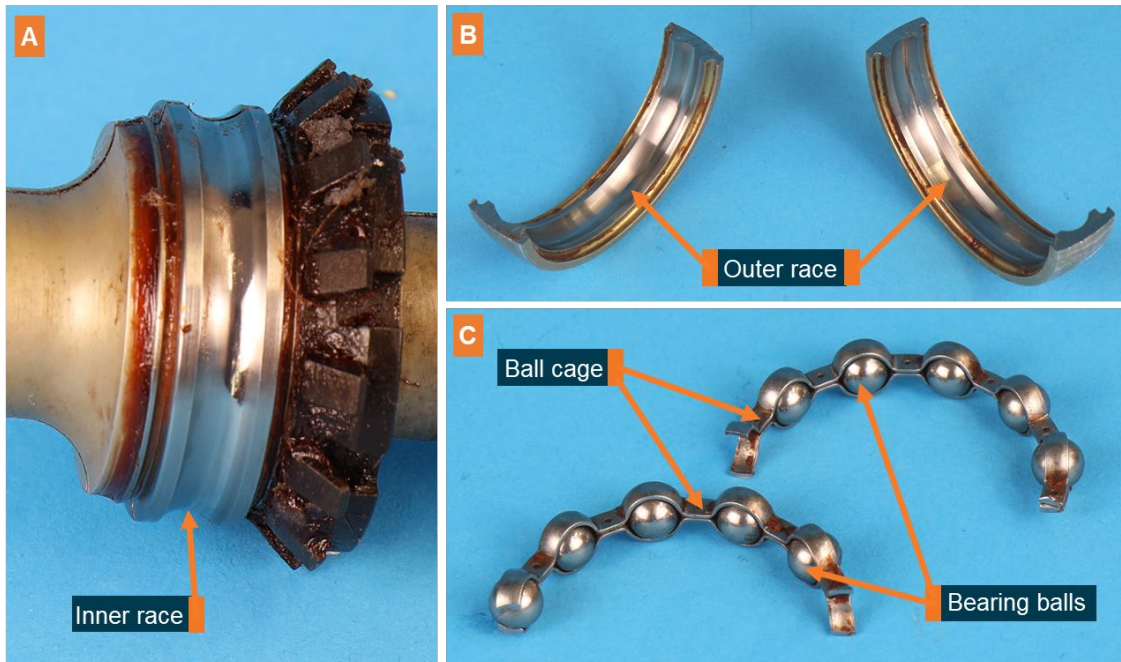
Figure 3: The aft fan shaft bearing, sectioned and disassembled.

For comparison, the aft bearing was sectioned and examined for signs of damage (Figure 3). There were no signs of rotational scoring between the bearing and the aft hanger. The bearing contained sufficient grease, which had the same appearance as Mobilgrease 28. The grease showed no signs of contamination.

On the aft bearing, surfaces of the inner and outer bearing race were in good condition, with some very small points of spalling damage⁴ on the inner race where contact would be made with the balls (Figure 4). No other mechanical damage associated with bearing degradation was observed (Figure 3, A and B). Likewise, there was no damage to the bearing balls or the ball cage retaining them (Figure 3, C).

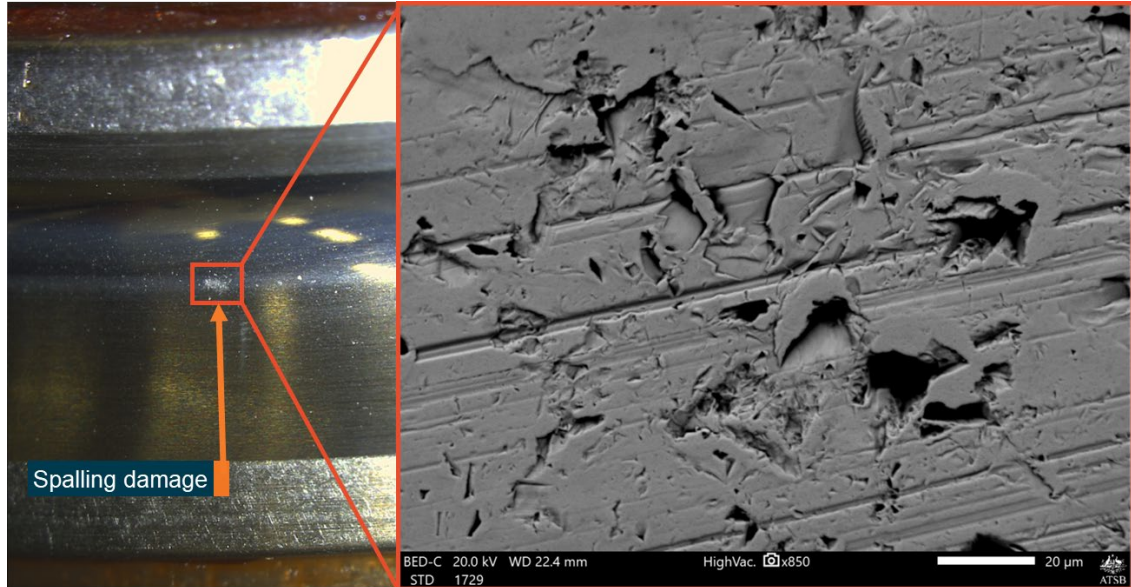
Figure 4: Inner race spalling damage seen through an optical microscope (left) and electron microscope (right)

The aft fan shaft bearing showed no signs of corrosion or damage associated with improper lubrication. The only damage observed were small regions of spalling. Such localised damage was most likely due to a foreign contaminant within the bearing, since other possibilities such as poor tolerances, misalignment or manufacturing defects would have resulted in more widespread damage within the bearing. The forward bearing failure could have resulted from exposure to similar contaminants, but the faces of the inner and outer race were too damaged to permit an assessment of the failure mechanism.
