Rejected take-off involving SAAB 340B, VH-ZRC

Flinders Island Airport, Tasmania on 4 November 2022

AO-2022-054

Final – 17 May 2023

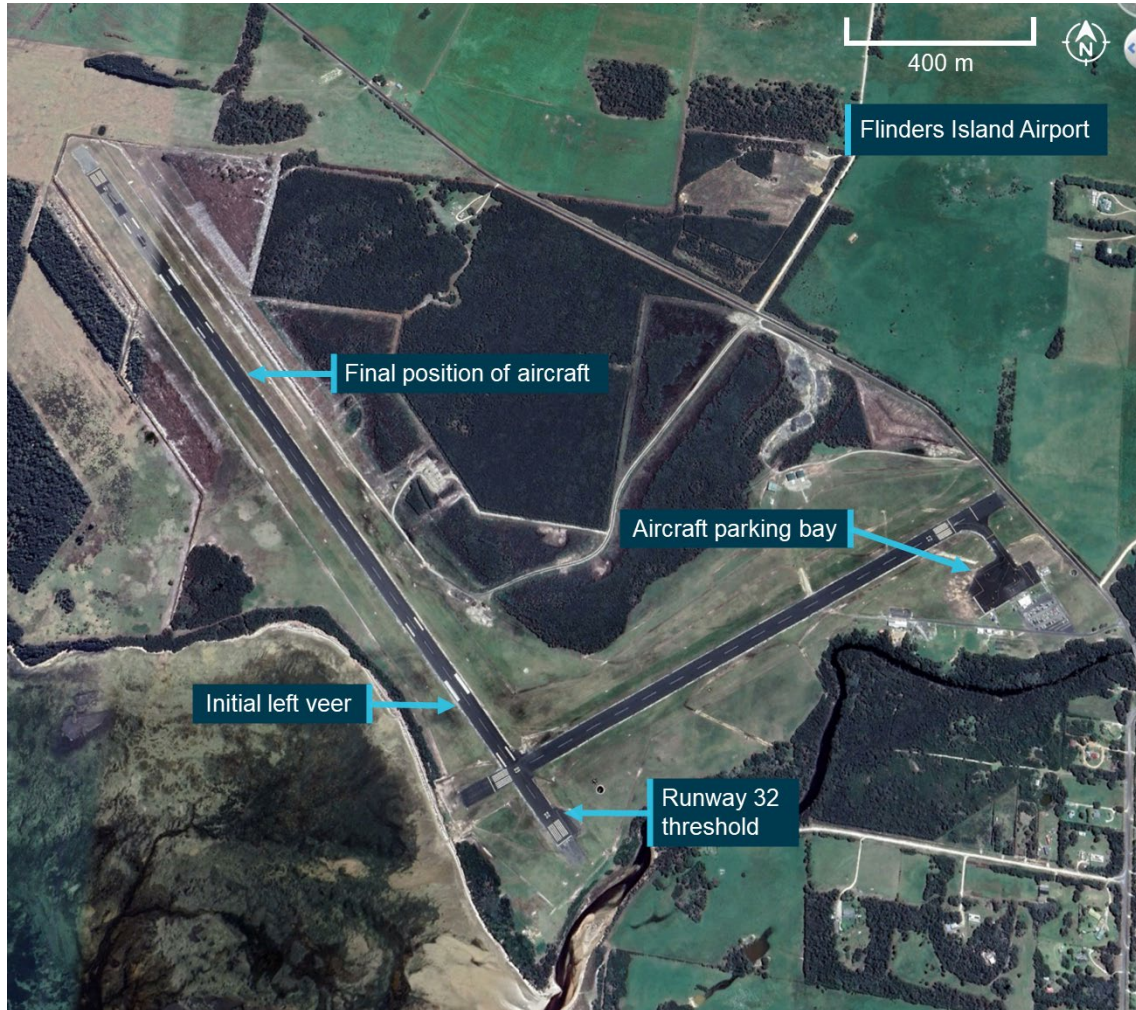
Figure 1: Flinders Island Airport

The first officer released the parking brake and conducted an immediate 180° left turn out of the parking bay (Figure 1). They then proceeded to taxi the aircraft to the threshold of runway 32 via runway 23.¹ The first officer commented that there was no abnormal handling or unusual power settings required to taxi the aircraft. They decided to taxi slowly so the cabin attendant had sufficient time to prepare the cabin for take-off. The first officer also recalled slowing the aircraft with the brakes prior to entering the runways. The aircraft entered runway 32, back tracked and lined up on the runway centreline in preparation for take-off.

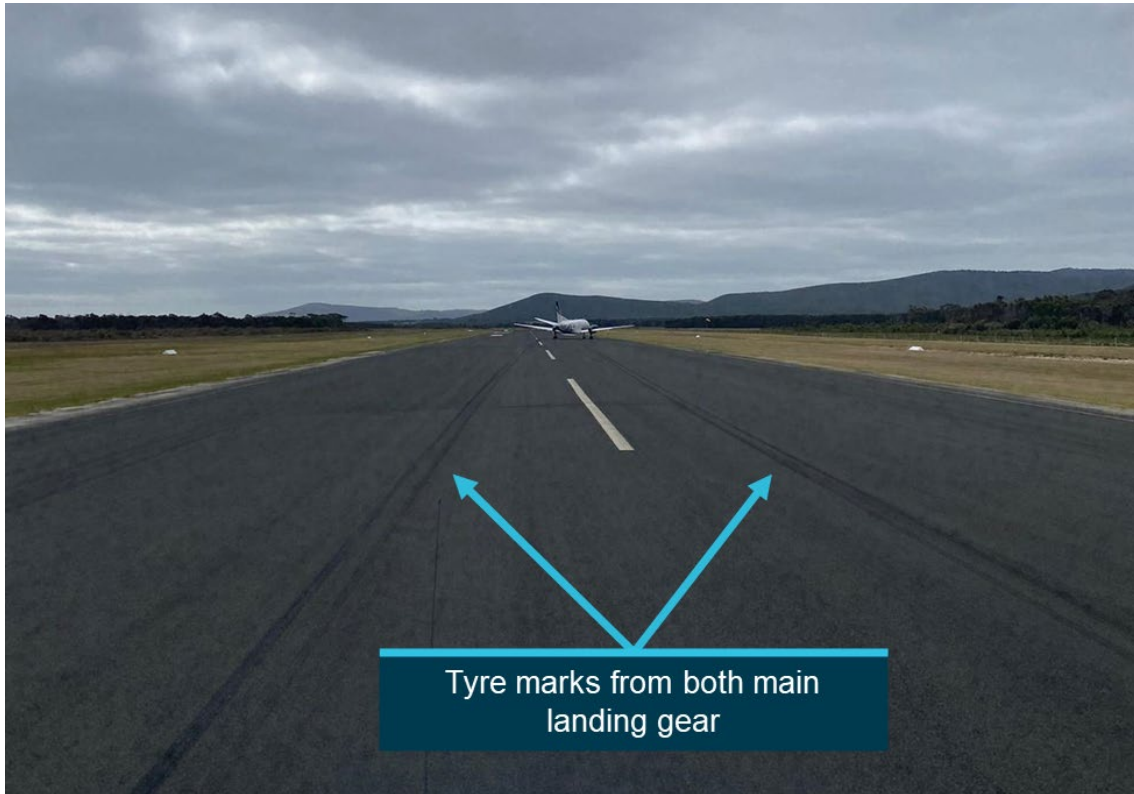
Figure 3: Tyre marks on runway

- tyre marks were evident commencing 300 m from the runway threshold until the aircraft came to a stop approximately 1,150 m from the runway threshold (Figures 3 and 4)
- initial tyre marks showed a veering to the left of centreline
- final tyre marks displayed a significant veer to the right with a change in tyre markings from a locked tyre to a deflated tyre prior to the aircraft coming to a stop (Figure 5).

Significant tyre marks, from all 4 main landing gear wheels, were observed on the runway after the occurrence. These tyre marks commenced early in the take-off roll and continued to the disabled
