# Propeller strike due to foreign object debris involving Beech 1900D, VH-NYA

Fortnum Aerodrome, Western Australia on 17 November 2022

**ATSB Transport Safety Report**

AO-2022-059

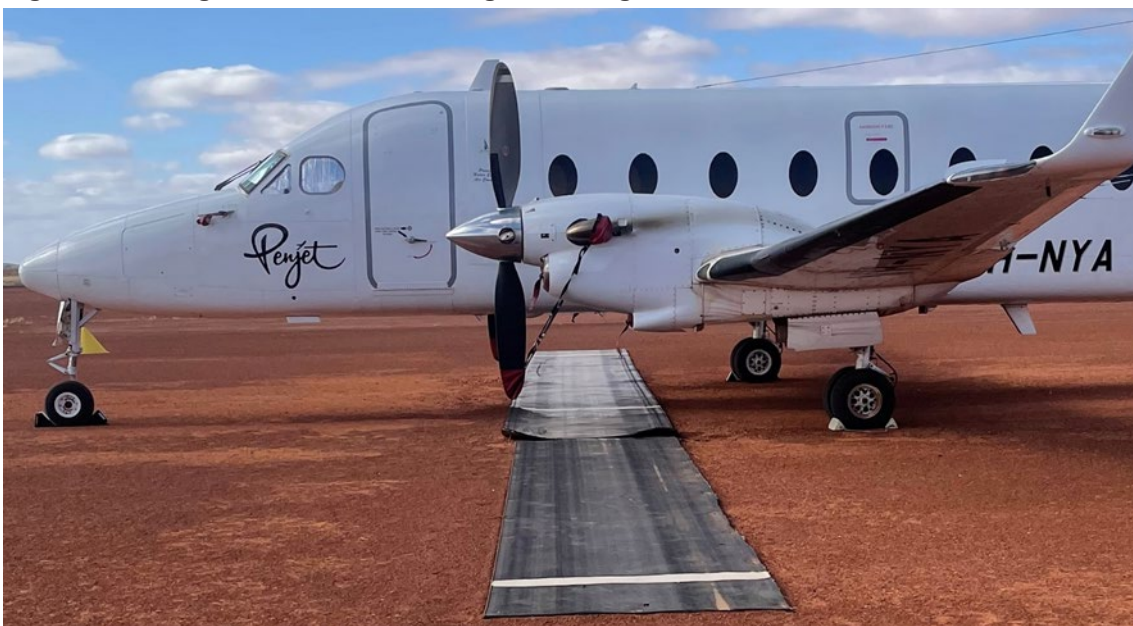
**Figure 1: Damaged aircraft and dislodged matting**

The aerodrome manager, who witnessed the event, advised that the propeller picked up a corner of the matting and one propeller blade was ejected about 50-100 m in the air. The blade landed on the apron about 10 m in front of the other aircraft parked near the fuel truck.

By aligning the centreline of the aircraft with the central white line, the aircraft was positioned with the left propeller disc located above the intersection of two conveyor belts. It is evident that the airflow produced at the propeller tips produced a lifting force on the matting and the corner nails of the inner belt were not sufficiently secured to hold it. As a result, the corner of the belt was drawn into the propeller arc and one propeller blade was sheared off near the hub and another blade was damaged. With one blade detached the propeller was severely unbalanced and generated significant engine vibration that damaged the aircraft.

Westgold Resources Limited advised that the conveyer belt strips and fixing nails were removed from the Fortnum Aerodrome apron.

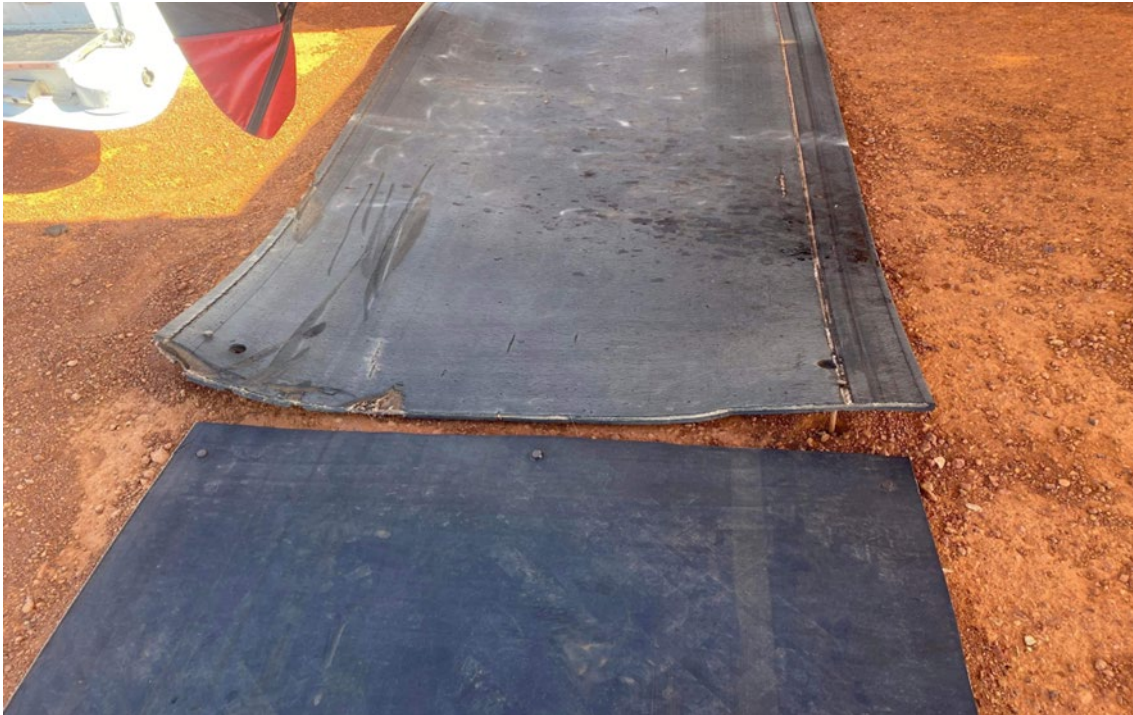
**Figure 2: Dislodged inner matting**

Although it is not possible to establish the condition of the inner belt before the accident, the aerodrome reporting officer and flight crews did not notice anything amiss. If other crews were also using the central white line to position aircraft over this matting, on those occasions one propeller would generally be placed over the intersection of the belts and there might have been progressive degradation of mat security. The crew did not have the opportunity to look at the matting as they might have done before an engine start in the same position.

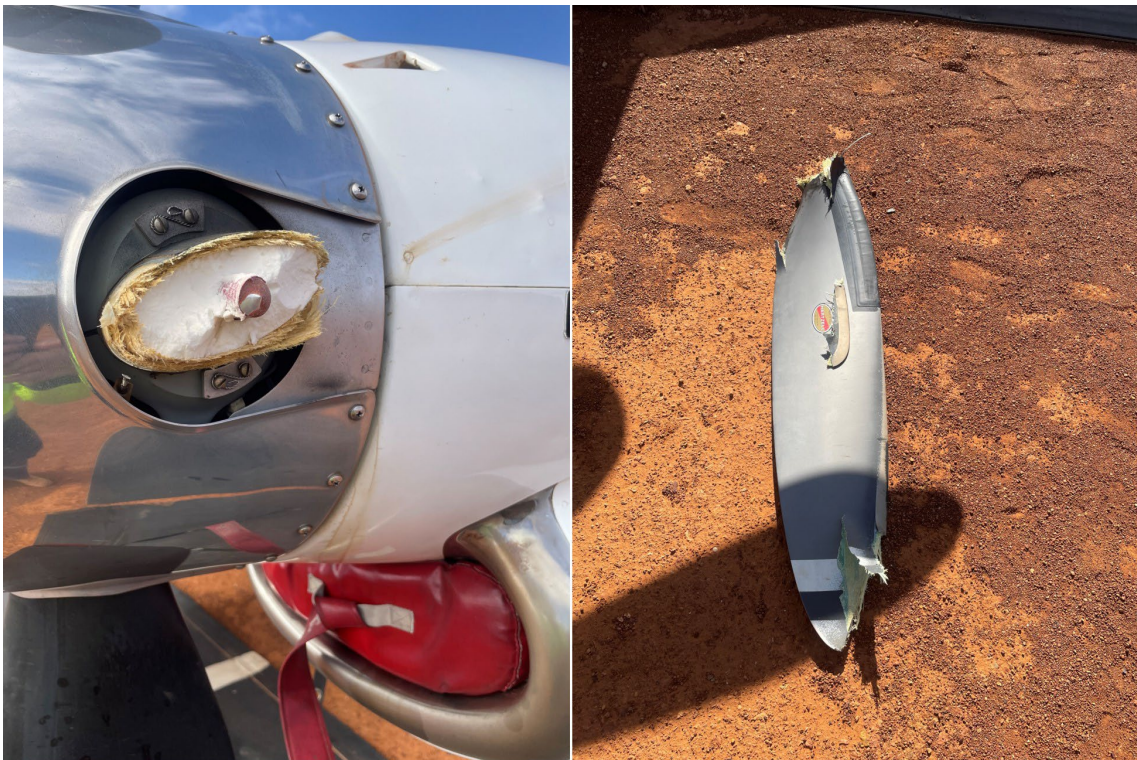
**Figure 3: Propeller hub and detached propeller**

In addition to the detached propeller blade (Figure 3), other damage included:

- another propeller blade snapped approximately 250 mm from the blade tip
- left engine propeller governor control arm fracture, with associated damage to top forward cowling
- buckling to the left engine firewall
- cracking to the nacelle structure adjacent to the left engine mount.
