Collision with rake of wagons and derailment of ore train R1006

Andoom (near Weipa), Queensland, 22 September 2019

ATSB Transport Safety Report

RO-2019-017 (Systemic)

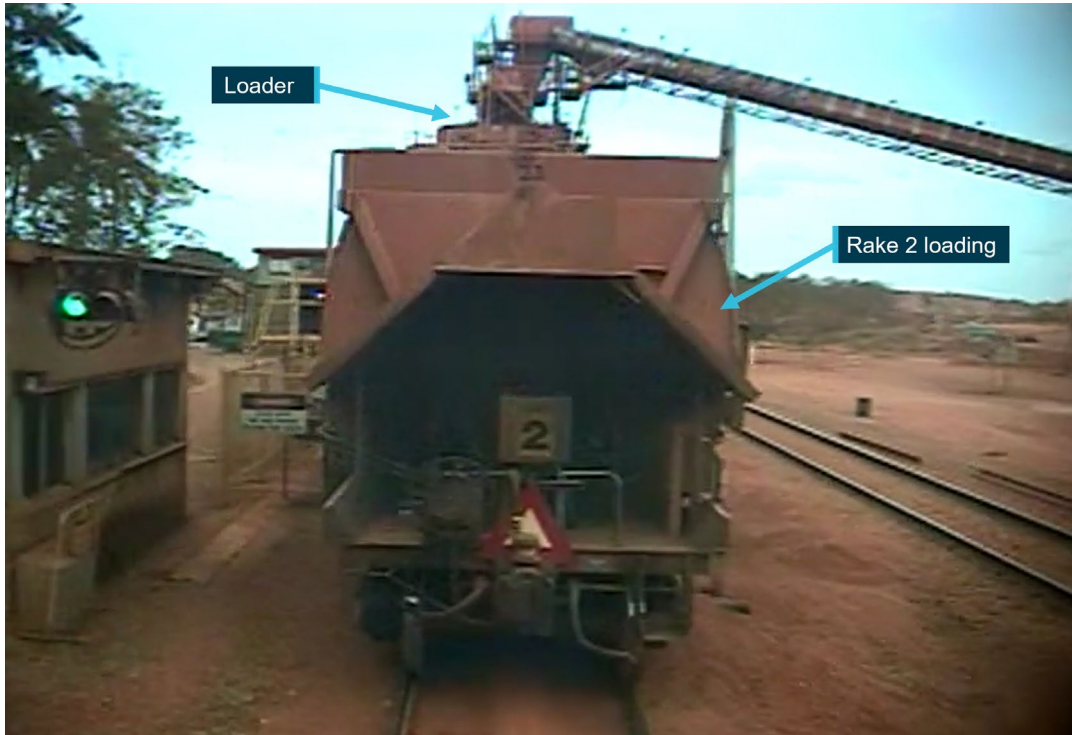
Figure 4: Front of train video capture just prior to the collision

aware that a train collision was imminent but was unable to prevent it despite different combinations of brake commands (Figure 4). During this period, the driver contacted the control centre by radio and advised them of the circumstances.

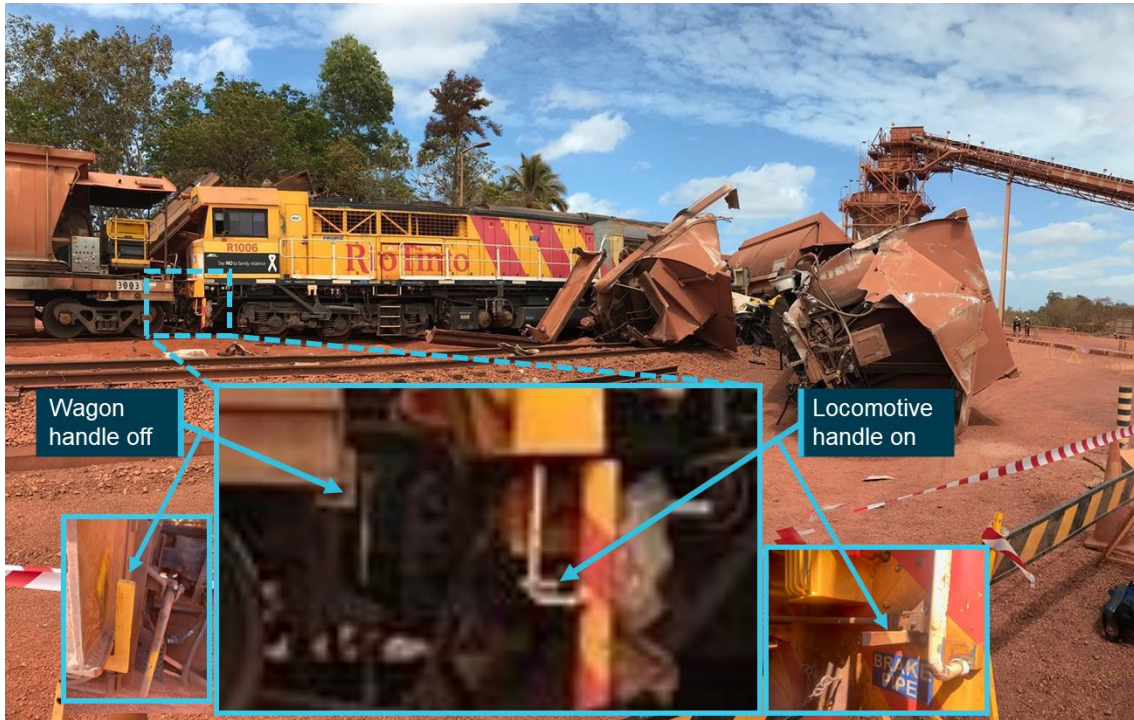
Figure 5: Position of brake pipe cocks on the locomotive (right) and following wagon (left)

An examination of the wreckage found that the pneumatic brake pipe cock was open on the locomotive (Figure 5 'locomotive handle on') but closed on the wagon directly behind the locomotive (Figure 5 'wagon handle off'). This configuration would prevent continuity of air through the train's brake pipe.

After the accident, the pneumatic brake pipe cock was found to be open on the locomotive but closed on the wagon directly behind the locomotive. This configuration would have prevented continuity of air through the train's brake pipe from the locomotive to the wagons.

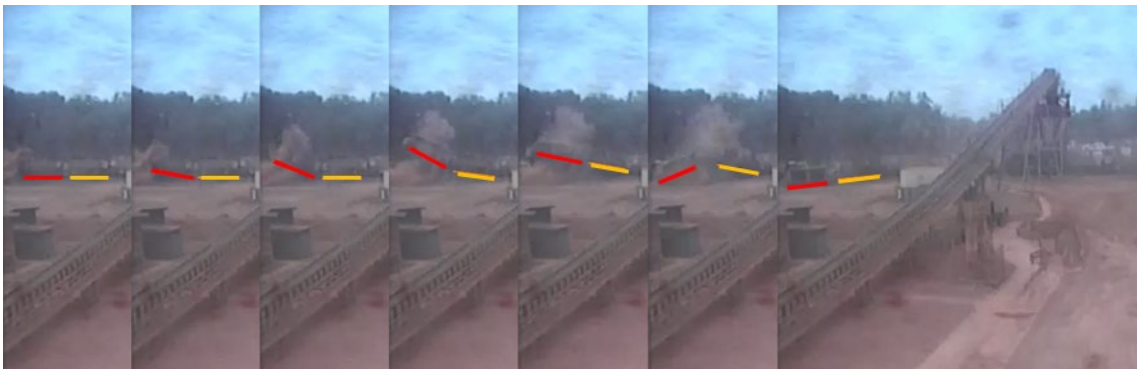
Figure 10: Footage of the collision sequence (composite of 1 second intervals travelling left to right)

The collision sequence was determined from closed-circuit television footage at the Andoom loading station. Figure 10 shows the trajectory of the second last (2089 - red line) and third last (2002 - amber line) wagon of the stationary rake when it was struck by locomotive R1006. Outside the field of view (to the left) was the last wagon (2023) of the rake. This wagon split in half on impact with the locomotive, with a portion landing on the rake mover mechanism to the left and another large portion landing to the right of the locomotive. The second last wagon could be seen to override remnants of the last wagon and then ride up over the locomotive before coming down to the right on its side. It was pushed clear of the adjacent track by the third last wagon, which the locomotive came to rest against (Figure 11).

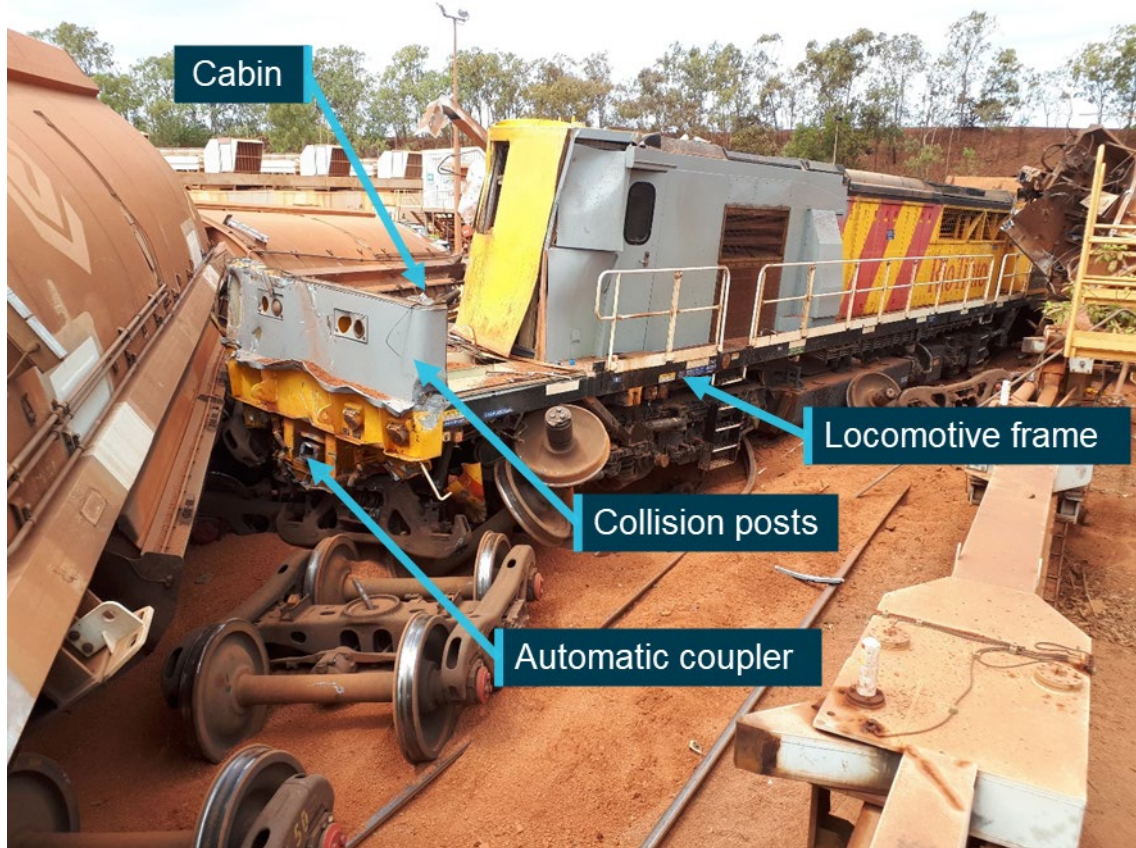
Figure 12: Locomotive collision posts

The coupler and frame of the locomotive took the majority of the initial impact forces. While the collision posts were struck as the locomotive under rode the trailing wagons, and withstood the impact with very little deformation, they were not effective at preventing the cabin from being crushed (Figure 12).

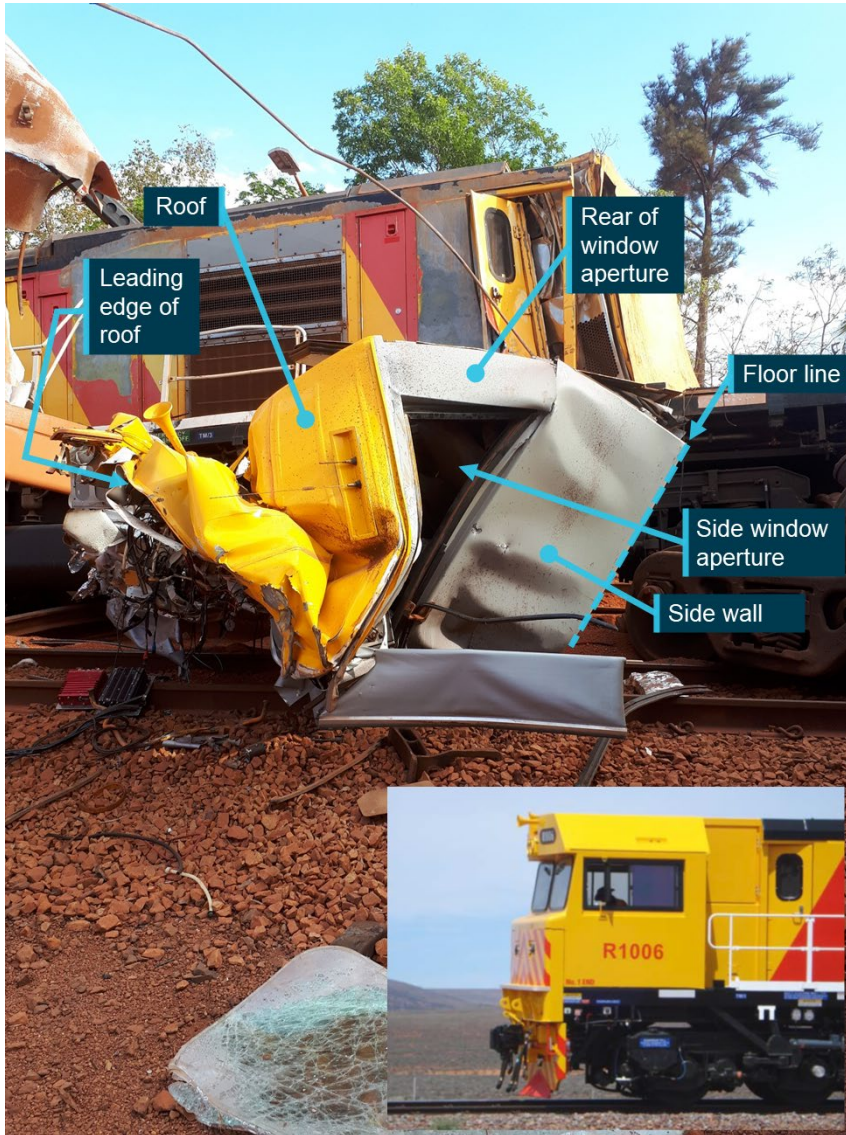
Figure 13: Damage to the driver’s cabin

The driver's cabin, which was a modular design (see *Modular cabin crashworthiness* below) became separated from the locomotive frame during the impact sequence. The cabin roof panel buckled under the compressive load of a wagon striking the windscreen area, and the horizontal roof panel folded back on itself. Further, it was also observed that, based on the folded direction of the panel to the rear of the side window aperture (Figure 13), a vertical compressive load had also been applied to the driver's cabin at some point in the impact sequence.

The vertical compressive load could have occurred due to an object coming down on the cabin or the cabin landing on its roof in the process of coming off the sub-floor structure. The damage sustained to the top right of the collision post near the modular cabin mounting point and the asymmetric compression of the services compartment immediately behind the cabin, suggests at least one wagon rode up over the collision posts

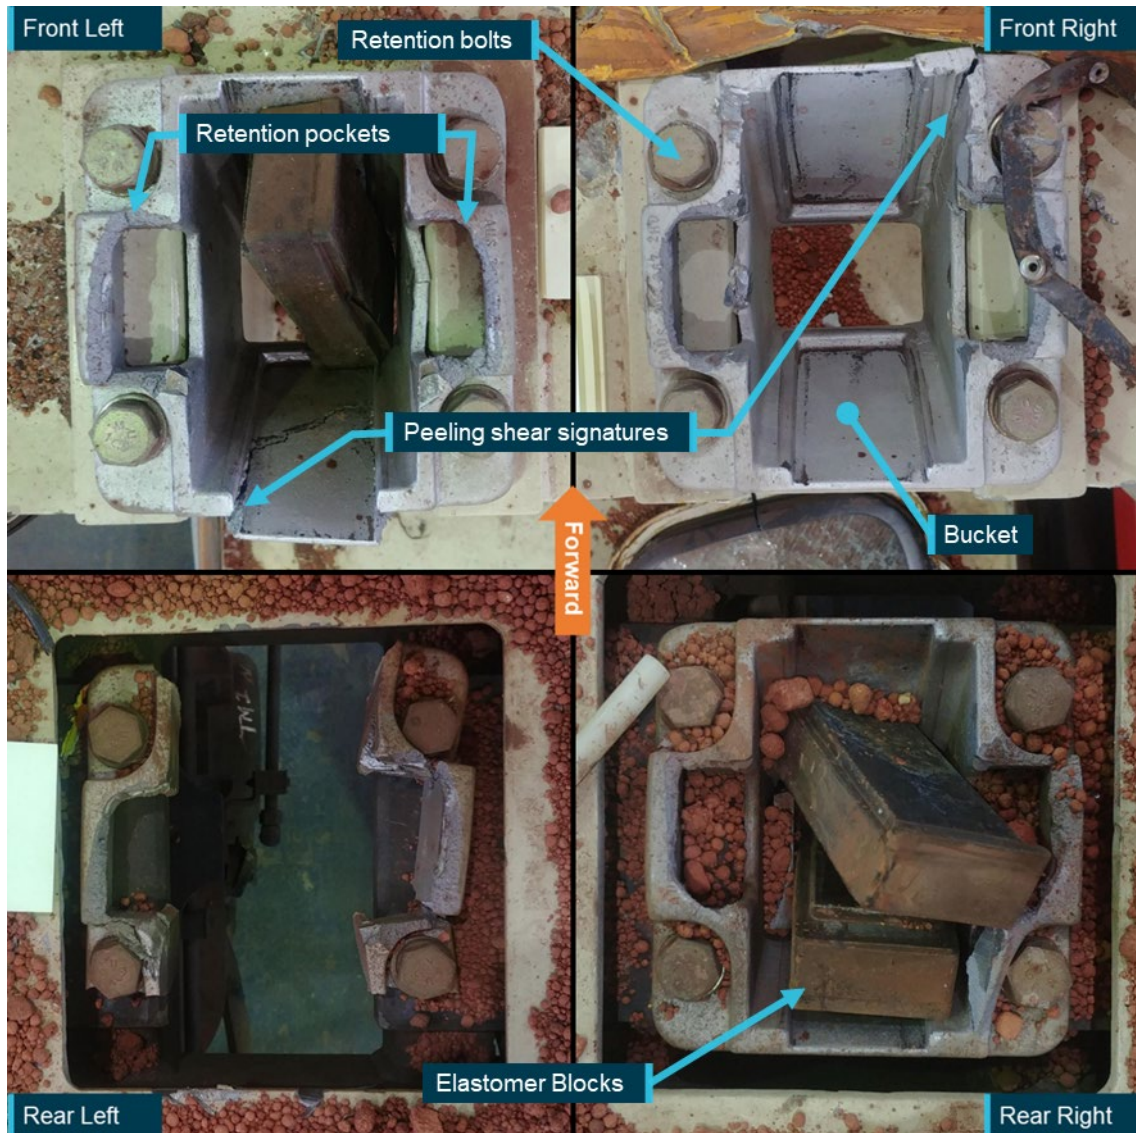
Figure 15: Cabin isolating resilient mounts

During the impact sequence, the front cabin mounts failed first under impact overload conditions. This allowed the cabin to fold back into the locomotive structure behind, resulting in the rear mounts also failing and the cabin separating from the locomotive structure.

In all cases, the wedge remained intact and the outer casting portion failed (Figure 15). Both front outer castings had peeling shear signatures from horizontal pressures applied by the wedge and elastomeric blocks. Markings on the rear right casting indicated the wedge departed to the right. The rear left outer casting disintegrated and had marks indicating the wedge may have departed with a large angle of rotation.

A feature common to both sides of all 4 aluminium outer castings was the failure of the top face of the retention pocket. This indicated that a substantial upwards load had been applied to each mounting point. All failures were symptomatic of a brittle material failing in overload. The failure force had been applied by the retention plates installed on the top of the wedge. The state of the retention plates after the accident varied widely. While some were bent and others were not, some were missing entirely due to their attachment bolts failing. However, there was evidence that some retention plates may have deformed or failed after the cabin had separated from the locomotive structure. In at least one case, a retention plate was bent upwards, which could not occur with the wedge positioned in the outer casting.

The design of the modular cabin mount was not resilient to frontal impact forces in the event of a collision. This increased the risk of their failure and separation of the cabin, removing the effectiveness of protection afforded by the collision posts.

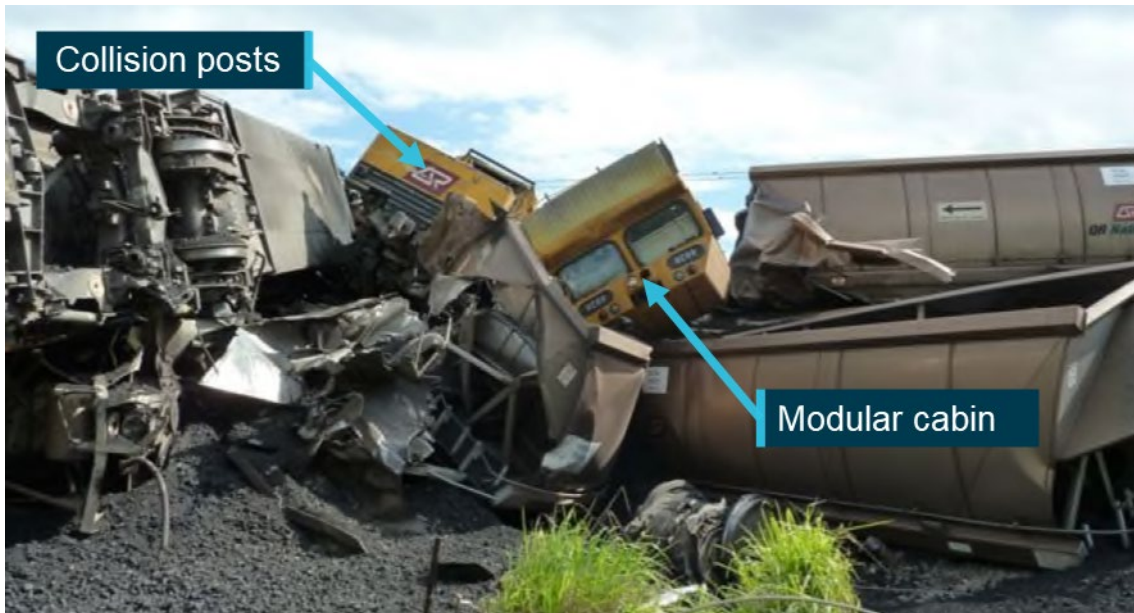
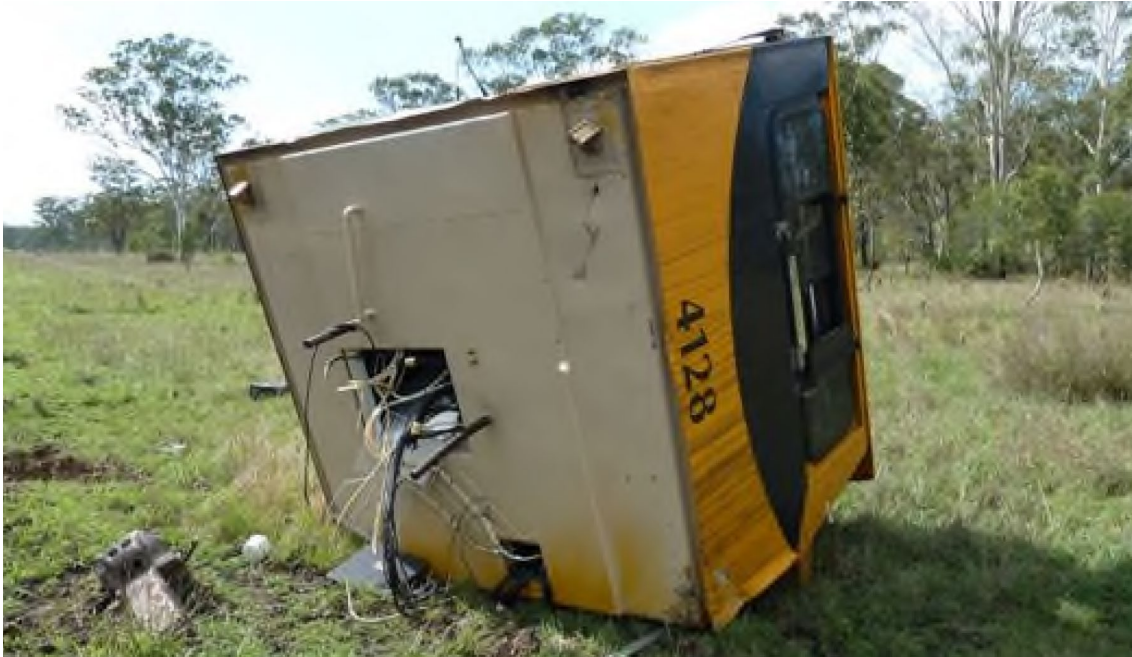
ElectroMotive concluded that the base of each resilient mount on the modular cabins had failed under the loads experienced during the collision. According to Downer EDI, the Ambrose GT42CU-AC locomotives were designed prior to AS7520.1. However, the original customer had specified the same shock load requirements as detailed in this standard. That is, 4g longitudinal, and 2g lateral and vertical. Similarly, Downer had specified the same requirements for the cabin mounts, with the addition of considering the static load for the vertical acceleration.

Both the Downer EDI and ElectroMotive reports made recommendations that the cabin mounts be strengthened. The Downer report additionally stated, 'It is highly undesirable that the cabin should separate from the locomotive, even under overload conditions'. The Downer EDI report discussed a modification to the design that claimed a fourfold increase in strength.

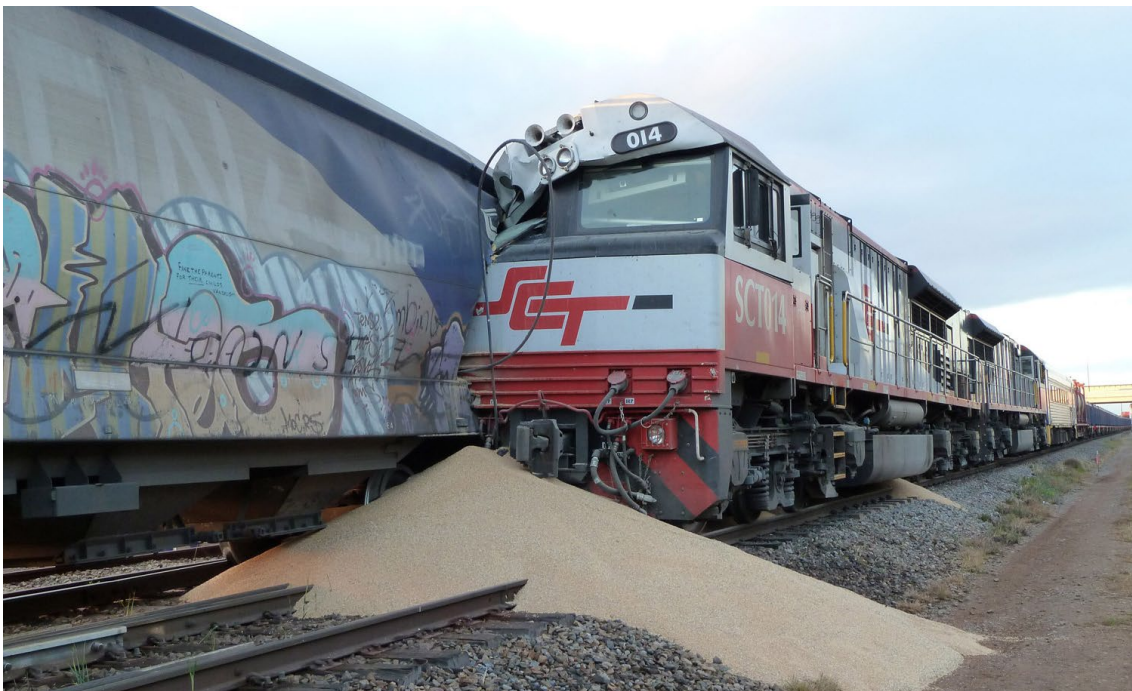
Figure 20: Locomotive SCT014 with collapsed right side of cabin

On 11 October 2011, an empty ore train struck loaded grain wagons traversing a turnout at Dry Creek, South Australia. The lead locomotive obliquely struck the wagons impacting the top right corner of the modular drivers' cabin (Figure 20).

The ATSB investigation found that the front right mount (on top of the collision post) failed due to direct contact with the grain wagons. While there was gross intrusion into right side of the cabin, the survivable space was maintained as the cabin structure remained in place behind the collision posts.

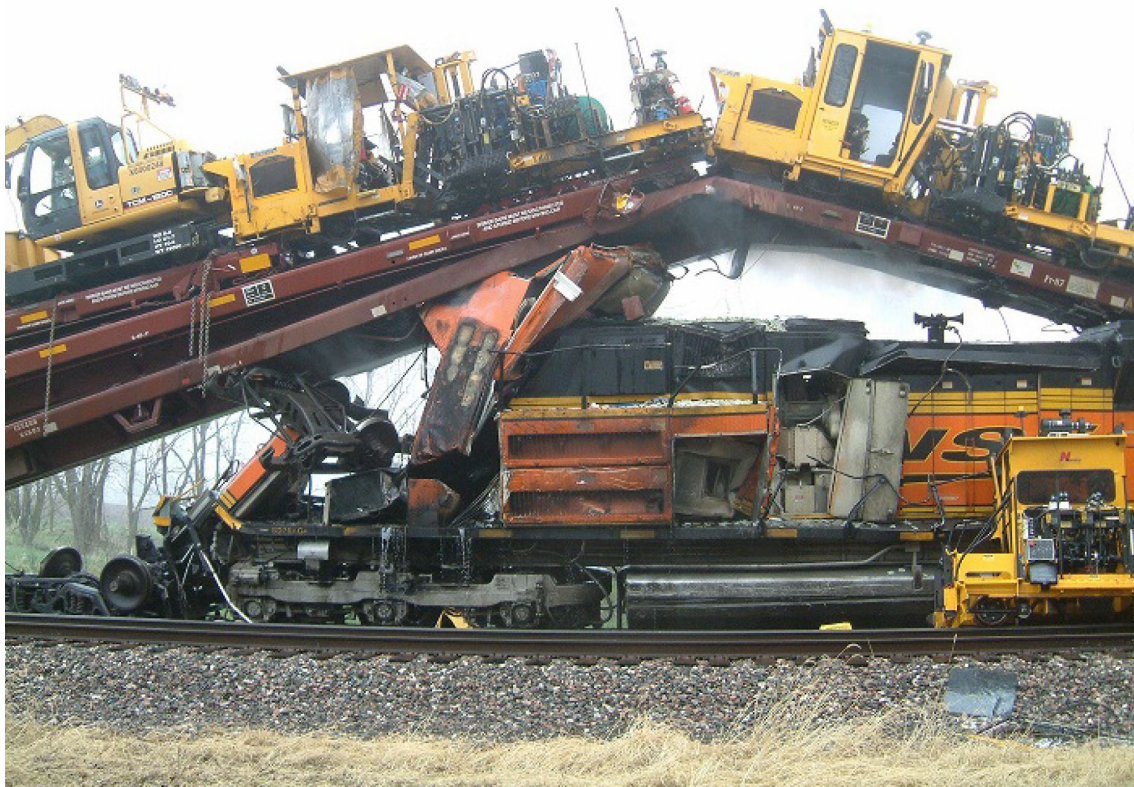
Figure 21: Locomotive over-ridden by equipment train

The modular cabin had sustained a substantial loss of occupied space. The cabin had separated from the locomotive and the bottom half of the cabin rotated up just over 90°. The roof and left rear corner of the cabin were crushed. The side walls remained intact to the point of the window line and the underside was relatively intact. The general condition of the modular cabin attachment points indicated that they had been subjected to severe vertical forces and shear. When the cabin separated, the short hood and collision posts no longer provided the protection intended by the crashworthiness design standards. It was noted in this impact that the collision posts were bent back over 30° (Figure 21).

Therefore, the NTSB recommended that the Federal Railroad Administration (FRA) (R-12-21) and Association of American Railroads (R-12-23) amend the relevant regulations and standards to ensure the protection of occupants of modular cabins in the event of a collision. They also recommended the FRA require crashworthiness performance validation for all new locomotive designs (R-12-22).
