Engine failure and collision with terrain involving S.E.D.E. Morane-Saulnier MS.893A, VH-UQI

22 km south-west of Archerfield Airport, Queensland, on 6 November 2020

ATSB Transport Safety Report

AO-2020-060

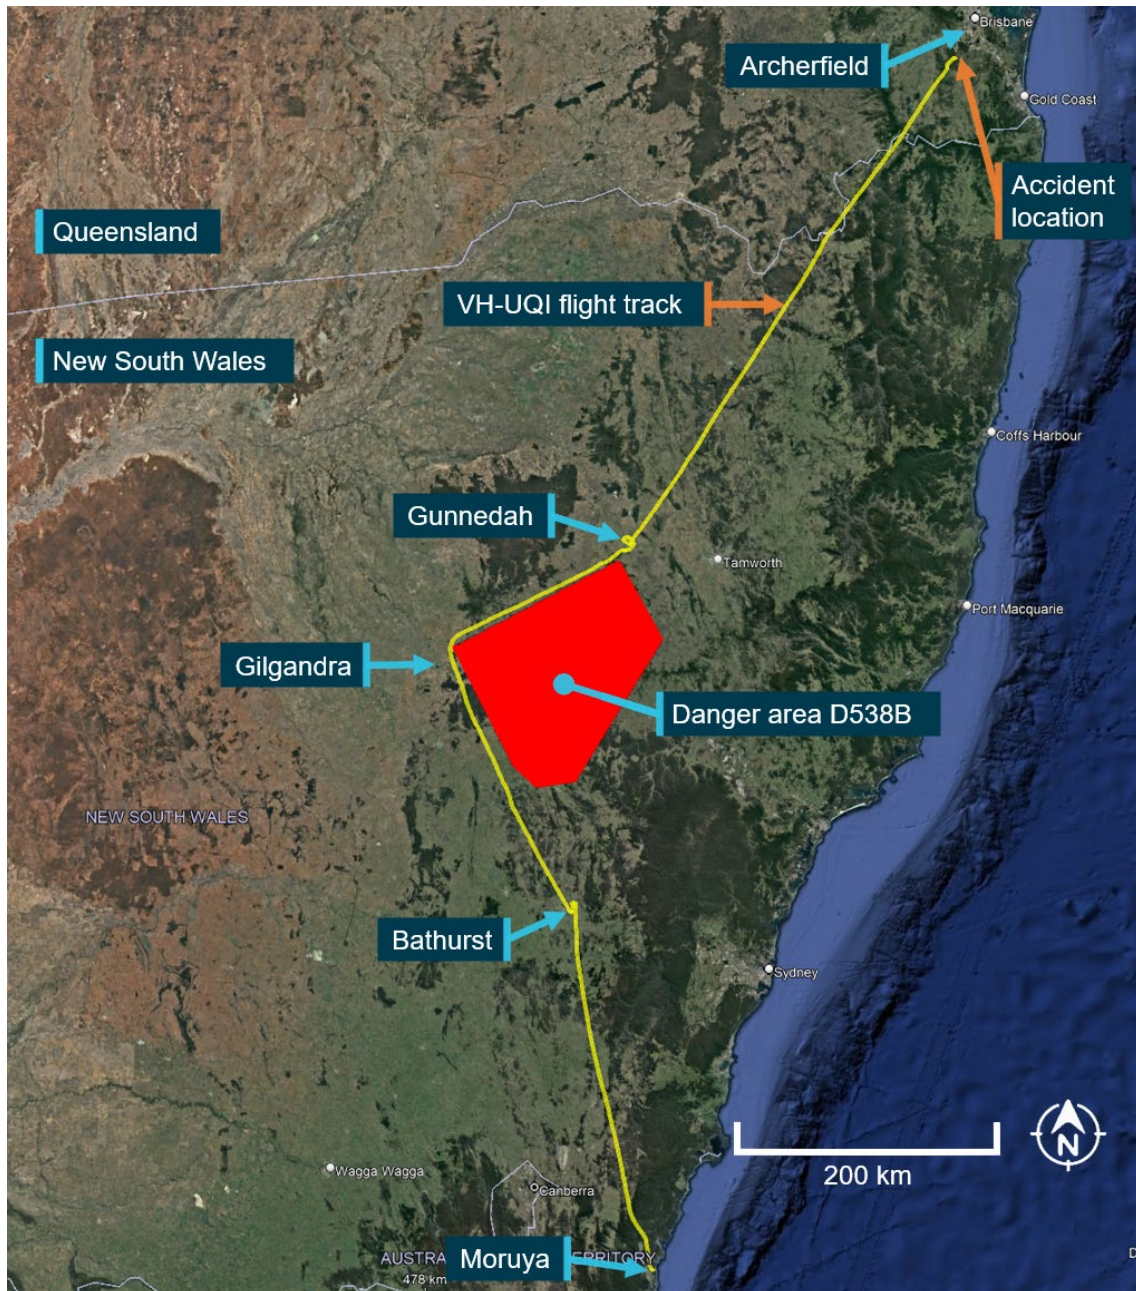
Figure 1: Recorded flight track of VH-UQI from Moruya, NSW to accident site

Figure 1 shows the flight track for the aircraft. The pilot flew to Bathurst without incident, where the aircraft was refuelled. Departing Bathurst, the aircraft tracked toward Gilgandra, before changing course to Gunnedah. The pilot recalled tracking around Danger area³ 538B, a military flying area, as the reason for this indirect route.

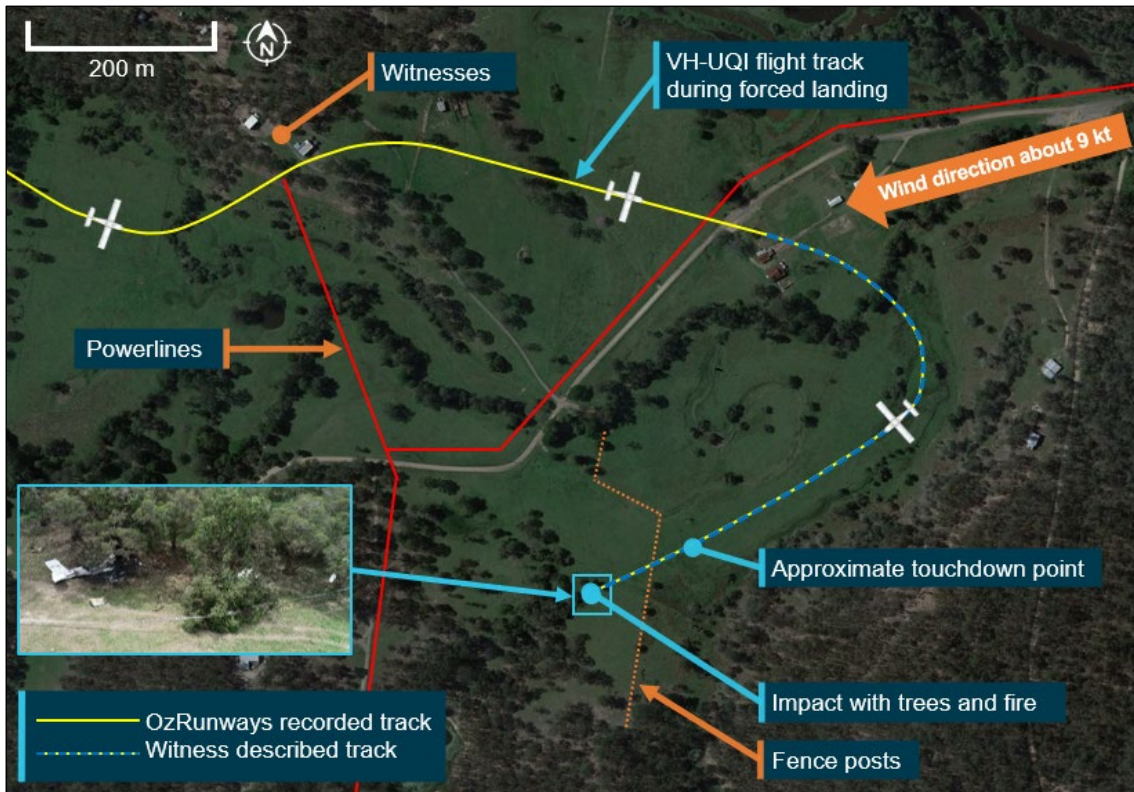
Figure 2: VH-UQI flight path and forced landing area

The pilot recalled that the aircraft ran rough and lost engine power, before complete engine stoppage. At the time, VH-UQI was approaching numerous built-up areas and the pilot had limited suitable forced landing area options. The pilot reported that their forward vision was obscured by black smoke and oil emanating from the engine. The recorded flight path showed that the aircraft conducted a right turn towards an open paddock (Figure 2).

The pilot had no recollection of the wind direction from the Archerfield aerodrome terminal information service⁷ or from local wind indicators. The final approach was in a south-westerly direction, which was downwind. The aircraft touched down about two-thirds of the way into the

paddock and then became temporarily airborne due to ground undulations before impacting trees. The impact resulted in significant disruption to the aircraft structure and initiated a post-impact fire.

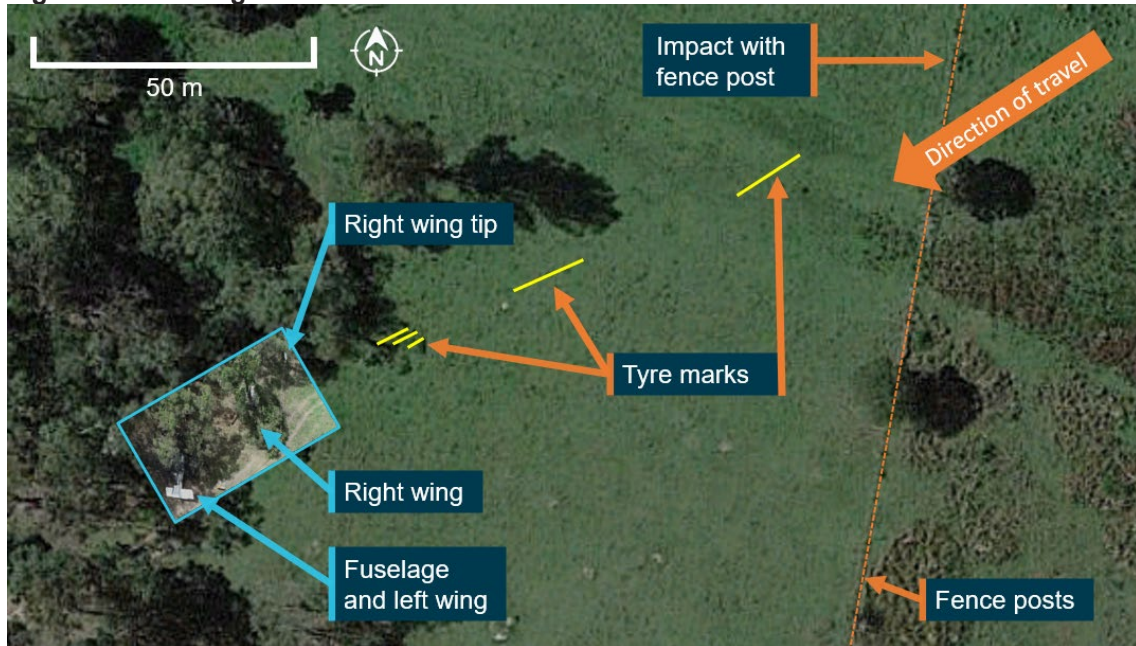
Figure 3: Aircraft ground contact and accident site

The right-wing tip struck trees about 2 m above the ground and separated from the wing. The right wing then impacted another tree, between the wing root and midway along the wing, then separated from the fuselage. This impact pivoted the aircraft 90° to the right. The fuselage and left wing travelled a further 10 m before coming to rest. The forward left side of the aircraft impacted a large tree, resulting in the engine, firewall and nose gear separating from the fuselage.

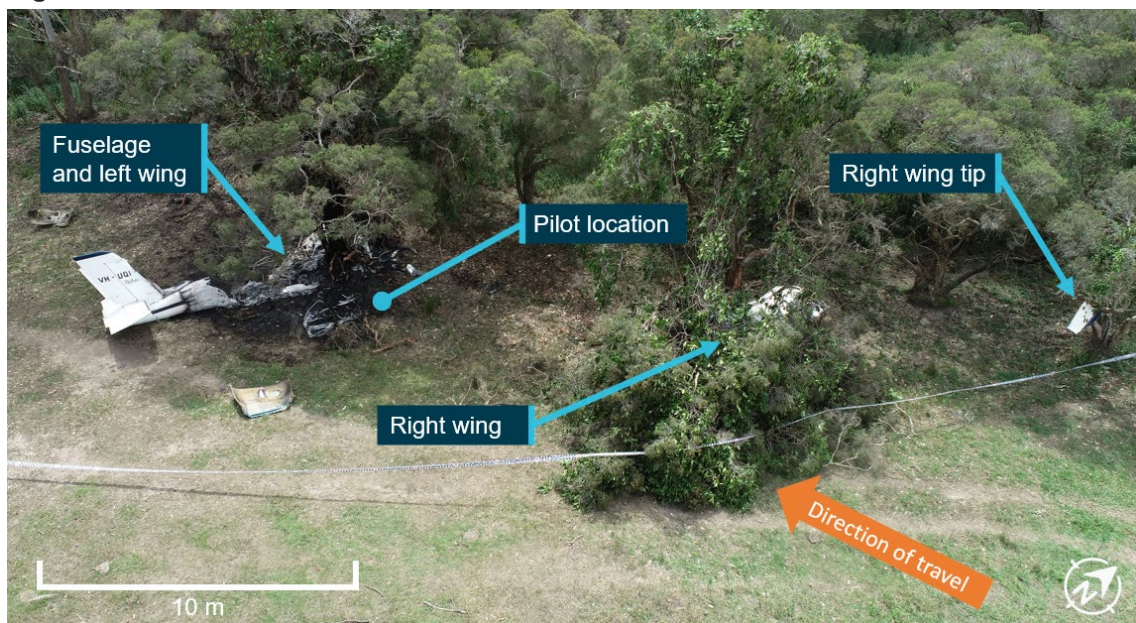
Figure 4: VH-UQI accident site

The engine, fuselage and left wing were exposed to a post-impact fire, and the empennage section remained largely unburnt (Figure 4). Examination of the aircraft structure and flight controls did not identify any pre-impact defects. The flaps were determined to be in the full down position at impact.

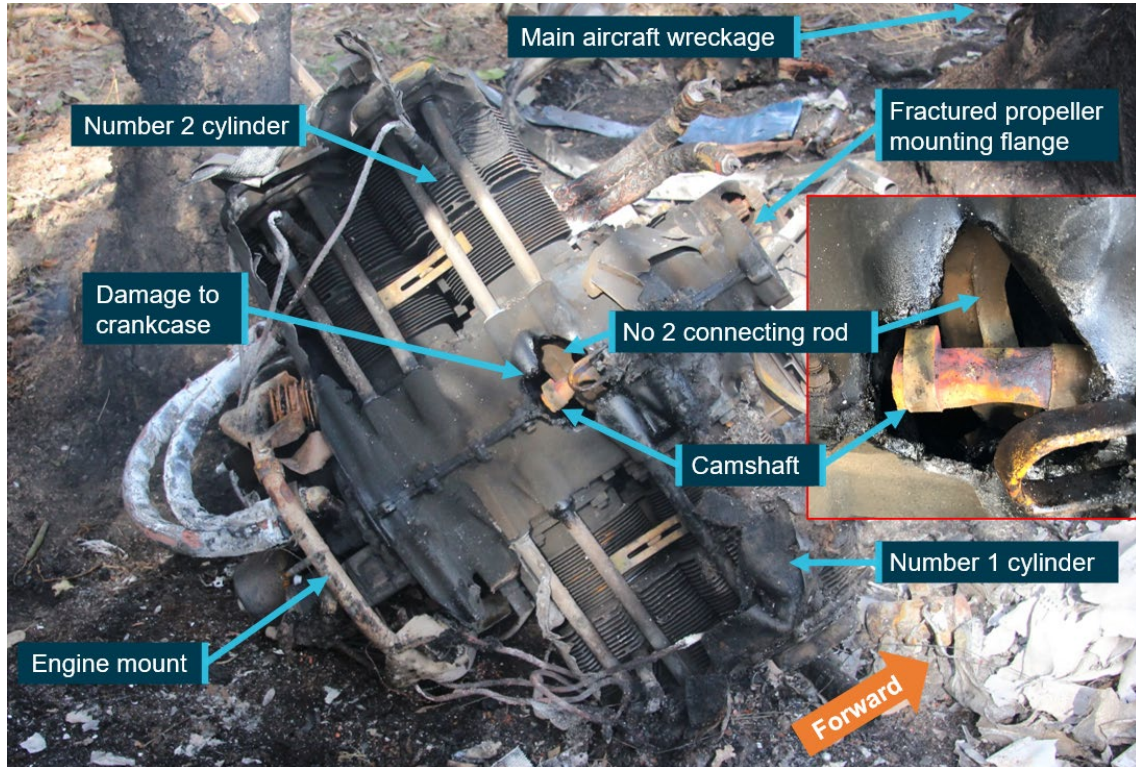
Figure 5: Engine assembly showing a hole in the crank case and internal damage

On-site examination of the engine identified a large hole in the top of the crankcase, between the number 1 and 2 cylinders. Visible through the hole was the fractured camshaft and number 2 piston connecting rod (Figure 5).

A smaller hole was noted on the underside of the crankcase, adjacent the number 1 cylinder and forward of the number 2 cylinder. The propeller and its mounting flange on the crankshaft had fractured in overload level with the front of the crankcase and was not affected by fire.

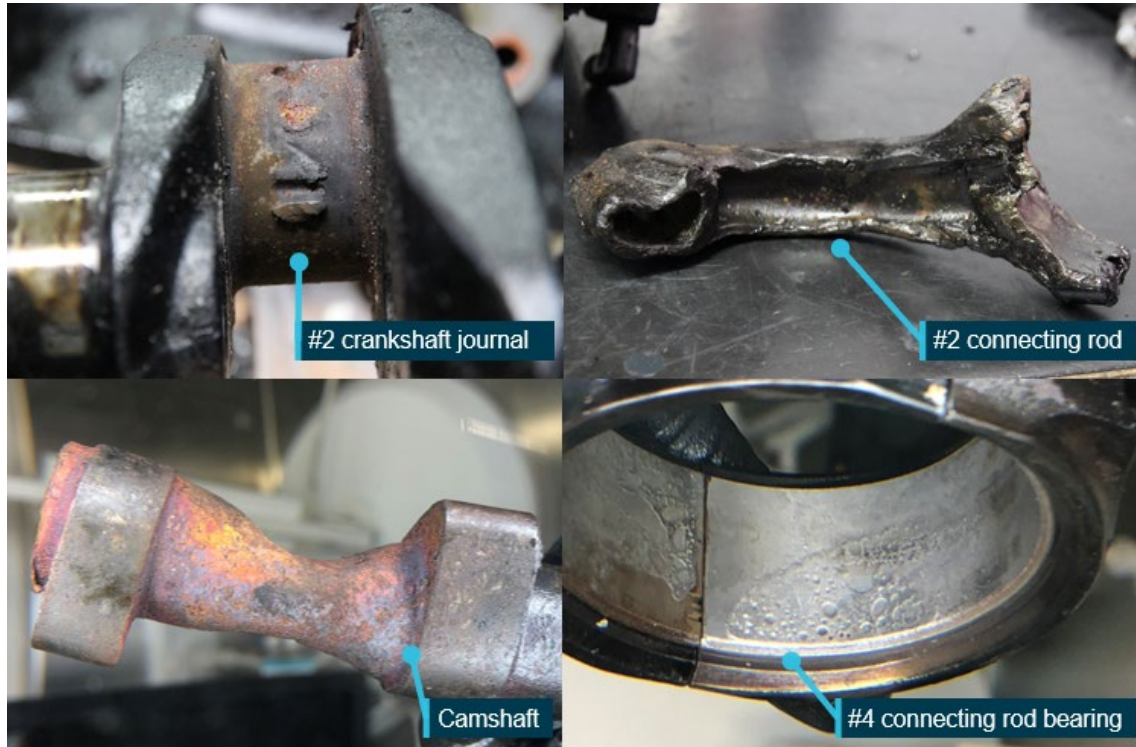
Figure 6: Damaged engine components removed from VH-UQI

The engine was disassembled and inspected under the supervision of the ATSB. The examination revealed that all components were heat affected from the post-impact fire. The crankcase had large holes either side of the number 2 cylinder and a series of adjacent impact marks on the internal surface. The number 2 connecting rod was fractured and separated from the crankshaft journal and piston. The connecting rod fracture surfaces were significantly damaged, which precluded any meaningful materials failure analysis.

The piston pin boss had fractured due to overstress; however, the piston pin showed no damage. The crankshaft showed significant impact damage and wear of the number 2 journal. The other journals were also discoloured but were otherwise undamaged. The number 2 journal bearing was destroyed, such that only small fragments remained. The number 1, 3 and 4 journal bearings did not exhibit any cracking, damage, or severe wear. Discrete areas of the bearing surface had a

‘cratered’ appearance, which was likely the result of localised melting of the thin bearing layer adjacent to the crankshaft journal. The absence of any significant operational wear associated with these areas, indicated that the melting was most likely due to the post-impact fire.

It was also found that the crankshaft oil supply galleries to the internal components were unobstructed. The damage to the number 2 conrod and bearing journals were consistent with the engine failure initiating due to breakdown of the number 2 bearing (Figure 6).

The connecting rod journal bearings fitted to the engine for VH-UQI were part number LW-13521 and marked with a manufacture date of 12-95. These were premodification bearings composed of an aluminium-tin alloy on a steel backing, which had been superseded in September 2004 by [Lycoming Service Instruction No. 1512](#). The LW-13521 bearings were required to be replaced with the upgraded bearings whenever new bearings were to be installed (such as at engine overhaul).

The ATSB determined that the initiating factor of the engine failure was likely the breakdown of the number 2 connecting rod journal bearings. This would have resulted in excessive clearance between the connecting rod and crankshaft journal. Therefore, this allowed increased flexure of the big end bearing housing under continued loading cycles, and ultimately fatigue failure of the connecting rod and damage to the surrounding components.
