# Separation occurrence involving Boeing 737-8FE, VH-YIO and Cessna Caravan 208, VH-YMV

Ballina Byron Gateway Airport, New South Wales on 16 September 2021

**ATSB Transport Safety Report**

AO-2021-038

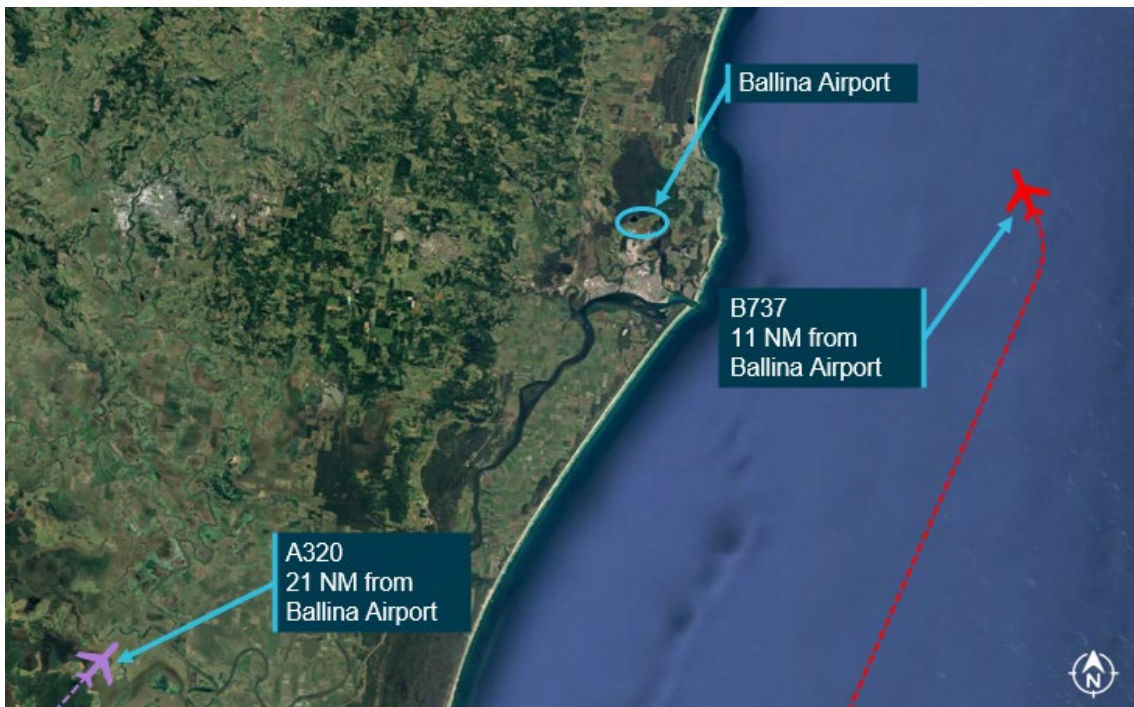
At 1341:27, the SFIS controller responded to the Caravan pilot's broadcast and provided the pilot with traffic information on the B737 and a Jetstar Airbus A320 (A320), registered VH-VQK, that was also inbound to Ballina Airport (Figure 2). The SFIS controller stated:

**At 1341:51, the pilot of the Caravan advised the SFIS controller that they had copied the traffic and correctly read back the transponder squawk code. Figure 2: A320 and B737 locations at 1341:27**

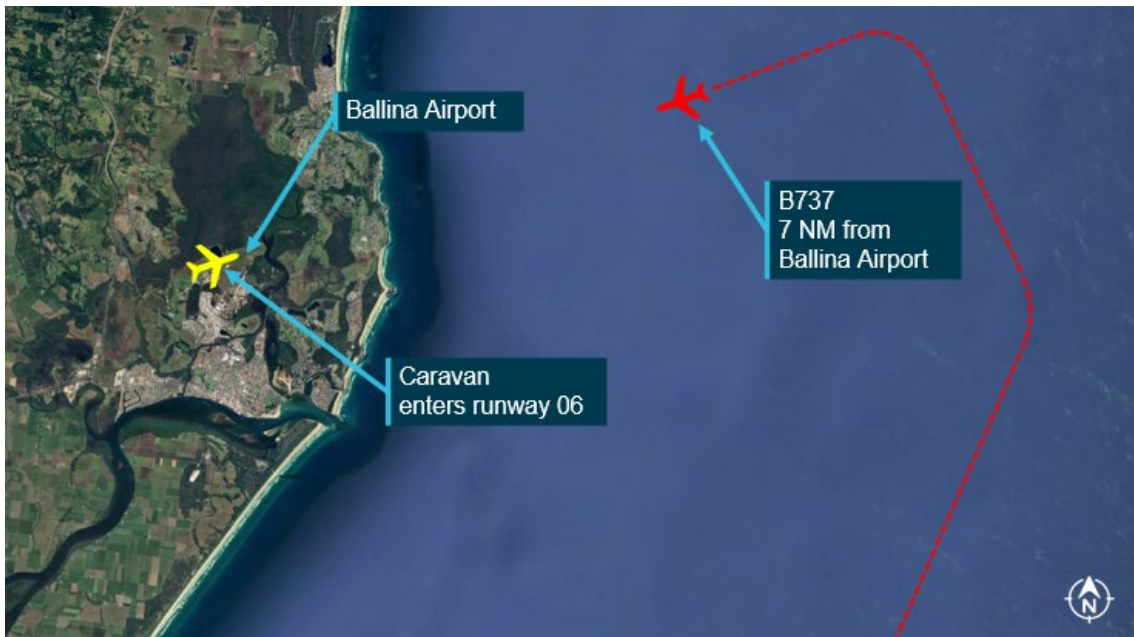
At 1343:28, the pilot of the Caravan made a broadcast on the CTAF stating that the aircraft was entering and rolling runway 06 (Figure 3).

**Figure 3: Caravan and B737 locations at 1343:28**

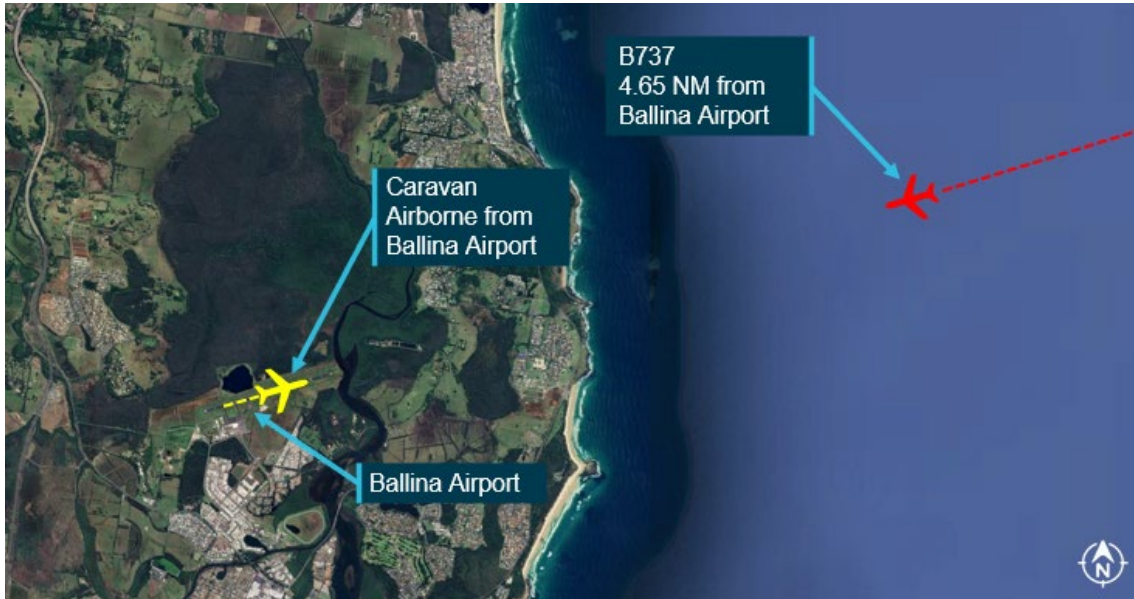
At 1344:15, the B737's FO made a further broadcast on the CTAF querying the Caravan's location. At 1344:19, the Caravan's pilot responded stating that the aircraft had just become airborne from runway 06 (Figure 4). The B737's FO immediately replied asking if the Caravan pilot could see the B737, which was now on a 3 NM final for runway 24. At 1344:36, the Caravan pilot confirmed sighting the B737, and its FO then requested the Caravan pilot to commence a turn. The Caravan pilot did not respond to the FO's broadcast, but the pilot did initiate a turn to the right shortly after becoming airborne.

**Figure 4: Caravan and B737 locations at 1344:19**

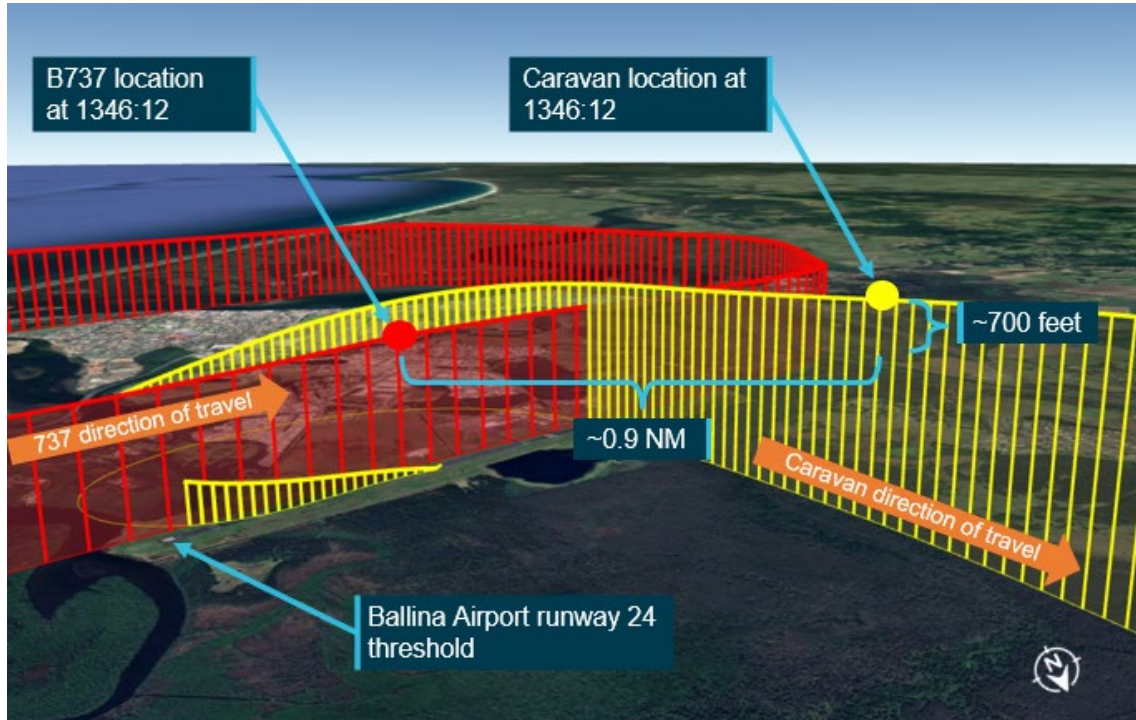
A review of recorded flight data indicated that the closest point of approach occurred at 1346:12 as the lateral separation between the 2 aircraft decreased to approximately 0.9 NM with vertical separation reducing to about 700 feet (Figure 5).

Figure 5: Caravan and B737 tracks and relative distances

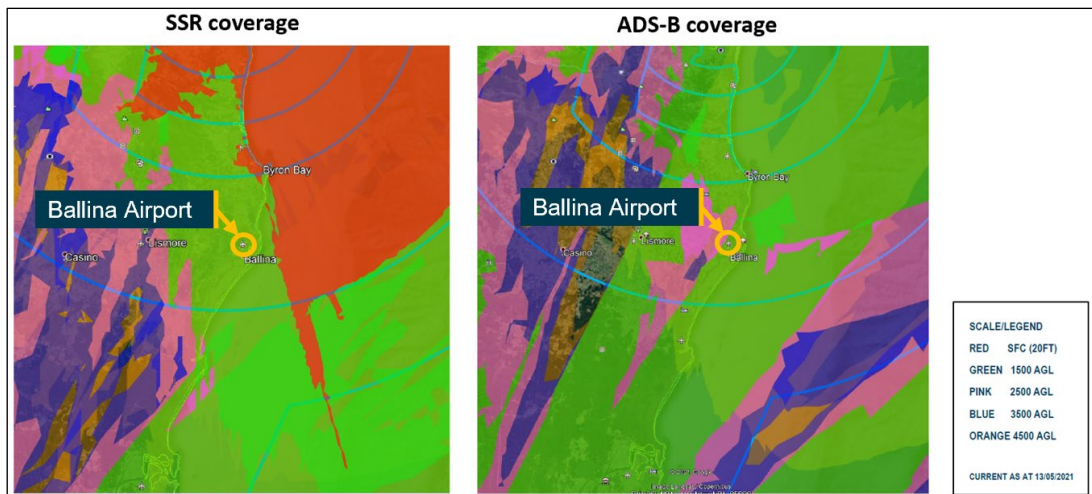
Documents developed by Airservices Australia before implementing the Ballina Airport SFIS contained a list of ‘critical components’ necessary for the service. Although ‘adequate surveillance coverage’ was one of these critical components, Ballina Airport had no ADS-B ground station and the surrounding area had significant limitations in SSR and ADS-B coverage. Surveillance coverage charts produced by Airservices Australia indicated that, near the airport, the SSR and ADS-B coverage did not commence until about 1,500 feet above ground level (Figure 8).

**Figure 8: SSR and ADS-B coverage within the vicinity of Ballina Airport**

The hazards and risks associated with the surveillance coverage limitations were identified by Airservices Australia prior to the implementation of the SFIS and documented as:

Limited surveillance coverage may lead to unintended aircraft proximity (Airprox), inadequate separation assurance (ISA), or loss of separation (LOS) occurrence.
