Air traffic control error involving Boeing 737, VH-YFT

Near Armidale, New South Wales on 19 October 2022

ATSB Transport Safety Report

AO-2022-052

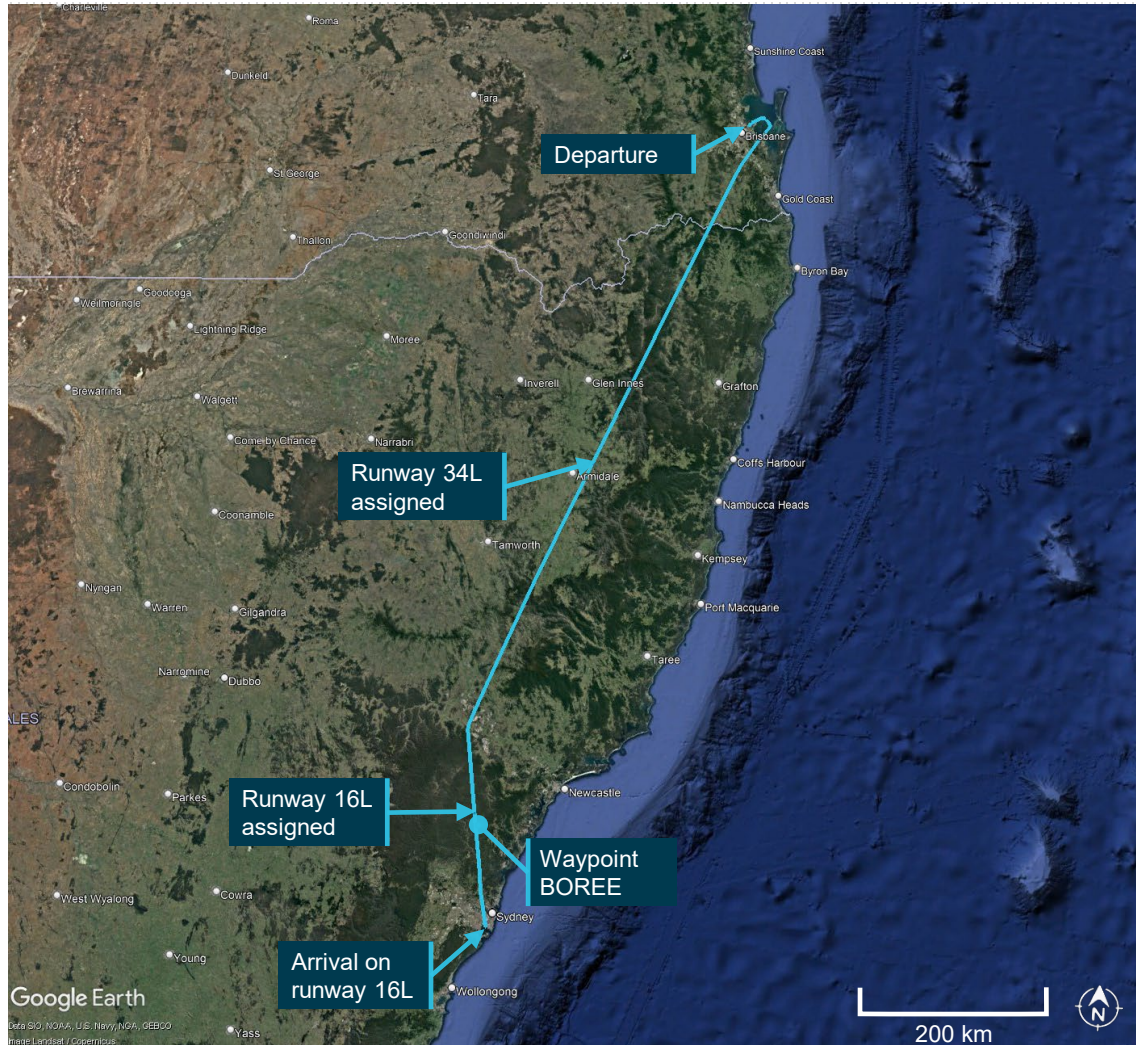
Figure 1: Flight path of VA942 with respect to when the runway was assigned.

On 19 October 2022, at 0148 Coordinated Universal Time (UTC), a Boeing 737-8FE aircraft, registered VH-YFT and operated by Virgin Australia as flight number VA942, departed Brisbane Airport, Queensland, on a domestic scheduled passenger flight to Sydney, New South Wales (Figure 1).

During the descent, the crew contacted Sydney Approach, informing them they were on descent to 10,000 ft and acknowledged receipt of the current ATIS. At this point, the aircraft was at about 17,275 ft and 6 NM from waypoint⁵ BOREE. The approach controller replied, confirming runway 16L and to expect an independent visual approach⁶ via the STAR to 6,000 ft.

Immediately, the crew questioned the runway assignment informing the approach controller they had been assigned 34L, rather than 16L. The approach controller confirmed that runways 16L and 16R were in operation, and that 16L had been assigned. The flight crew accepted runway 16L, and the approach controller advised the crew that ‘...if you do need some extra track miles to get down to let me know [to] give you some vectors.’ The aircraft continued as cleared and joined the approach as normal.

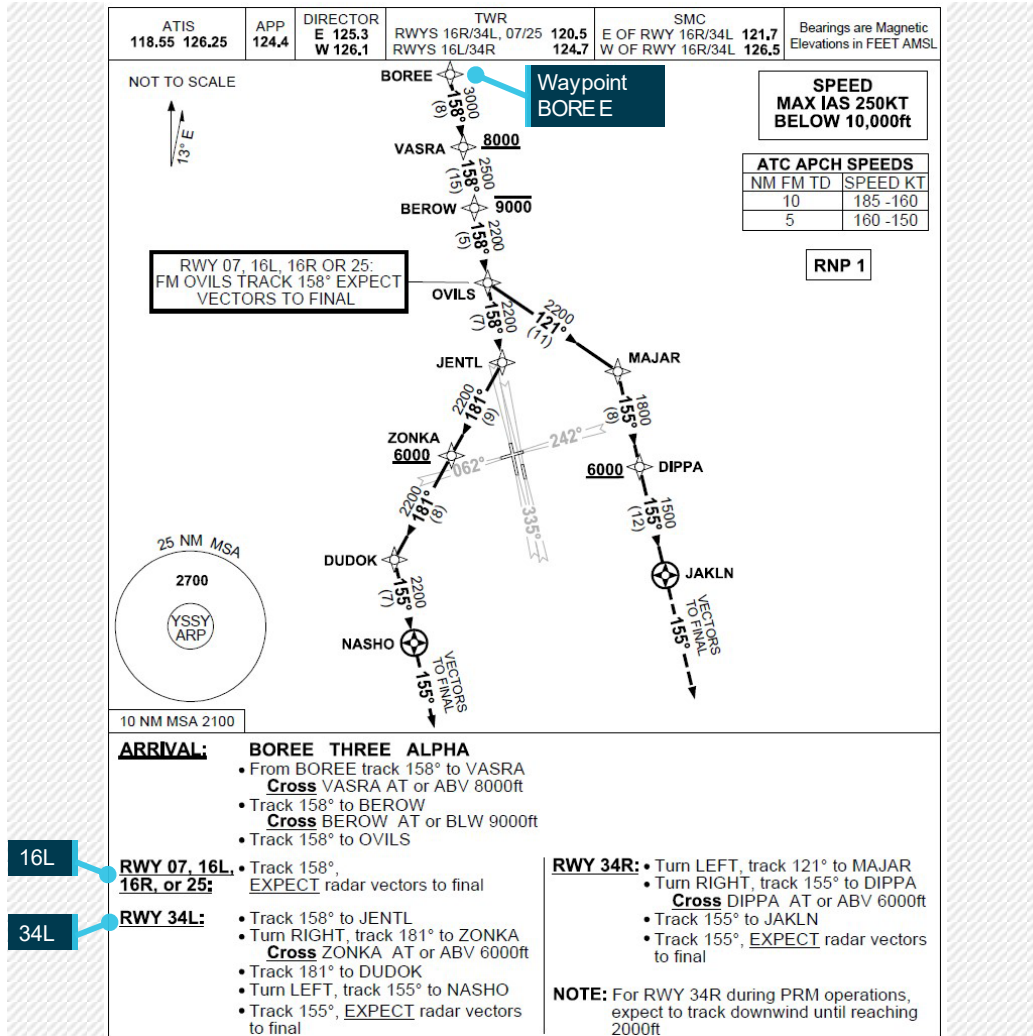
Figure 2: BOREE 3A Arrival STAR Chart

The BOREE 3A arrival positioned aircraft to receive radar vectors to final for all Sydney Airport runways, including 16L and 34L. Waypoint BOREE is the initial approach fix, and the track then later branches for the different runways at waypoint OVILS (Figure 2). The crew reached waypoint BOREE about one minute after the correct runway was confirmed, which required that the approach be re-briefed by the crew. In this case, the change to the approach required that the aircraft fly the procedure as briefed to OVILS where radar vectors would then be provided by ATC.
