Collision with terrain involving Robinson Helicopter Company R44, VH-TKI

Forresters Beach, New South Wales on 19 November 2022

ATSB Transport Safety Report

AO-2022-060

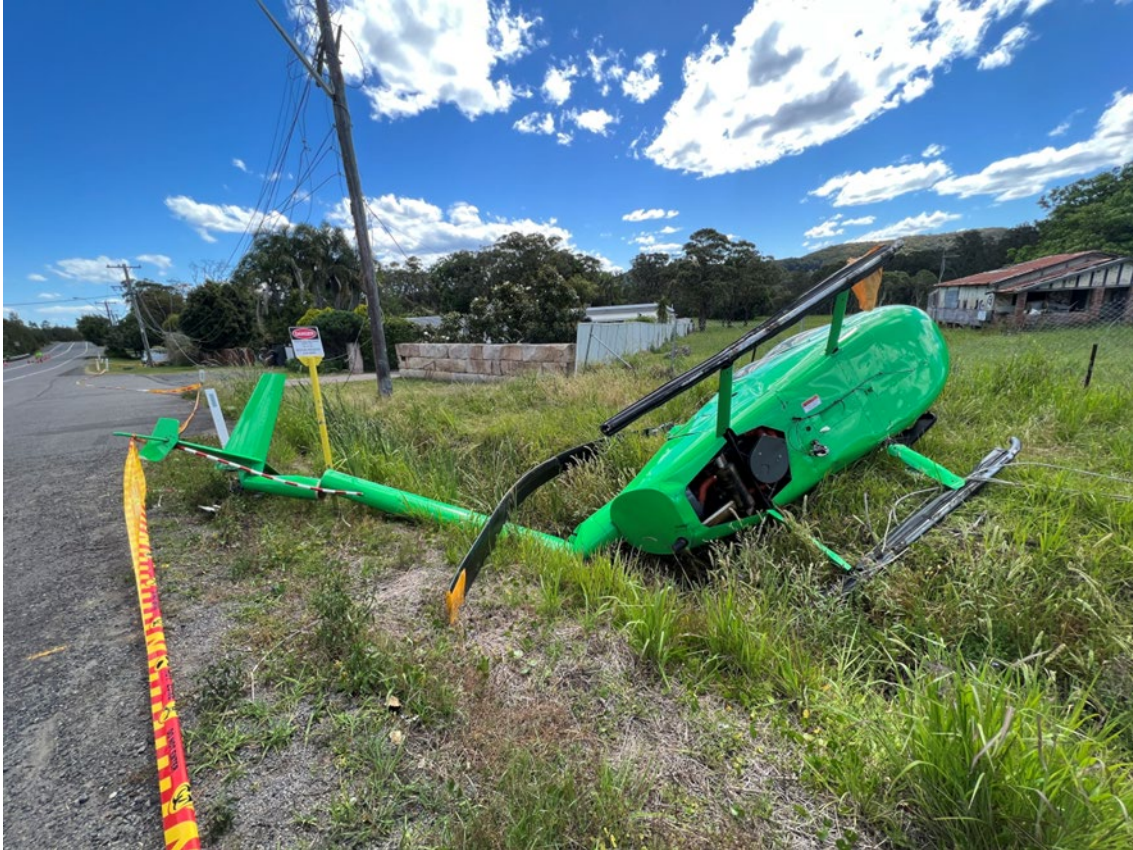
Figure 1: Accident site

Recognising the helicopter's proximity to the people gathered at the venue and in the street below, the pilot attempted to manoeuvre the helicopter away from the landing site towards a clearing on the opposite side of the road. However, the rate of rotation increased, with the helicopter making two and a half revolutions before striking powerlines and colliding with terrain. The pilot and both passengers sustained minor injuries and the helicopter was substantially damaged (Figure 1).

The ATSB attended the site and conducted an inspection of the wreckage (Figure 1). The helicopter had struck high and low-voltage power lines during the descent and came to rest on its left side, spanning a drainage culvert.

The tail boom skin was disrupted in 2 locations but was still attached to the helicopter. The fracture surfaces on the drive shaft were consistent with overstress and attributed to the impact with terrain. Similarly, damage to the tail rotor gearbox housing showed evidence of uniform overstress attributed to the impact. A review of witness videos showed no evidence of tail boom disruption in flight and the engine could be heard to operate normally.

The main rotor blades showed evidence of low rotational energy with both blades still intact and connected to the hub. Additionally, no major ground scars were observed on-site. The pilot advised that the low rotor RPM horn sounded at approximately the same time the helicopter struck the powerlines.

The positions of the collective and the throttle were examined during the on-site inspection and the collective was found lowered with the half throttle set. It could not be determined from the onsite inspection what control inputs were applied prior to descent and it is likely that these controls were disrupted following the collision with terrain as the pilot fell in that direction across the controls.

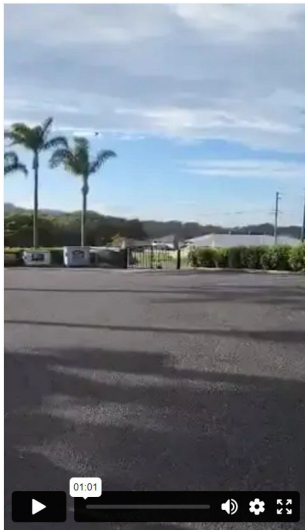
Video 1: First approach

In the video footage of the first approach, ([Video 1](#)) taken from the edge of the landing site, the helicopter became unstable in the final stages of the approach, with the nose yawing to the right. The yaw was arrested by the pilot, but sideways drift was evident as the approach continued. Upon terminating into a hover over the landing site, the tail again began yawing from side to side before the pilot conducted a missed approach.

vortex interference (Figure 5). The yaw fluctuations experienced during the first approach were consistent with the onset of an unanticipated yaw but were not identified by the pilot.

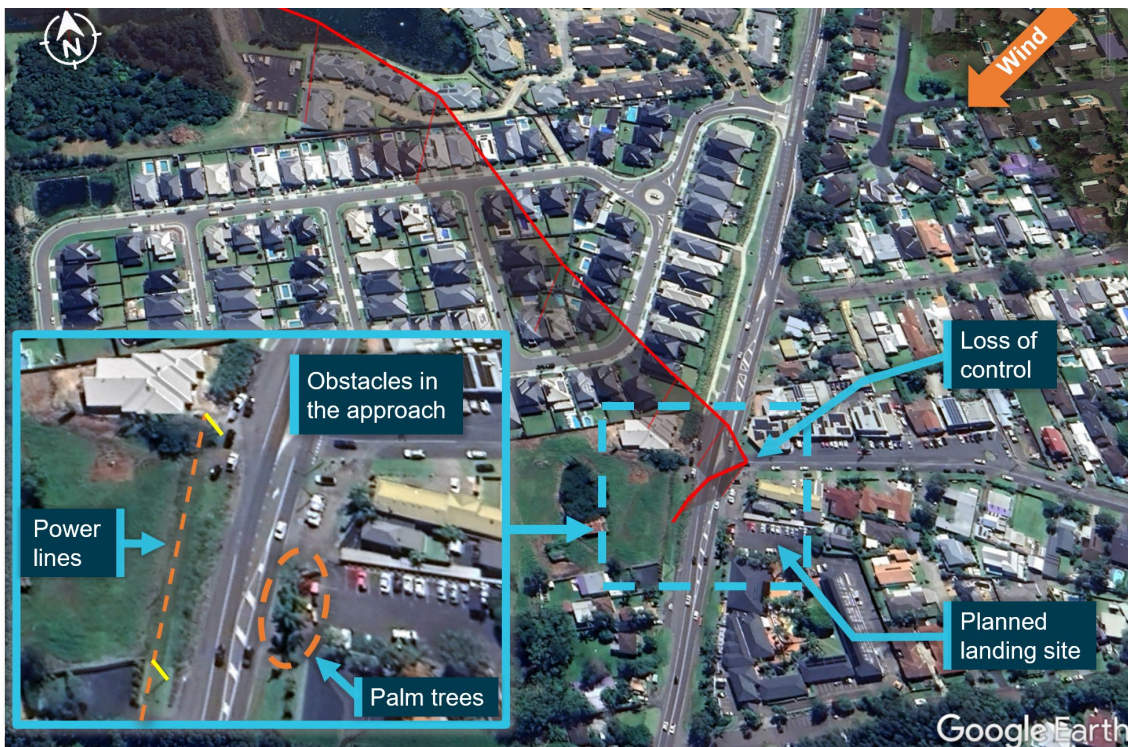
Figure 2: Final approach path

The data extracted from the onboard GPS (Figure 2), indicated the track for both approaches was approximately south-east.

The flight track extracted from the helicopter GPS is shown in red. The inset shows the proximity of the obstacles (power lines and palm trees) under the approach to the planned landing area. The relative wind can be seen to be almost perpendicular to the track from the left, an area of known hazard for the onset of LTE.

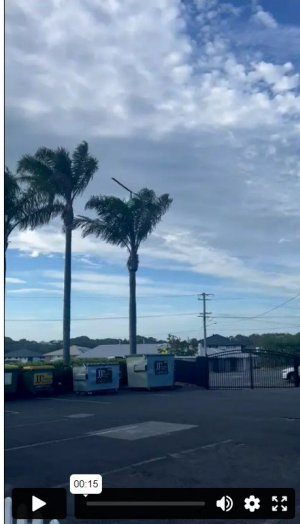
Video 2: Accident sequence

Video footage of the second approach (Video 2) showed that the helicopter approached at approximately 100 ft above ground level before suddenly yawing to the right. The rate of rotation could be seen to accelerate, and the radius of turn tighten as the helicopter rotated through two

and a half revolutions. Directional control of the helicopter was not recovered, and the rotational speed of the main rotor blades could be heard to decrease as the helicopter began to descend. The rotating descent continued until the helicopter struck powerlines and then collided with terrain.

Video footage of the accident sequence showed a right yaw with accelerating rotation, also consistent with the symptoms of an unanticipated yaw event.

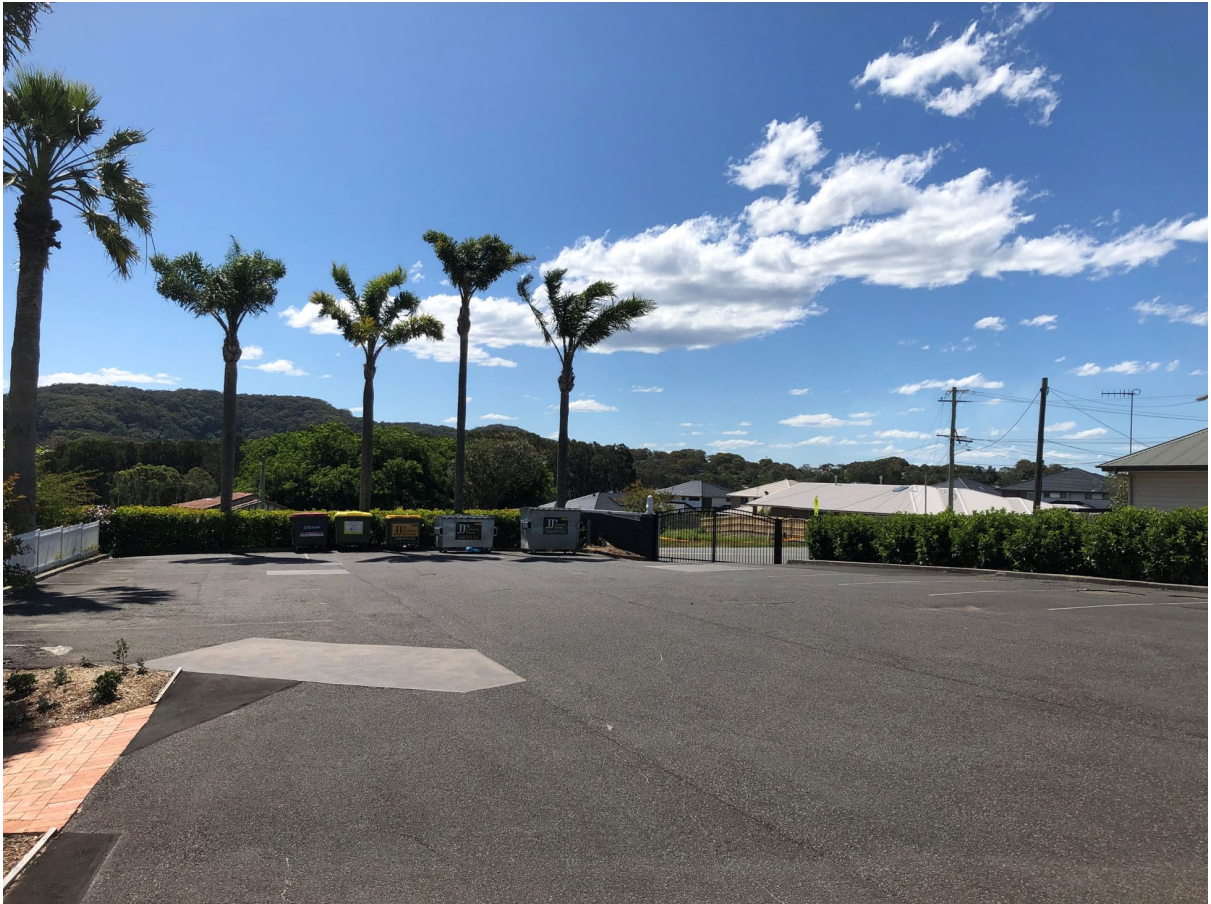
Figure 3: Planned landing site looking in the direction of the approach

The venue was located on a main road in a built-up suburban area (Figure 2). The approach to the carpark was planned to overfly a clearing on the opposite side of the road to the venue before passing over powerlines along the road, and palm trees at the perimeter of the carpark (Figure 3). The helicopter would be required to enter an out of ground effect hover at approximately 50 ft above ground level, before conducting a vertical descent to the ground.

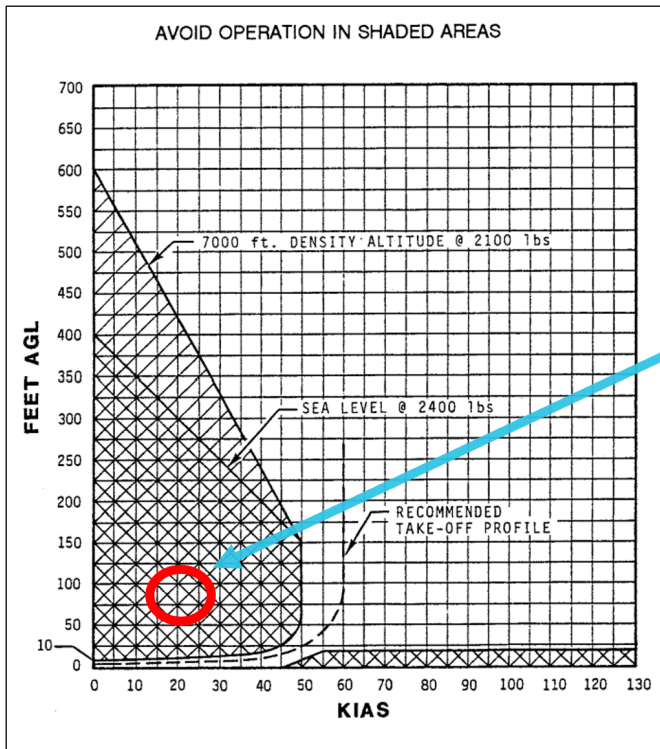
Figure 4: R44 height-velocity diagram

Where a site is considered to be a confined landing area, CASA guidance in Advisory Circular [AC 91-29 Guidelines for helicopters – suitable places to take off and land](#) recommended that in addition to aircraft performance, ‘the height velocity diagram should also be carefully considered before operating from these areas’. The R44 flight manual included a height-velocity diagram, which defined the conditions from which a safe power-off landing could be made. A notation on the diagram encouraged pilots to avoid operation in the shaded area. The approximate speed and height at which the aircraft was flown during the occurrence with respect to the height-velocity diagram is shown in Figure 4.

Area of helicopter operation at the time of the occurrence

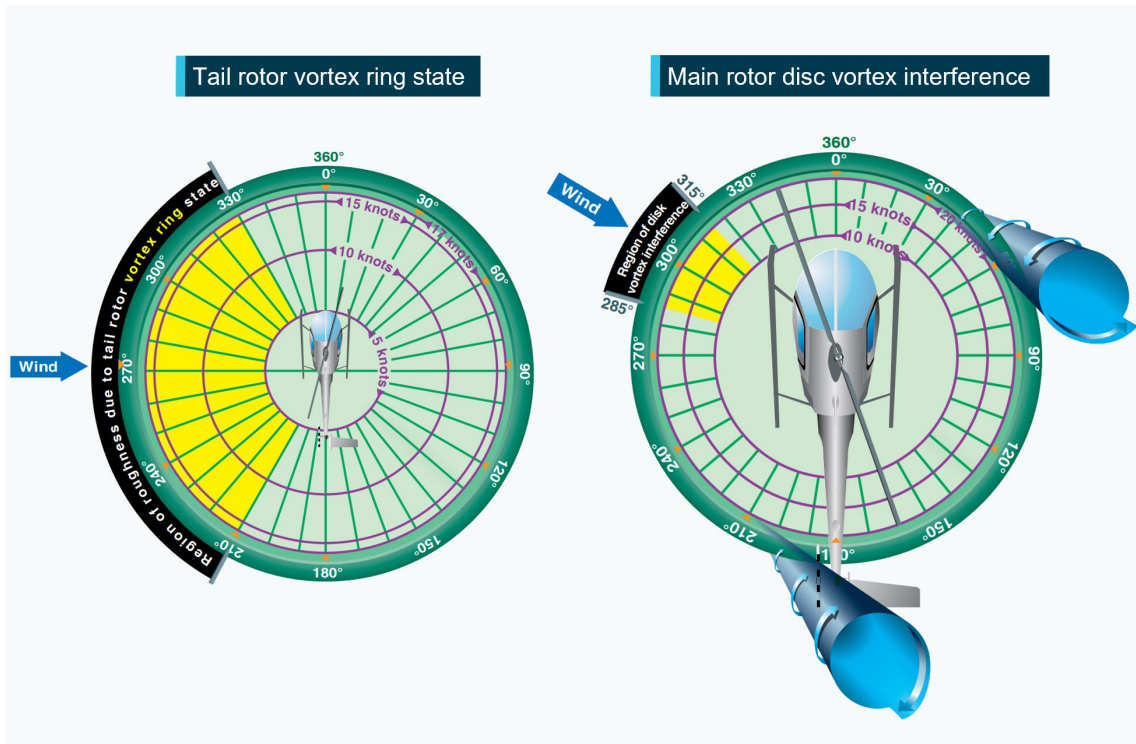
Figure 5: Azimuths⁵ of concern for loss of tail rotor effectiveness

Several wind directions relative to the nose of the helicopter, shown in Figure 5, are conducive to LTE when single rotor helicopters fitted with counter-clockwise rotating main rotor blades such as the R44, are flown at speeds of less than 30 kt. The wind directions that were of relevance during VH-TKI’s approach included the following:

- 210–330°, tail rotor vortex ring state. Turbulent air produced by the tail rotor blade vortices recirculate through the tail rotor leading to the development of unsteady airflow through the tail rotor and fluctuations in tail rotor thrust. The change in thrust means that the airflow around the tail rotor will vary in direction and speed, requiring an increase in rudder pedal workload to maintain directional control. The loss of this tail rotor efficiency increases the power demand and there is an additional antitorque requirement.

- 285–315°, main rotor disc vortex interference. Winds at velocities of 10–30 kt from the left front cause the main rotor blade vortices to enter the tail rotor disc producing turbulent airflow that interferes with the tail rotor. High power settings generate an associated increase in main rotor downwash and blade tip vortices. The turbulent airflow increases the likelihood of main rotor disc vortex interference as illustrated in Figure 5.

Considering the recorded Gosford weather observations of the wind from the north-east at 10 kt, the approach track placed the wind from a direction and at a speed known to be conducive to the onset of loss of tail rotor effectiveness (LTE) via both tail rotor vortex ring state and main rotor disc
