# Drive belt tensioning motor failure involving Robinson R44 helicopter, VH-ZUJ

Hamilton Island Airport, Queensland 8 January 2023

AO-2023-005

Final – 31 May 2023

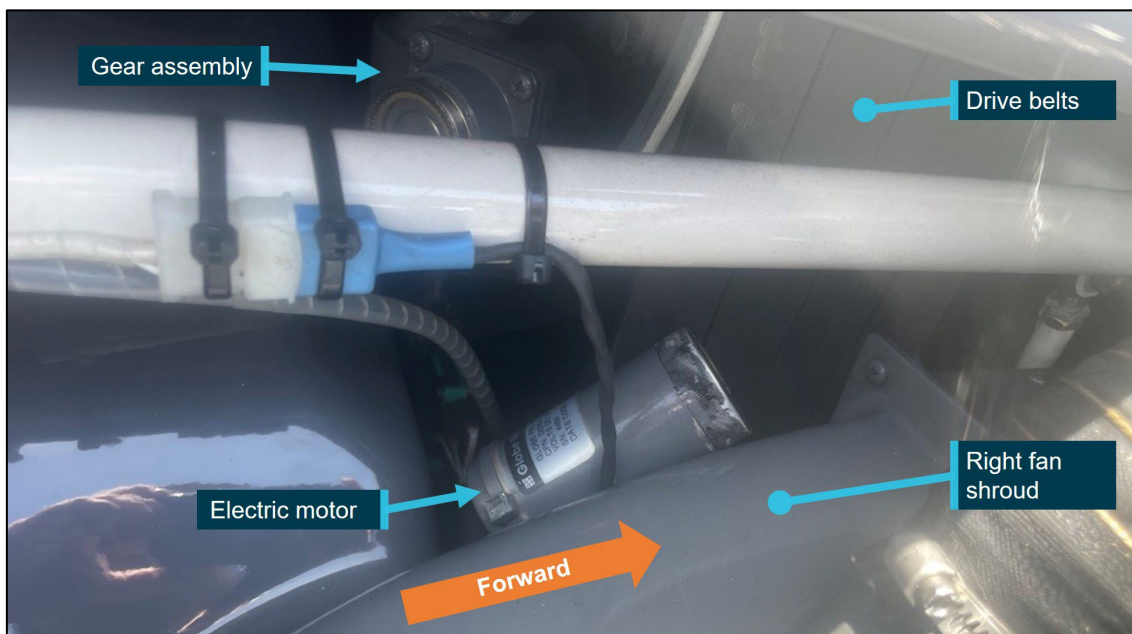
**Figure 1: Electric motor position**

Ground crew visually inspected the drive belt tensioner assembly and found that the clutch actuator electrical drive motor had separated from the gear assembly and was found between the drive belts and fan shroud. The motor was still attached electrically to the aircraft, and the gear assembly was securely attached to the drive belt tensioner assembly. (Figure 1)

On noticing the clutch caution light and waiting the requisite 10 seconds, the pilot carried out the clutch caution light emergency procedure and was able to land immediately. Had the landing been delayed in this incident it is possible that the position of the electric motor, between the drive belts and right fan shroud, could have caused damage to the drive belts and created a hazard to the safety of flight.

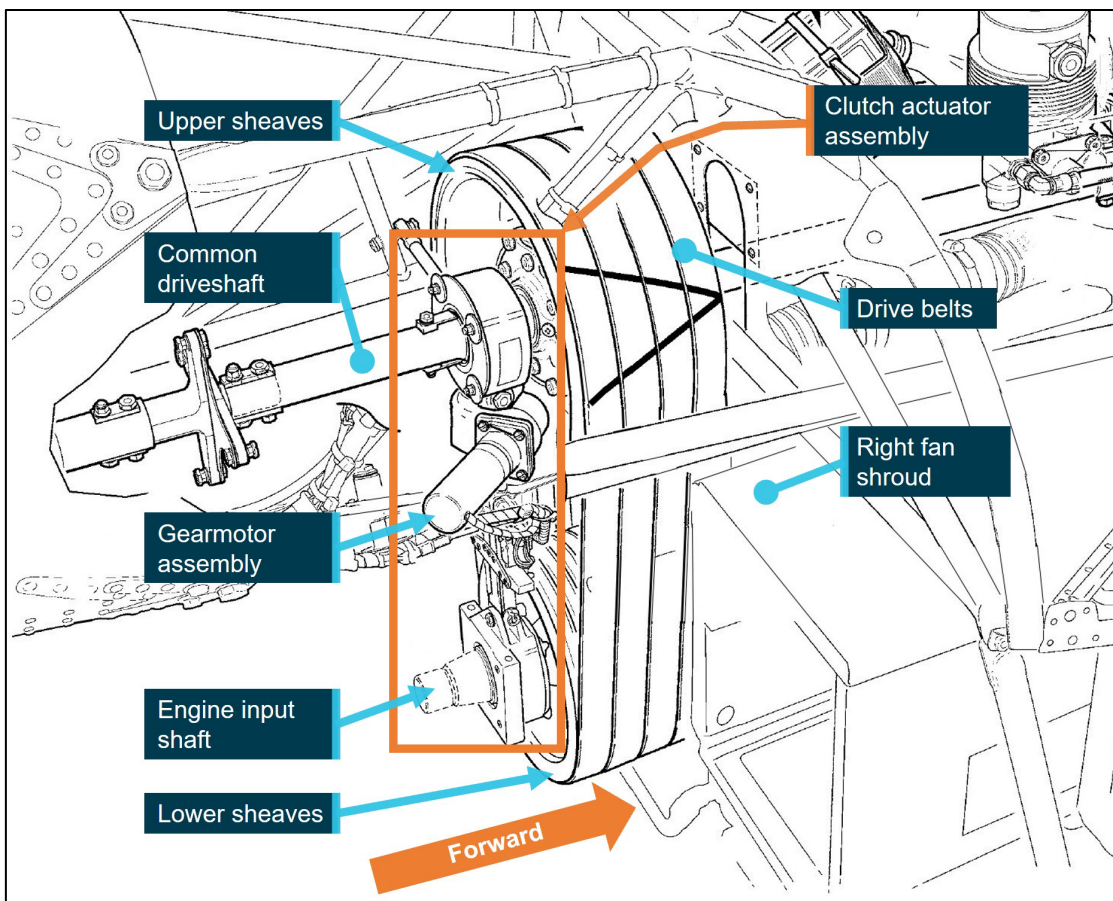
**Figure 2: R44 clutch assembly**

The Robinson R44 helicopter's rotor drive system incorporates a belt driven common shaft for main and tail rotor drive. Power is transmitted from the engine to the main and tail rotors through vertically mounted sheaves (also commonly called drive pulleys) and a v-belt arrangement (Figure 2). The drive assembly carries 4 double-banded v-belts. Each drive belt consists of 2 single v-belts that are bonded by a common rubber backing (tie-band). The lower drive sheave is bolted to the output flange of the engine crankshaft, while the upper sheave is located immediately above on the common main and tail rotor driveshaft.

Before the engine is started, the clutch actuator is placed in the disengaged position, which leaves the v-belts slack and allows the engine to start and run freely without the load of the main and tail rotors. A pilot-operated, electrically-driven actuator progressively tensions the drive belts and enables power transfer from the engine to the rotor system.

belt stretching, and a down limit switch to set the clutch disengaged positions. The clutch gearmotor assembly uses an electric motor to drive the actuator, via a worm-drive<sup>1</sup> arrangement, which ensures that belt tension forces are not fed back into the actuator motor; this allows the motor to be de-energised and belt tension to be maintained. The gearmotor assembly is attached to the belt tensioner by 4 corrosion resistant screws. (Figure 2)

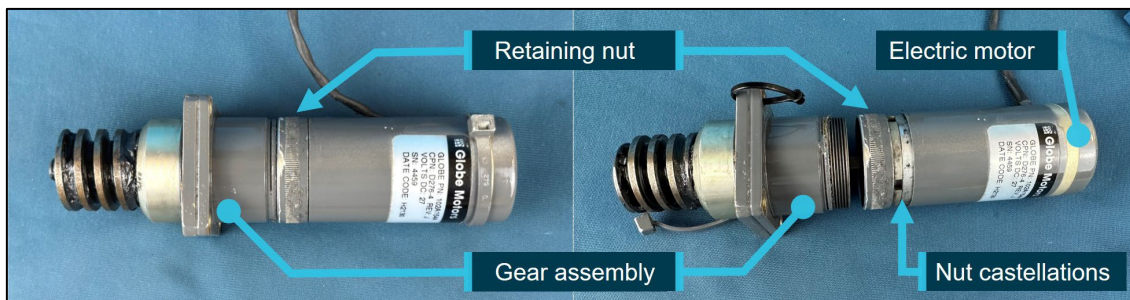
**Figure 3: Gearmotor assembly**

The clutch actuator electrical motor and gear assembly, collectively known as the gearmotor assembly, are factory assembled. The assembly is not field serviceable or repairable, requiring return to the manufacturer if unserviceable. The motor is attached to the drive gear by a threaded, free-rotating, captive retaining nut. The retaining nut is secured with a commercially available thread locking adhesive and torqued with a c-spanner using castellations built into the nut. The electric motor case is then partially slid over the retaining nut, covering the castellations. (Figure 3) The design does not include a mechanical locking device, and no visual indication of loosening creep is embodied.

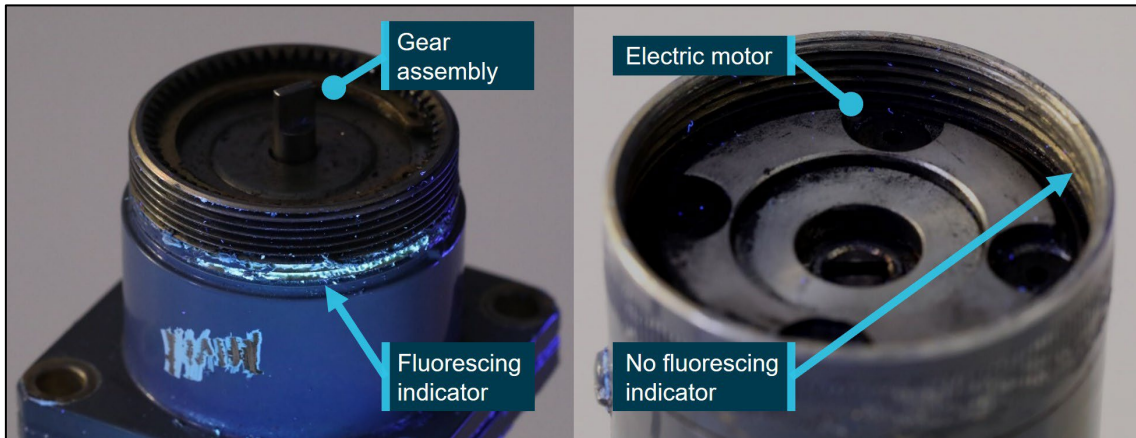
**Figure 4: Gearmotor UV light inspection**

The incident gearmotor assembly was retained and inspected by the ATSB. The inspection noted the following (Figure 4):

- No unusual damage to the threads of the electric motor or gear assembly was evident.
- A black residue was found in the root of the gear assembly threads. This residue was not chemically identified due to an insufficient amount available for analysis.
- The thread locking compound specified was designed to fluoresce in ultraviolet light to enable inspection of the fastener. The ATSB assembled a test piece with the locking compound and when disassembled the compound was evident when examined under ultraviolet light.
- No evidence of thread adhesive was found on the engaging threads of either part of the incident gearmotor assembly under ultraviolet, or visible light conditions.
- Fluorescent residue was found on a threaded section of the gear assembly, outside of the engaging threads section.

The gearmotor assembly process incorporated the application of a thread adhesive designed to act as a secondary locking device to prevent the inadvertent loosening of the electric motor due to normal helicopter vibrations in flight. ATSB inspection of the threaded sections of the incident gearmotor under ultraviolet light showed that the thread adhesive was not visible in an area that would reliably ensure the security of the motor. This resulted in loosening of the motor due to normal operating vibrations. The reason for the absence of thread locking adhesive on the mating surfaces of the threads could not be determined.

The absence of thread adhesive during assembly, and its associated lubricating effect, probably reduced the intended design clamping force between the gear assembly and electric motor. It is important to note that the residue found in the gear assembly threads was not chemically identified so the impact it had on adhesion or lubrication, could not be assessed. The extent to which these factors influenced the failure of the gearmotor assembly was not determined, but it is possible that a reduced assembly clamping load contributed to the failure.

- Thread adhesive was not applied to the threads or applied to the threads in a manner that would effectively prevent the in-service loosening of the motor.
- The gearmotor electric motor separated from the gearmotor assembly due to normal aircraft vibrations.

Robinson Helicopter Company advised that they are actively working with the component manufacturer to rectify identified quality issues with the gearmotor assembly and are considering updating the procedures for the inspection of the clutch actuator assembly.
