Fuel Mayday declaration involving Boeing 737-838, VH-VZO

abeam Wave Rock, Western Australia on 18 July 2022

ATSB Transport Safety Report

AO-2022-035

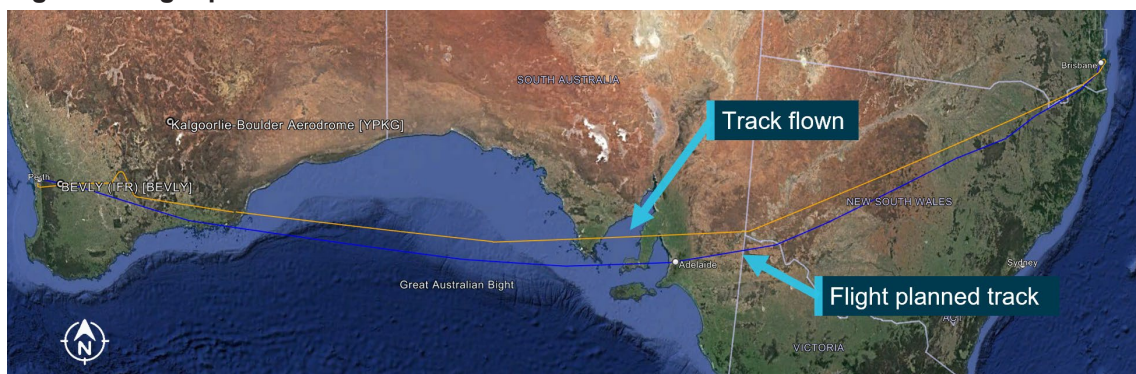
Figure 1: Flight path

Due to significant forecast headwinds, the flight was planned to fly south of the direct path, overhead Mildura, Adelaide, across the Great Australian Bight, then to Perth and estimated to take 5 hours and 30 minutes. Early in the cruise, the aircraft encountered stronger headwinds than forecast so the flight crew contacted air traffic control (ATC) and requested, and received, a clearance to fly slightly north of the planned track.

The aircraft was descended earlier than planned from flight level (FL) 340¹ to FL 280, due to turbulence and to also take advantage of lesser headwinds and remained at this level as it passed Adelaide.

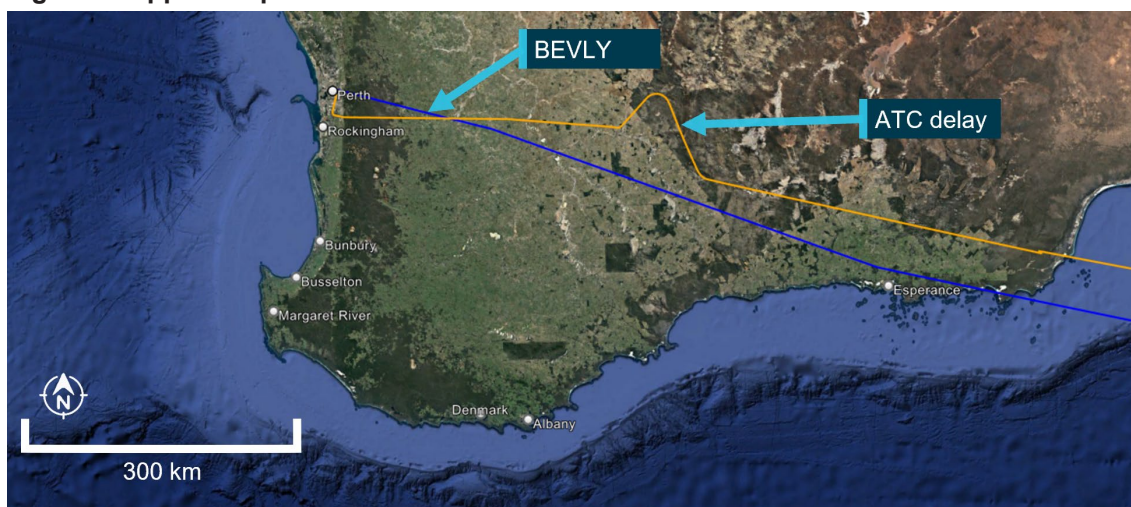
Figure 2: Approach path

The flight crew continued to request, and receive, track shortening from ATC. Later in the cruise, ATC advised the crew there were significant delays for arrivals into Perth and they could expect around 13 minutes delay before passing BEVLY, a waypoint⁵ on the arrival procedure (Figure 2). ATC instructed the crew to reduce to minimum speed and to temporarily turn off-track to delay the BEVLY passing time. The crew had estimated passing BEVLY at 0226 and asked ATC for the expected passing time and were subsequently advised it would be 0242. They advised ATC that they were carrying 10 minutes of traffic holding fuel, which was required for traffic holding at Perth. As such, they could cross the waypoint at 0236 however, they did not have enough fuel on board to cross BEVLY at 0242. They also advised they would need to remain at altitude until they passed HAMTN, a waypoint on the arrival procedure, and to descend at 230 kt in a continual descent to conserve fuel.

ATC advised the flight crew that the order of aircraft in the arrival sequence could not be changed unless they declared a fuel MAYDAY, which the crew subsequently did. The aircraft was then given priority for the approach.

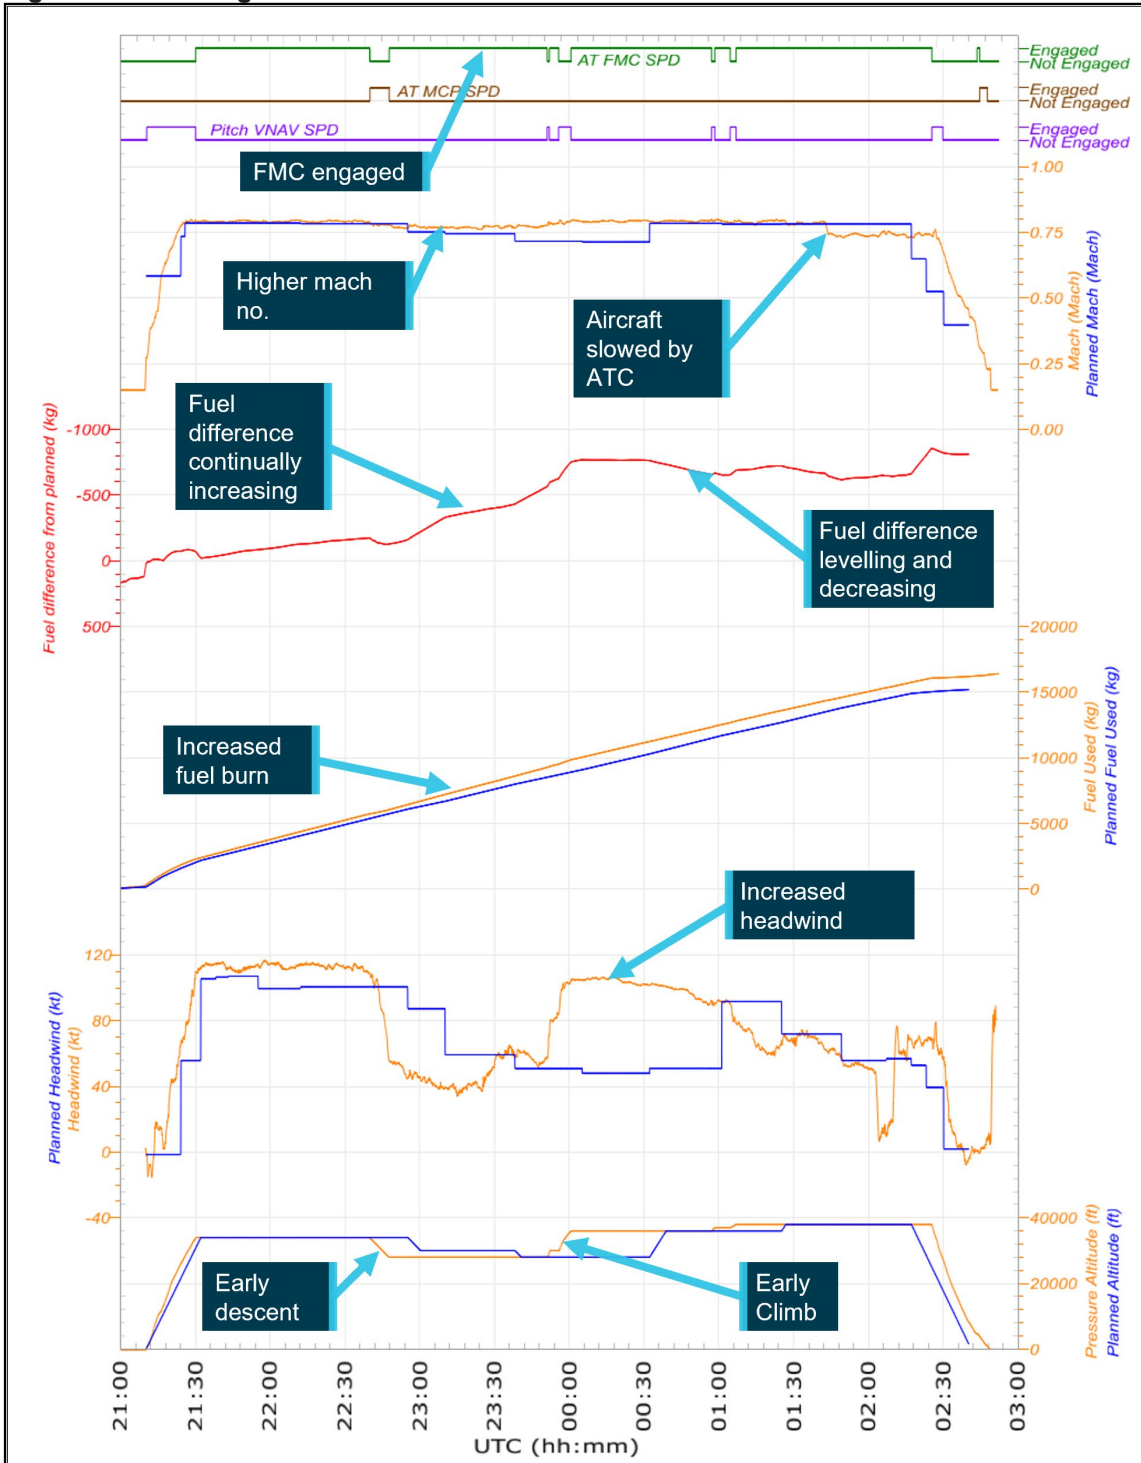
Figure 3: QF933 flight data

The ATSB downloaded the data from the aircraft's flight data recorder. Figure 3 shows verified flight data for certain recorded parameters during the flight. The data showed the:

At approximately 2242, the aircraft descended earlier than planned from FL 340 to FL 280, following assessment of the actual winds. The crew then engaged the FMC for the cruise at

FL 280, however, the Mach number did not reduce to that planned, resulting in the aircraft using more fuel than expected in the flight plan.

The data also showed that at 2348, when the aircraft climbed early from FL 280 to FL 360, the aircraft had approximately 800 kg of fuel less than planned. The actual fuel burn then reduced while the aircraft was flown at a higher level than planned however, the fuel quantity remained approximately 600/700 kg below the planned level for the remainder of the flight.

During the cruise segments, a Mach number faster than the planned value was flown, resulting in the aircraft using approximately 700–800 kg of extra fuel in the first part of the flight. The FMC was most likely selected to the ECON speed, which will use the selected cost index to set the best economy speed. The ATSB could not verify what cost index value was selected by the flight crew prior to the flight, as this parameter was not correctly recorded in the flight data.
