Grounding of *Trinity Bay*

Harrington Shoal, Queensland on 19 January 2021

ATSB Transport Safety Report

MO-2021-001

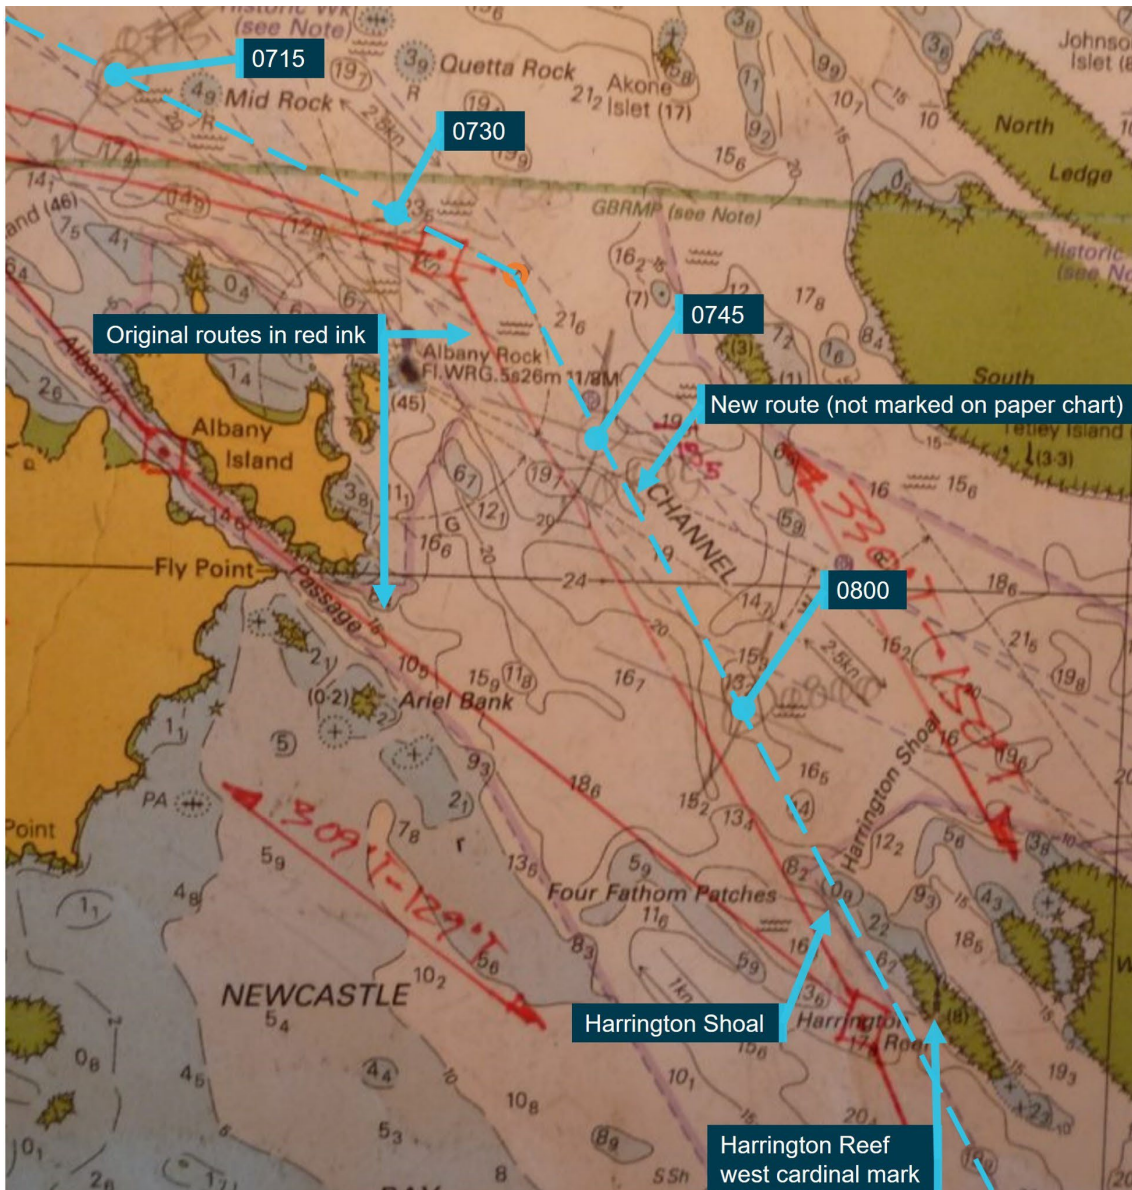
Figure 3: Section of Aus chart 839 used on board *Trinity Bay*

Image of a section of paper chart Aus 839 used on board at the time of the grounding showing original passage plans marked in red ink and radar fixes made by the OOW leading up to the grounding.

At 0800, the OOW plotted another radar fix on the paper chart and visually confirmed that the Harrington Reef west cardinal mark remained on the ship's port side (Figure 3). They verified the radar fix again and then checked the depth sounder, which indicated a depth of 17.5 m. They noted that the paper chart indicated a similar depth, and once again assessed that there was no cause for concern.

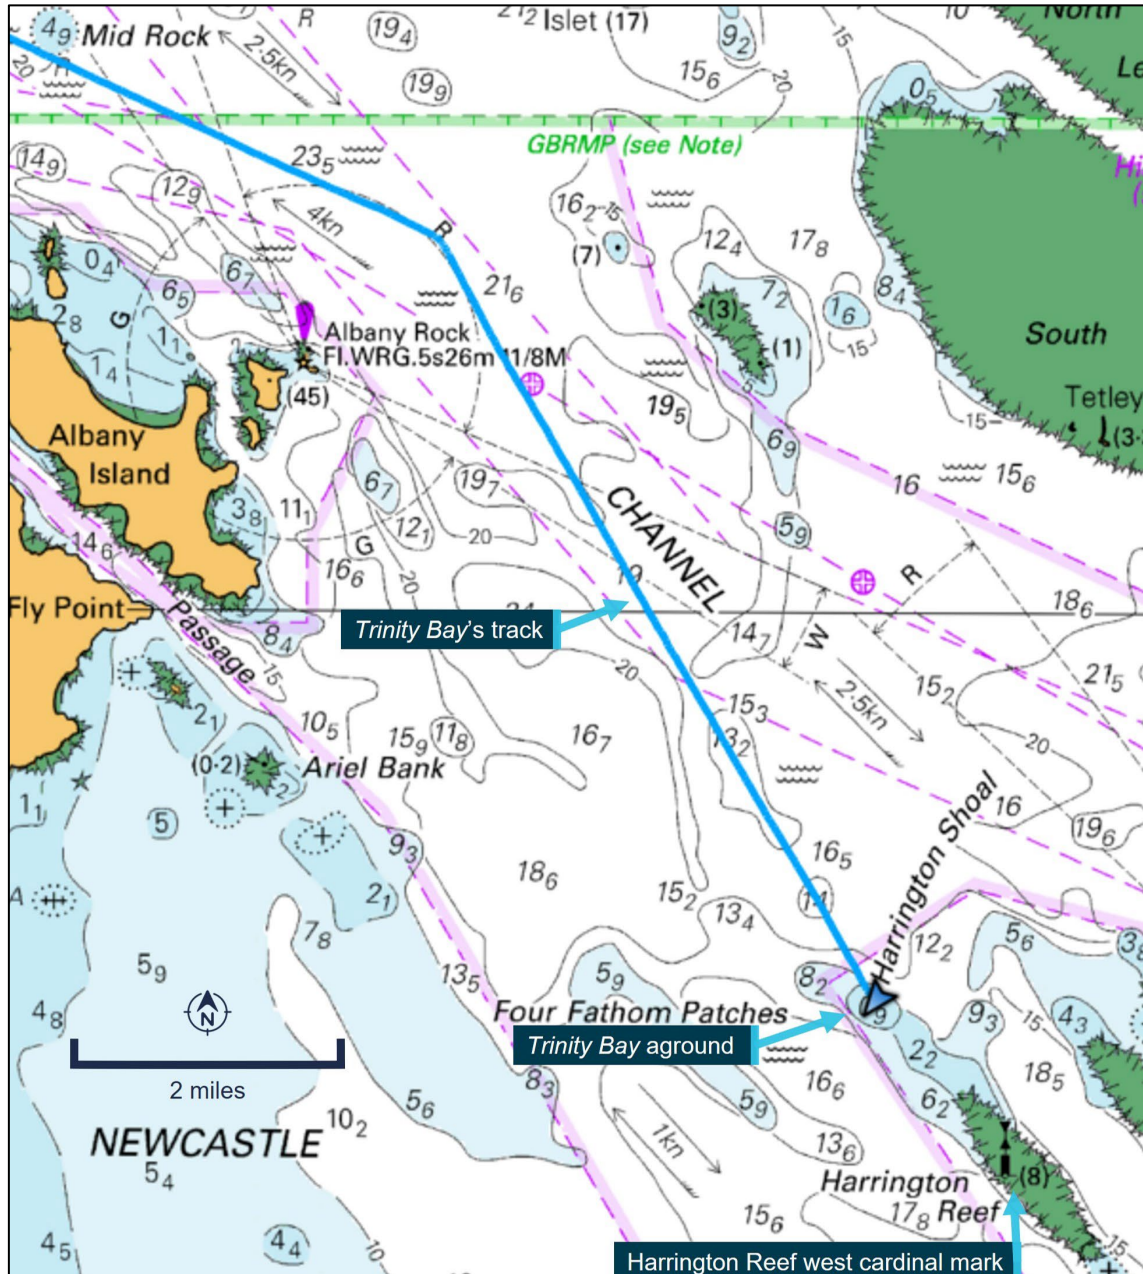
Figure 4: Section of chart Aus 839 showing Trinity Bay's track

0.63 m. As the ship's speed continued to decrease rapidly, the OOW realised that the ship was aground (Figure 4). In response, they brought the main engine telegraph to stop and called the master on the ship's telephone.

Trinity Bay's automatic identification system (AIS) data overlaid onto chart Aus 839.

The master, who had awoken on hearing the ship's engine pitch change, immediately went to the bridge. The master checked the ECS which showed that the ship was aground on Harrington Shoal, a charted feature with a depth of 0.9 m situated north-west of Harrington Reef (Figure 4). The master also noted that the ECS showed the route leg passing directly across Harrington Shoal. The master then checked the paper chart which confirmed that the ship's track, projected forward from the OOW's last two position fixes, passed directly over Harrington Shoal.

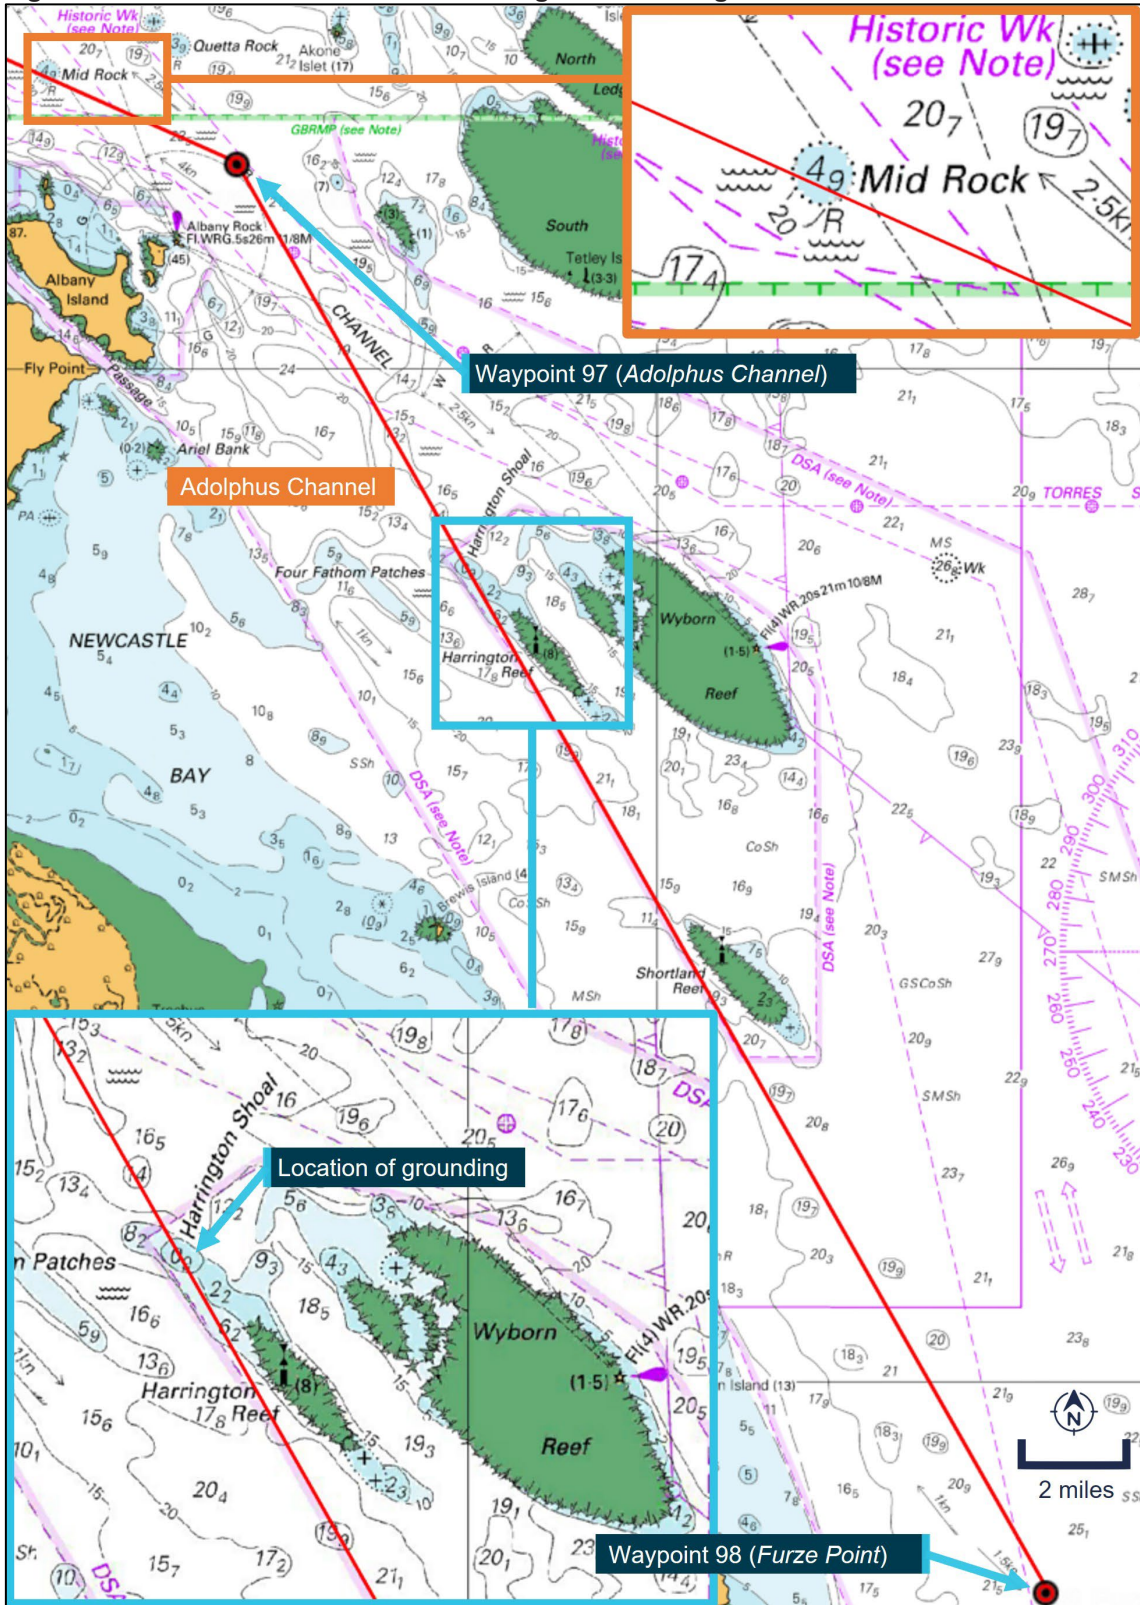
Figure 6: Section of chart Aus 839 showing new route legs

Trinity Bay's master used the 'Passage Plan CNS-HI' workbook (Figure 5), to construct the new route from Thursday Island to Cairns. Part of this route included a segment from Adolphus Channel to Cairns and the master utilised the waypoints listed for this segment directly from the 'WAYPOINTS MASTER LIST'. This included a leg from waypoint 97 (*Adolphus Channel*) to waypoint 98 (*Furze Point*) which passed directly over Harrington Shoal (Figure 6). Additionally, the route planned using these waypoints also resulted in the preceding leg being laid across Mid Rock, a charted underwater rock.

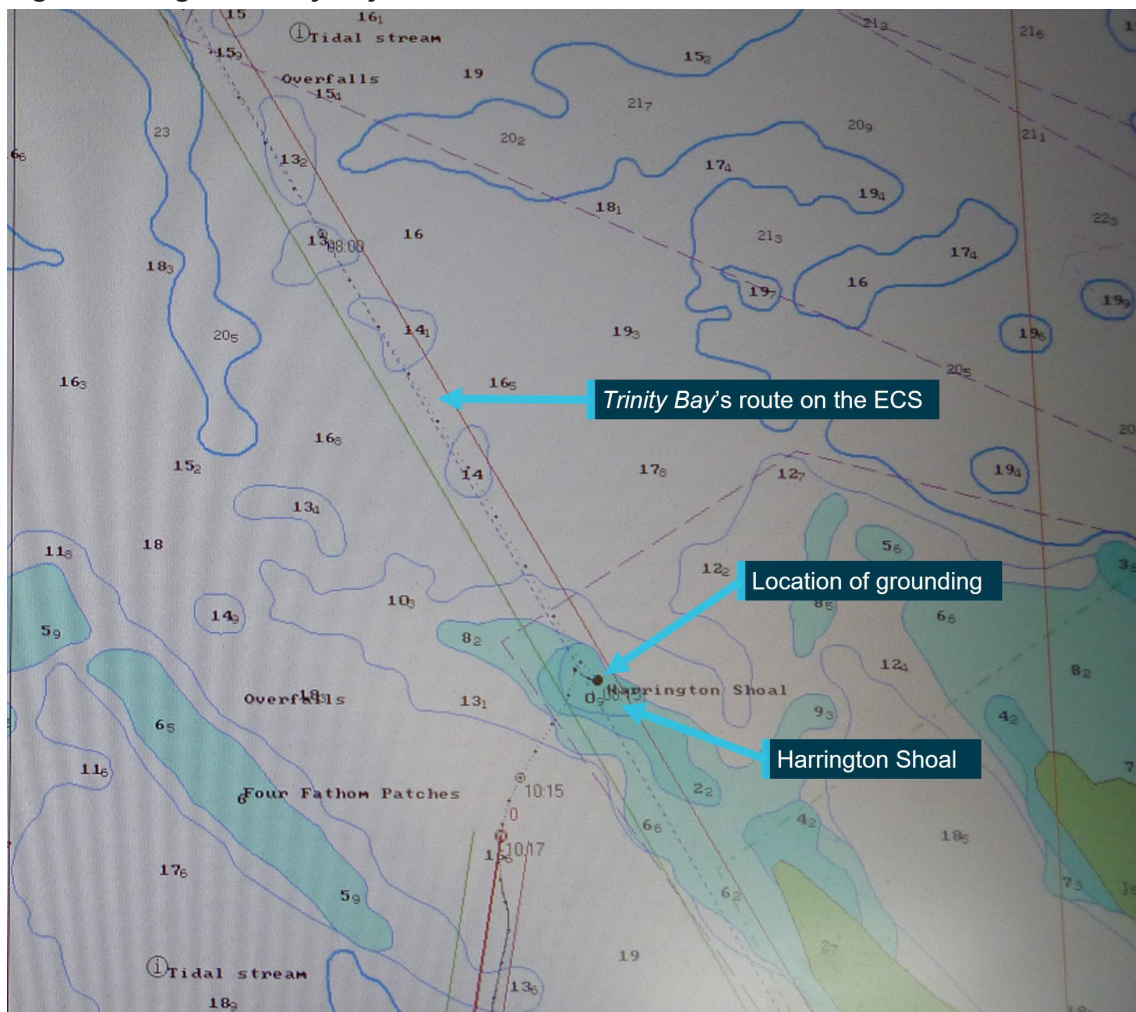
Figure 7: Image of Trinity Bay's ECS screen

The newly created waypoints and route was not marked on paper charts, which were the ship's primary means of navigation. There was also no independent verification of the route by another deck officer, nor was there a briefing for watchkeepers before commencing the voyage.

Image of TRANSAS ECS screen taken after grounding showing Trinity Bay's planned route and track in vicinity of Harrington Shoal. Source: Sea Swift, annotated by the ATSB.

AMSA issued a prohibition notice¹⁷ prohibiting the use of the TRANSAS ECS for navigation. As a result, the marine manager shut down the ECS and posted a notice on the bridge advising crew of its removal from service. AMSA subsequently permitted *Trinity Bay* to continue the voyage subject to conditions, including the provision of status updates and damage assessments every 12 hours.

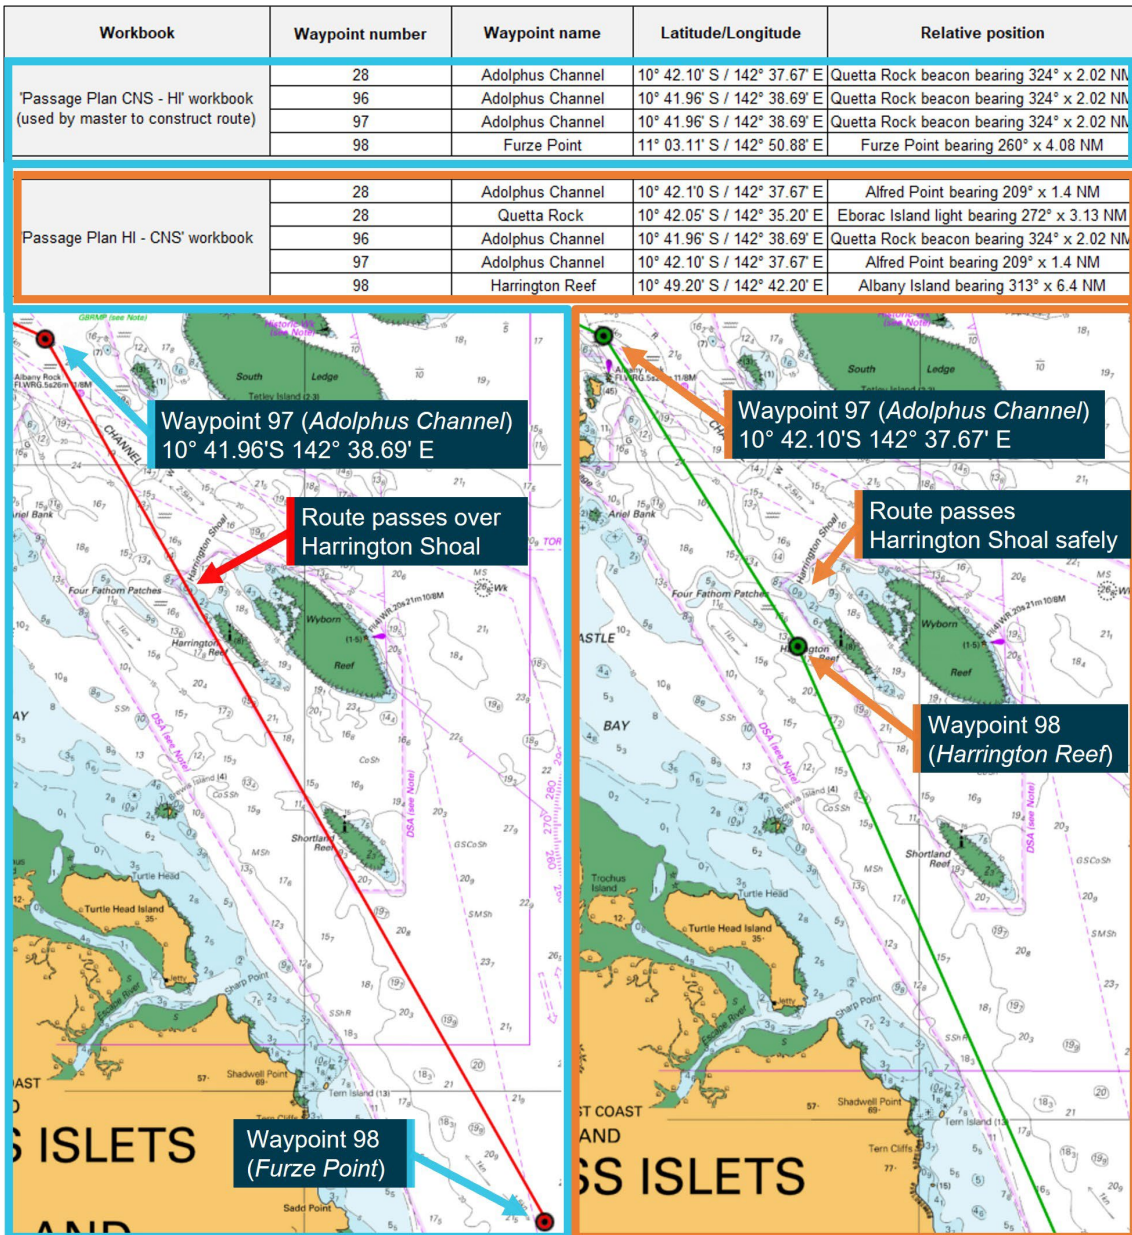
Figure 8: ATSB analysis showing discrepancies in waypoints and resulting routes

Examination of the other workbook (the ‘Passage Plan HI-CNS’ workbook) found that waypoints 97 and 98 differed from those with the same name and number in the workbook used by the master to construct the new route. In the ‘Passage Plan HI-CNS’ workbook’ waypoint 97, although still named ‘Adolphus Channel’, had coordinates that were different, and matched those of waypoints 28 and 96 in the workbook used by the master. Additionally, in this workbook, waypoint 98 was an entirely unique waypoint named ‘Harrington Reef’.

Examination of *Trinity Bay*’s printed passage plan document for the grounding voyage also showed that the parallel index lines listed for the new route’s legs from waypoint 97 to waypoint 98 and from waypoint 98 to waypoint 99 were incorrect. However, these incorrect parallel index lines corresponded to the equivalent legs had the route been constructed using the ‘Passage Plan HI-CNS’ workbook. This indicated that the master likely used the incorrect waypoints from the ‘Passage Plan CNS-HI’ but copied the parallel index line information for the equivalent route legs from the ‘Passage Plan HI-CNS’ workbook.

The chart figure on the left shows the route passing over Harrington Shoal using waypoints from the 'Passage Plan CNS – HI' workbook. The chart figure on the right shows a route, constructed with the same numbered waypoints but from the 'Passage Plan HI – CNS' workbook, passing Harrington Shoal safely.

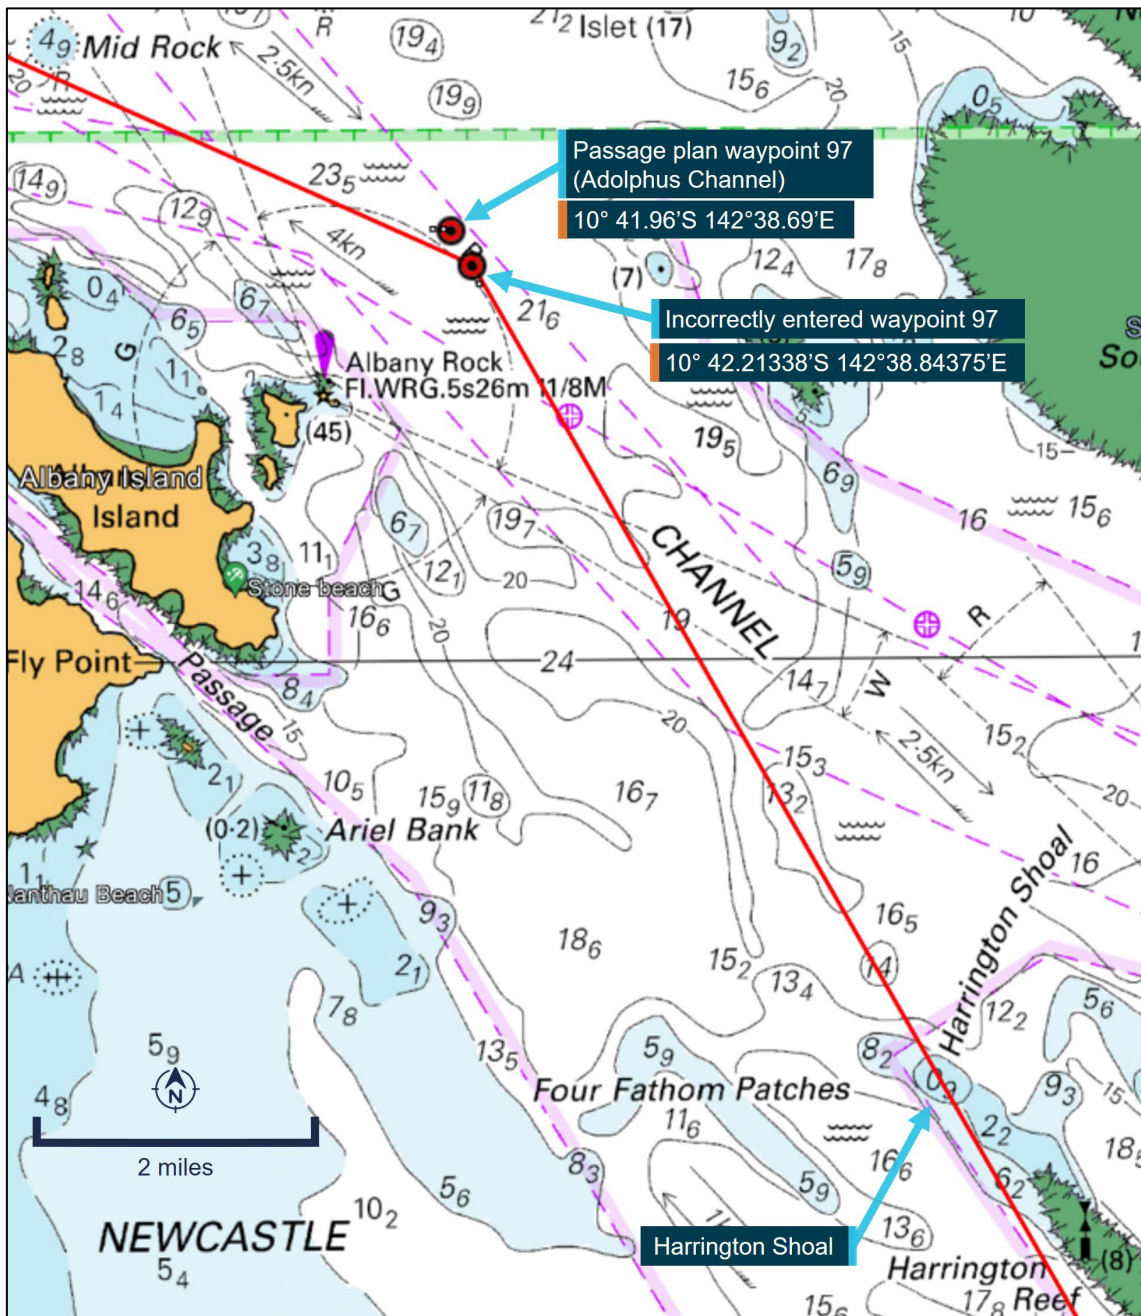
Figure 9: Section of chart Aus 839 showing incorrectly input waypoint

The difference in the waypoint coordinates equated to the incorrectly entered waypoint being about 0.30 miles south-east of the coordinates for waypoint 97 detailed in the printed passage plan (Figure 9). Routes using either waypoint resulted in the following leg passing directly over Harrington Shoal although the preceding leg was moved about 0.15 miles away from Mid Rock.

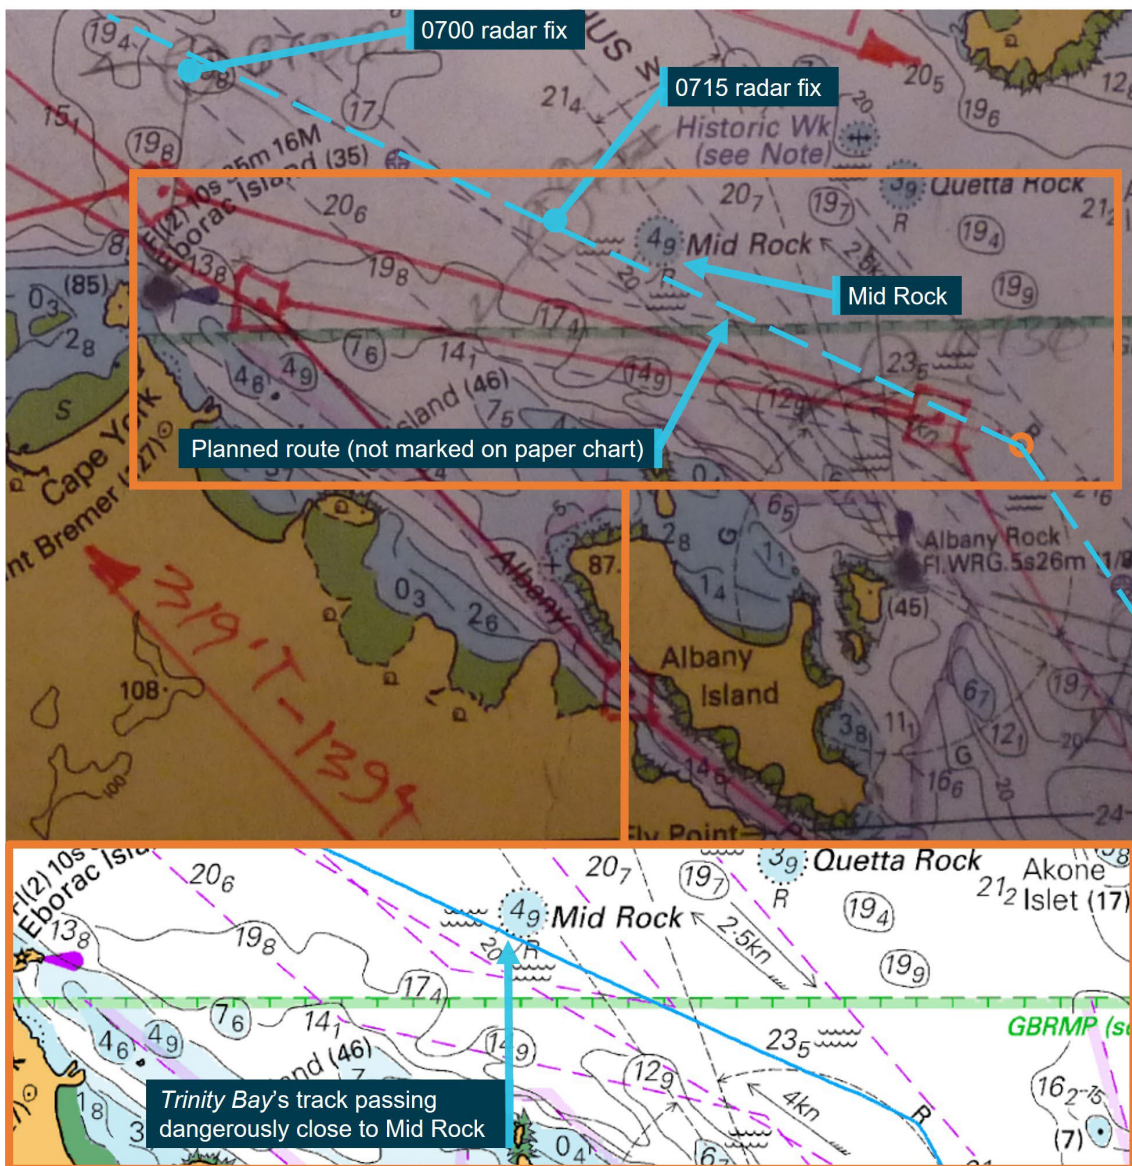
Figure 10: Chart extracts showing *Trinity Bay's* passage close to Mid Rock

The OOW's radar fix, plotted at 0715, (Figure 10) showed the vessel on track to pass dangerously close to Mid Rock, a charted underwater rock with a depth of 4.9 m. However, the OOW was not alerted to the danger and continued with the passage eventually passing about 0.18 miles from Mid Rock at about 0720.

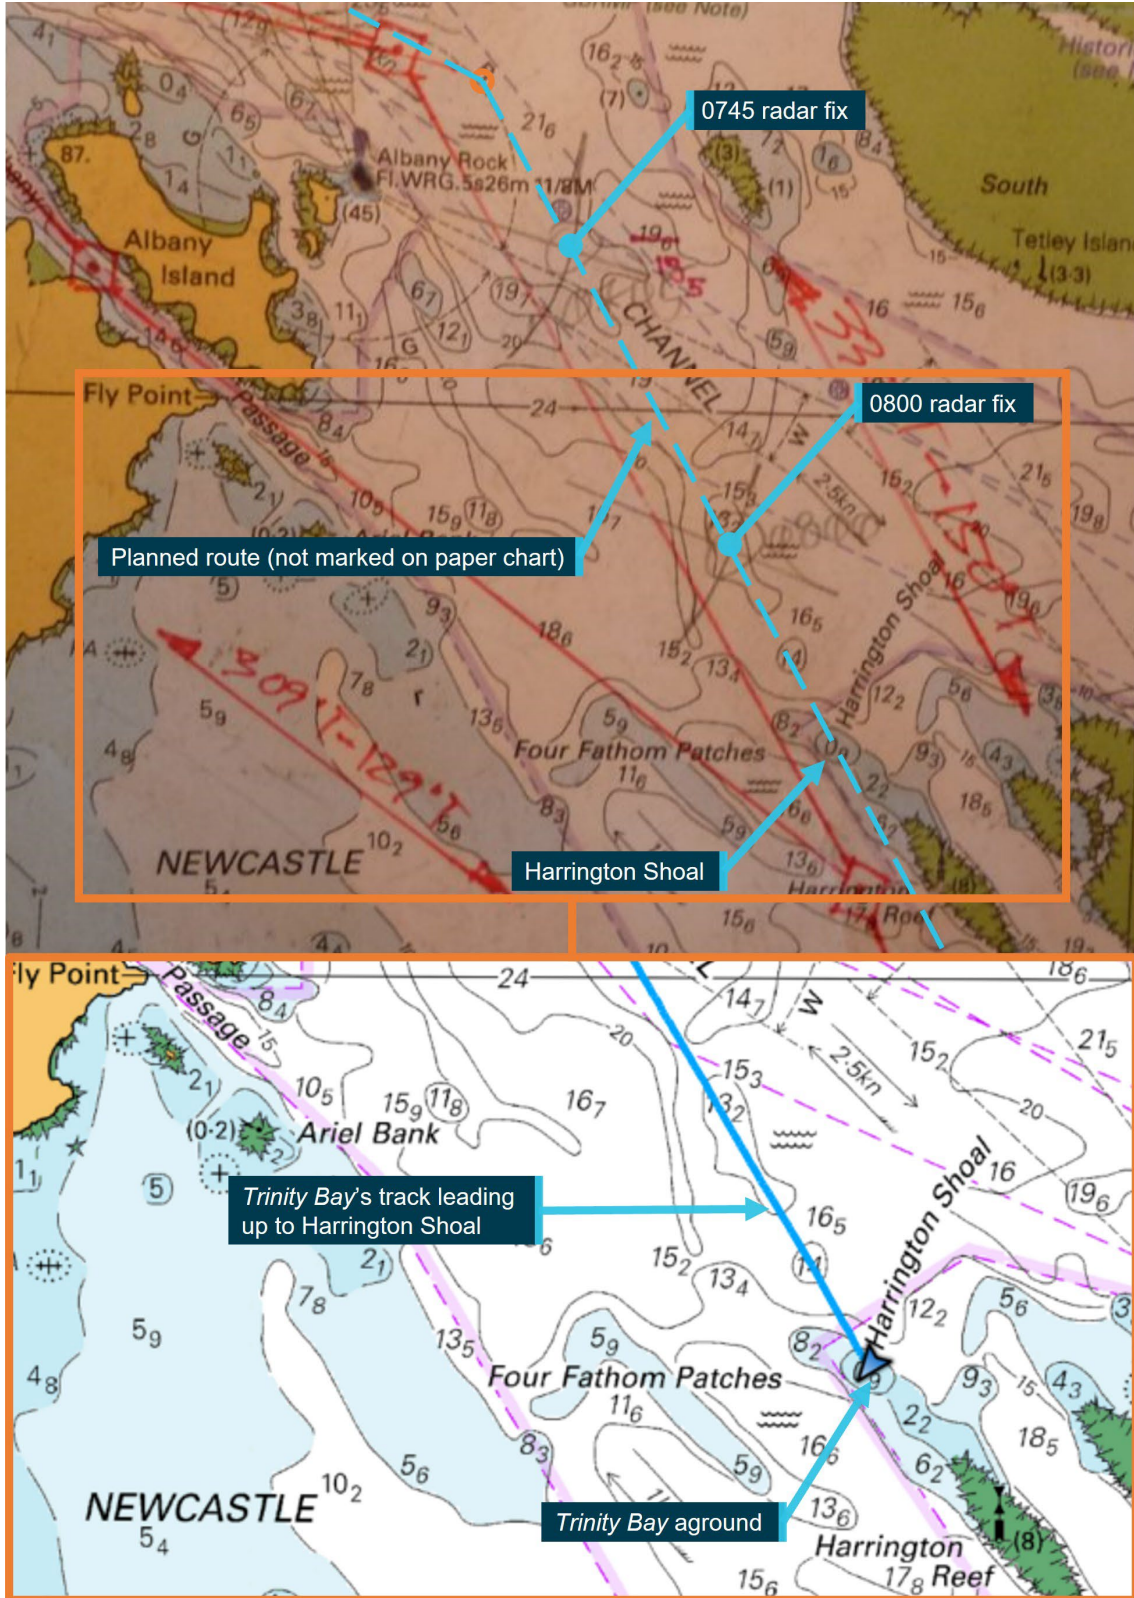
Figure 11: Chart extracts showing *Trinity Bay's* passage leading up to grounding

Radar fixes on the paper chart at 0745 and 0800 similarly showed the ship on track to pass over Harrington Shoal (Figure 11). While the OOW started to become concerned when they observed

In both the above instances, the ECS display would also have shown the ship standing into danger.

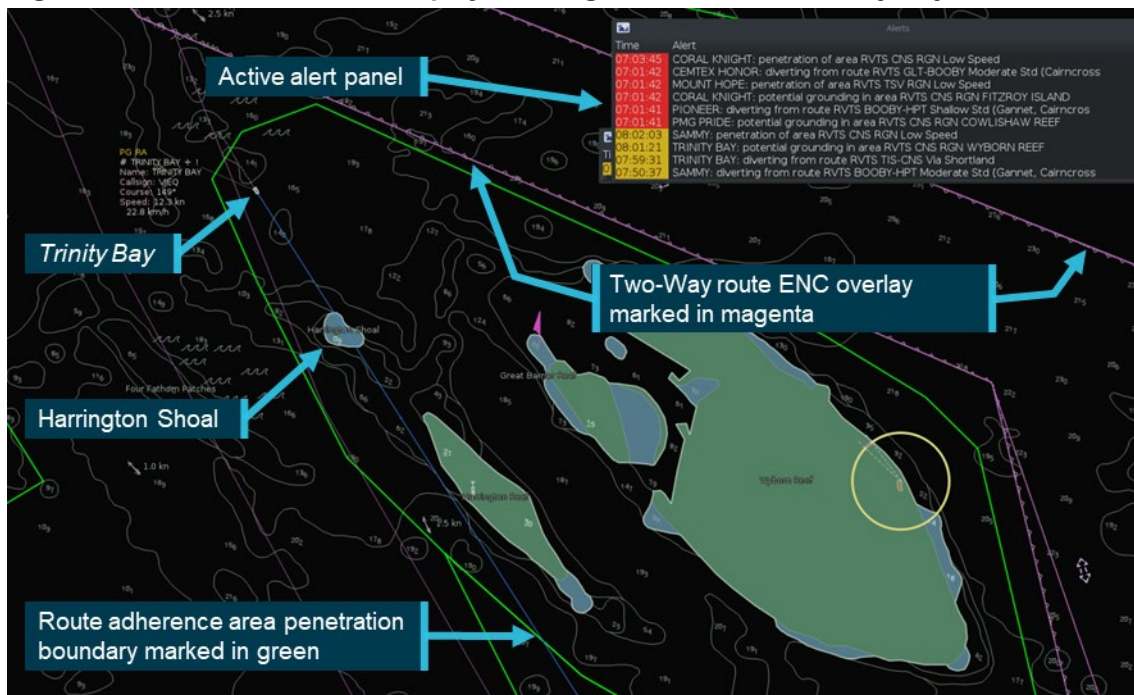
Figure 13: MaritimeCONTROL display showing visual alerts for *Trinity Bay*

The system allowed for the configuration of boundaries to areas of critical interest including potential grounding areas, shallow water areas and other areas hazardous to navigation. These boundaries enabled the generation of visual and audible alerts to alert the VTSO to the development of situations potentially dangerous to navigation including area penetration alerts, shallow water alerts, alerts for entry and exit to the REEFREP area, line crossing alerts for critical turns and alerts if a vessel's speed slowed significantly (indicative of grounding) (Figure 13).

Image of MaritimeCONTROL screen showing ENC overlay of the Two-Way route and route adherence area penetration boundaries. The top right of the screen shows visual potential grounding alerts for Trinity Bay as a result of its breach of the green area boundary around Harrington Reef and Wyborn Reef.
