Grounding of *Hagen Oldendorff*

Port Hedland, Western Australia on 9 April 2022

ATSB Transport Safety Report

MO-2022-007

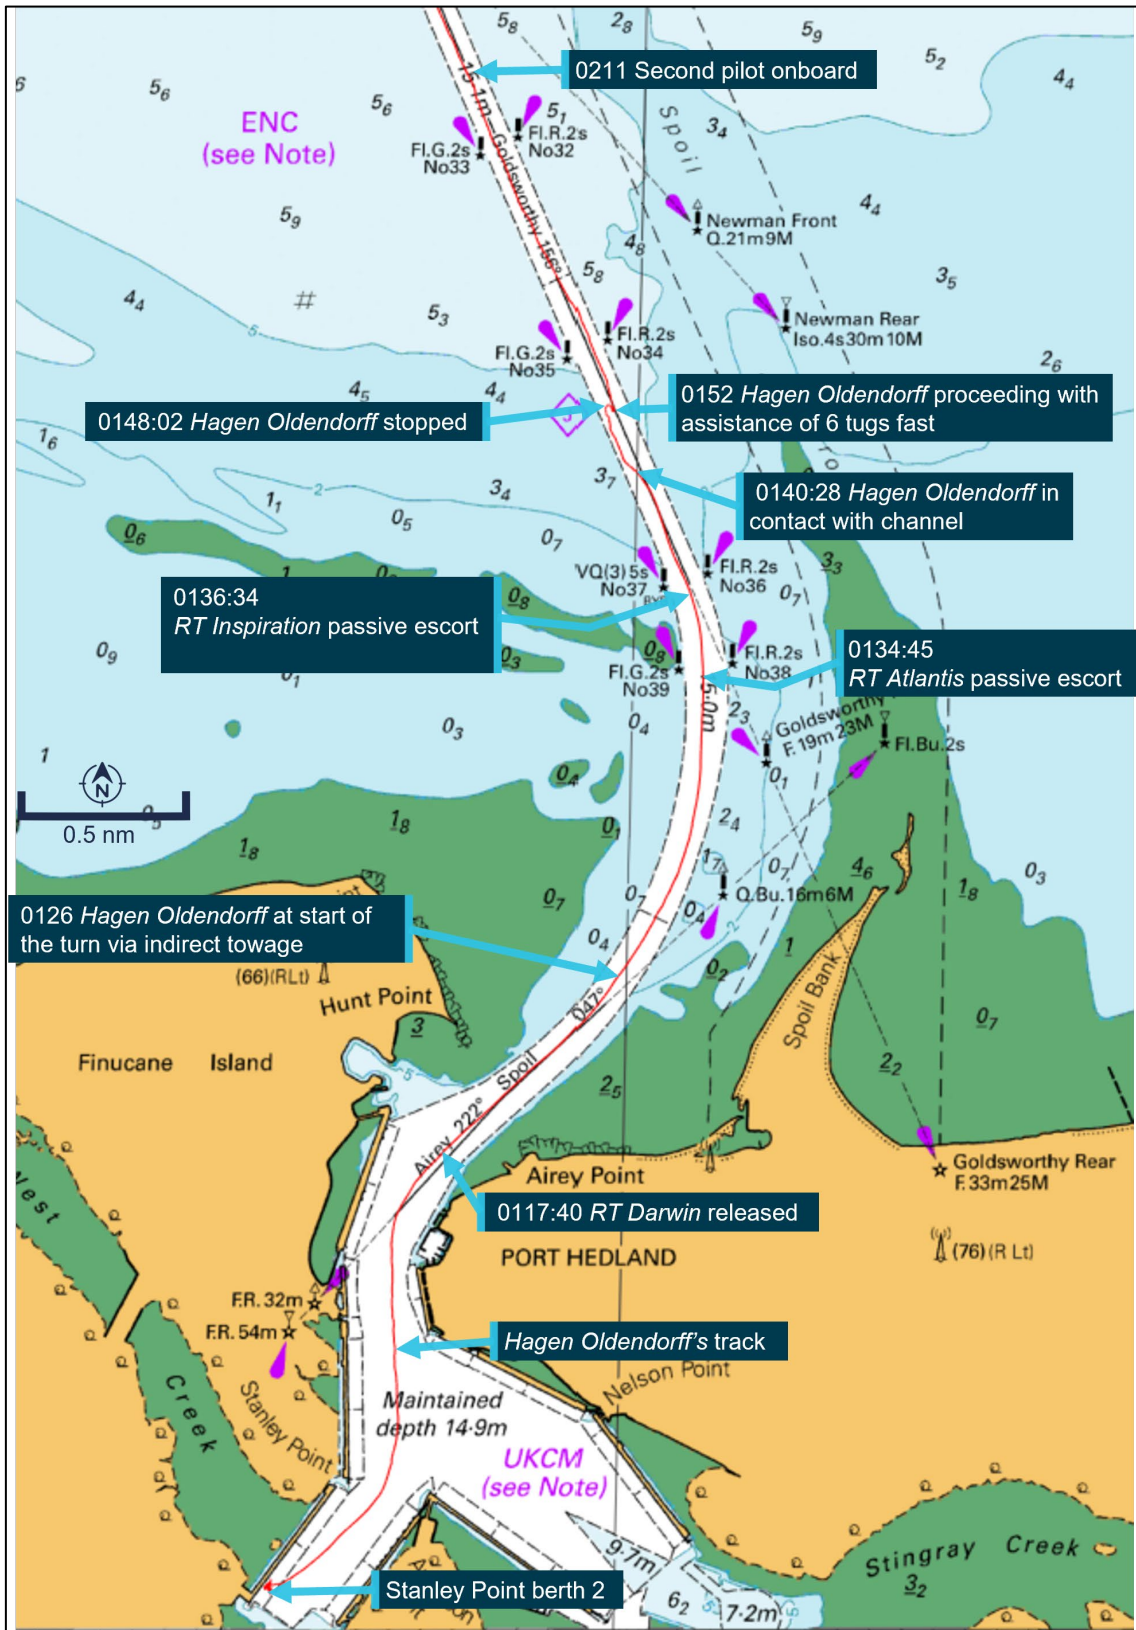
Figure 3: *Hagen Oldendorff's* track showing location of key events

At about that time, *Hagen Oldendorff* was passing beacons 36-37 in the Goldsworthy channel (Figure 3), turning to port at a rate of turn (RoT)⁸ of about 4° per minute and its speed was 6.7 knots, with the main engine set to full ahead (51 RPM). The aft tug was being utilised to control the RoT and steady the ship on the Goldsworthy leading lights (leads) line (aligned 156°-336°). At 0137:26, the ship was steady on a heading⁹ of about 334° and its course over ground was 336°, when the pilot ordered starboard 10° (Table 1).

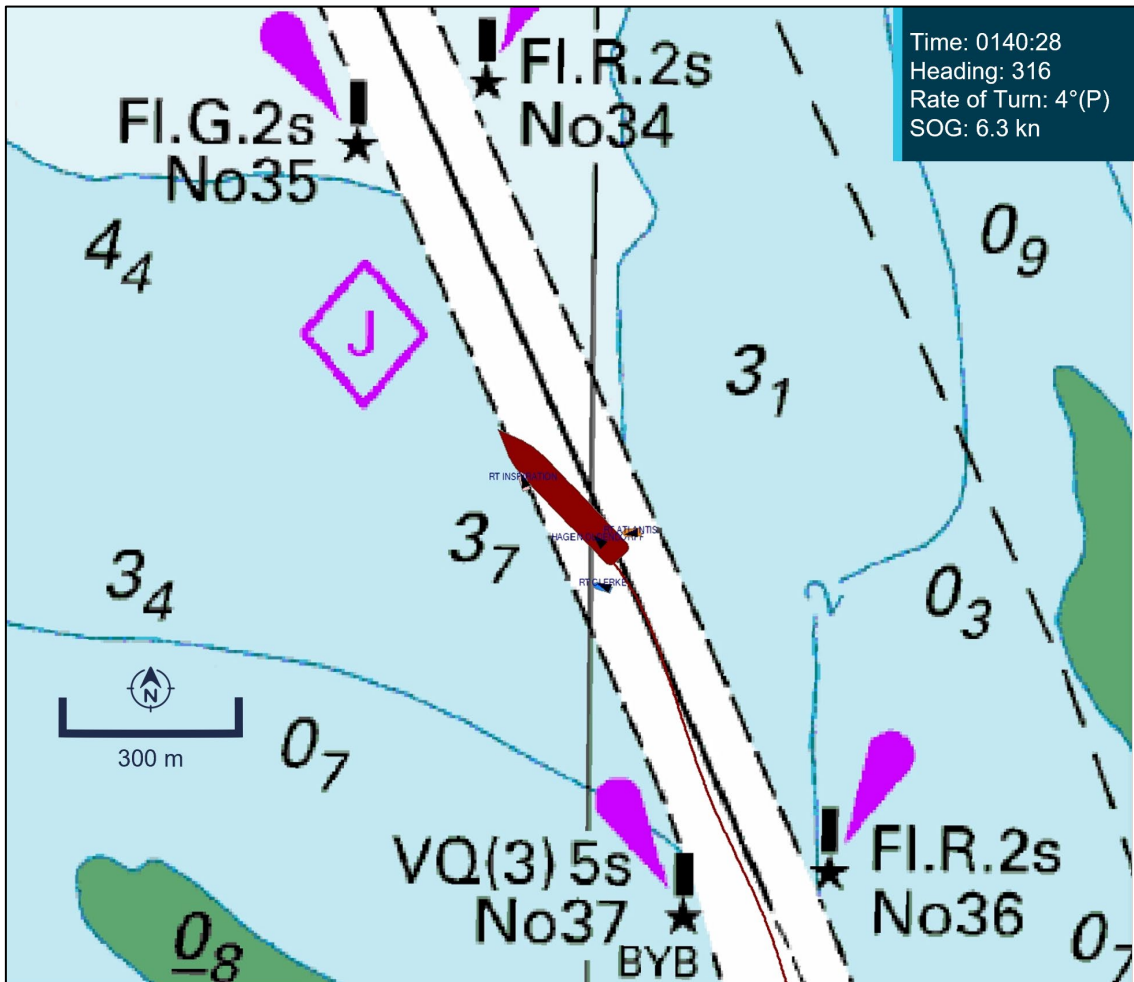
Shortly after 0140:28, there was a sharp reduction in both the ship's speed and its RoT to port. Recorded data confirmed that the ship had contacted the steep channel batter (the side of the navigable channel) (Figure 4). The ship's bow then swung away from the side of the channel to starboard. In less than a minute, the RoT had increased to 19°(starboard). The ship's speed at that time was 4.8 knots (Table 1).

Figure 4: *Hagen Oldendorff's* position at 0140:28, close to the time of grounding

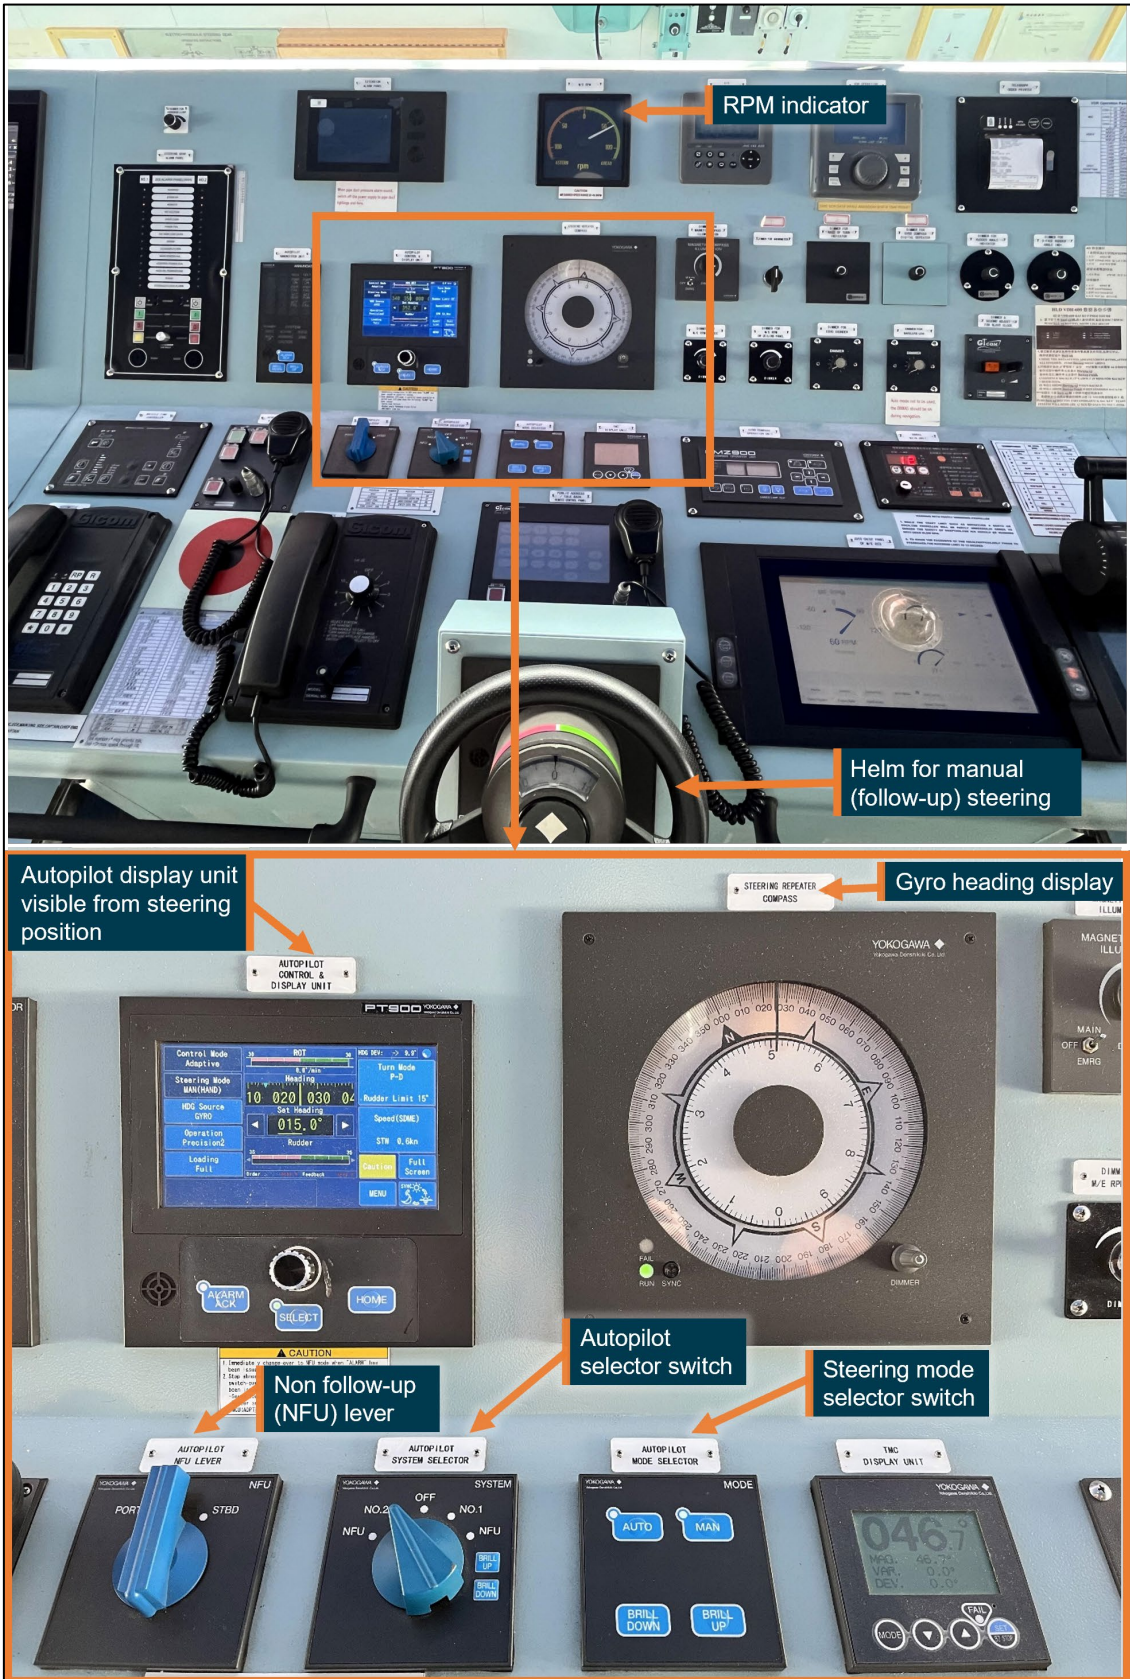
The autopilot display unit had an electronic rudder angle indication available (Figure 5) with its own independent power supply. The rudder (helm) order and feedback could be viewed on the display.

Figure 5: Hagen Oldendorff's bridge console layout showing the control and display unit

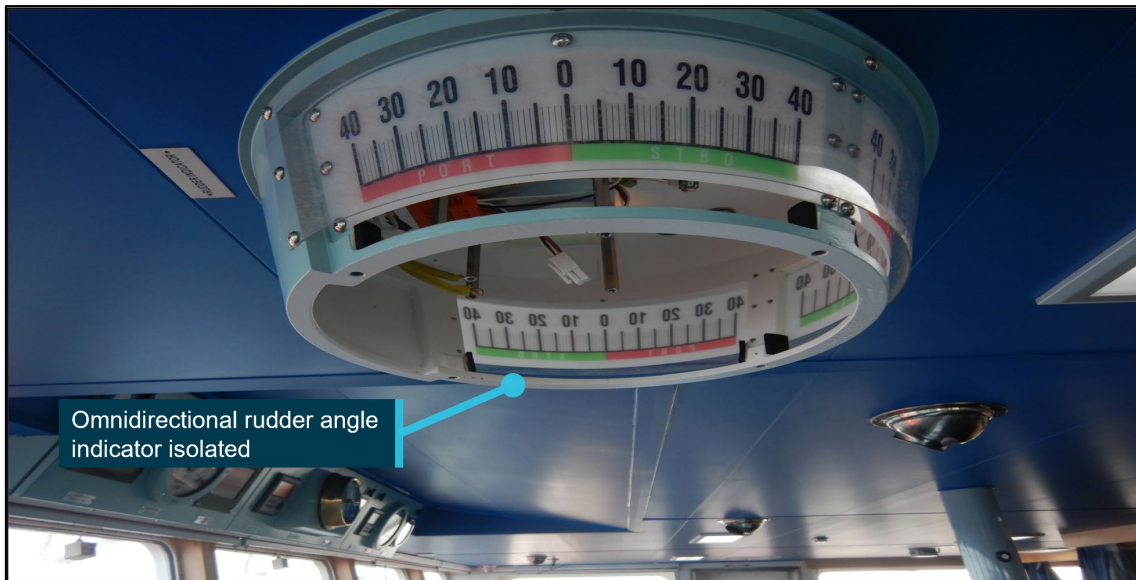
The post-incident shipboard investigation identified that the tracking motor of the omnidirectional rudder angle indicator (Figure 6) had burnt out, causing a short circuit. This short circuit tripped the common circuit breaker in the bridge cabinet. Hence, all rudder angle indicators lost power and stopped functioning at the time of the incident. Light and dimmers for the rudder angle indicators were also supplied from the same circuitry, resulting in the loss of all indicator illumination. When the omnidirectional indicator was isolated post-incident, all other rudder angle indicators were found to be functional.

Figure 6: Bridge omnidirectional rudder indicator (isolated and partly dismantled)
