Collision between truck and V/Line train 7727

Barwon Terrace level crossing, South Geelong, Victoria on 03 April 2023

ATSB Transport Safety Report
Rail Occurrence Investigation (Defined)
RO-2023-003
[Preliminary – 28 June 2023]

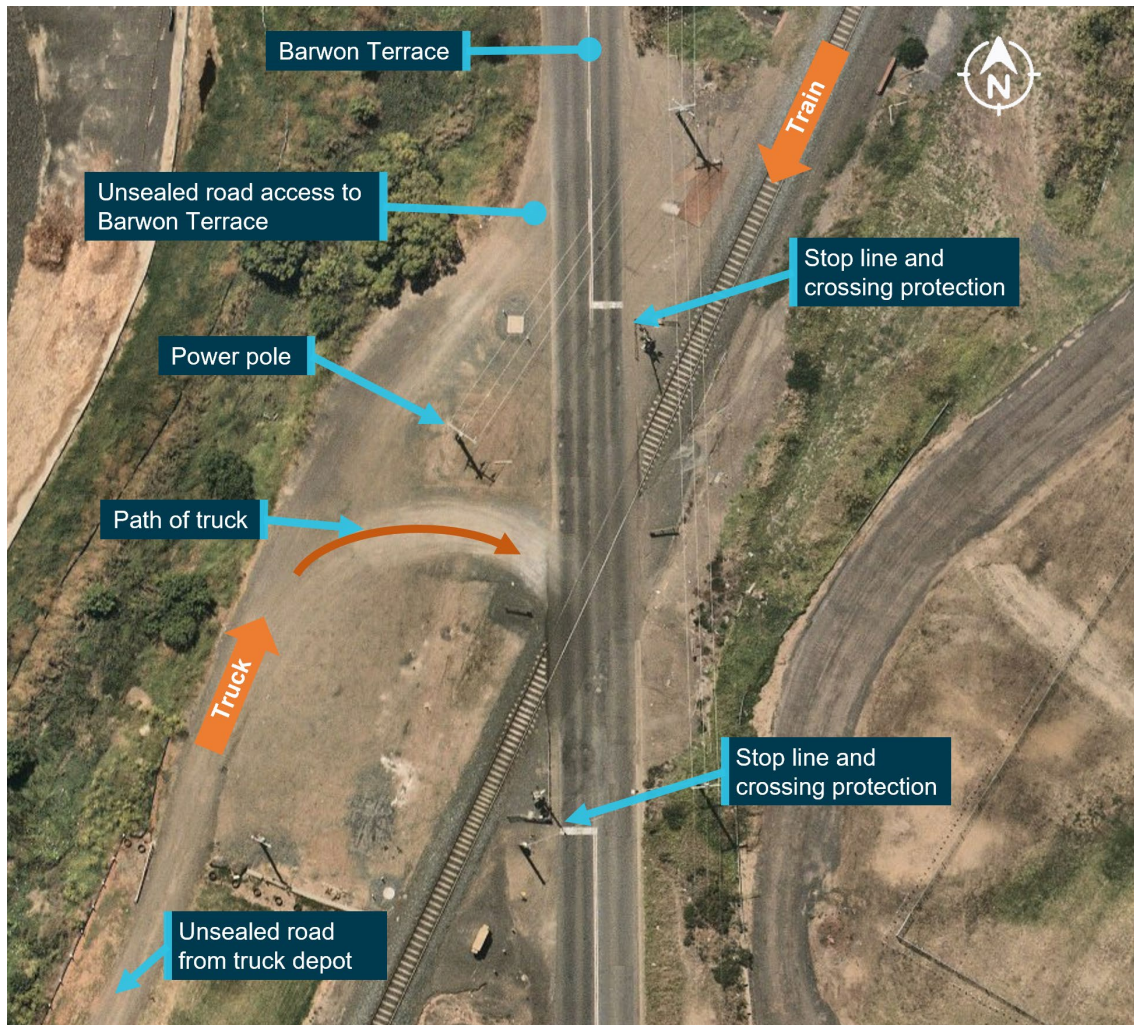
Figure 1: Direction of travel of truck and train and location of level crossing

After travelling along the unsealed road towards Barwon Terrace, the truck proceeded onto the level crossing between the boom barriers and stop lines located on either side of the crossing (Figure 1).

The unsealed road used to access the truck depot widened at its intersection with Barwon Terrace. There was evidence of at least two routes being used by road traffic (Figure 1). One route joined Barwon Terrace north of the protecting boom barrier. A second route (taken by the truck on this day) joined Barwon Terrace between the boom barriers. Tyre tracks on the unsealed road indicated that this second route was in regular use.

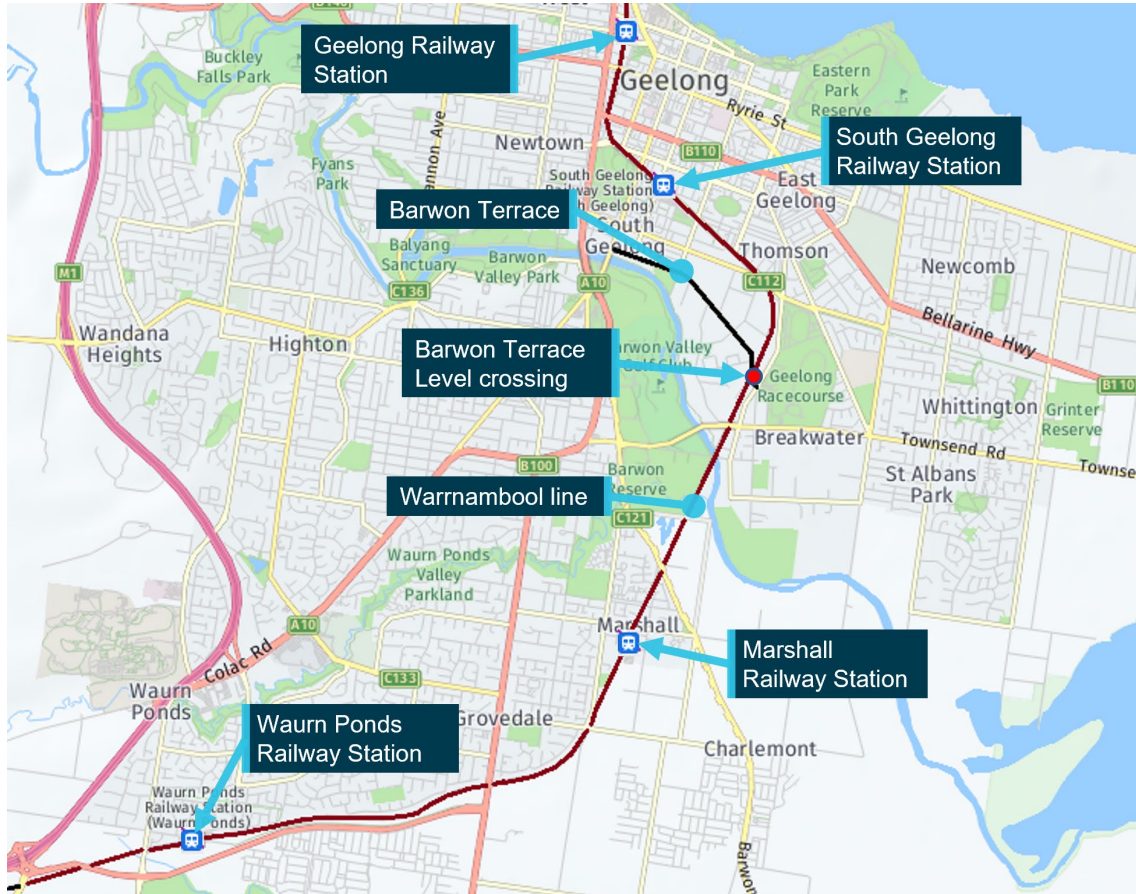
Figure 2: Train route and location of Barwon Terrace level crossing

Earlier at about 0631, V/Line train 7727, an empty six-car set with only the driver and a conductor on board, departed Geelong Railway Station towards Waurn Ponds (Figure 2). The train was being taken to Waurn Ponds Railway Station for a passenger service to Melbourne. As the train was being relocated, it did not stop at South Geelong Railway Station.

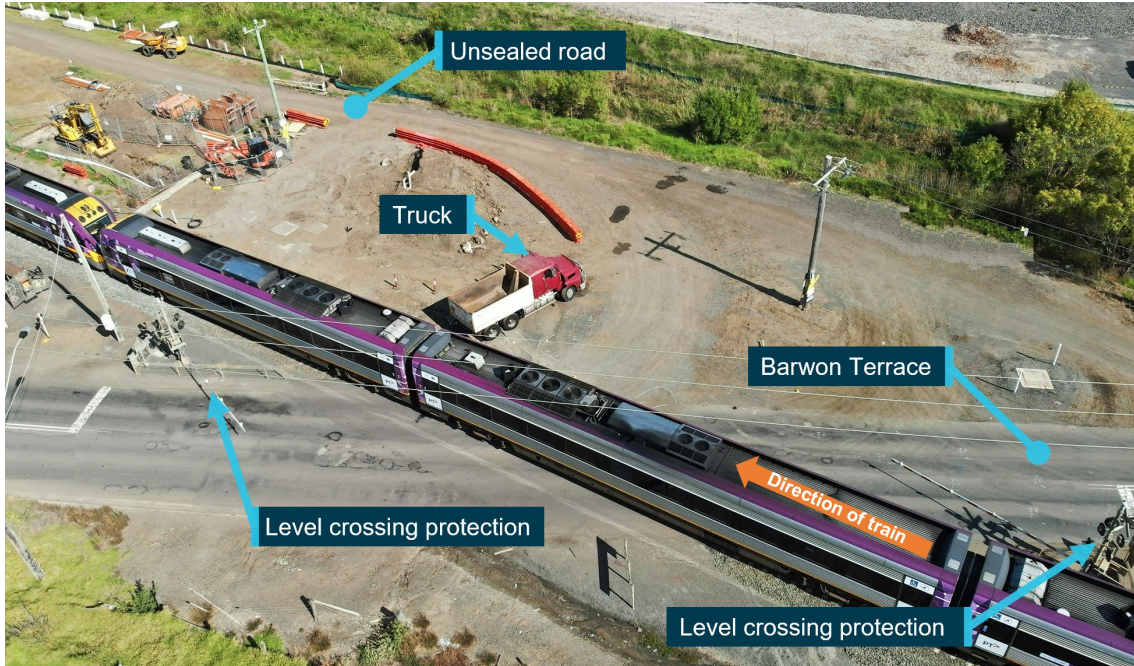
Figure 3: Location of truck and train after the collision

The force of impact caused the truck to spin around in a clockwise direction (Figure 3) and the driver was fatally injured. The truck sustained substantial damage.

The train sustained minor damage to its front, did not derail and was able to be driven to the Waurn Ponds stabling yard. The train driver and the conductor were not injured.

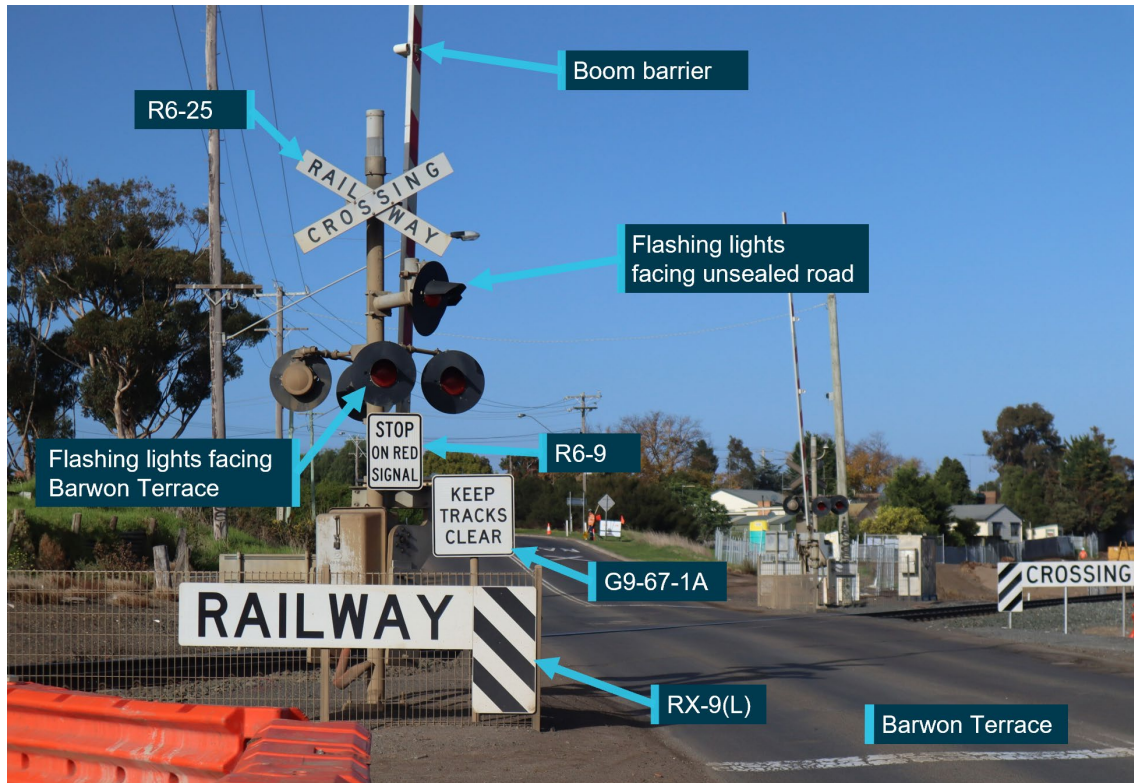
Figure 4 - Level crossing protection equipment at the Barwon Terrace level crossing

The protection equipment at the level crossing consisted of boom barriers, flashing lights, warning bells and warning signage on each side of the crossing (Figure 4). The warning signage consisted of a Railway Crossing combination sign (R6-25), a Stop on Red Signal sign (R6-9), a Keep Tracks Clear Sign (G9-67-1A) and a Railway crossing with marker assembly sign [RX-9(L)].

The level crossing protection was observed to be working at the time of the collision.

The level crossing warning lights at the northern end of the crossing consisted of two sets of red flashing lights. One set of lights faced north along Barwon Terrace. A second set of flashing lights faced across Barwon Terrace towards the northern end of the intersecting unsealed road.
