Loss of control involving a Robinson R44, VH-RYO

Moorabbin Airport, Victoria, 3 January 2013

ATSB Transport Safety Report
Aviation Occurrence Investigation
AO-2013-005
Final – 23 April 2013

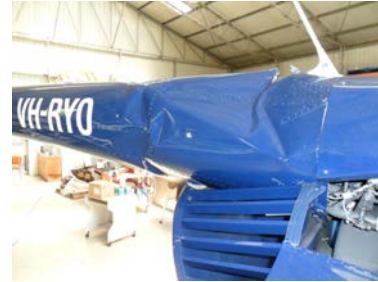
Helicopter damage

The student exited the helicopter. Fuel was observed spilling from the helicopter, but no fire resulted. The student received minor injuries and the helicopter sustained serious damage (Figure 1).

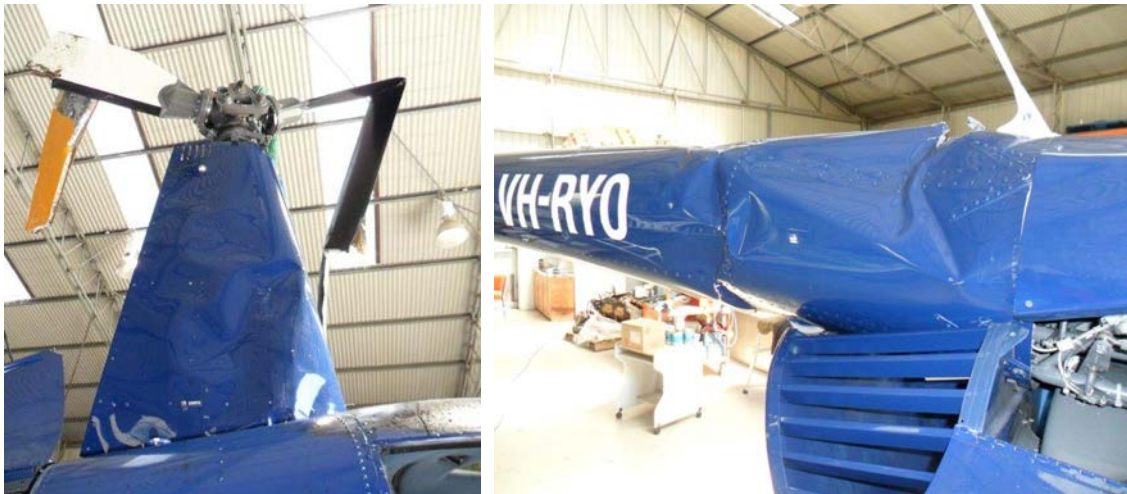
Figure 1: Helicopter damage

The student reported that he had applied an excessive amount of left cyclic and left yaw control pedal to compensate for the absence of the instructor in the left seat. This resulted in the helicopter sliding and yawing to the left, and the left skid contacting the ground. In an attempt to avoid a dynamic rollover⁴, the student inadvertently raised the collective, rather than lowering it to reject the takeoff. The student advised that he was aware of the correct procedure for reacting to an impending dynamic rollover, but for unknown reasons, he responded to the contrary.

A witness reported hearing the rotor RPM behaving erratically and observing the helicopter pitching and rolling. The tail boom contacted the ground several times and the helicopter then rotated around the tail and came to rest on its right side.
