Australian Government Australian Transport Safety Bureau

Loss of control involving a Robinson R22, VH-HVW

70 km SW of Lake Nash Station, Northern Territory, 1 September 2013

ATSB Transport Safety Report Aviation Occurrence Investigation AO-2013-137 Final – 8 April 2014 Released in accordance with section 25 of the Transport Safety Investigation Act 2003

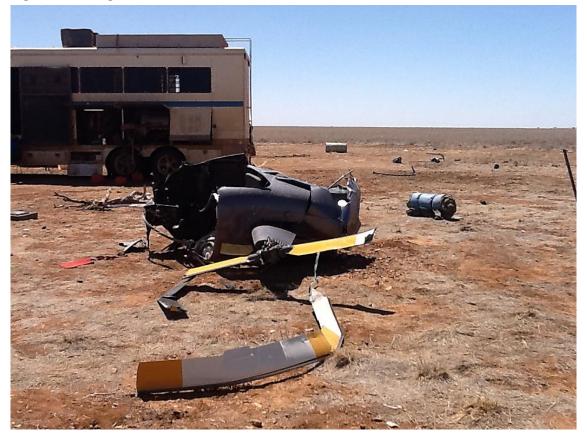
Figure 1: Damage to VH-HVW

Shortly after take-off, the helicopter was observed by witnesses at the stock camp to commence a steep climbing left turn. As the helicopter turned into a downwind position, a number of the witnesses reported that the wind appeared to affect the controllability of the aircraft. It appeared that the pilot attempted to respond to the situation, however, there was insufficient altitude to recover. The helicopter skids contacted the ground and became separated. The helicopter slid along the ground and then flipped over a number of times before coming to rest near the stock camp. During the accident sequence, the pilot was ejected from the helicopter and sustained serious injuries; the helicopter was destroyed (Figure 1).

The aircraft owner attended the accident site, and based on his observations and that of the witnesses, believed that when the helicopter was in a downwind position, a negative G¹ situation may have occurred. During the subsequent attempted recovery, the pilot appeared to have pushed the nose of the helicopter forward in an attempt to regain airspeed; however, the helicopter contacted the ground.
