Collision with terrain involving Van's Aircraft RV-6, VH-TXF

near Mudgee Airport, New South Wales | 14 September 2014

ATSB Transport Safety Report
Aviation Occurrence Investigation
AO-2014-149
Final – 15 January 2016

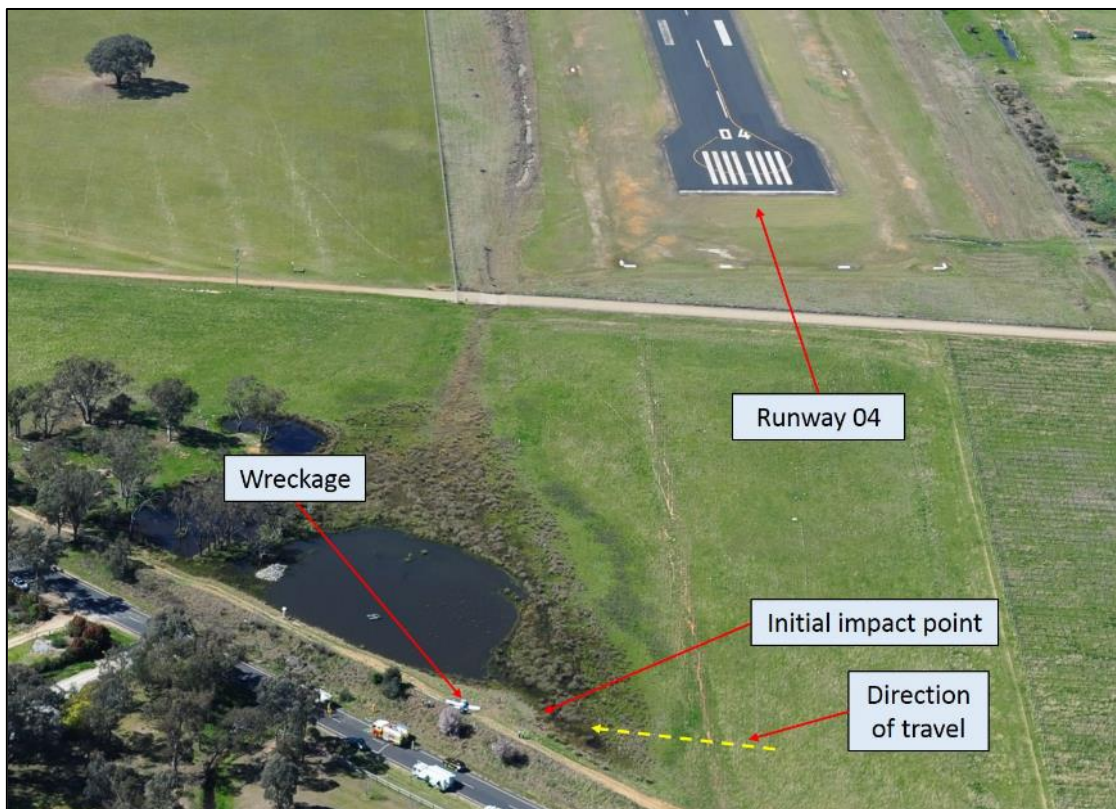
The aeroplane continued its high angle of bank left turn beyond the final approach heading and, at about 1053, collided with terrain about 300 m south-west and short of the threshold of runway 04 (Figure 1 and Figure 2). No witnesses reported seeing the aeroplane impact the terrain.

Figure 1: Aerial view of the accident site on the day, showing the threshold of runway 04 and direction of travel prior to impact

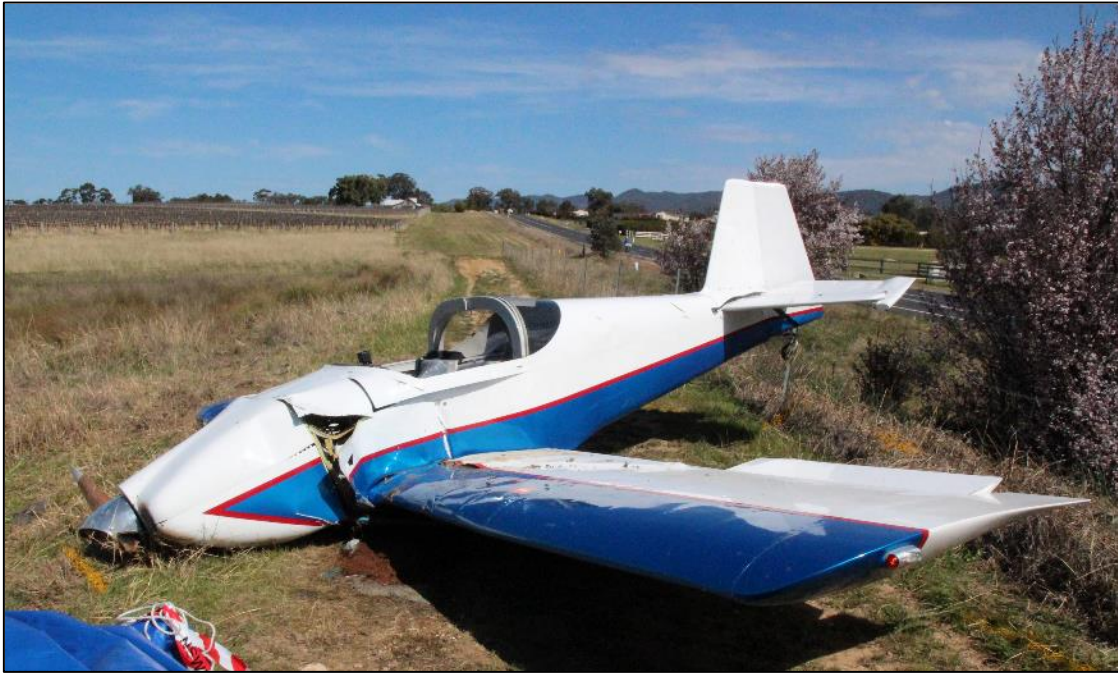
Figure 2: Accident site, looking east-south-east and showing the airport boundary fence

The aeroplane struck the ground in a north-westerly direction, coming to rest about 18 m beyond the initial impact point. The impact collapsed the aeroplane's fixed landing gear, damaged the engine, carburettor and air filter and ruptured the left wing fuel tank. The damage to the aeroplane and surrounding area indicated that the aeroplane impacted the ground in an upright, slightly left-wing low and nose-down attitude. All of the aeroplane's major components were accounted for at the site. No evidence of fire or pre-impact damage was observed and flight control continuity was verified.

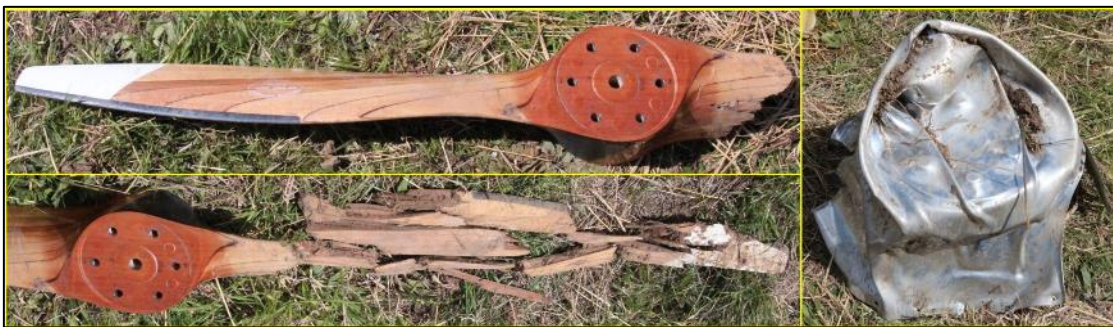
One blade of the aeroplane's two-bladed wooden propeller was broken off at the root and shattered (Figure 3). The other blade remained attached to the hub. The unbroken blade and metal spinner that covered the propeller hub exhibited no evidence of rotational scratch marks or power at impact.

Figure 3: Broken two-bladed propeller blade and metal spinner, showing the reconstructed detached/shattered blade

The witness accounts of the engine being silent during the turn onto final approach, and the lack of rotational signatures on the propeller, indicates that the engine was not operating when the aeroplane collided with terrain. No defects were identified that would have precluded normal engine operation prior to the accident, and uncontaminated fuel was being supplied to the engine at that time.

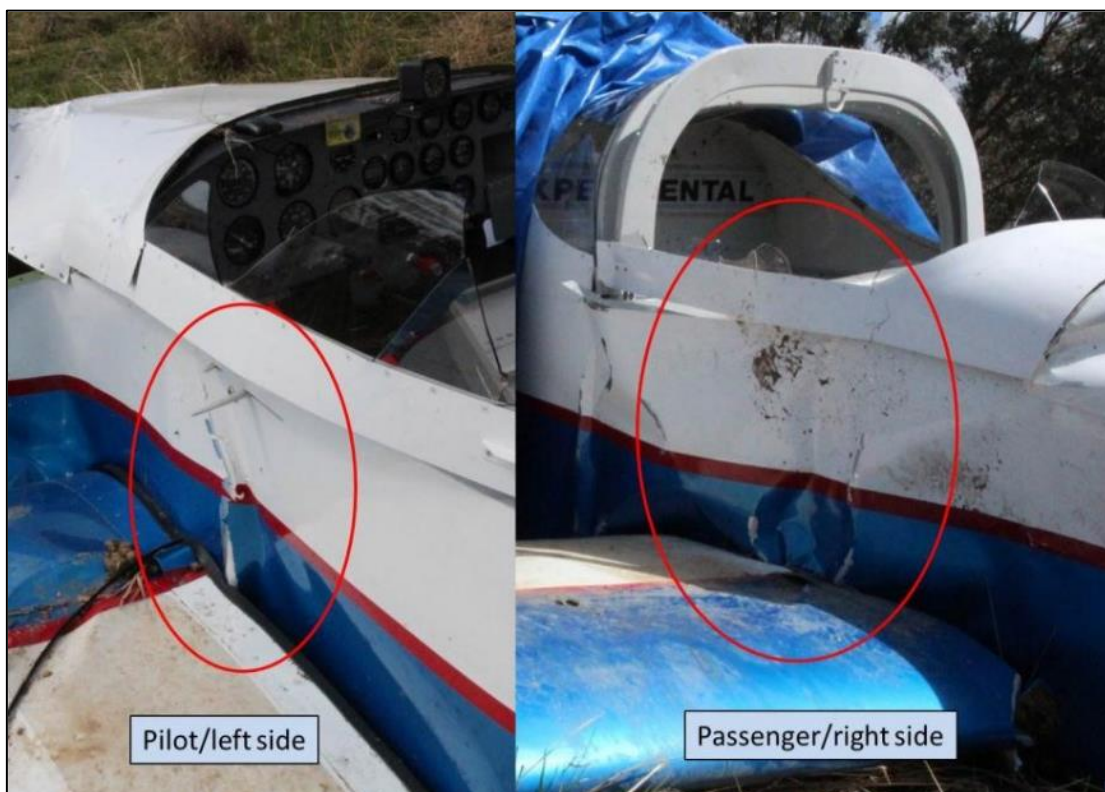
During the impact sequence, the sides of the cockpit buckled, reducing the liveable space and allowing the fuselage behind the pilot and passenger to move forward (Figure 4). As a result, both occupants’ shoulder harnesses slackened and the occupants were no longer adequately restrained. Together with the effect of the estimated impact forces imparted to the occupants, this reduction in liveable space meant that the accident was considered not survivable.

Figure 4: Cockpit region showing buckling alongside the left and right seats

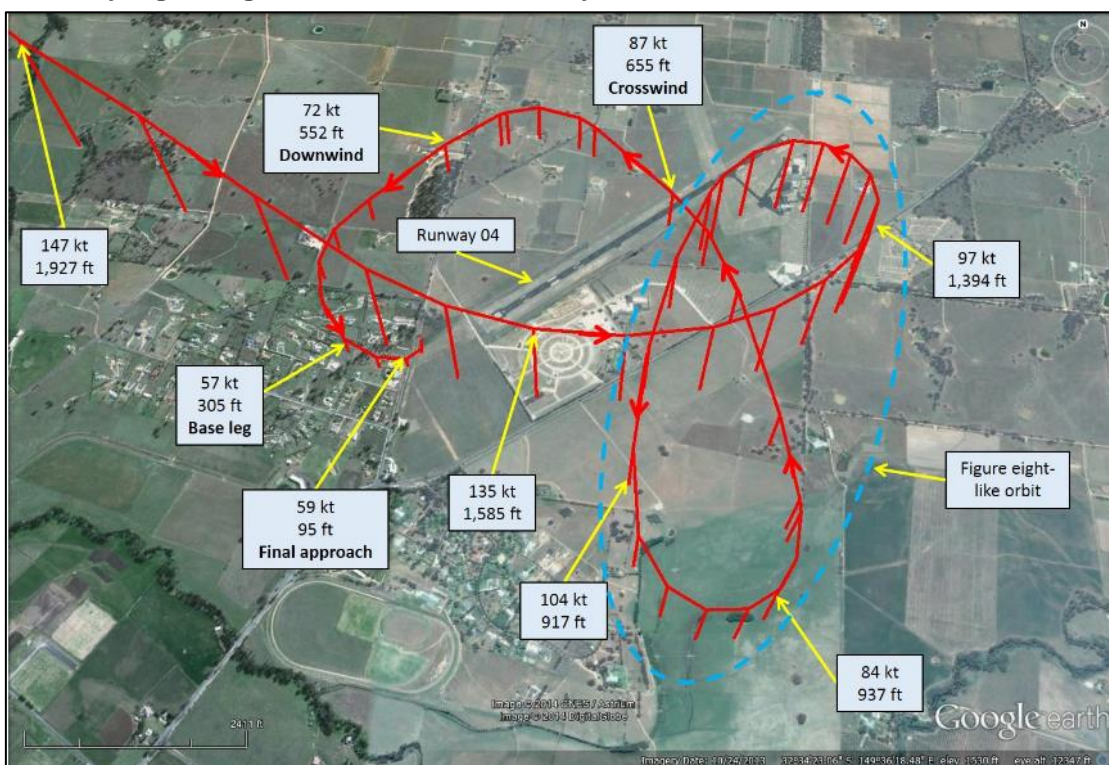
The data for the day of the accident commenced at about 1019 and showed the path taken by the pilot from start-up at Dubbo Airport to the approach at Mudgee Airport. ATSB analysis of this data determined the aircraft’s height above ground, ground speed and heading at the various data points. This included the circuit entry at Mudgee, a southerly, figure eight-like orbit prior to the aeroplane joining the downwind leg of the circuit and the turn onto final approach to land as described by witnesses (Figure 5).

Figure 5: ATSB analysis of the recorded GPS data for the flight showing the aircraft’s heading, height above ground, and ground speed at various data points. The area of the southerly, figure eight-like orbit is indicated by a dashed blue border

of the aeroplane from entering the circuit, through to the landing. None of the approaches analysed displayed a similar figure eight-like orbit prior to joining the crosswind leg as was done on arrival at Mudgee (Figure 5).

- a bank angle of about 48°
- a descent rate of 1,770 ft/min
- an airspeed of 59 kt (4 kt below the target approach speed)
- an accelerated stall speed of 58 kt.

In combination these findings indicated that the aeroplane's airspeed was about 1 kt above the calculated accelerated stall speed, or within about 0.5 kt when considering the aeroplane's increased weight, which was above the kit manufacturer's recommended gross weight.

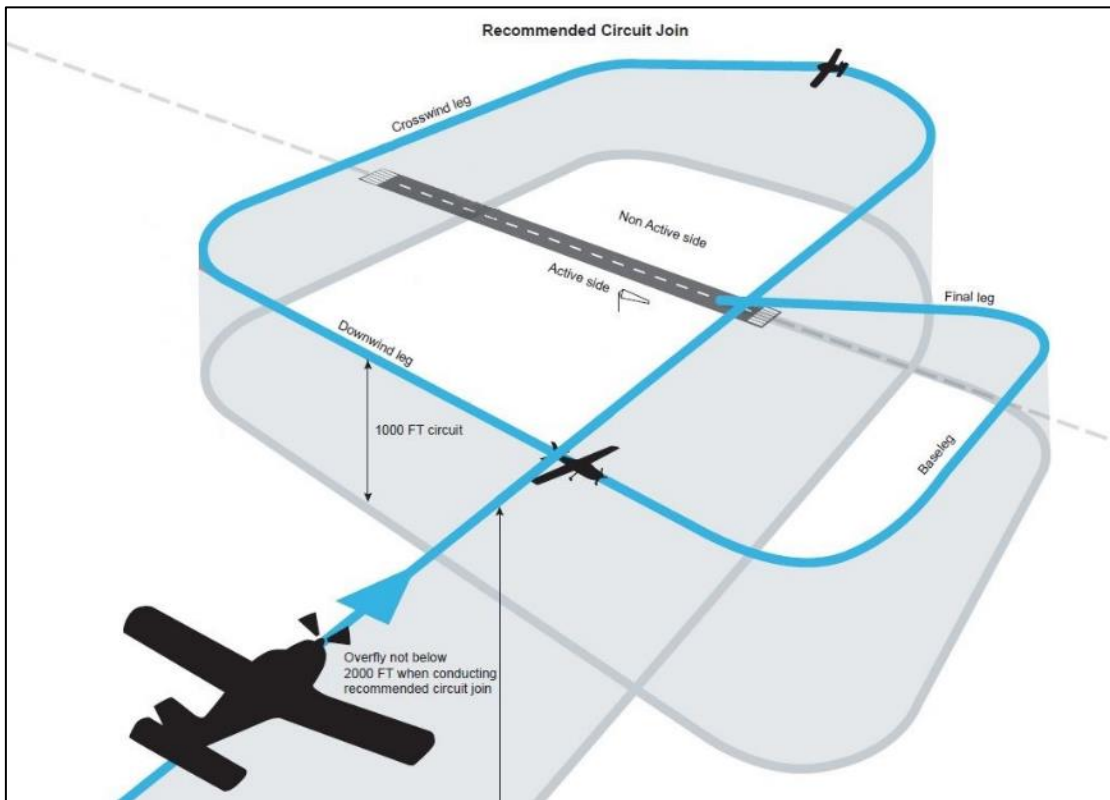
Among other guidance, CASA Civil Aviation Advisory Publication (CAAP) 166-1(3) *Operations in the vicinity of non-controlled aerodromes* strongly recommended the use of standard circuit procedures at all non-controlled aerodromes.¹² Standard traffic circuit procedures were designed to facilitate orderly flow of aircraft traffic. Given these standard traffic circuit procedures, other aircraft operating in the vicinity of the aerodrome would have a reasonable expectancy of where to locate other joining and circuit traffic, informing affected pilots’ ‘see and avoid’ procedures (Figure 6). The traffic entry procedure generally consisted of overflying the aerodrome to ascertain the wind direction and which runway was in use by other aircraft, before joining a circuit pattern for landing.

Figure 6: Circuit entry procedures – non-controlled aerodrome

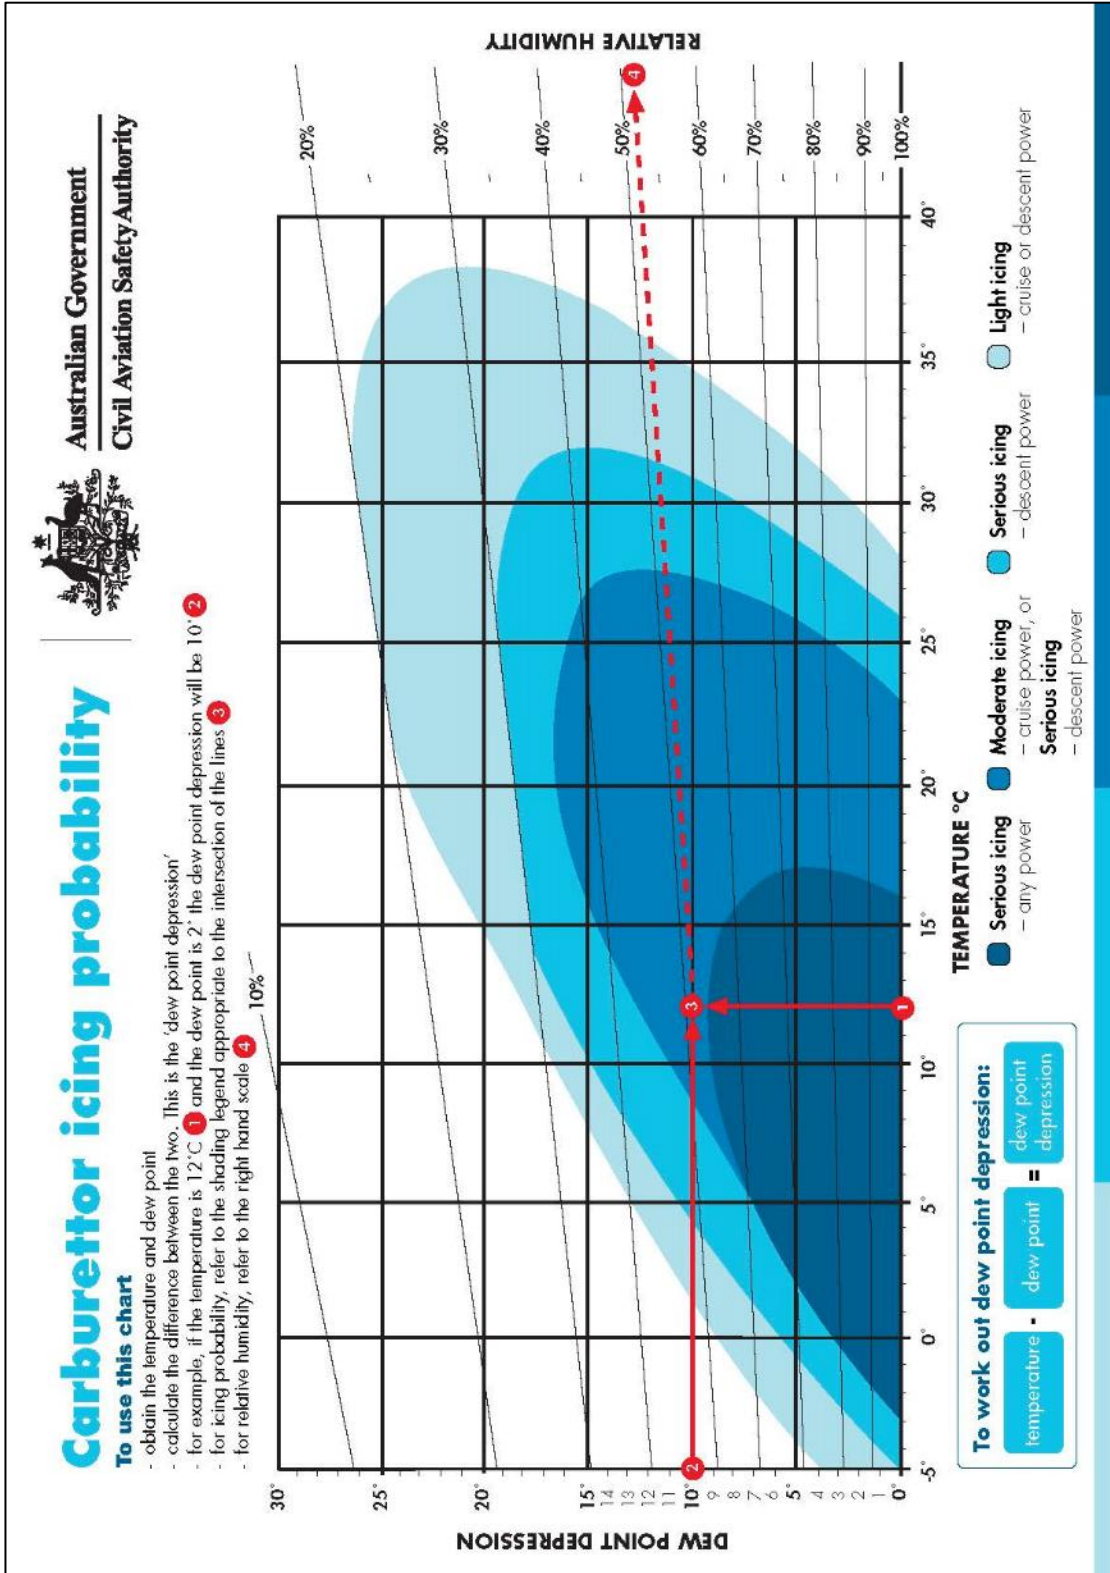
The observed weather at Mudgee Airport at the time was fine with a 6 kt breeze from the north and no cloud in the vicinity. The recorded temperature at about the time of the accident was 17 °C, with a dew point⁷ of 11 °C. Given those temperatures, the probability of carburettor icing was calculated to be in the serious icing range for descent power, and moderate icing with cruise power selected (see *appendix A – Carburettor icing-probability chart*, available from the Civil Aviation Safety Authority (CASA) website at www.casa.gov.au).

Conditions around the time of the accident were conducive to serious carburettor icing at descent power, such as during the circuit and approach onto final. In combination, the as-found positions of the carburettor heat control in the depressed OFF position, and of the surrounding push/pull controls in the pulled-out positions, were consistent with the carburettor heat control being in the OFF position before impact. In this case, it is probable that the air temperature in the carburettor was in the icing range and that carburettor ice would have formed. Although the pilot was reported in the habit of using carburettor heat at lower power settings, it is possible they forgot on this occasion, or were not aware of the suitability of the environmental conditions for carburettor icing.

Appendix A – Carburettor icing-probability chart
